GORT HISTORIC LANDFILL - H0181-01

RESPONSE TO REQUEST FOR INFORMATION

Prepared for: Galway County Council

Date: November 2022

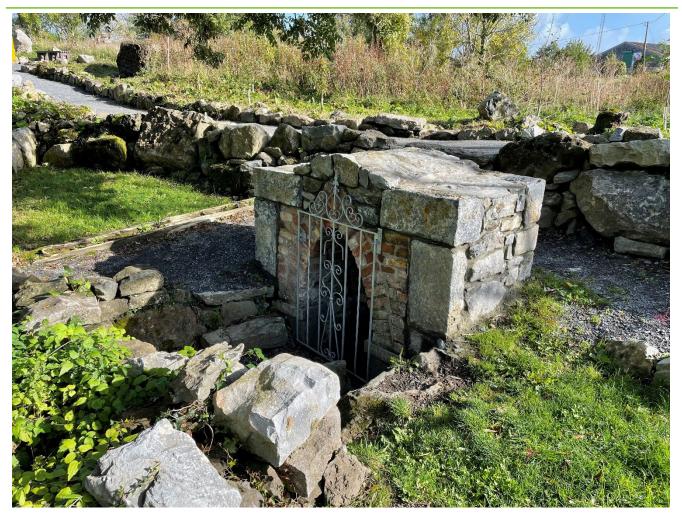
Figure 2-1: St Machan's Holy Well

The location of the Holy Well is included on the Drawing contained in Appendix 4. A photo of the well is shown in Figure 2.1.

FT confirms groundwater monitoring results for Samples No. 22408528 and 517824 refers to the Holy Well identified in Photo No. 1 and 2 of Appendix 2 'Site Walkover Checklist and Photographic Log' of the updated Tier 2 Assessment.

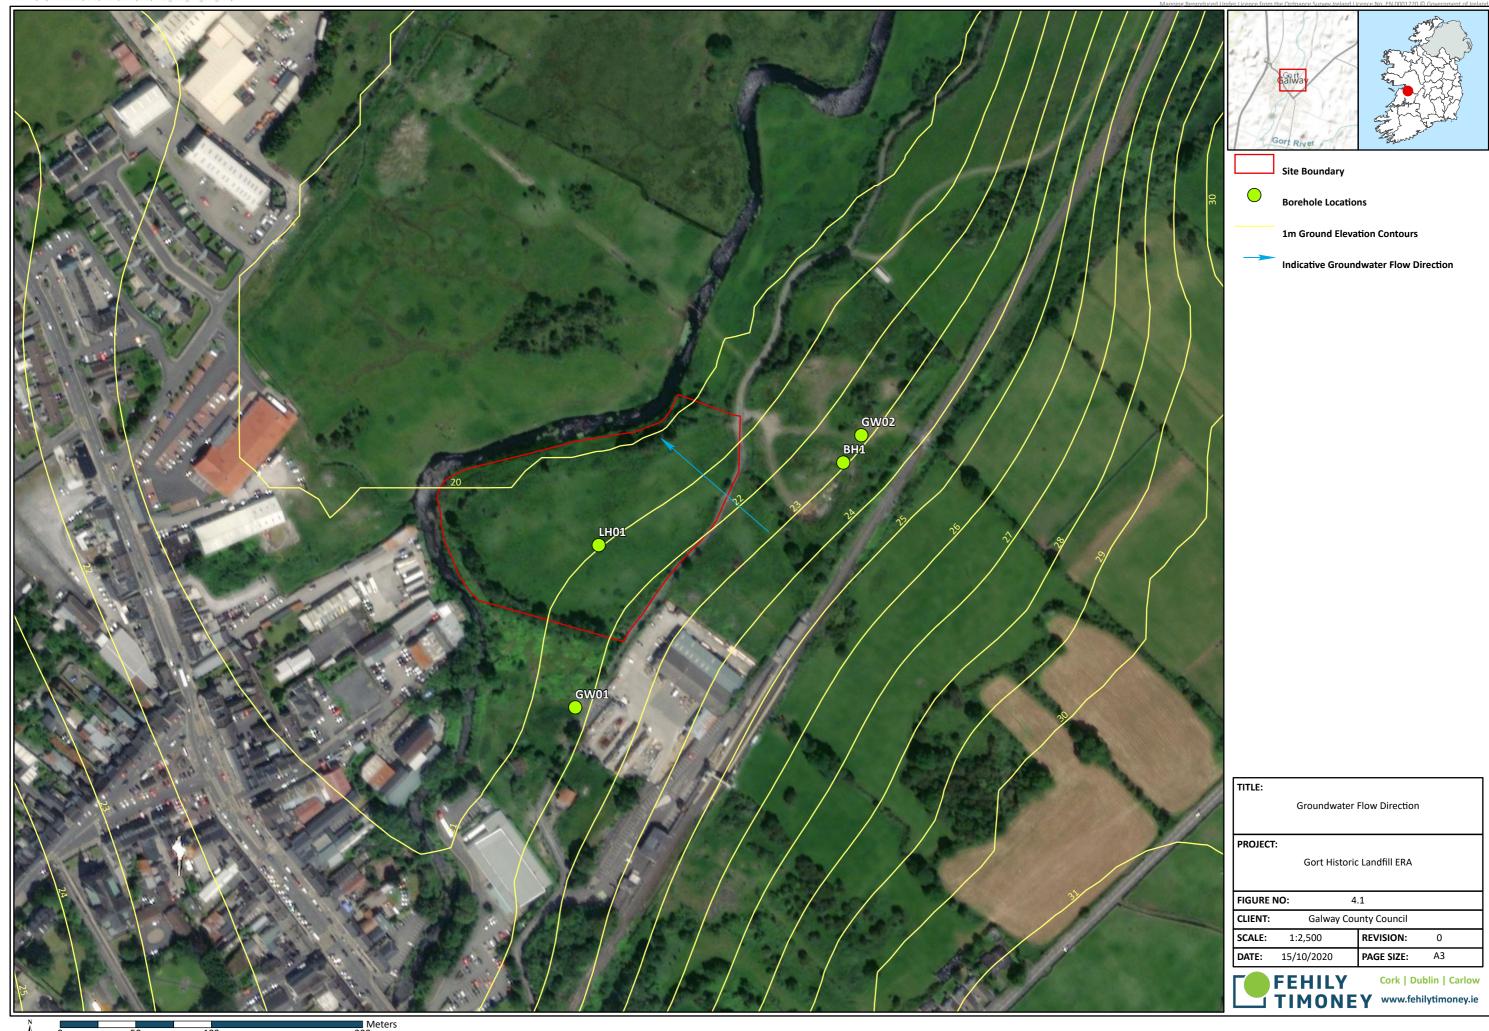
Figure No. 4.1 'Groundwater Flow Direction'

FT confirms the direction of the groundwater flow is south-east to north-west towards the River Gort.

Figure 4.1 'Groundwater Flow Direction' shows the correct direction of groundwater flow is included in Appendix 3.
