# APPENDIX 1

Site Walkover Checklist and  
Photographic Log

# PHOTOGRAPHIC LOG

Gort Historic Landfill  
Gort Co. Galway  
**Geophysical Survey**

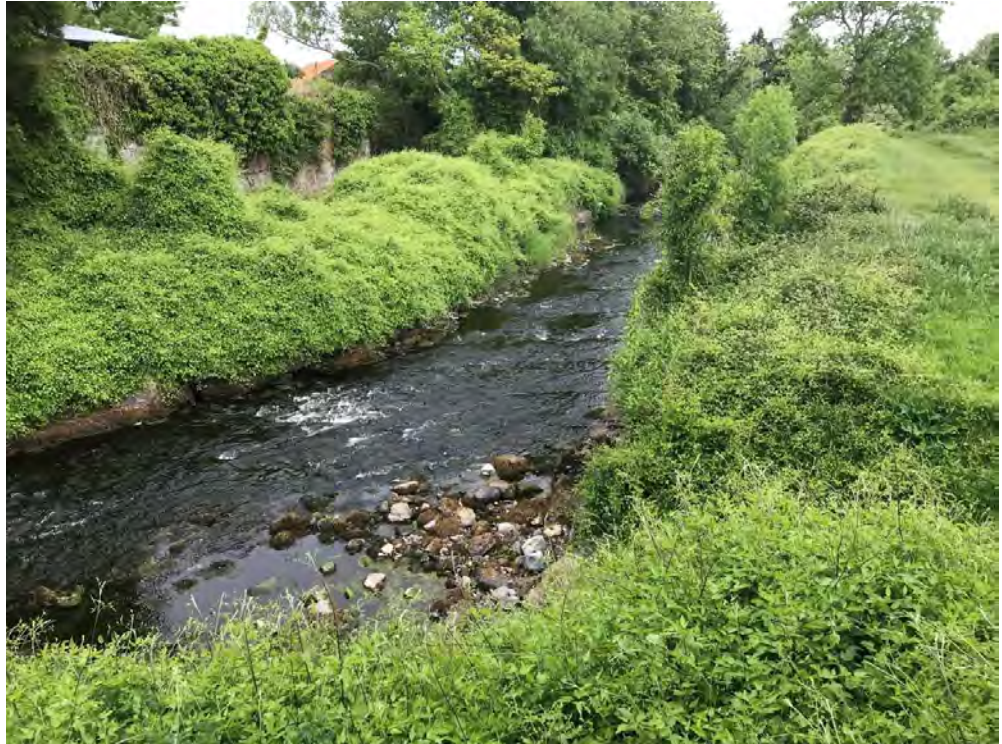
**Photo No.**  
**1**

River upstream, near Holy Well, potential monitoring location

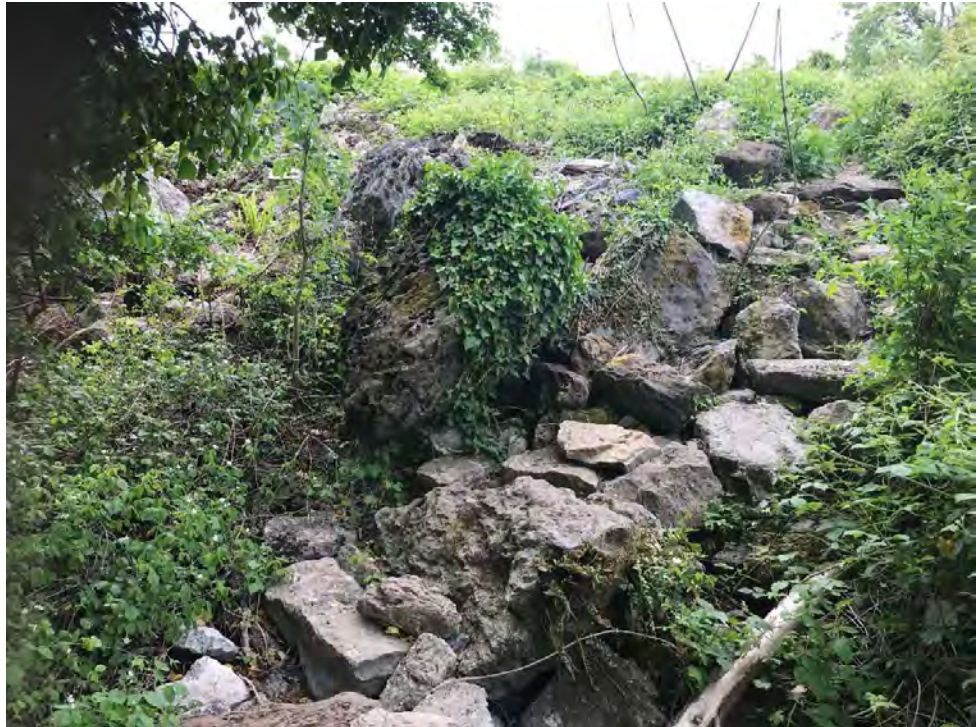
**Photo No.**  
**3**

Deposition of stone/construction and demolition waste to land adjacent the landfill area

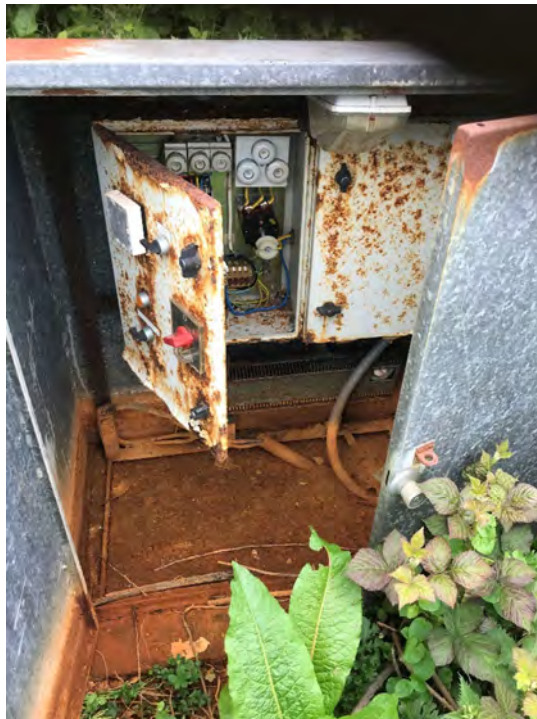
**Photo No.**  
**4**

Control cabinet with ESB metered connection, assumed pump controller, ON Off Auto settings

9. Are there any indications of remedial measures? (Provide details)		
Capping	✓	Site capped with soil
Landfill gas collection	✓	No
Leachate collection	✓	Yes, abandoned leachate collection and pumping system, pump control unit, manhole, rising main see Photolog

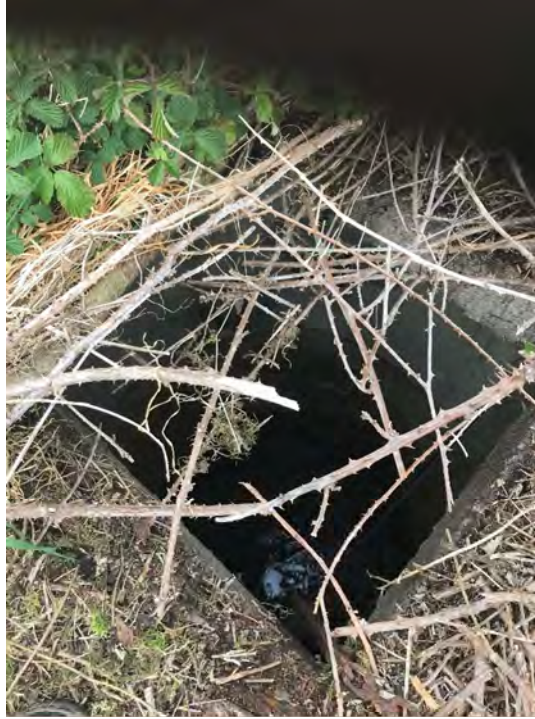
**Photo No.**  
5

Pump sump (dilapidated), assumed leachate management system, note level sensor cable, gate valve non return valve.

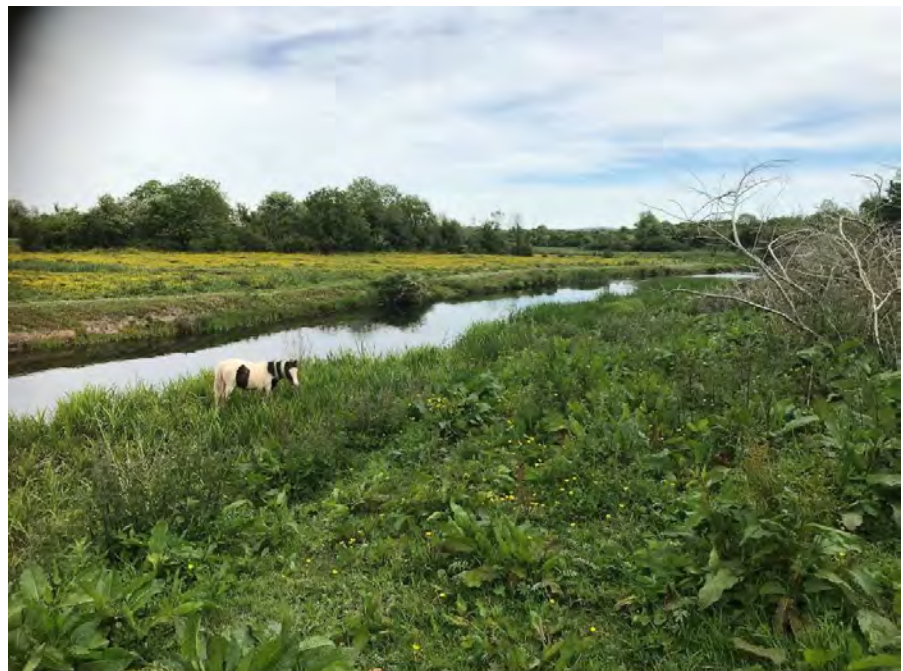
**Photo No.**  
6

Landfill adjacent to river bank

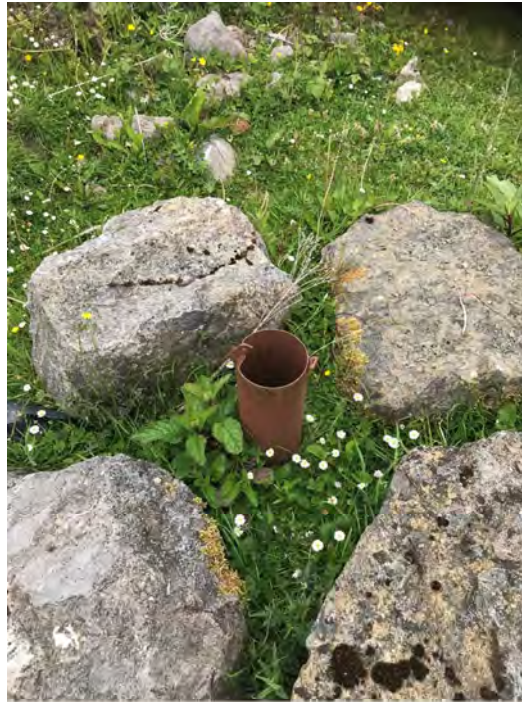
**Photo No.**  
**9**

Groundwater monitoring infrastructure to North East of site

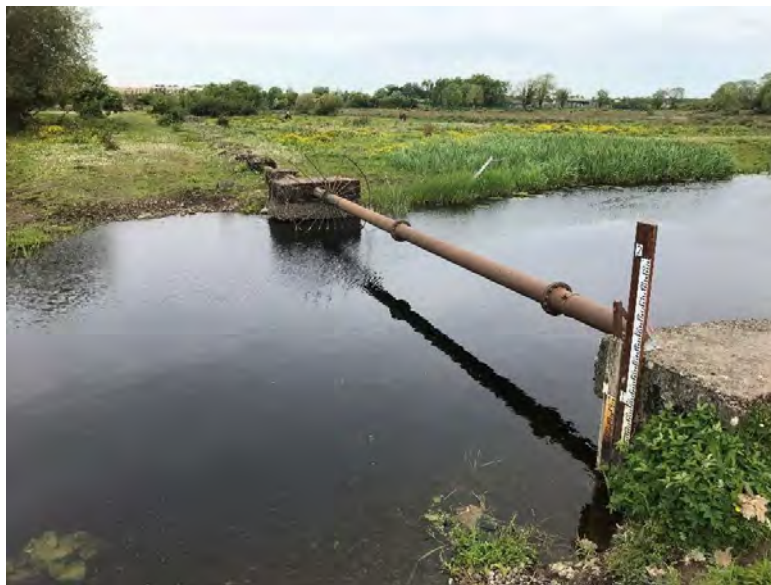
**Photo No.**  
**10**

Foul water main river crossing – Potential downstream monitoring location

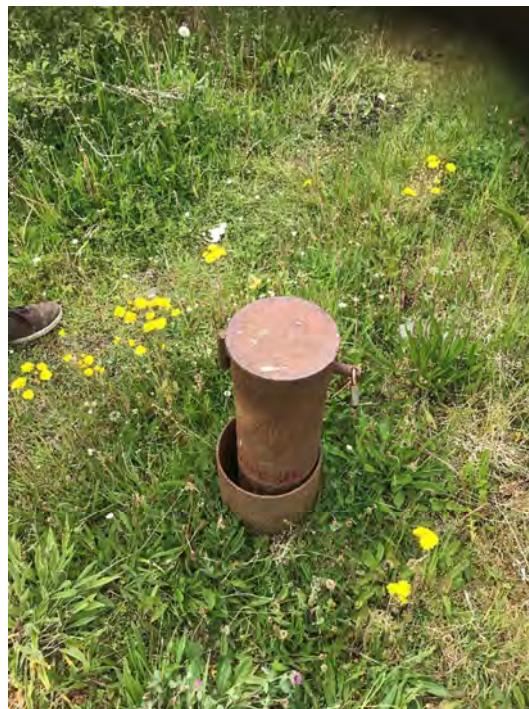
**Photo No.**  
**12**

**Description:**  
Groundwater monitoring  
borehole at site entrance
