Causeway Geotechnical
Report

Galway Historic Landfills – Gort Ground Investigation

Report No.: 19-1465B

Date: August 2020

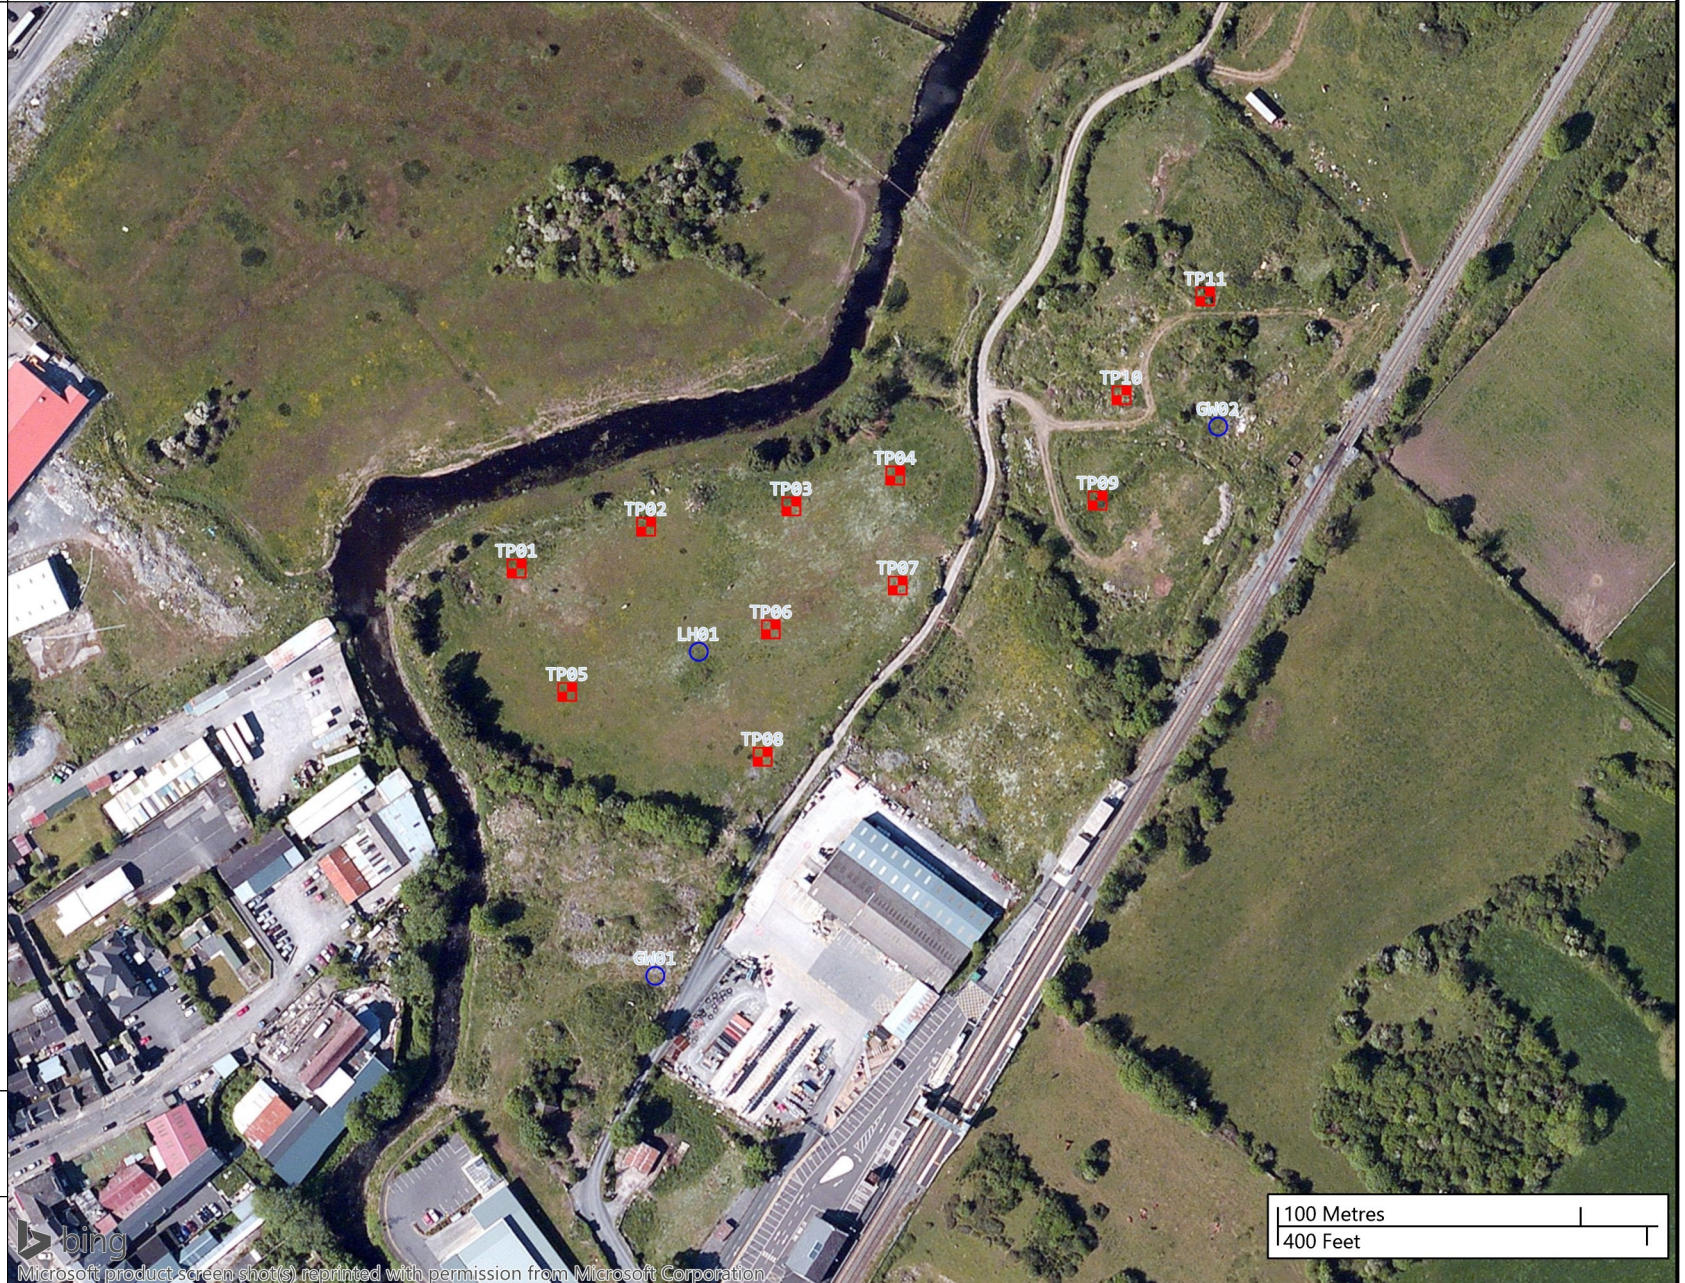
Title:
Exploratory Hole Location Plan

- Locations By Type - RO
- Locations By Type - TP

The exploratory holes and in-situ tests were located as instructed by the Client's Representative, as shown on the exploratory hole location plan in Appendix A.

The plan coordinates (Irish Transverse Mercator) and ground elevation (mOD Malin) at each location are recorded on the individual exploratory hole logs. The exploratory hole plan presented in Appendix A shows these as-built positions.
