HISTORIC LANDFILL AT GORT, CO. GALWAY

TIER 2 RISK ASSESSMENT

Prepared for: Galway County Council

Date: October 2022

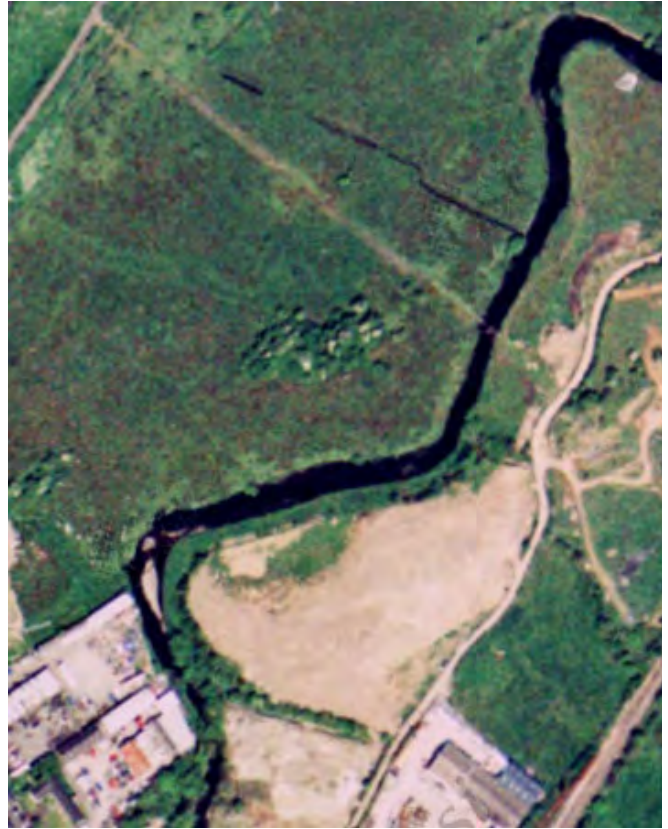
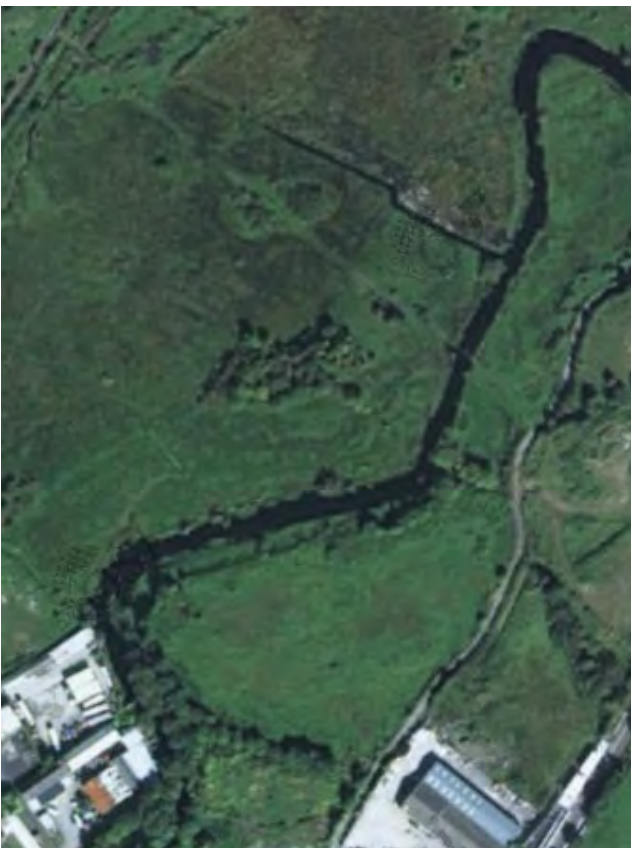
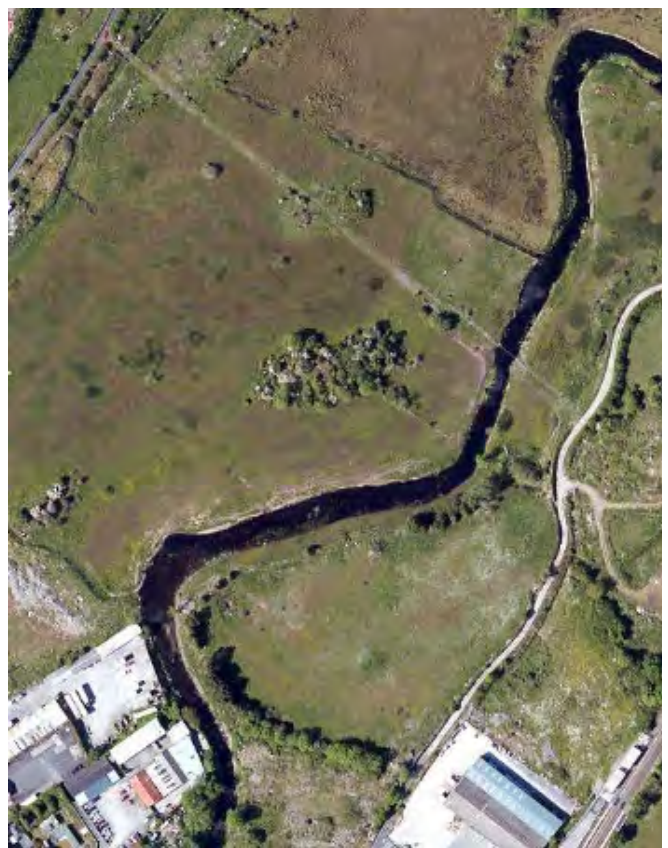
Figure 2-11: Historical Aerial Imagery¹

OSI aerial imagery, from 1995 and 2000, shows evidence of activity at the landfill site, while on imagery from 2005-2012 and 2011-2013 indicates this activity seems to have ceased.
