CAUSEWAY
— GEOTECH

GEOTECHNICAL LABORATORY TEST RESULTS

Project Name:	Galway Historic Landfills - Tuam
Project No.:	19-1465A
Client:	Galway County Council
Engineer:	Feehily Timoney

Tuam Historic Landfill
Tuam Co. Galway
Geophysical Survey

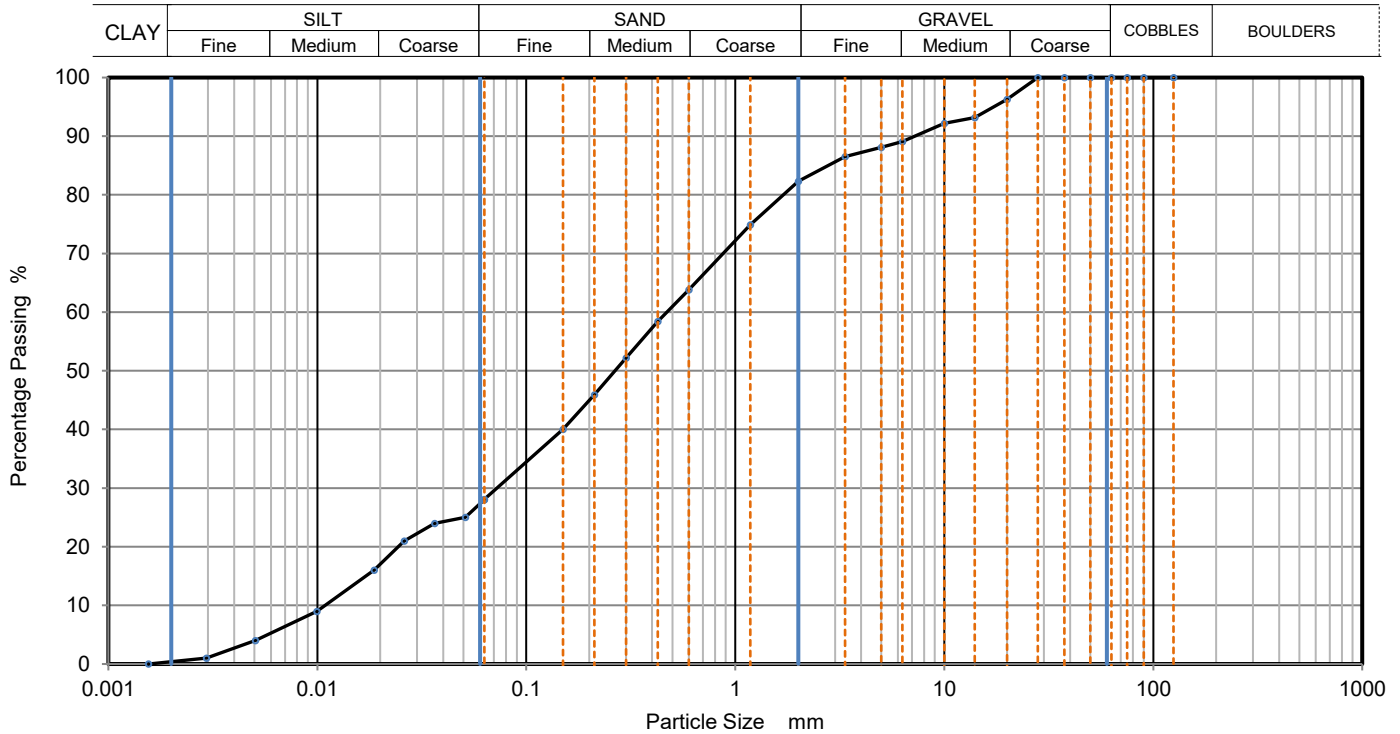
Test Method **BS1377:Part 2:1990, clauses 9.2 and 9.5**

Sieving		Sedimentation	
Particle Size mm	% Passing	Particle Size mm	% Passing
125	100	0.06300	28
90	100	0.05114	25
75	100	0.03638	24
63	100	0.02603	21
50	100	0.01872	16
37.5	100	0.00994	9
28	100	0.00505	4
20	96	0.00294	1
14	93	0.00156	0
10	92		
6.3	89		
5	88		
3.35	87		
2	82		
1.18	75		
0.6	64		
0.425	58	Particle density (assumed)	
0.3	52	2.65 Mg/m3	
0.212	46		
0.15	40		
0.063	28

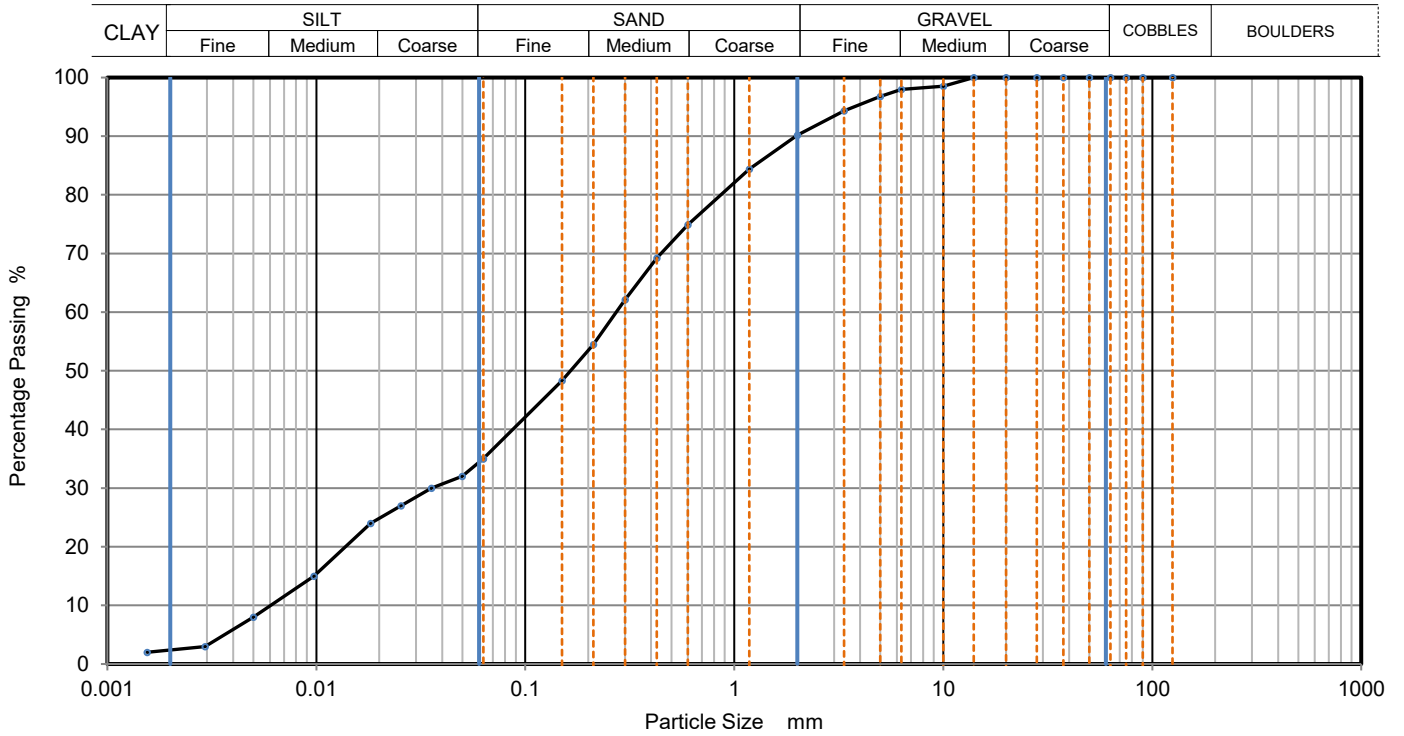
Test Method **BS1377:Part 2:1990, clauses 9.2 and 9.5**

Sieving		Sedimentation	
Particle Size mm	% Passing	Particle Size mm	% Passing
125	100	0.06300	35
90	100	0.04990	32
75	100	0.03551	30
63	100	0.02542	27
50	100	0.01819	24
37.5	100	0.00972	15
28	100	0.00499	8
20	100	0.00293	3
14	100	0.00155	2
10	99		
6.3	98		
5	97		
3.35	94		
2	90		
1.18	84		
0.6	75		
0.425	69	Particle density (assumed)	
0.3	62	2.65	Mg/m3
0.212	55		
0.15	48		
0.063	35

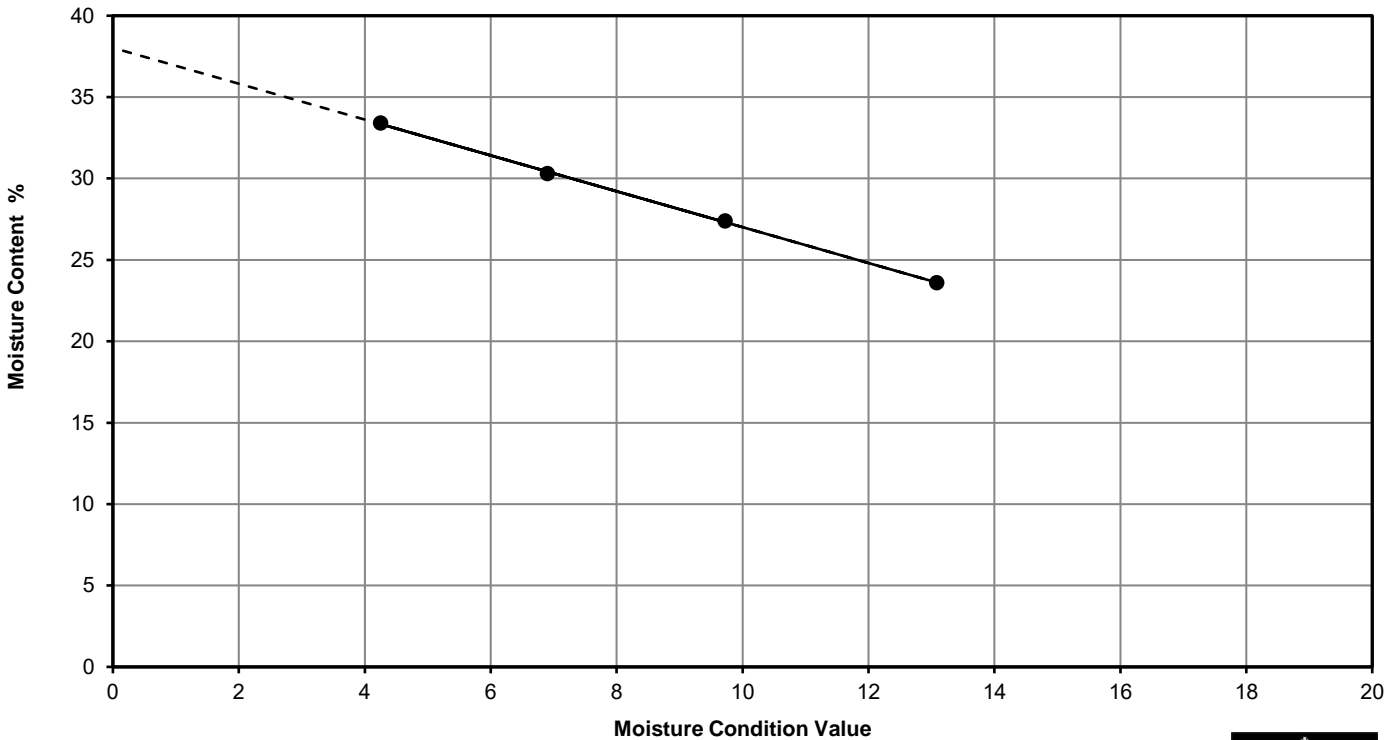
Moisture Condition Value / Moisture Content Relationship

MCV Test Number	1	2	3	4	
Moisture Content, %	27.4	30.3	33.4	23.6	
Moisture Condition Value	9.7	6.9	4.2	13.1	
MCV report	9.7	6.9	4.2	13.1	
Effective / Valid data point	YES	YES	YES	YES	
Specimen remarks

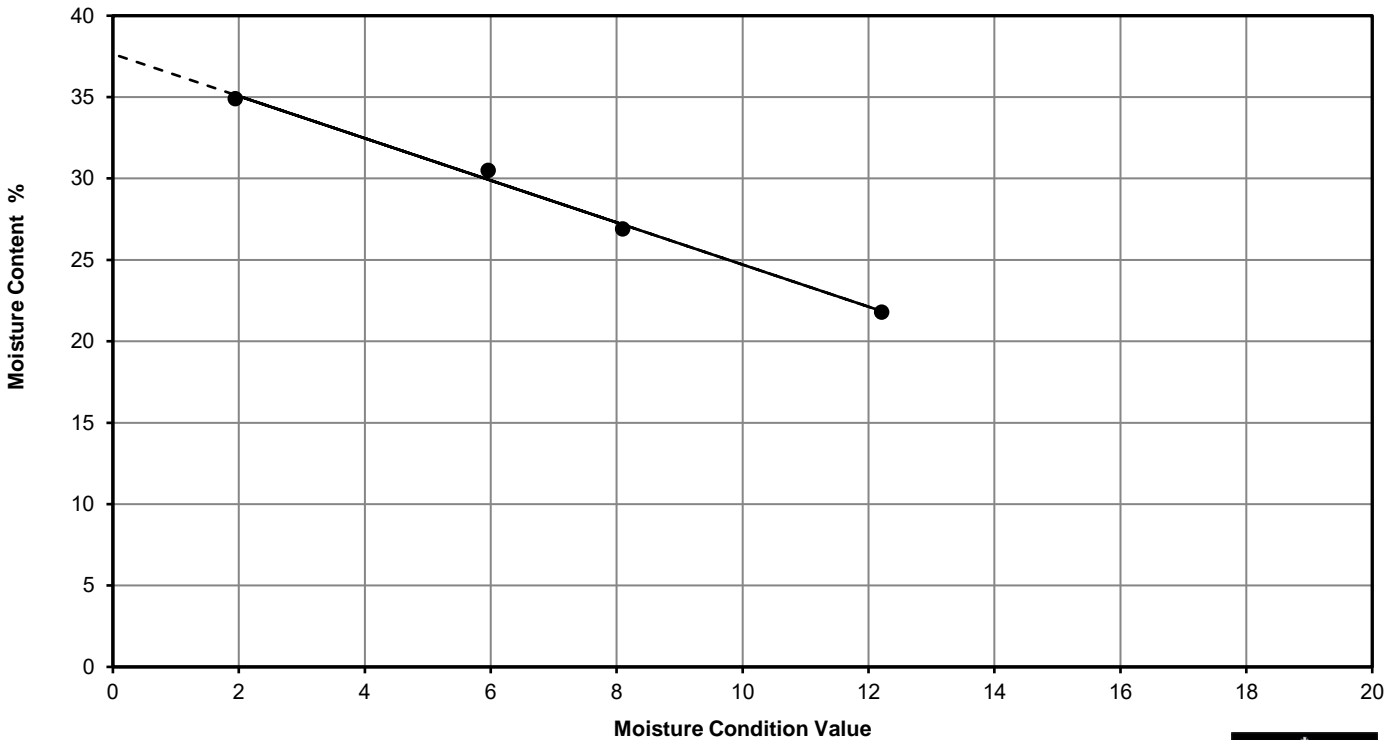
Moisture Condition Value / Moisture Content Relationship

MCV Test Number	1	2	3	4	
Moisture Content, %	26.9	30.5	34.9	21.8	
Moisture Condition Value	8.1	6.0	1.9	12.2	
MCV report	8.1	6	1.9	12.2	
Effective / Valid data point	YES	YES	YES	YES	
Specimen remarks

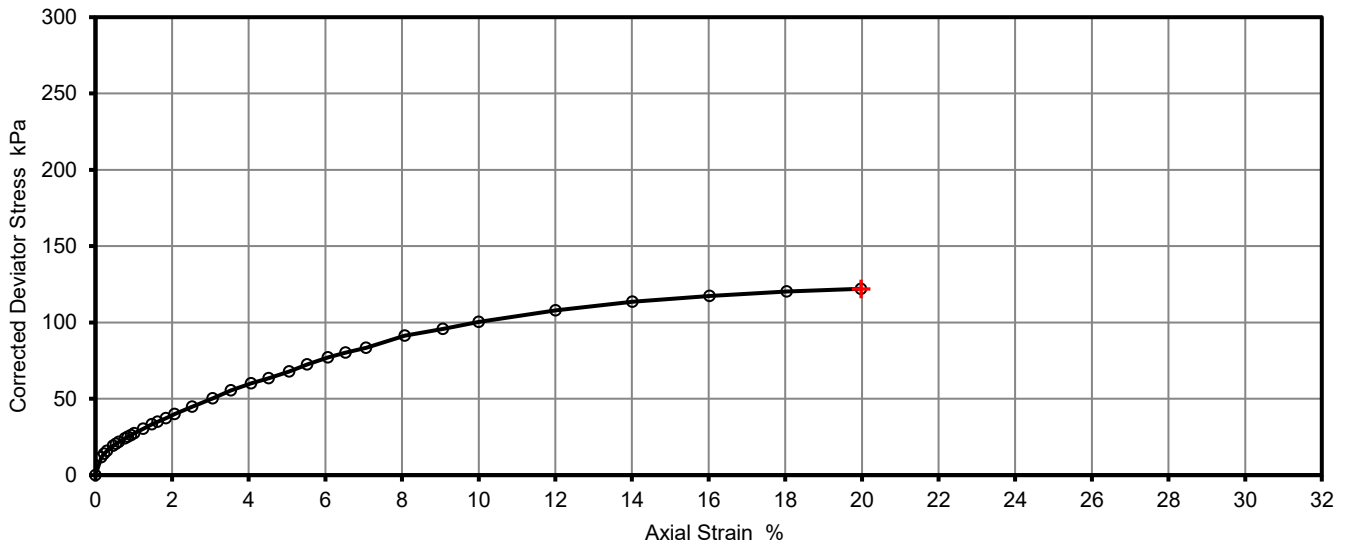
Deviator Stress v Axial Strain

Deviator stress corrected for area change and membrane effects based on Fig 11 BS1377-7:1990

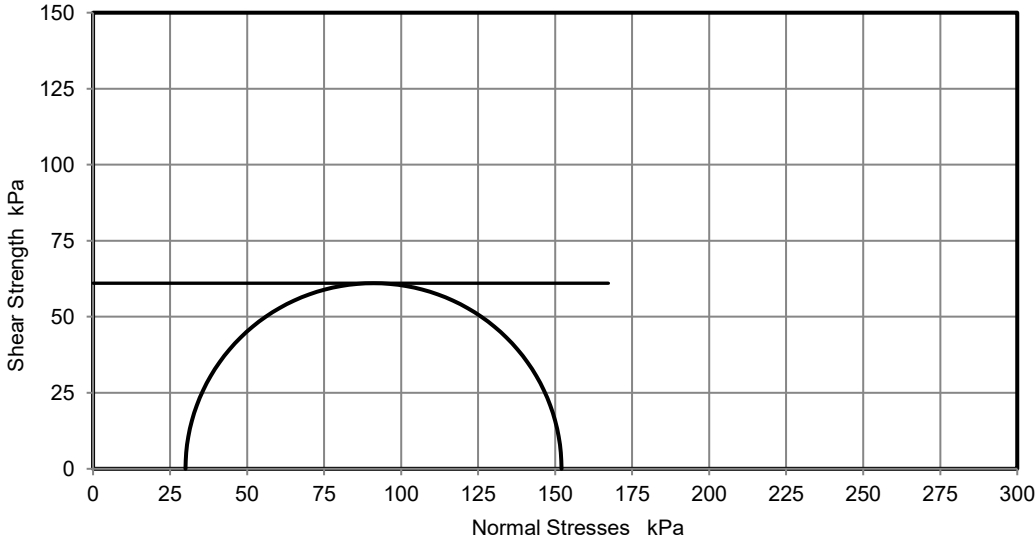
Mohr Circles

Mohr circles and their interpretation is not covered by BS1377-7. This is provided for information only.

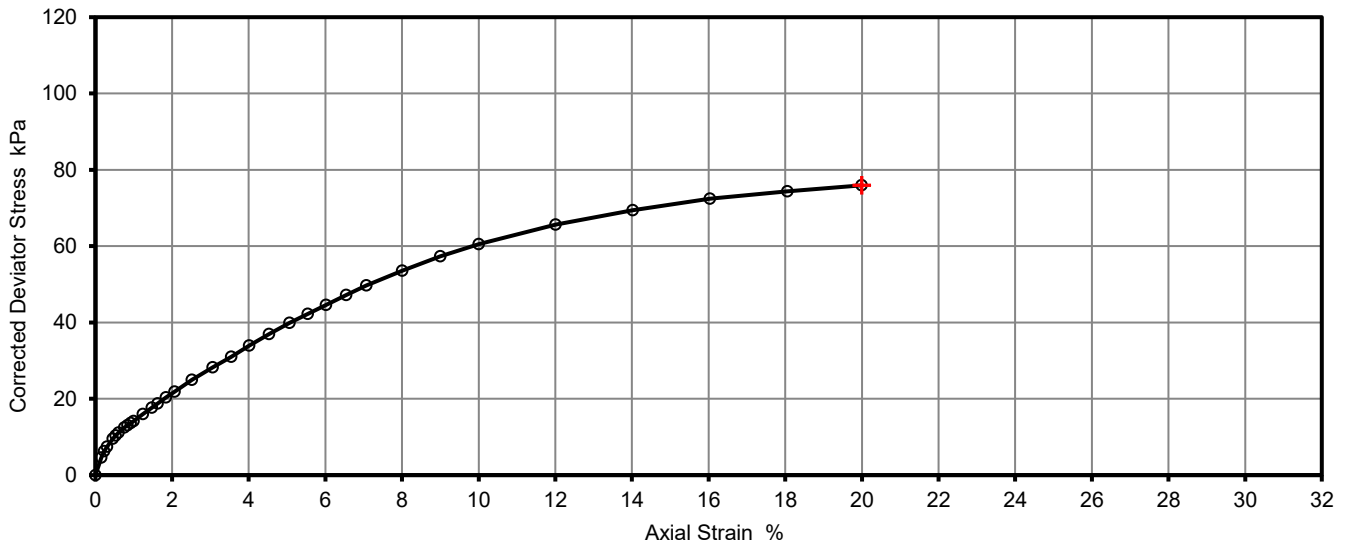
Deviator Stress v Axial Strain

Deviator stress corrected for area change and membrane effects based on Fig 11 BS1377-7:1990

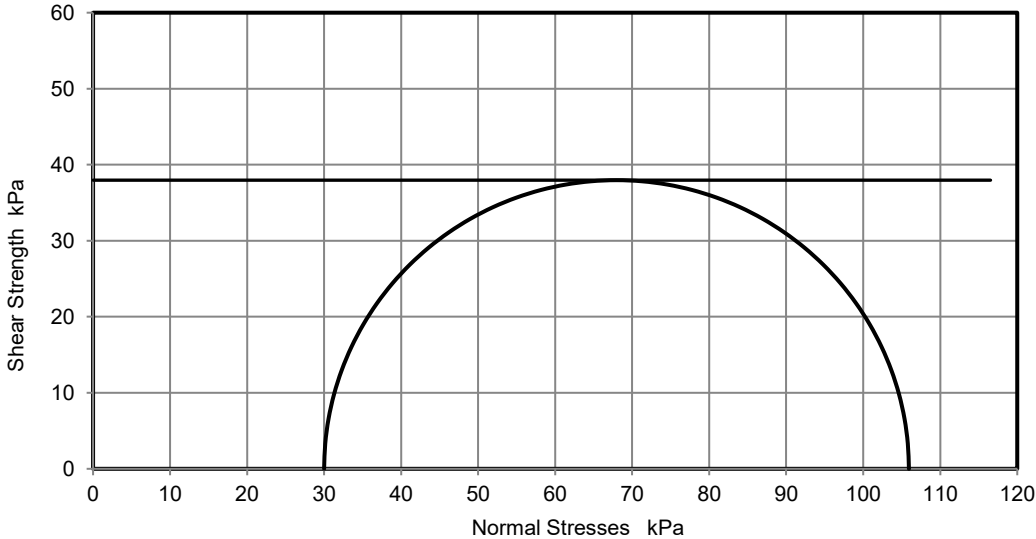
Mohr Circles

Mohr circles and their interpretation is not covered by BS1377-7. This is provided for information only.

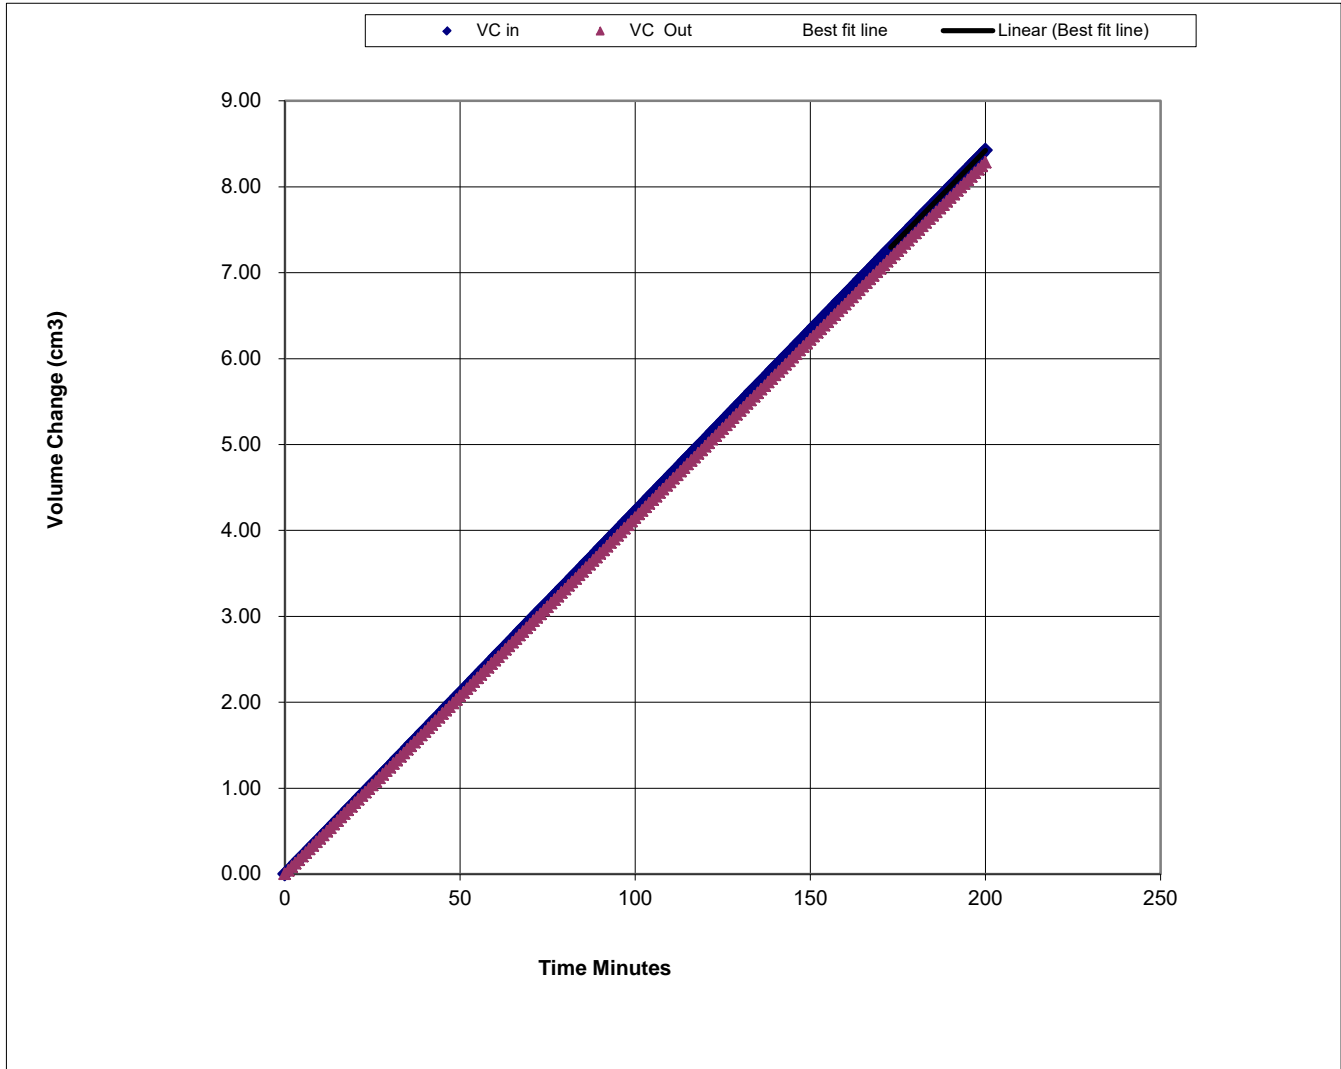
Permeability Stage		
Cell Pressure	kPa	520
Mean Effective Stress	kPa	20
Back Pressure Diff.	kPa	10
Mean Rate of Flow	ml/min	0.0418
Average Temperature	'C	20
Vertical Permeability K_v	m/s	8.6E-09

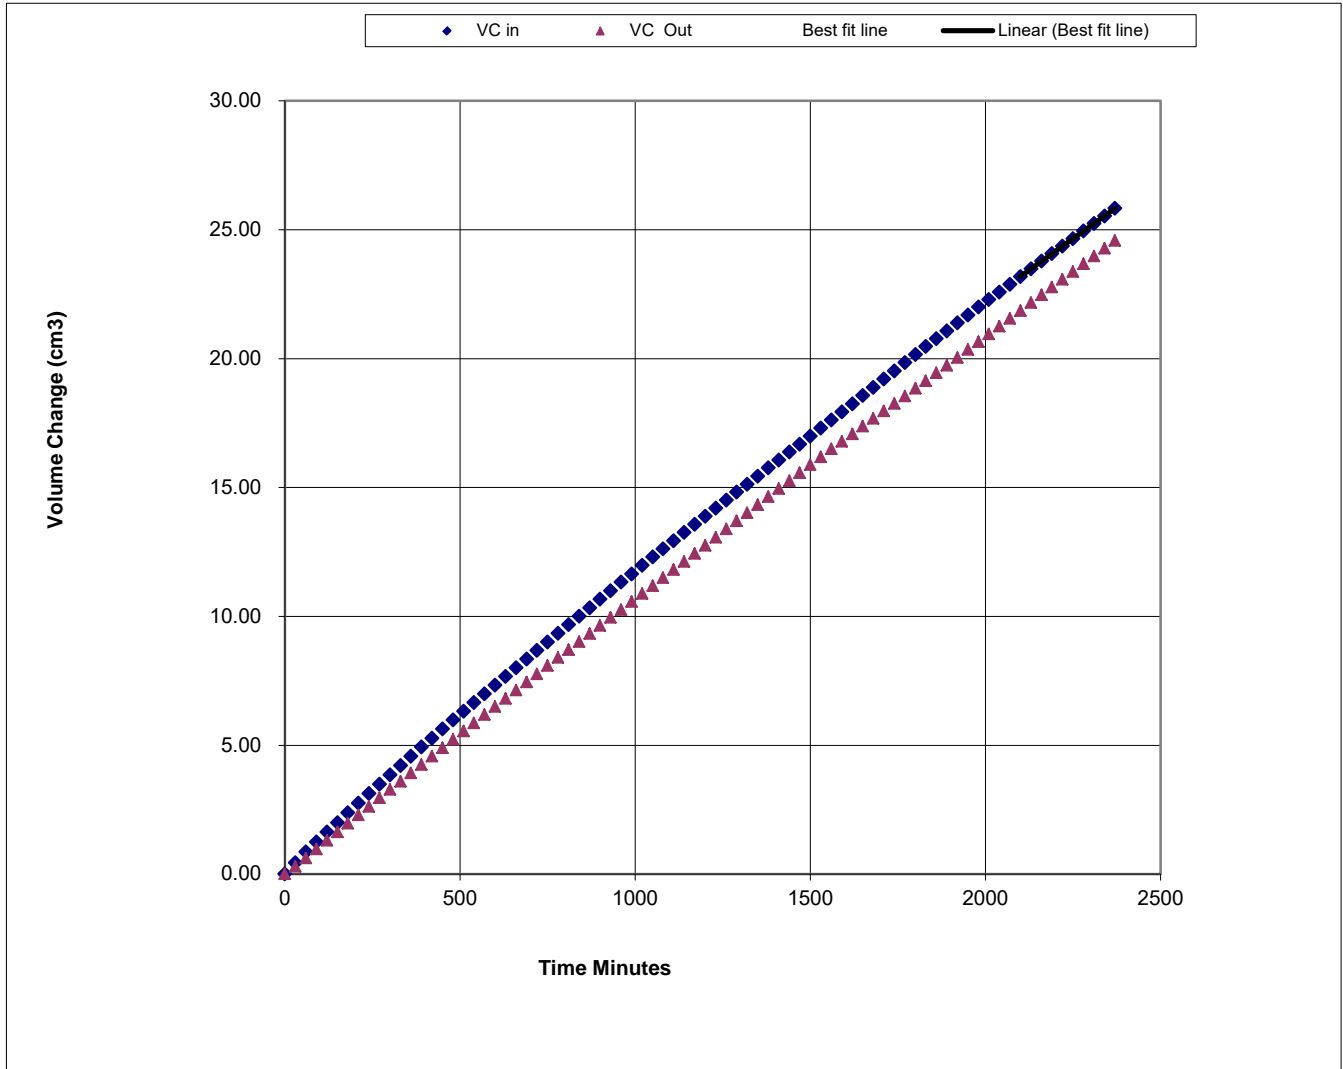
Permeability Stage		
Cell Pressure	kPa	470
Mean Effective Stress	kPa	20
Back Pressure Diff.	kPa	10
Mean Rate of Flow	ml/min	0.0098
Average Temperature	'C	20
Vertical Permeability Kv	m/s	2.0E-09

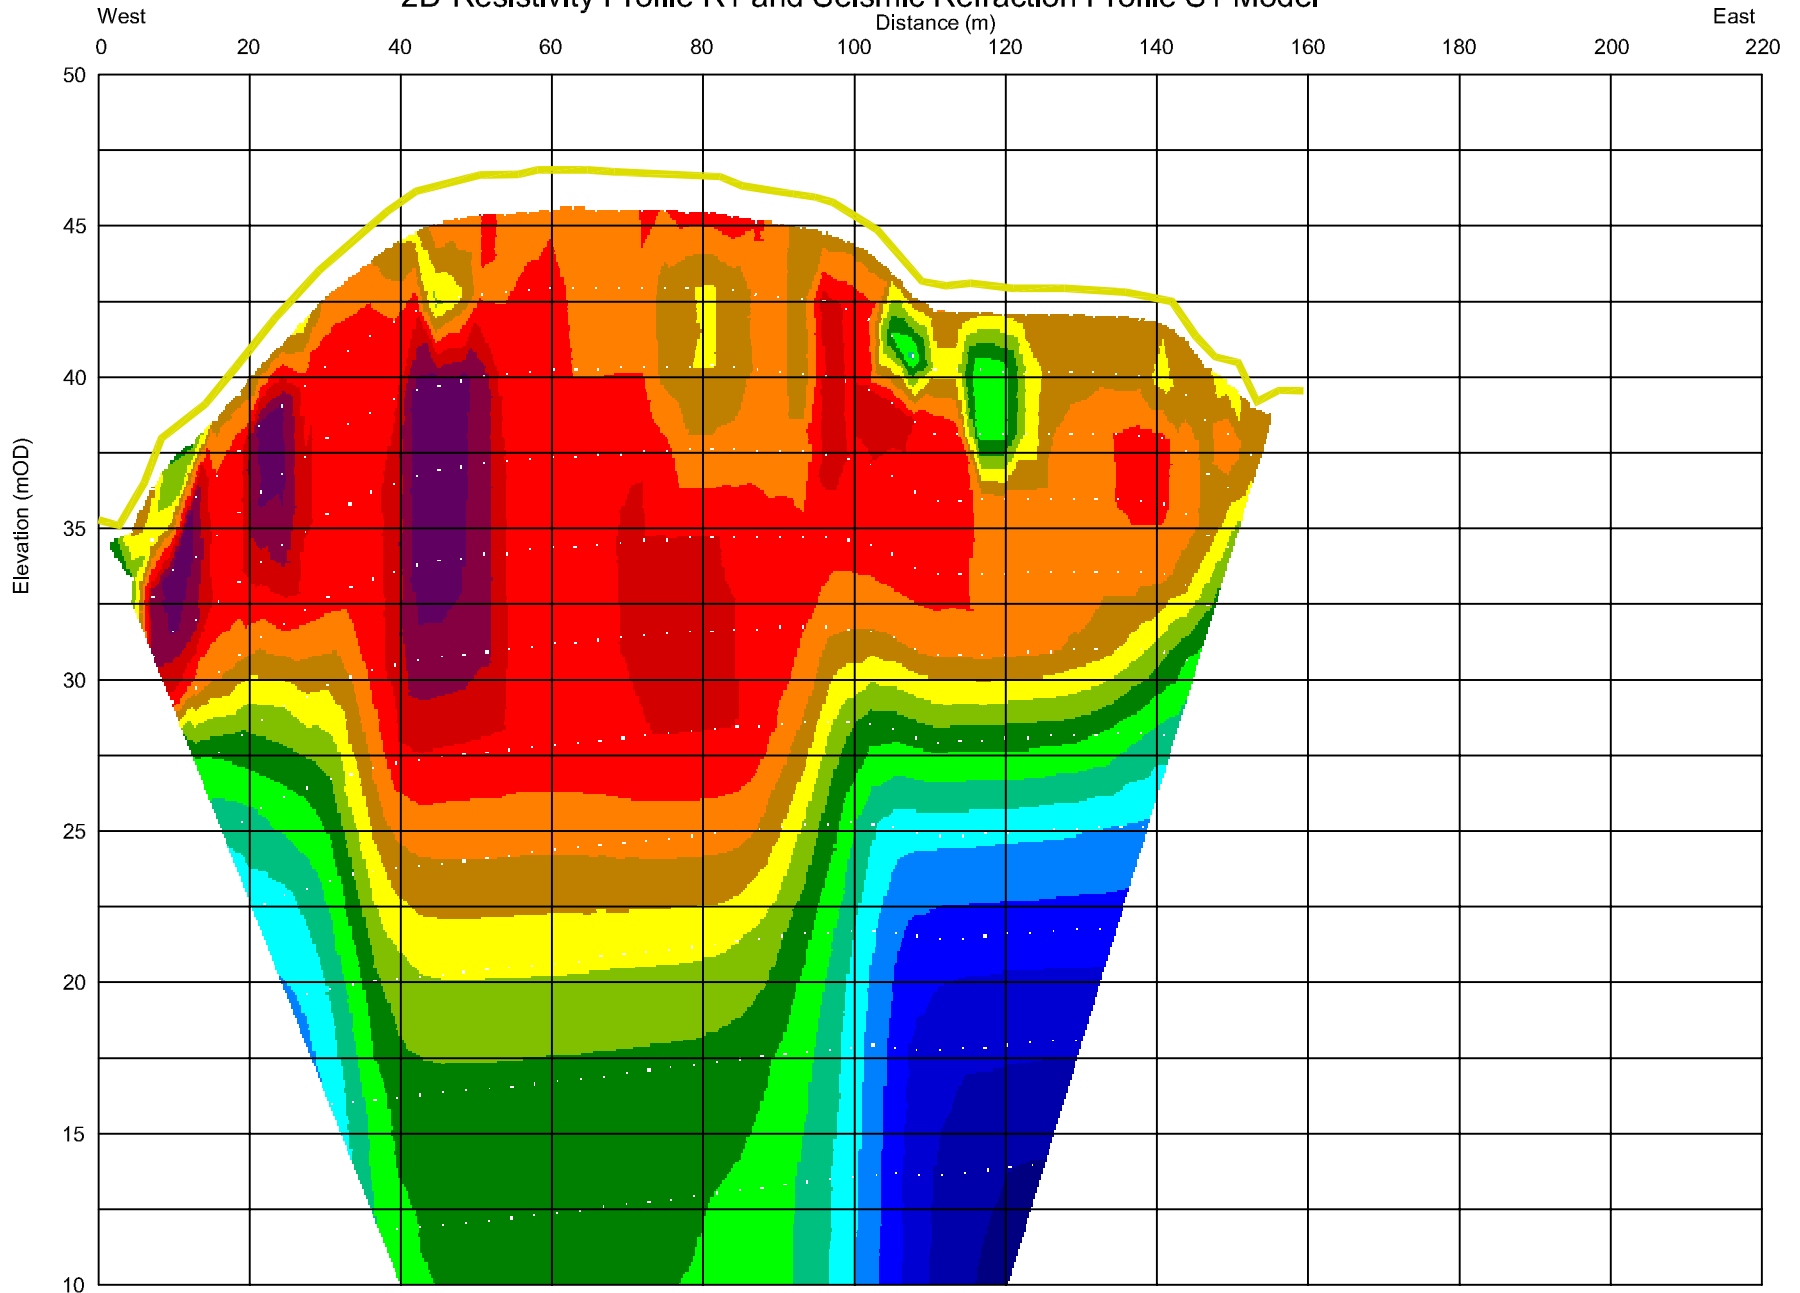
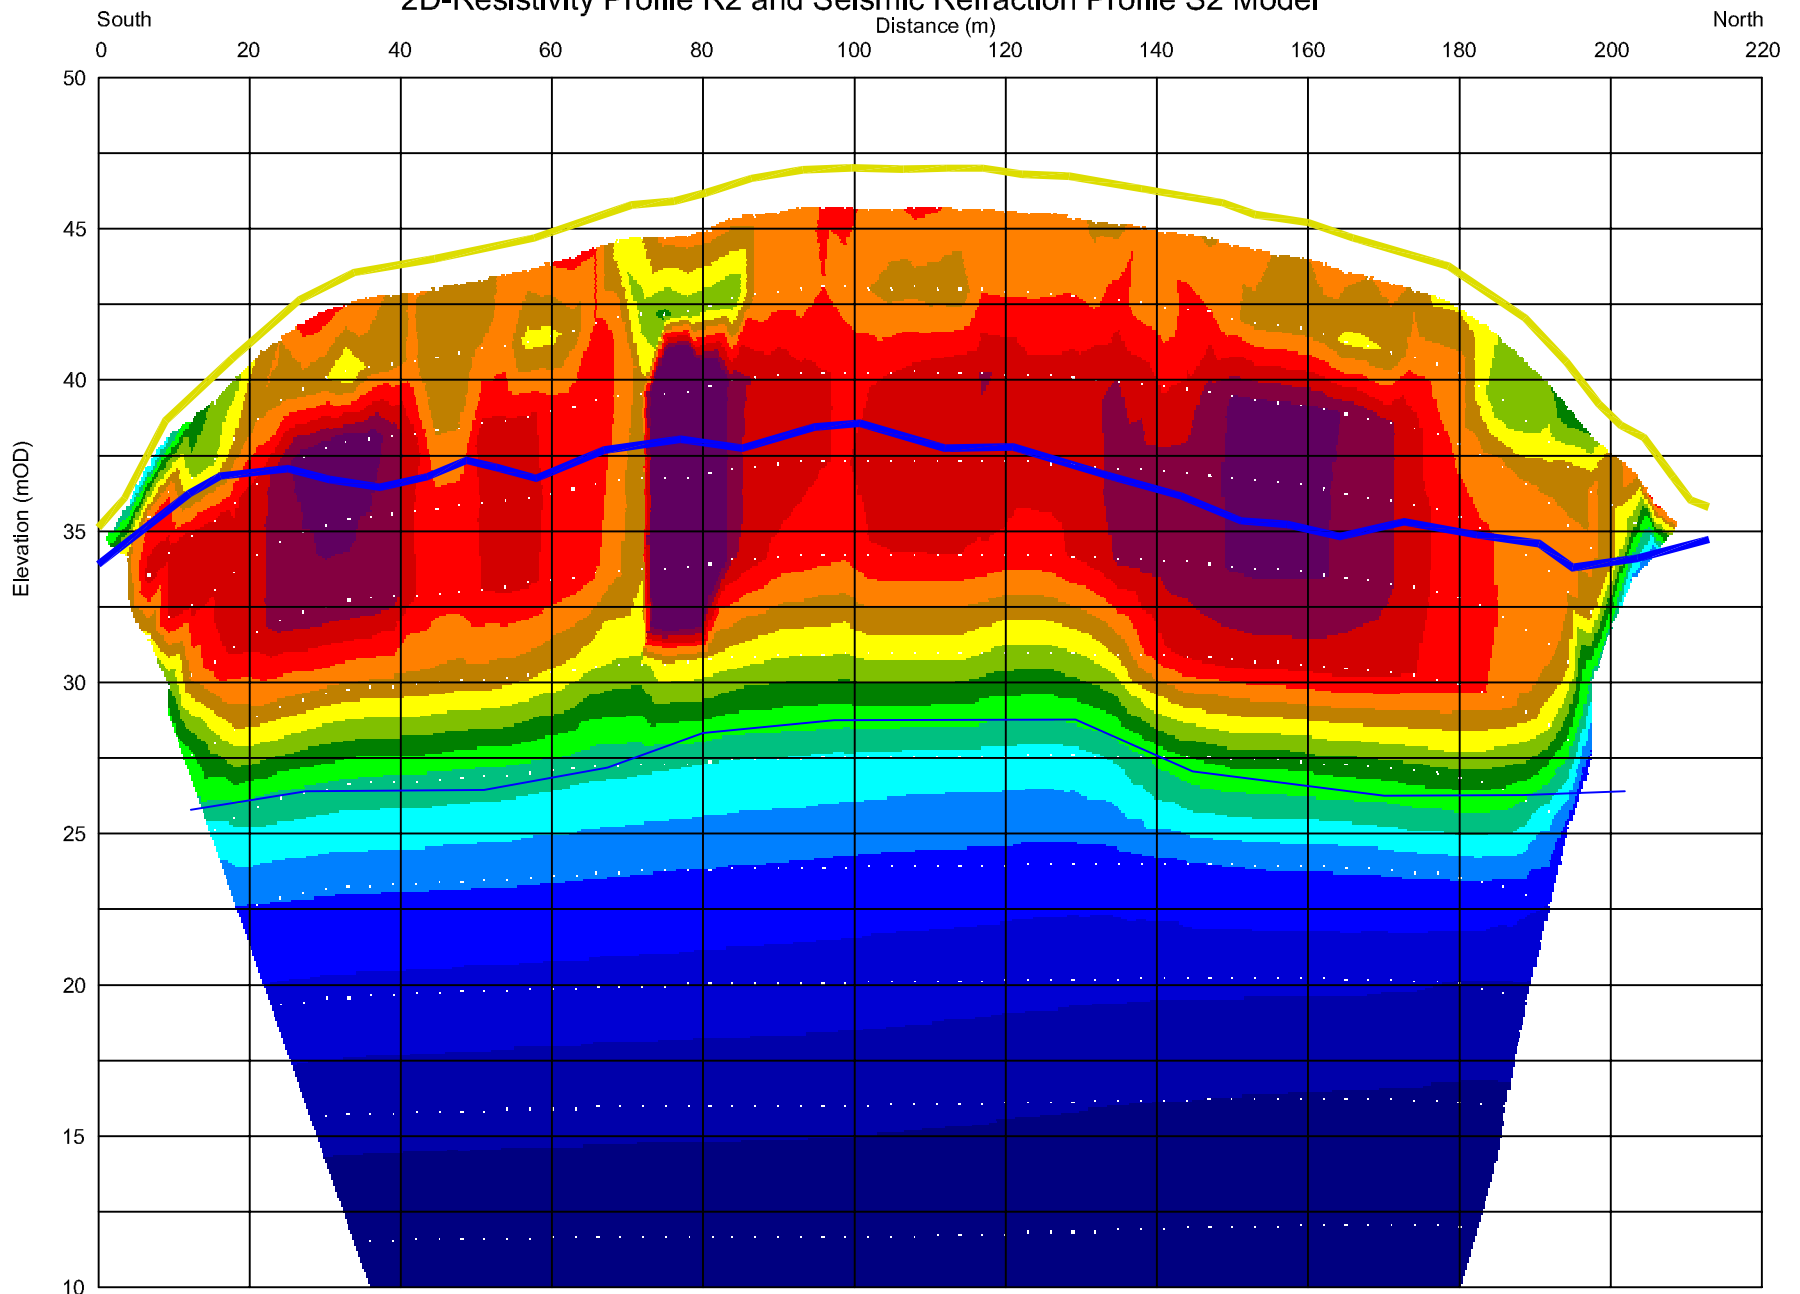
CLIENT FTCO
PROJECT Tuam Historic Landfill
Geophysical Survey
TITLE Figure 1: Models of
Geophysical Survey

2D-Resistivity Profile R1 and Seismic Refraction Profile S1 Model

2D-Resistivity Profile R2 and Seismic Refraction Profile S2 Model

The p-wave seismic velocity is closely linked to the density of subsurface materials and to parameters like compaction, stiffness, strength and rock quality. The higher the density of the subsurface materials the higher the seismic velocity. Similarly, for the other parameters it is generally valid that a more compacted, stiffer and stronger material will have a higher seismic velocity. For rock, the seismic velocity is higher when the rock is stronger, less weathered and has a higher quality. If the rock is more weathered, broken, fractured, fissured or karstified then the seismic velocity will be reduced compared to that of intact fresh rock.

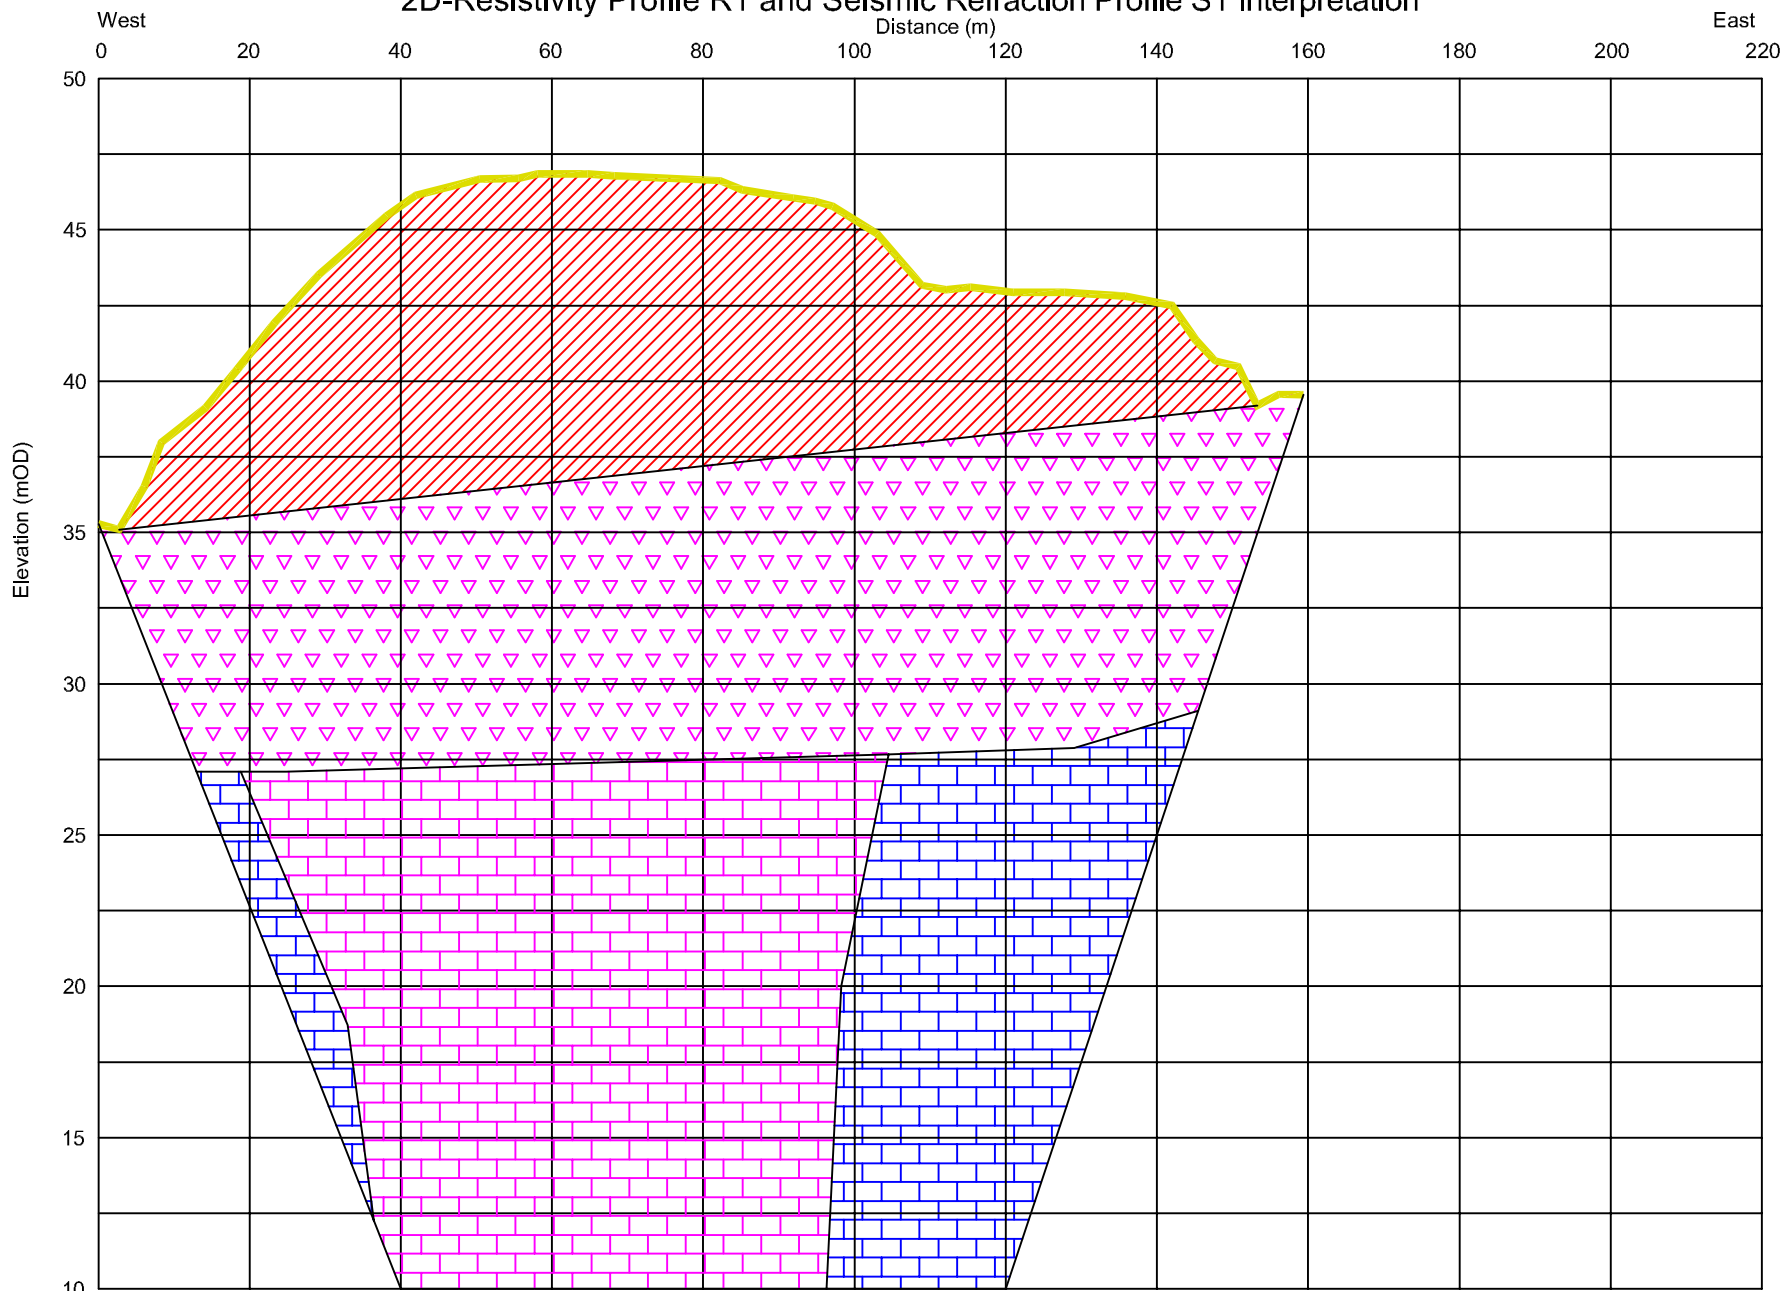
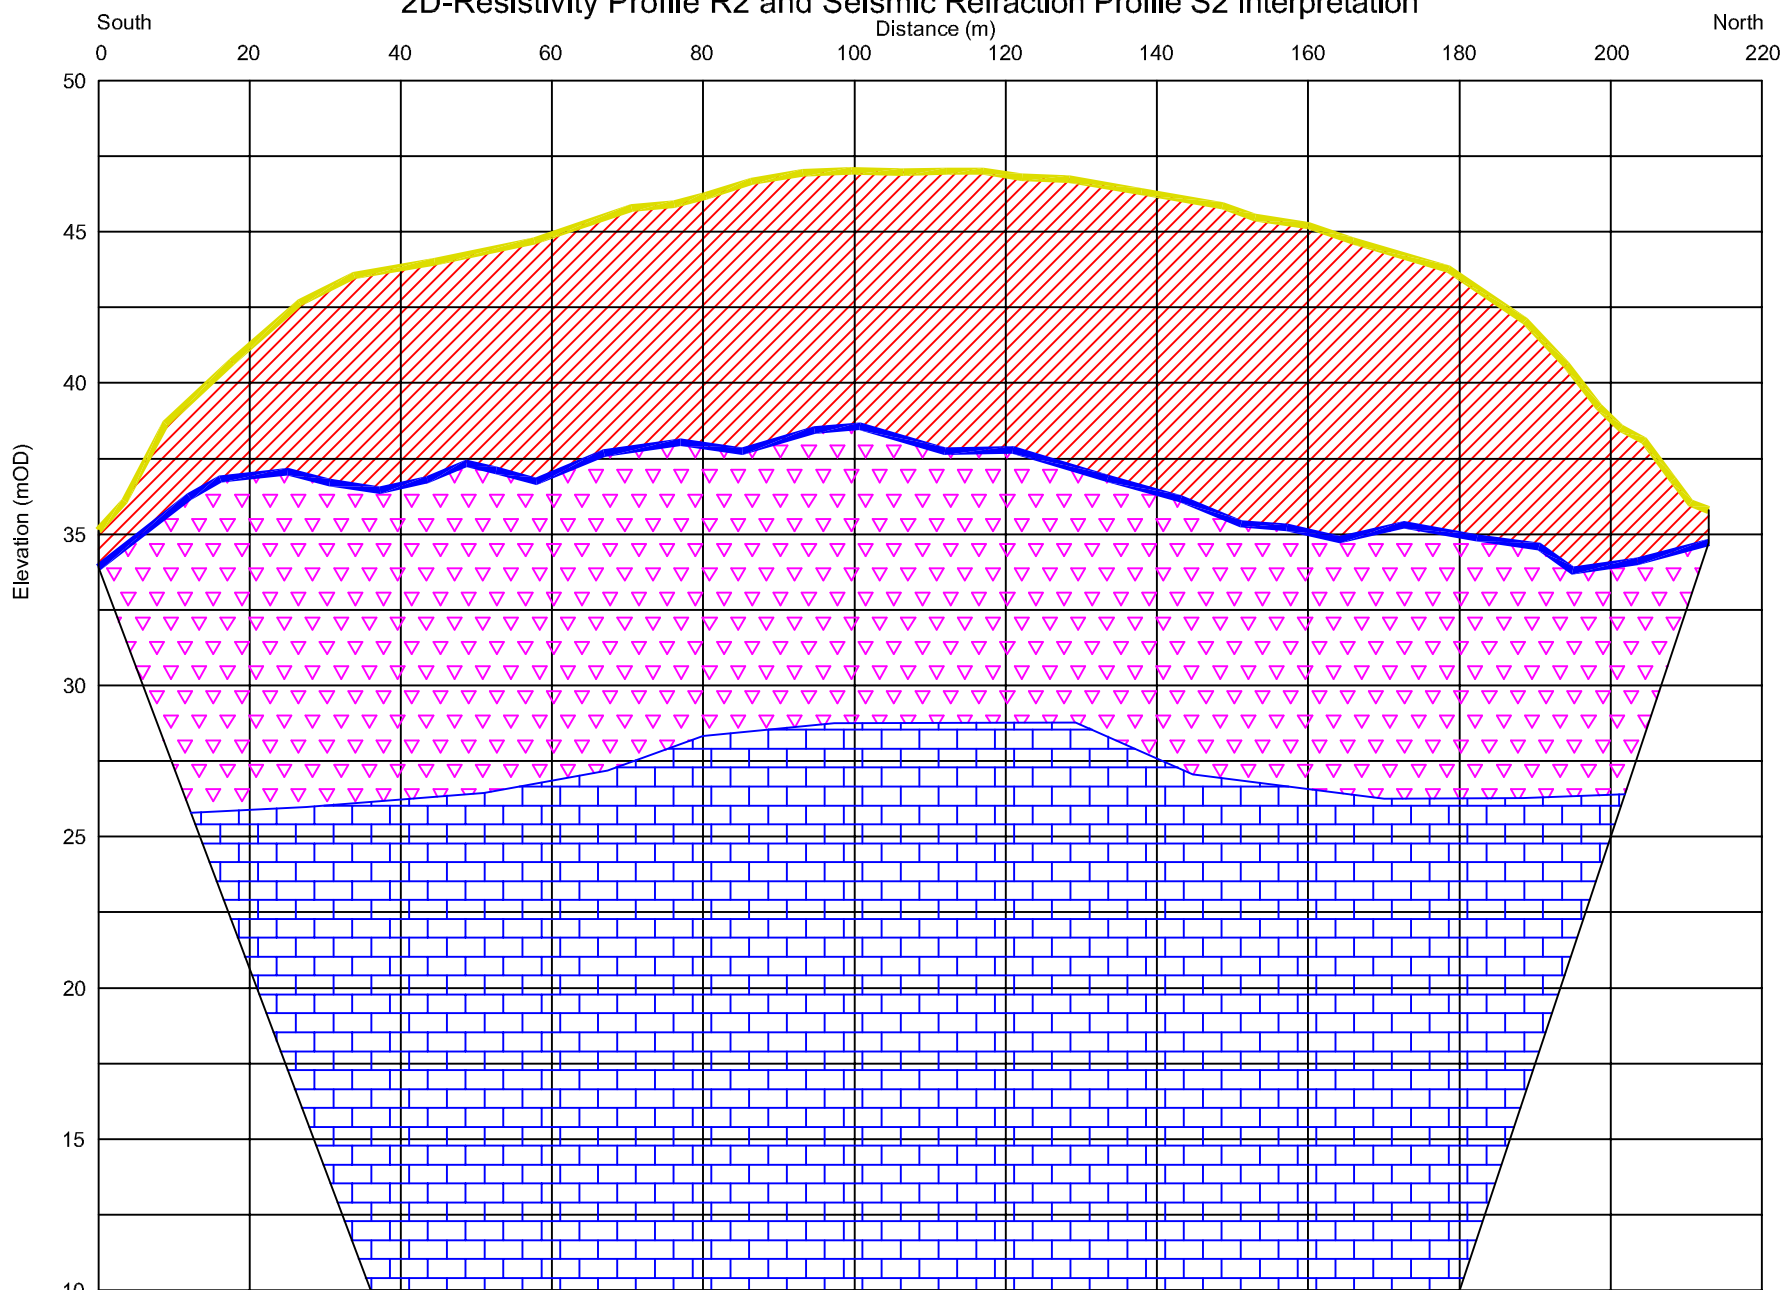
CLIENT FTCO
PROJECT Tuam Historic Landfill
Geophysical Survey
TITLE Figure 2: Interpretation of
Geophysical Survey

2D-Resistivity Profile R1 and Seismic Refraction Profile S1 Interpretation

2D-Resistivity Profile R2 and Seismic Refraction Profile S2 Interpretation
