GALWAY HISTORIC LANDFILL

TIER 2 RISK ASSESSMENT HISTORIC LANDFILL AT TUAM, CO. GALWAY

Prepared for: Galway County Council

Date: October 2022

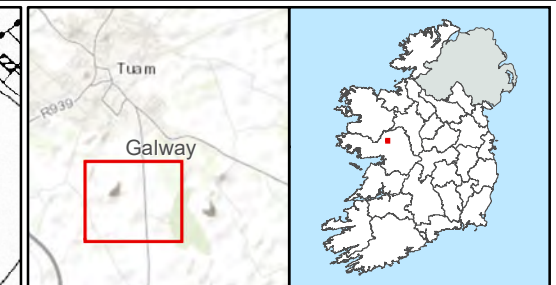
TITLE:		OSI Historical Mapping	
PROJECT:		Tuam Historic Landfill ERA	
FIGURE NO:		2.10	
CLIENT:		Galway County Council	
SCALE:	1:5000	REVISION:	0
DATE:	18/10/2021	PAGE SIZE:	A3

The earliest historical map available on the OSI website dates from 1837-1842. Review of this map shows that the site was historically marsh land. The latter 1888-1913 OSI historical mapping also displays previous use as marsh land. There are no distinct features noted within the site boundary or in the vicinity, on both map series.

OSI historical mapping presented in Figure 2.10 and Figure 2.11.

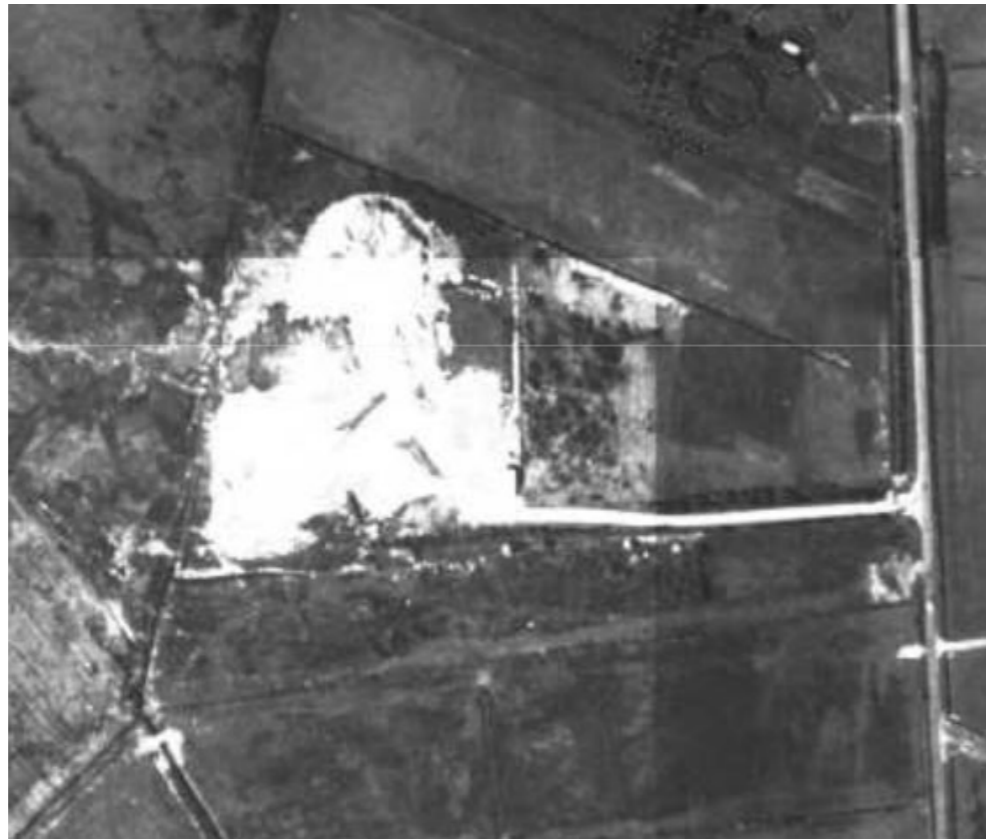
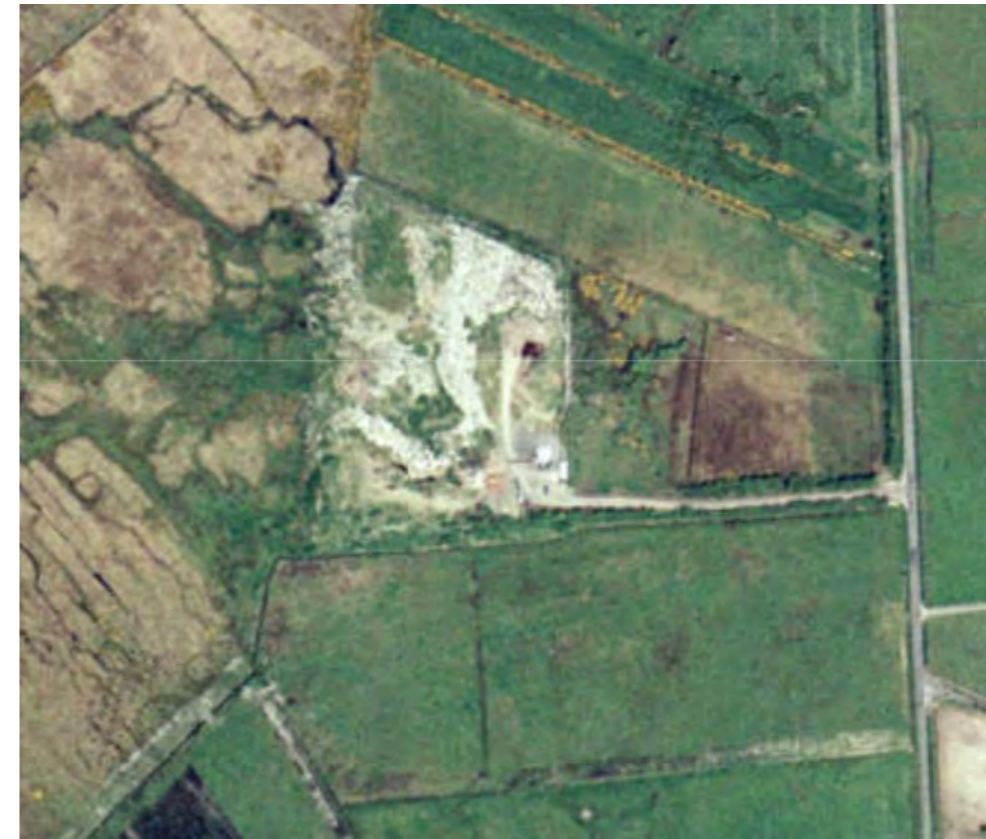
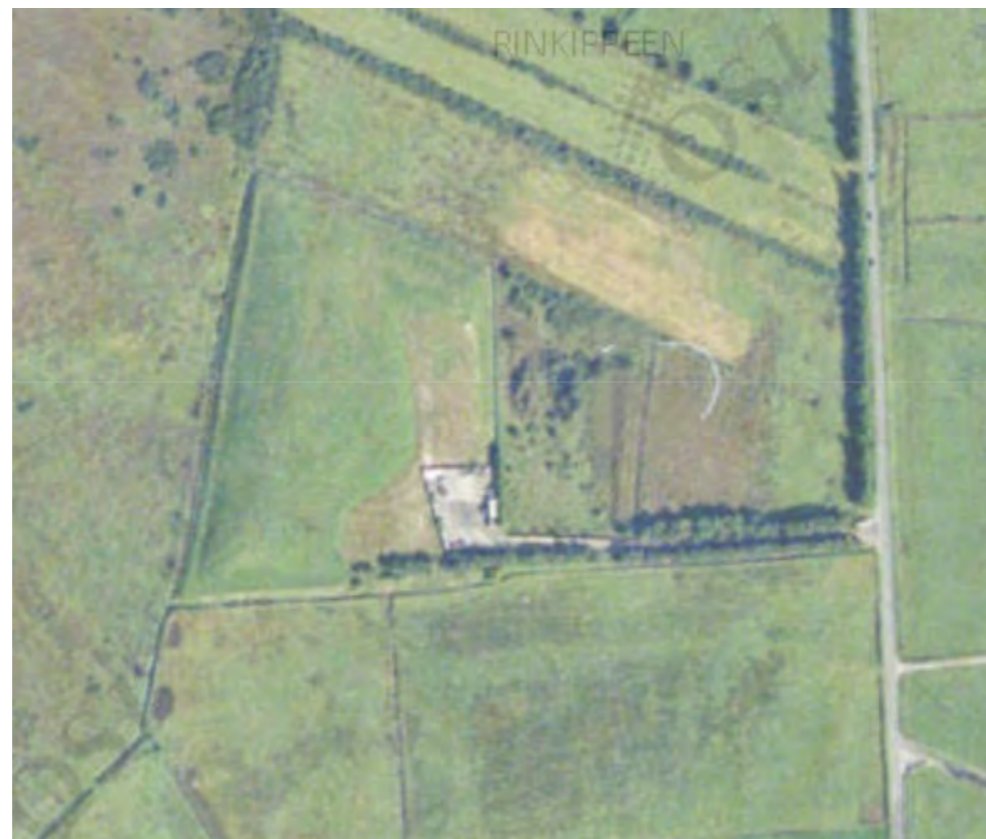
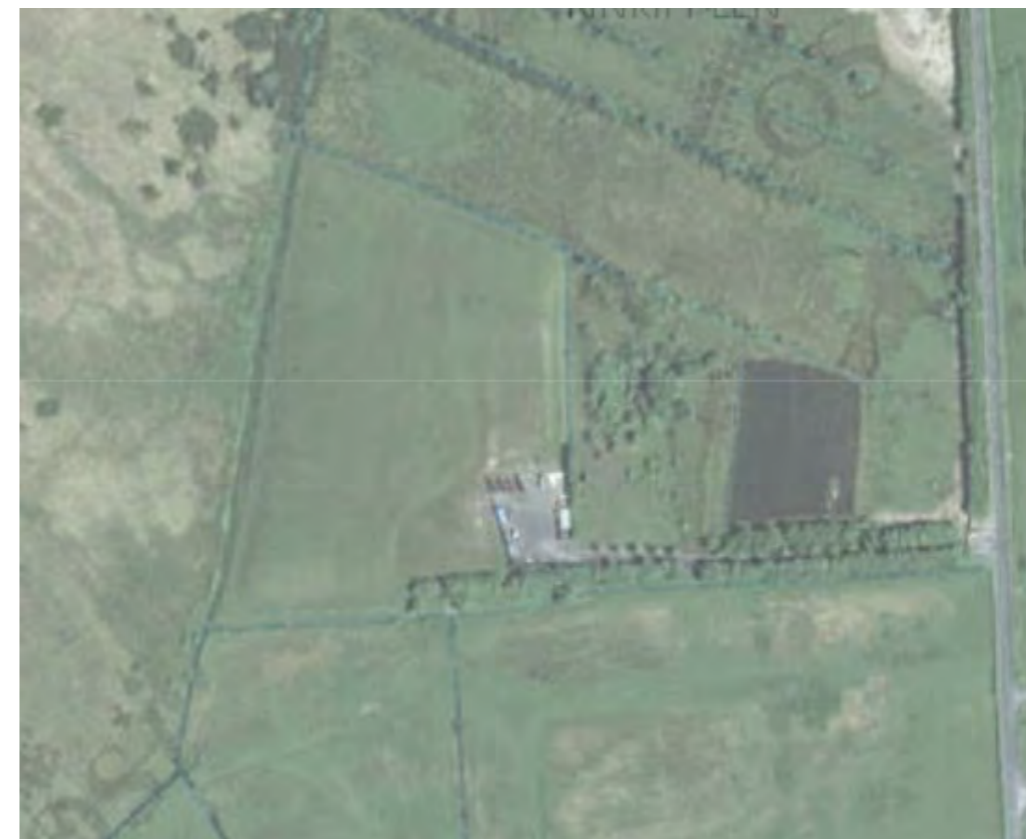
Figure 2-11: Historical Aerial Imagery¹

More recent OSI historical imagery, from 1995 and 2000, show evidence of landfilling activities, while on imagery from 2005-2012 and 2011-2013 this activity seems to have ceased and capping completed. The images produced corresponds with the site closure and remediation plan which was developed in 1999 following closure of the site of the site in 1998. The aerial image from 1995 shows that the landfill of waste is still occurring while imagery from 2000 shows that some capping of the site has occurred or is ongoing at the time the image was produced. Information provided by GCC states that a GCL capping layer was constructed over 30,000 m² of the landfill in 2001. Imagery from 2005 shows that the site has been completely capped and grass has been established. Imagery also shows the development of the civic amenity site between 2000 and 2005.

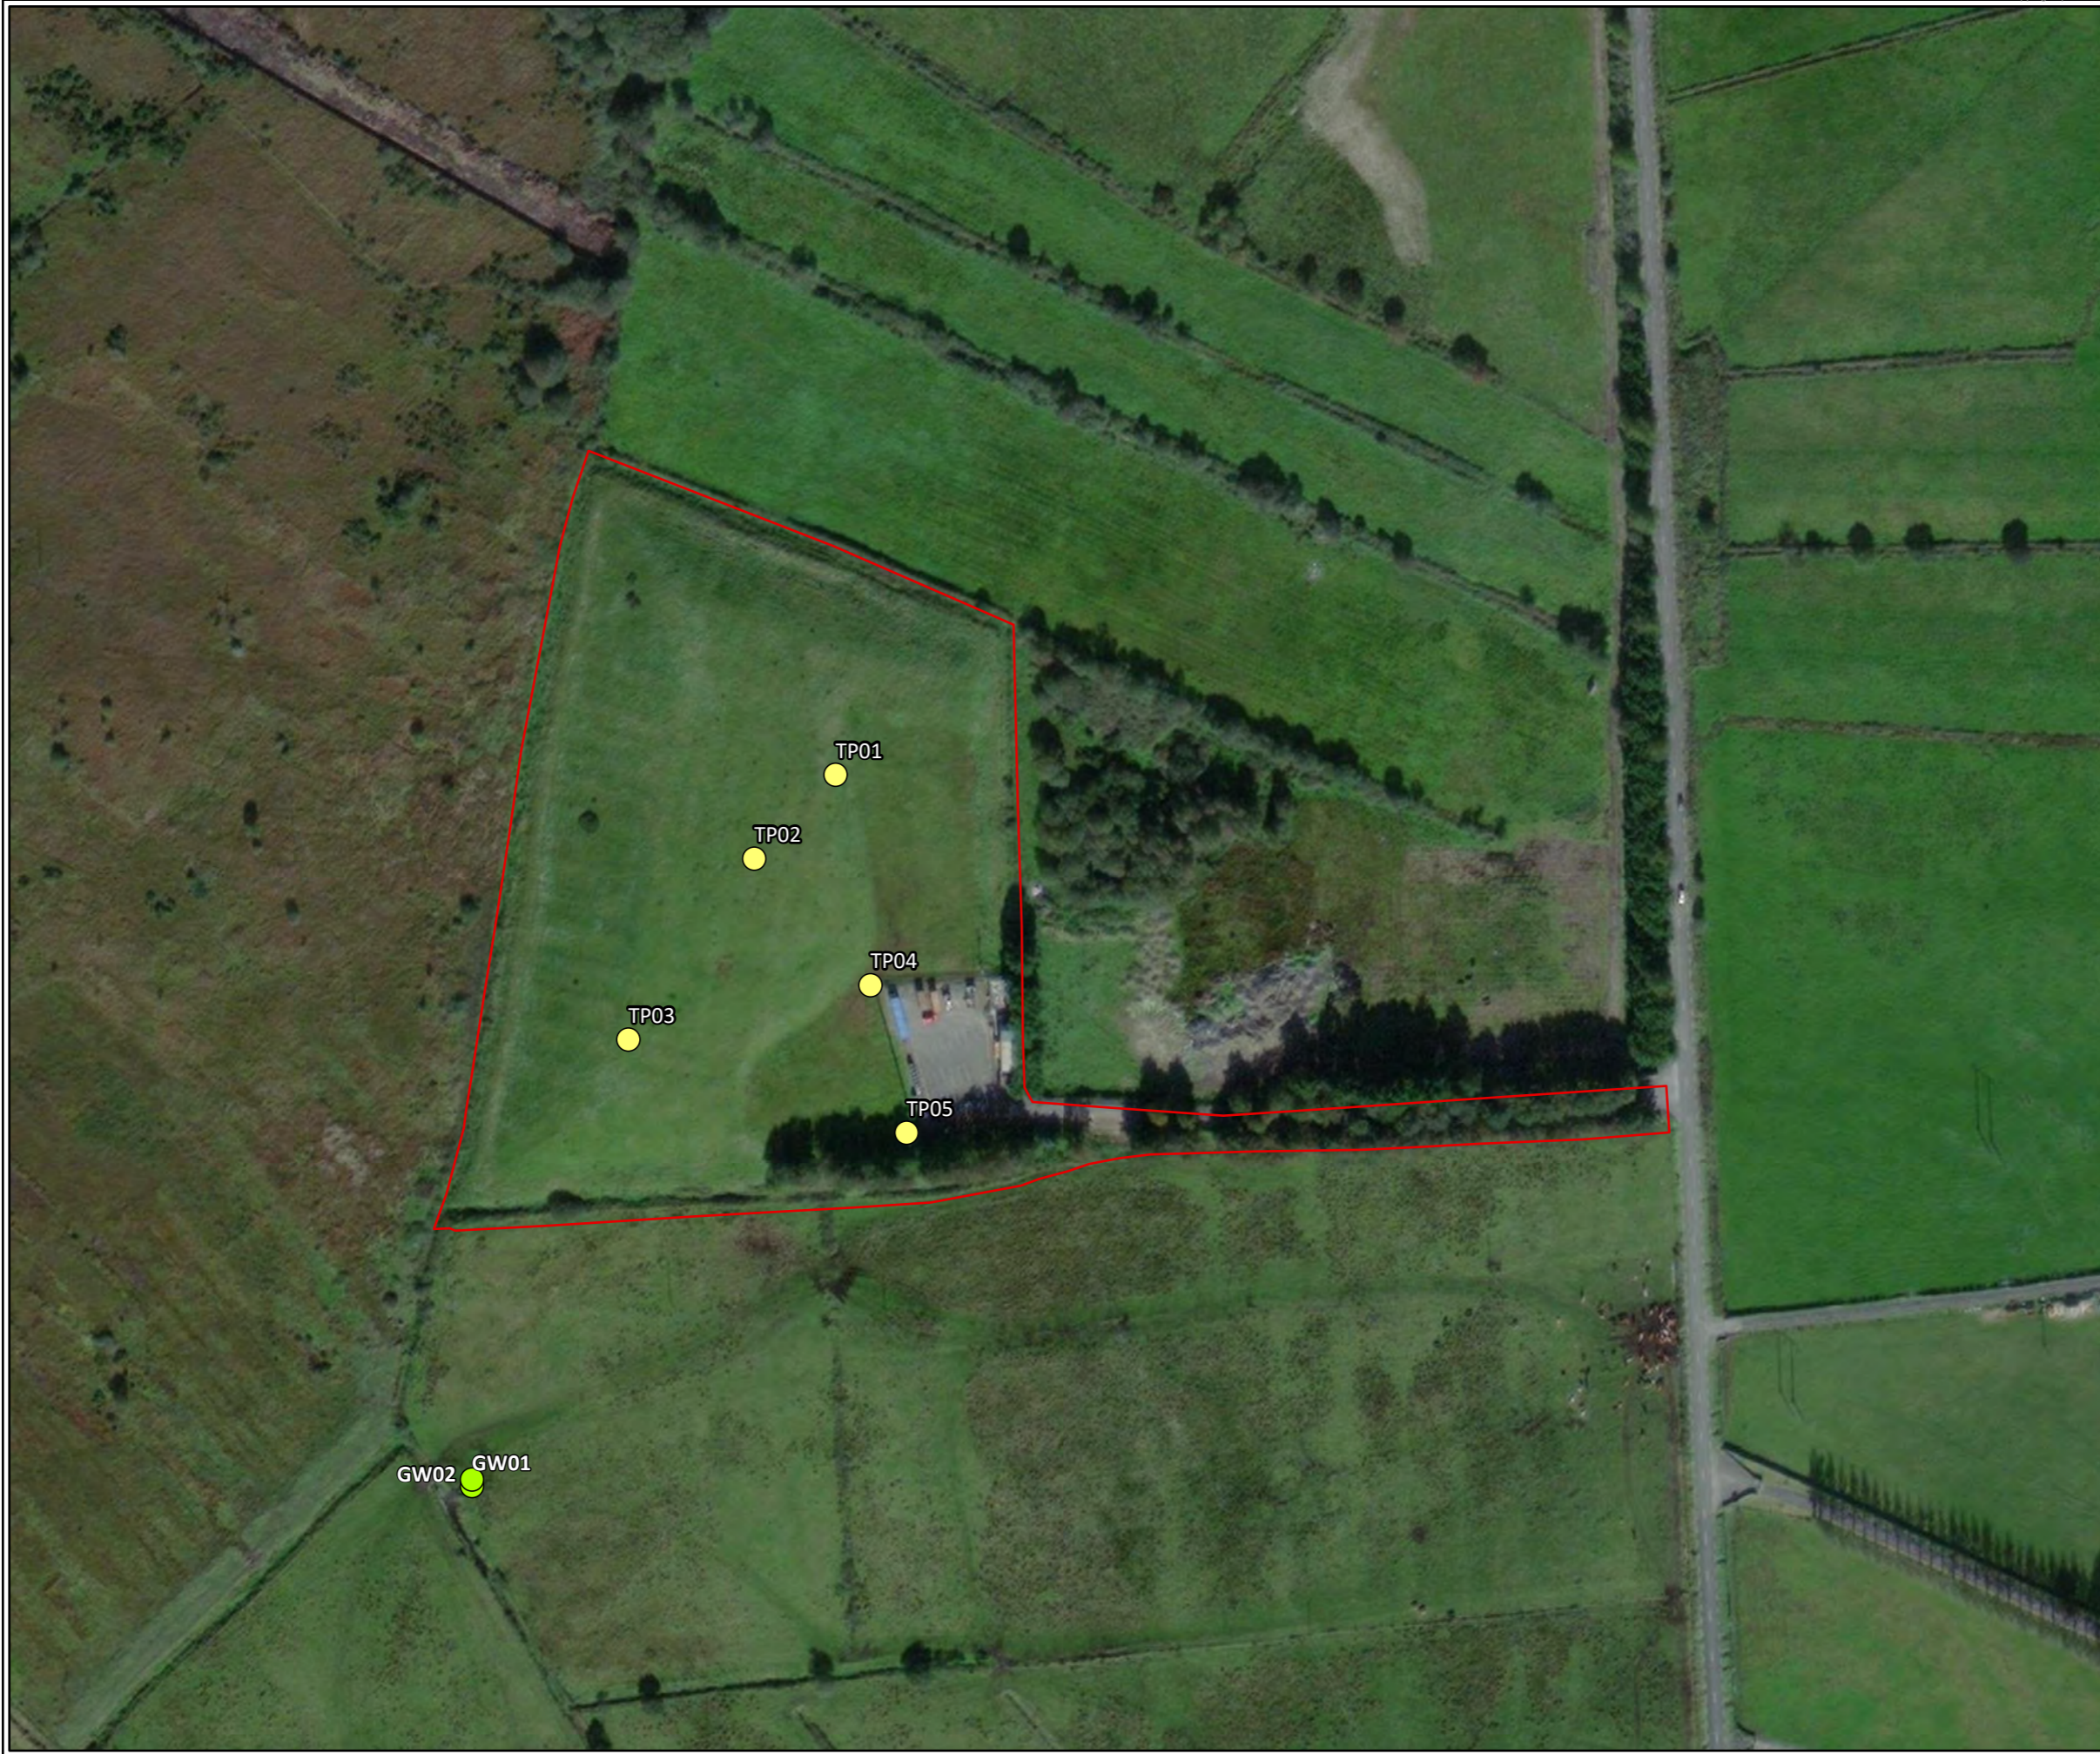
TITLE:	
Site Investigation Location Plan	
PROJECT:	
Tuam Historic Landfill ERA	
FIGURE NO:	3.1
CLIENT:	Galway County Council
SCALE: 1:2,000	REVISION: 0
DATE: 18/10/2021	PAGE SIZE: A3

- Site Boundary
- Trial Pit
- Groundwater Well

A Causeway Geotech (CGL) Engineering Geologist supervised the advancement of 5 No. trial pits, shown in Figure 3.1, on the 7th July 2020.

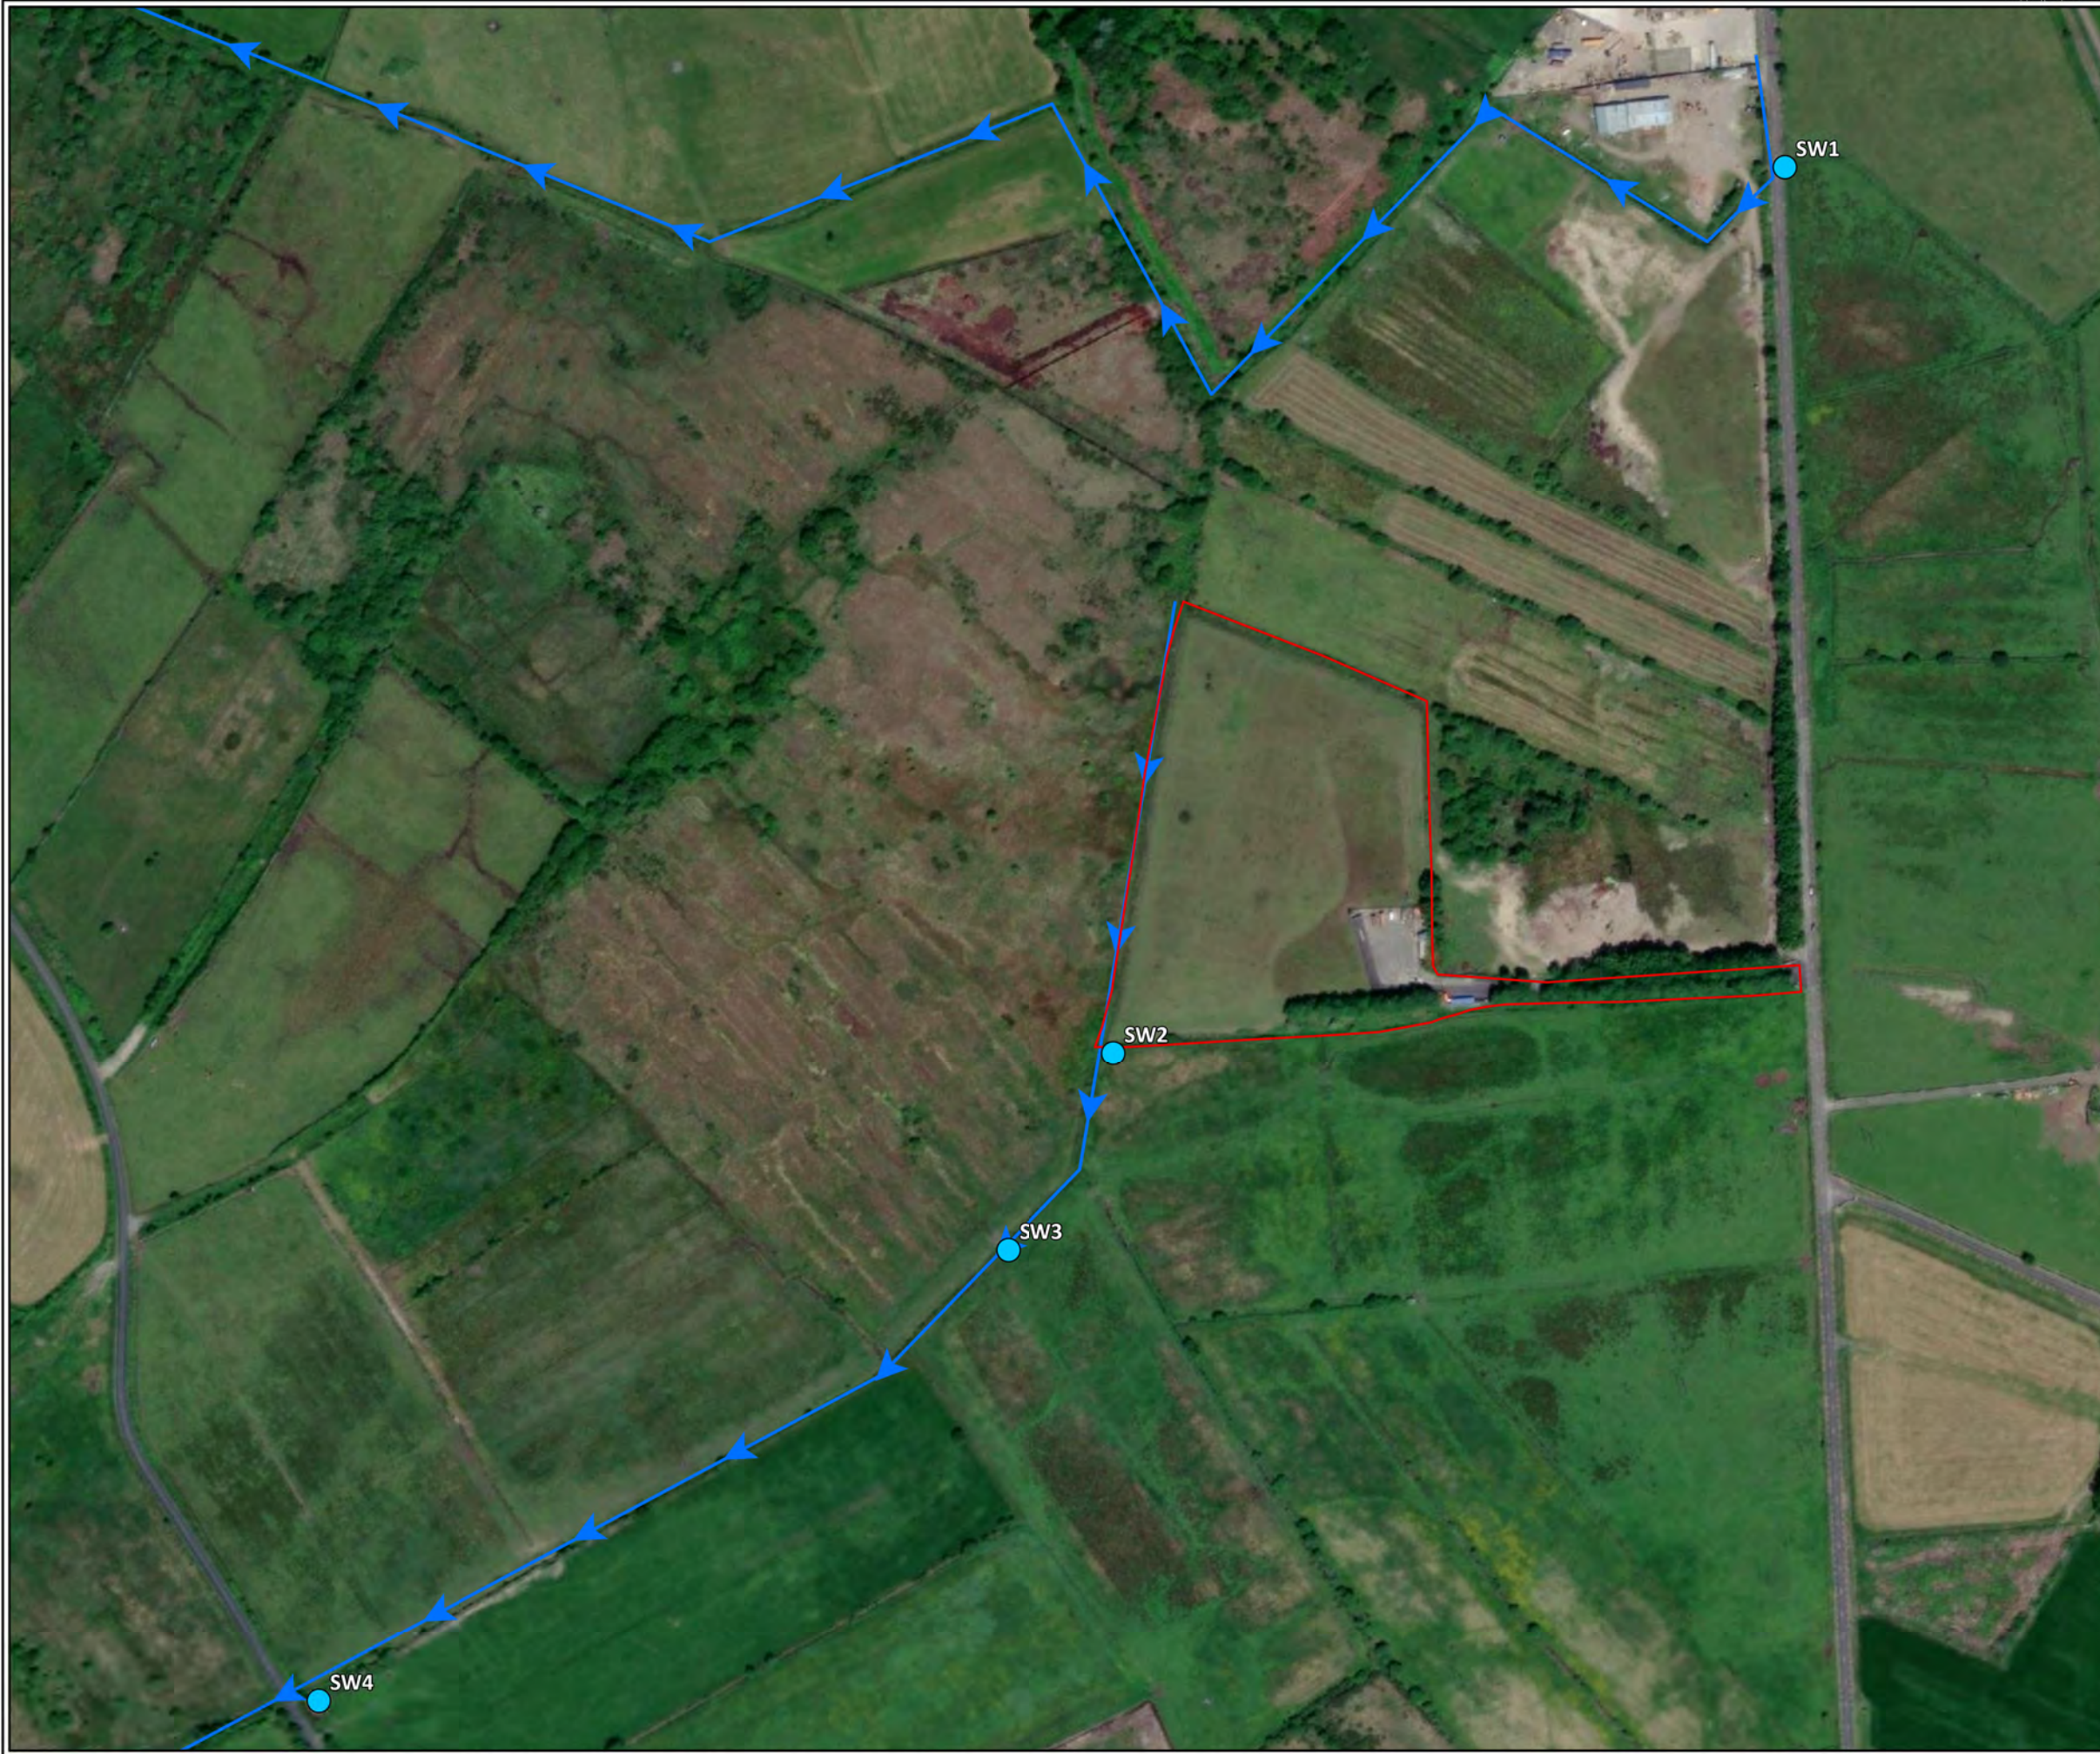
TITLE:	Surface Water Sampling Locations		
PROJECT:	Tuam Historic Landfill ERA		
FIGURE NO:	4.2		
CLIENT:	Galway County Council		
SCALE:	1:3,500	REVISION:	0
DATE:	26/10/2022	PAGE SIZE:	A3

- Site Boundary
- Surface Water Monitoring Locations
- Surface Water Flow Direction

The results of surface water sampling analysed from the 4 No. sampling locations (SW1 to SW4) at the site have been assessed against the Maximum Admissible Concentration (MAC) and the Environmental Quality Standard (EQS) as per S.I. No. 77/2019 - European Union Environmental Objectives (Surface Waters) (Amendment) Regulations 2019.
