## **APPENDIX 2**

Site Walkover Checklist and  
Photographic Log

**Site Location:** Tuam Historic Landfill

Closure and Remediation Plan

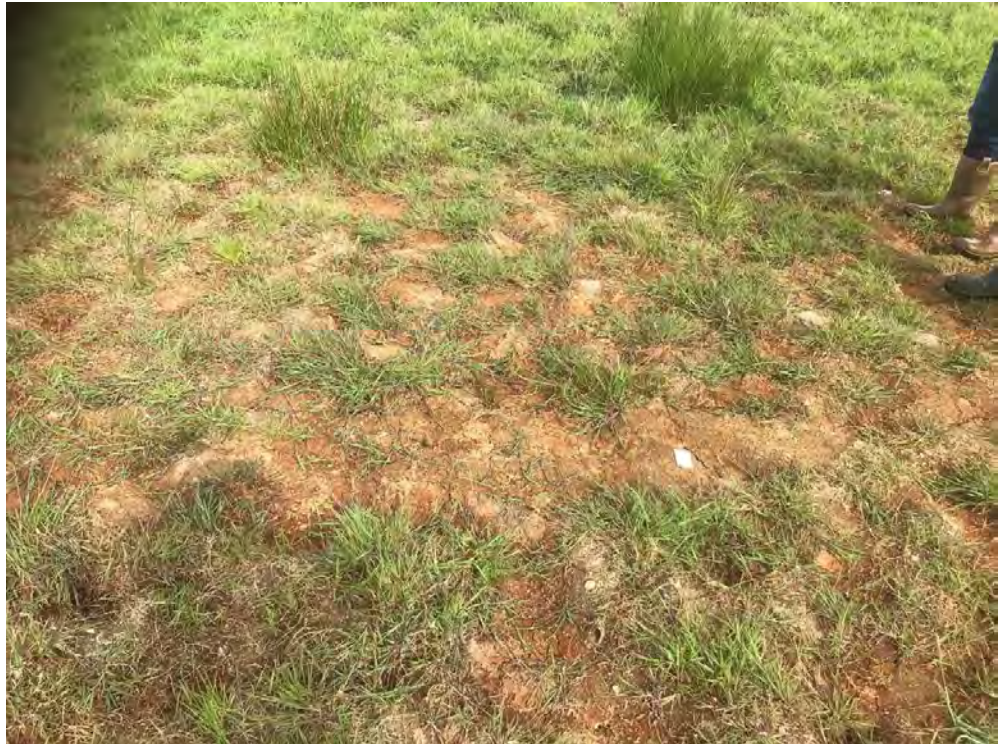
**Photo No.**  
**1**

Evidence of possible leaching or seepage to localized flat area.

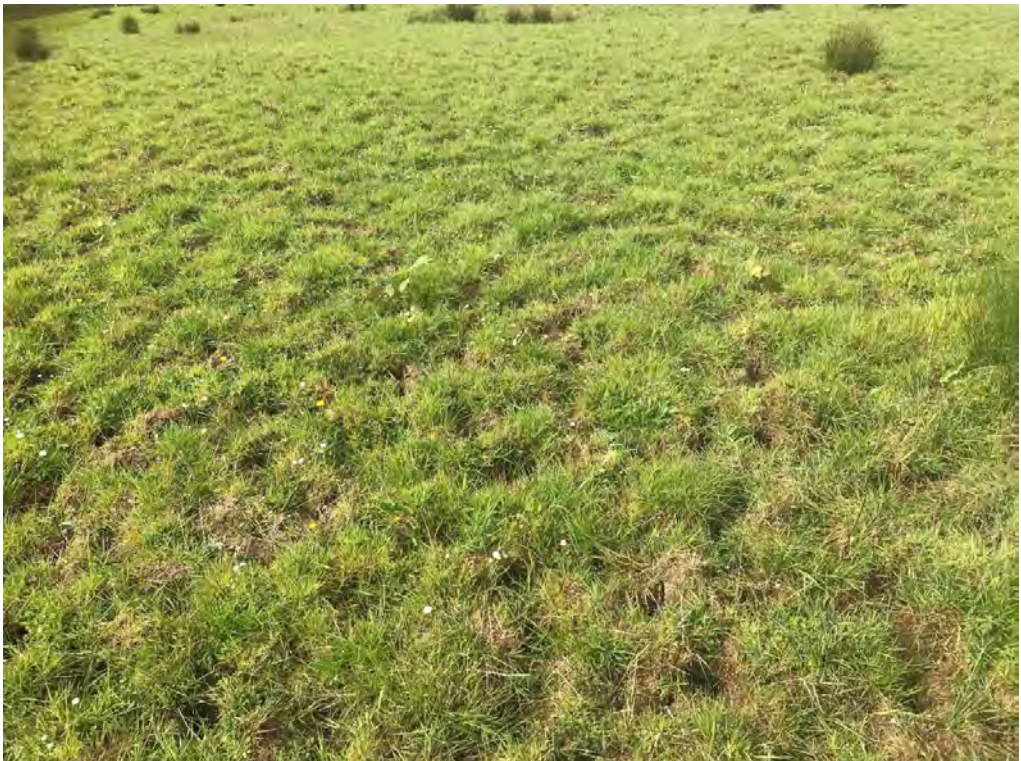
**Photo No.**  
**2**

Heavy Poaching of Landfill Capping.

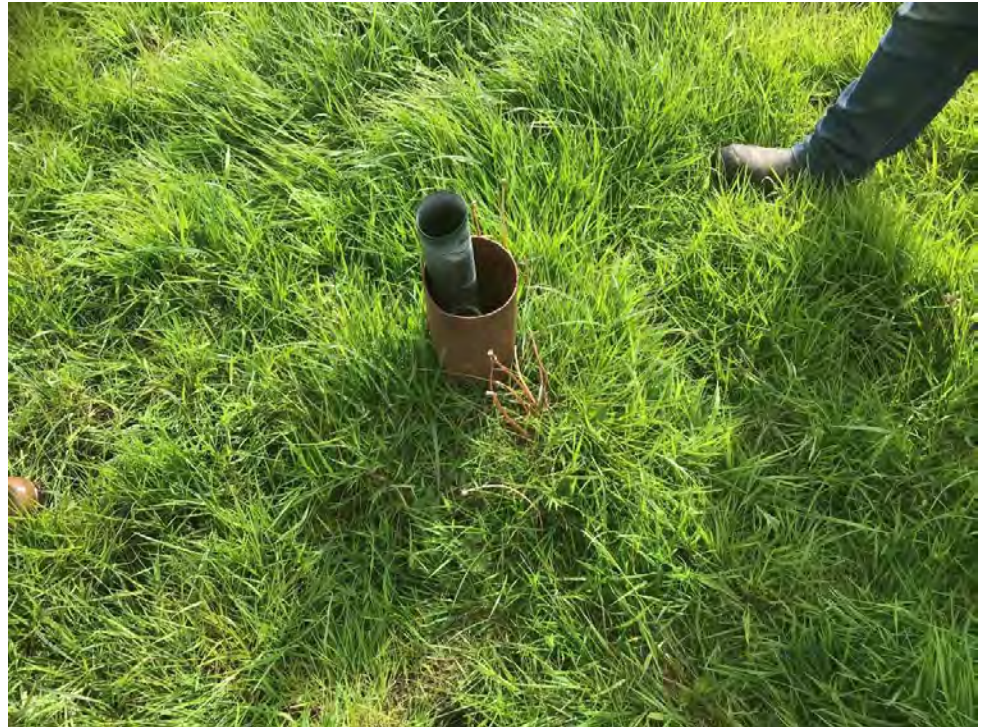
Leachate monitoring point to top of landfill

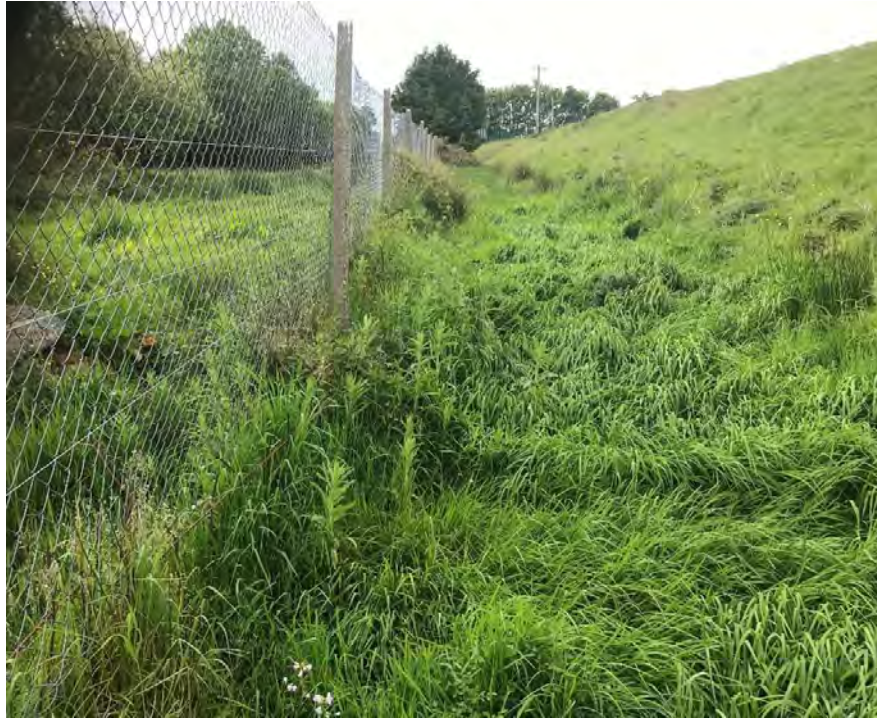
Surface water drain to landfill boundary, site fencing

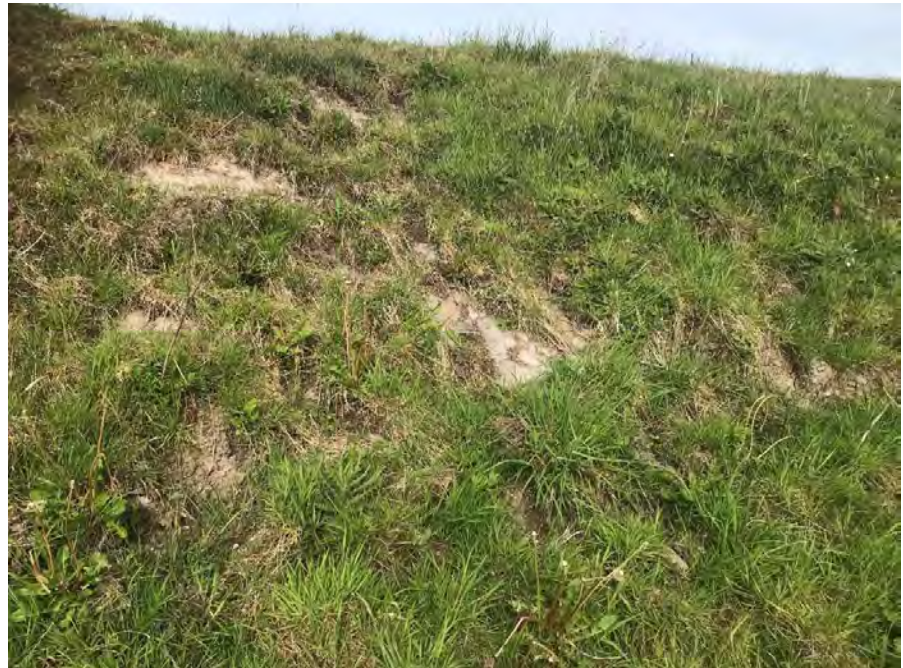
**Photo No.**  
**6**

Evidence of slippage/erosion of landfill capping to side slopes, exposed geocomposite clay liner, evidence of animal damage and poaching

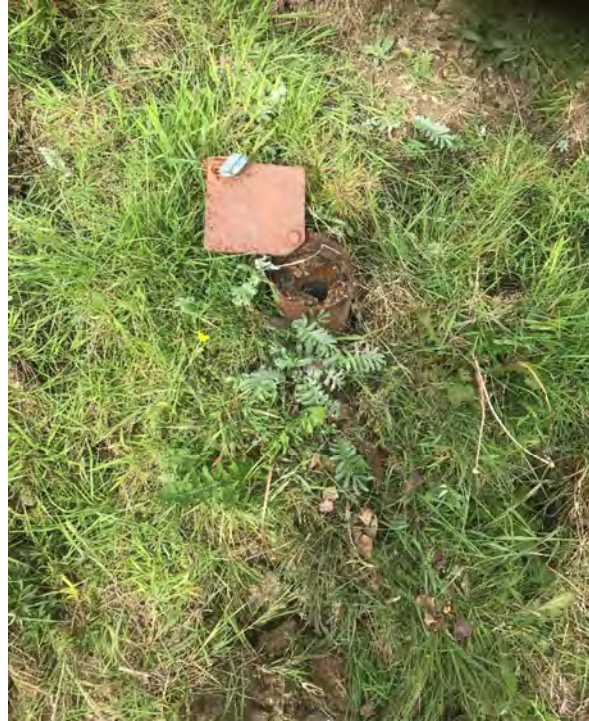
Leachate monitoring infrastructure (heavily corroded)

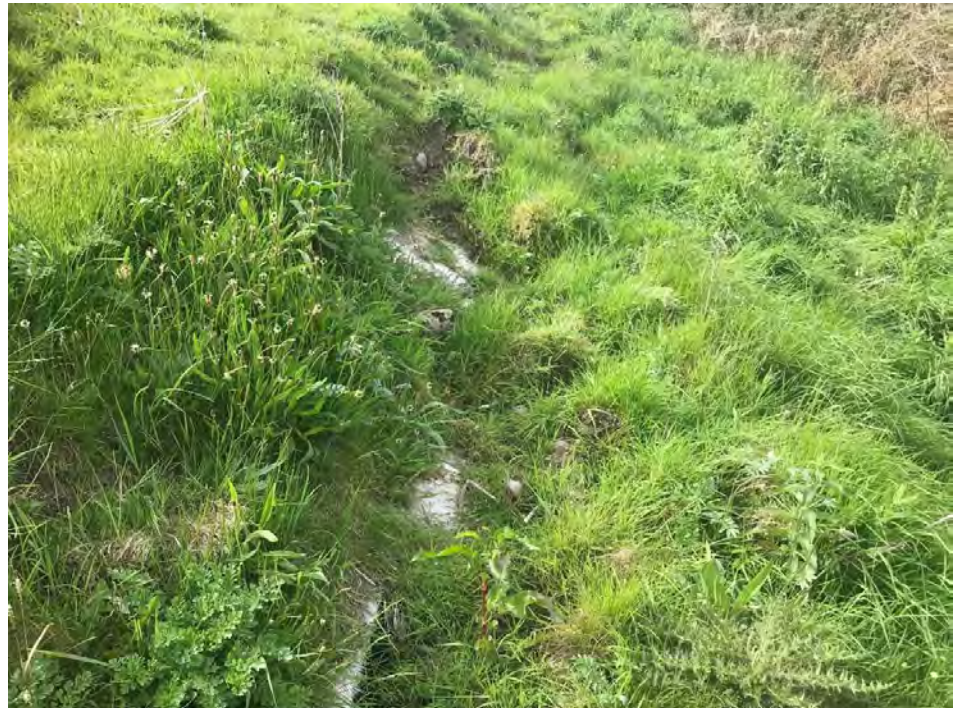
**Photo No.**  
**8**

Further expose G.C.L. to side slopes

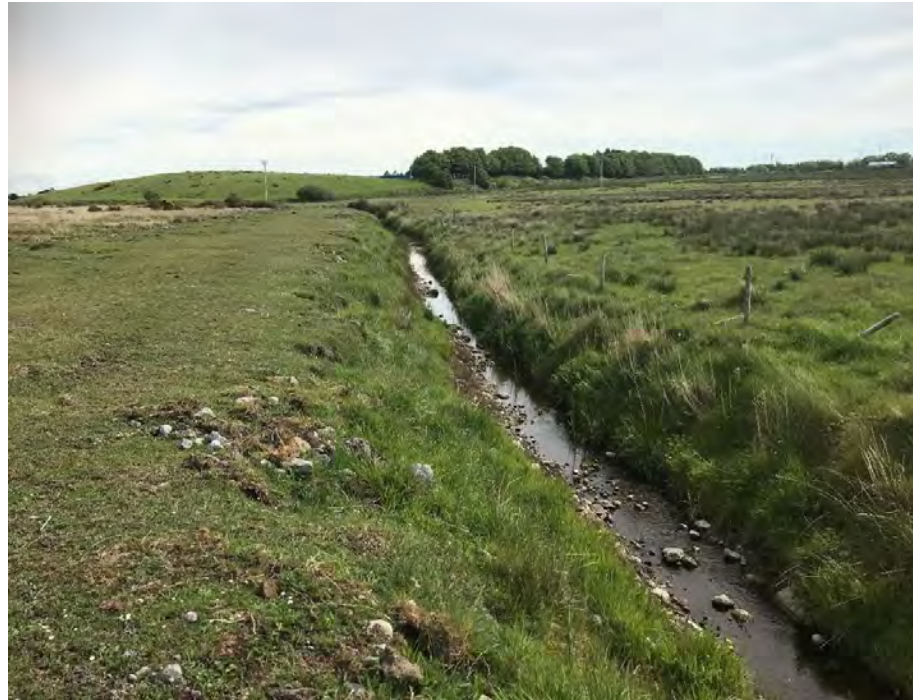
Surface water stream/bog drain, Flow to South West, linked to landfill surface water drains

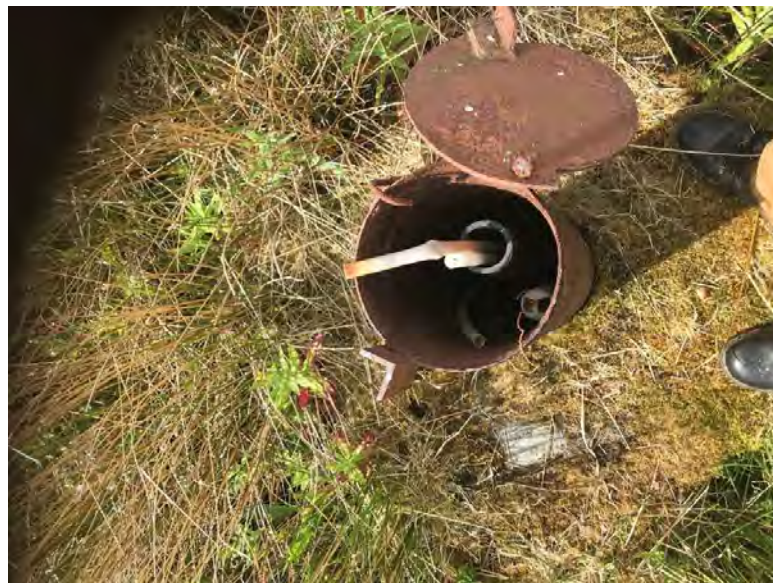
**Photo No.**  
**10**

Groundwater monitoring infrastructure, offsite.

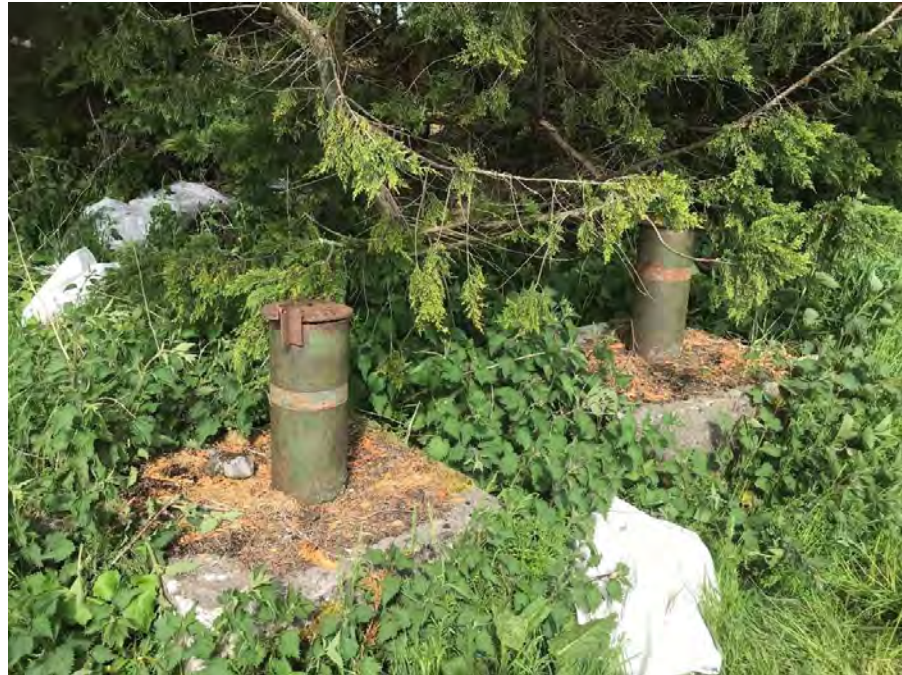
Groundwater monitoring boreholes at entrance to civic amenity

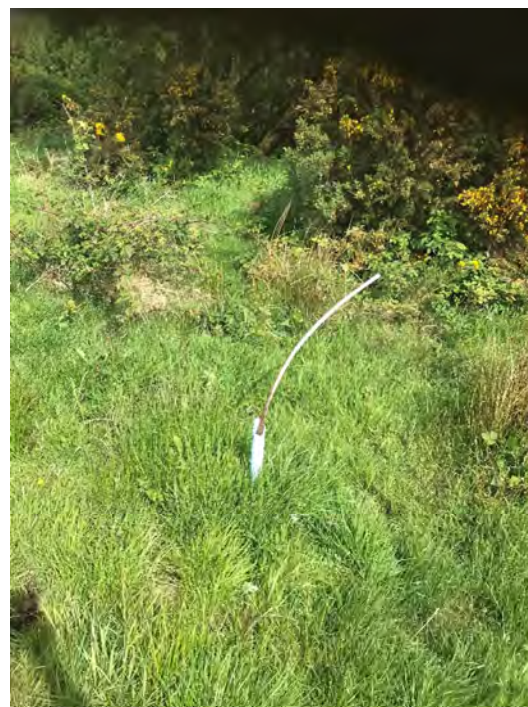
**Photo No.**  
**12**

Groundwater monitoring boreholes
