## **APPENDIX 6**

Causeway Geotechnical  
Reports 2020 and 2022

## Tuam Landfill – Ground Investigation

Report No.: 22-0418

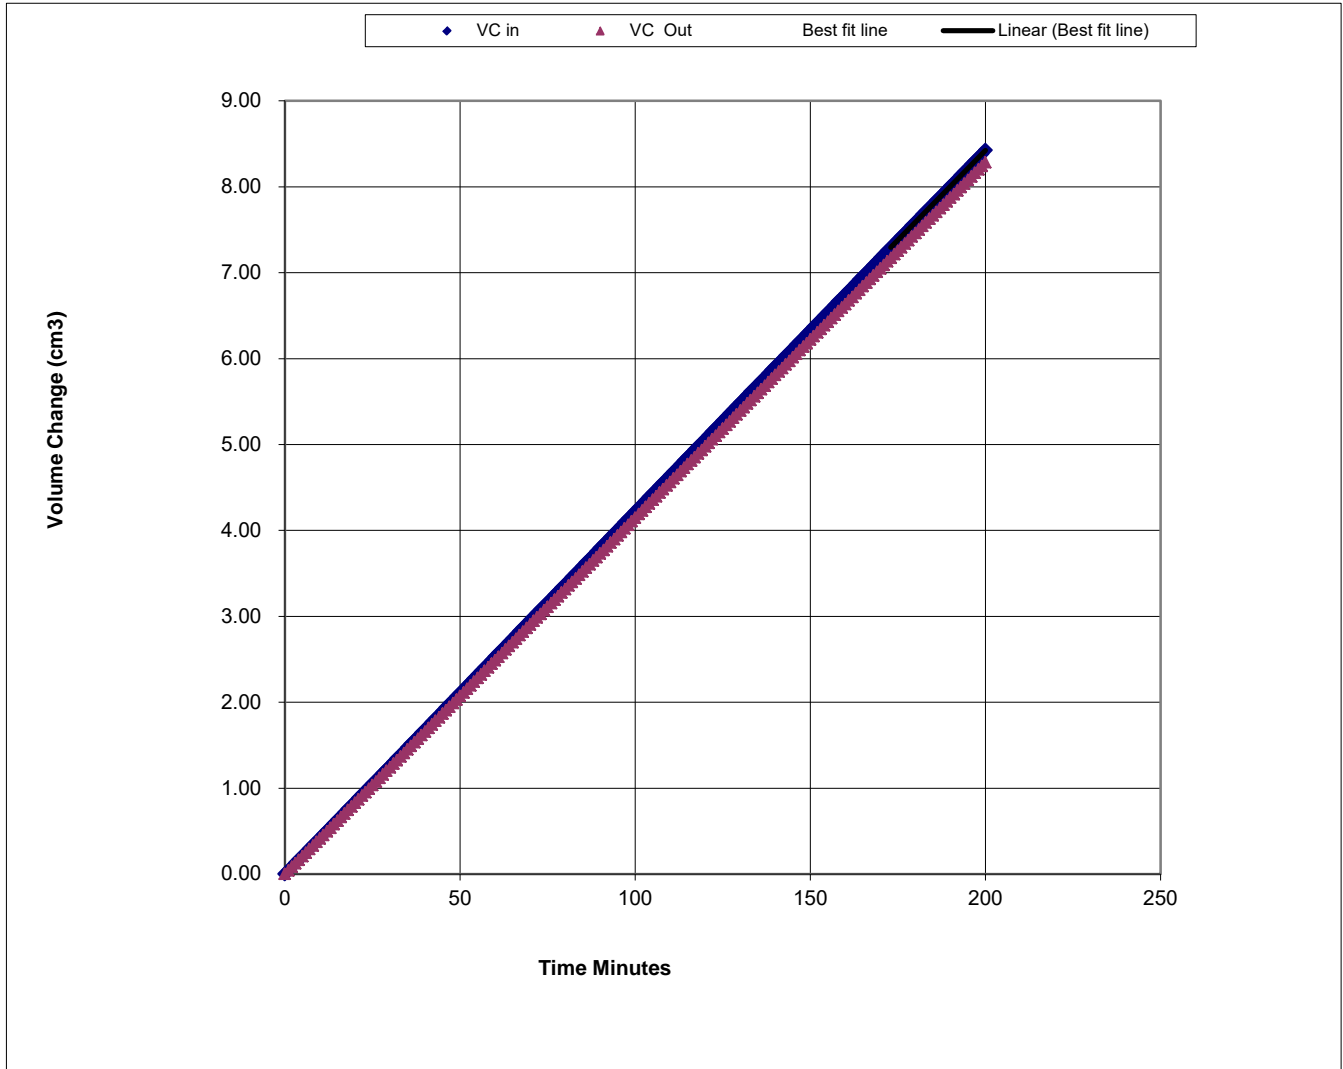
## Permeability Stage

Permeability Stage		
Cell Pressure	kPa	520
Mean Effective Stress	kPa	20
Back Pressure Diff.	kPa	10
Mean Rate of Flow	ml/min	0.0418
Average Temperature	'C	20
Vertical Permeability K <sub>v</sub>	m/s	8.6E-09

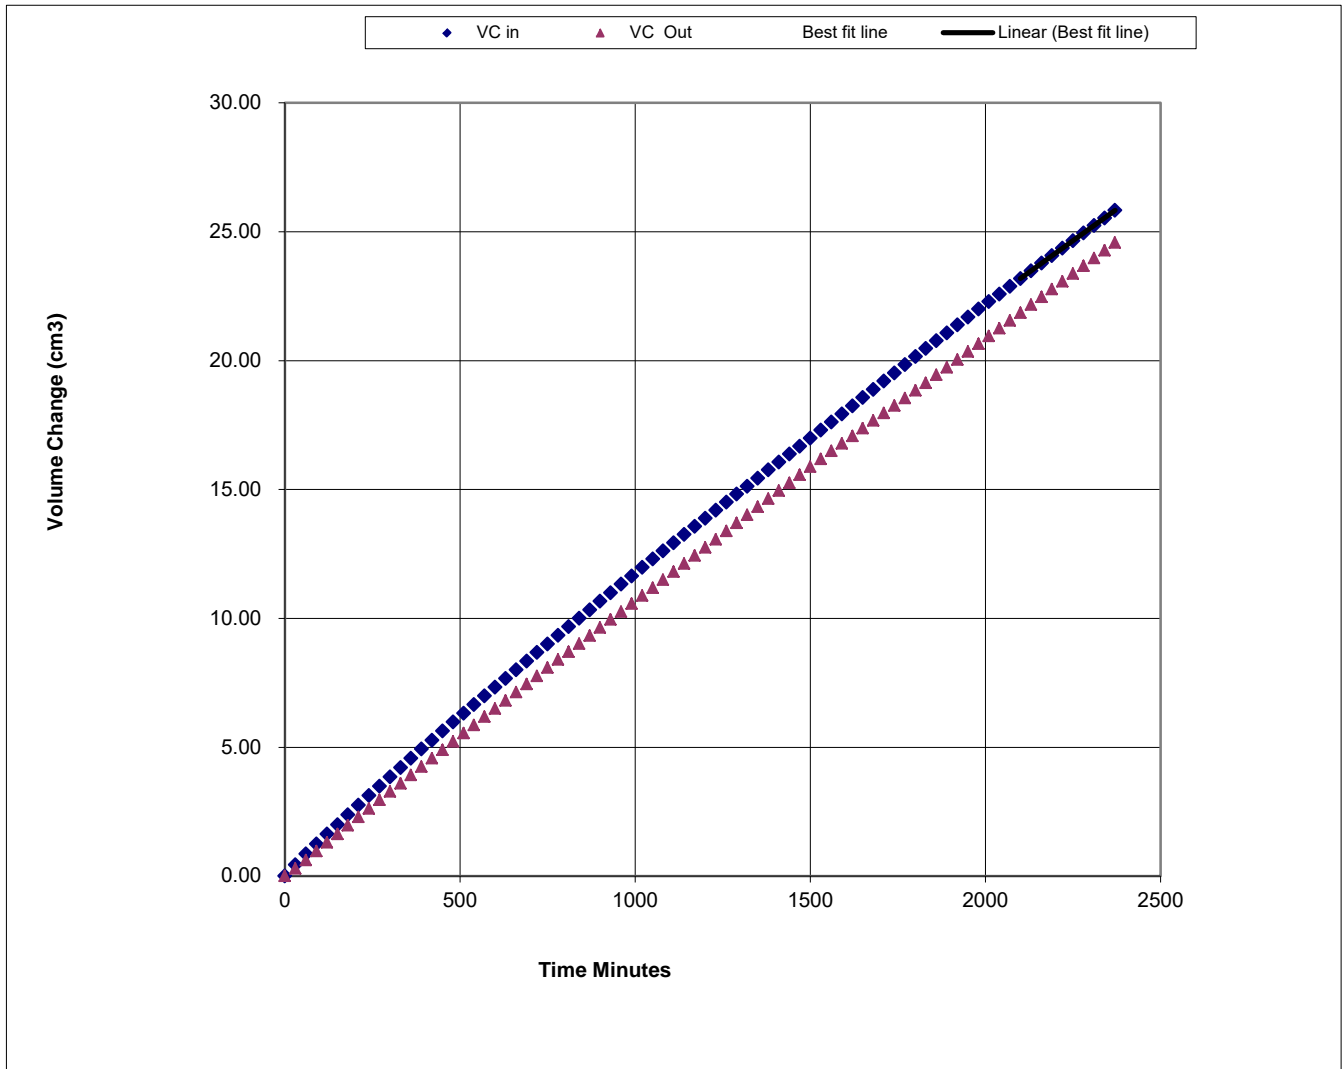
## Permeability Stage

Permeability Stage		
Cell Pressure	kPa	470
Mean Effective Stress	kPa	20
Back Pressure Diff.	kPa	10
Mean Rate of Flow	ml/min	0.0098
Average Temperature	'C	20
Vertical Permeability Kv	m/s	2.0E-09
