CARTRON BIG HISTORIC LANDFILL SITE, CO. LONGFORD

Tier 2 Risk Assessment

Prepared for:
Longford County Council

Date: November 2022

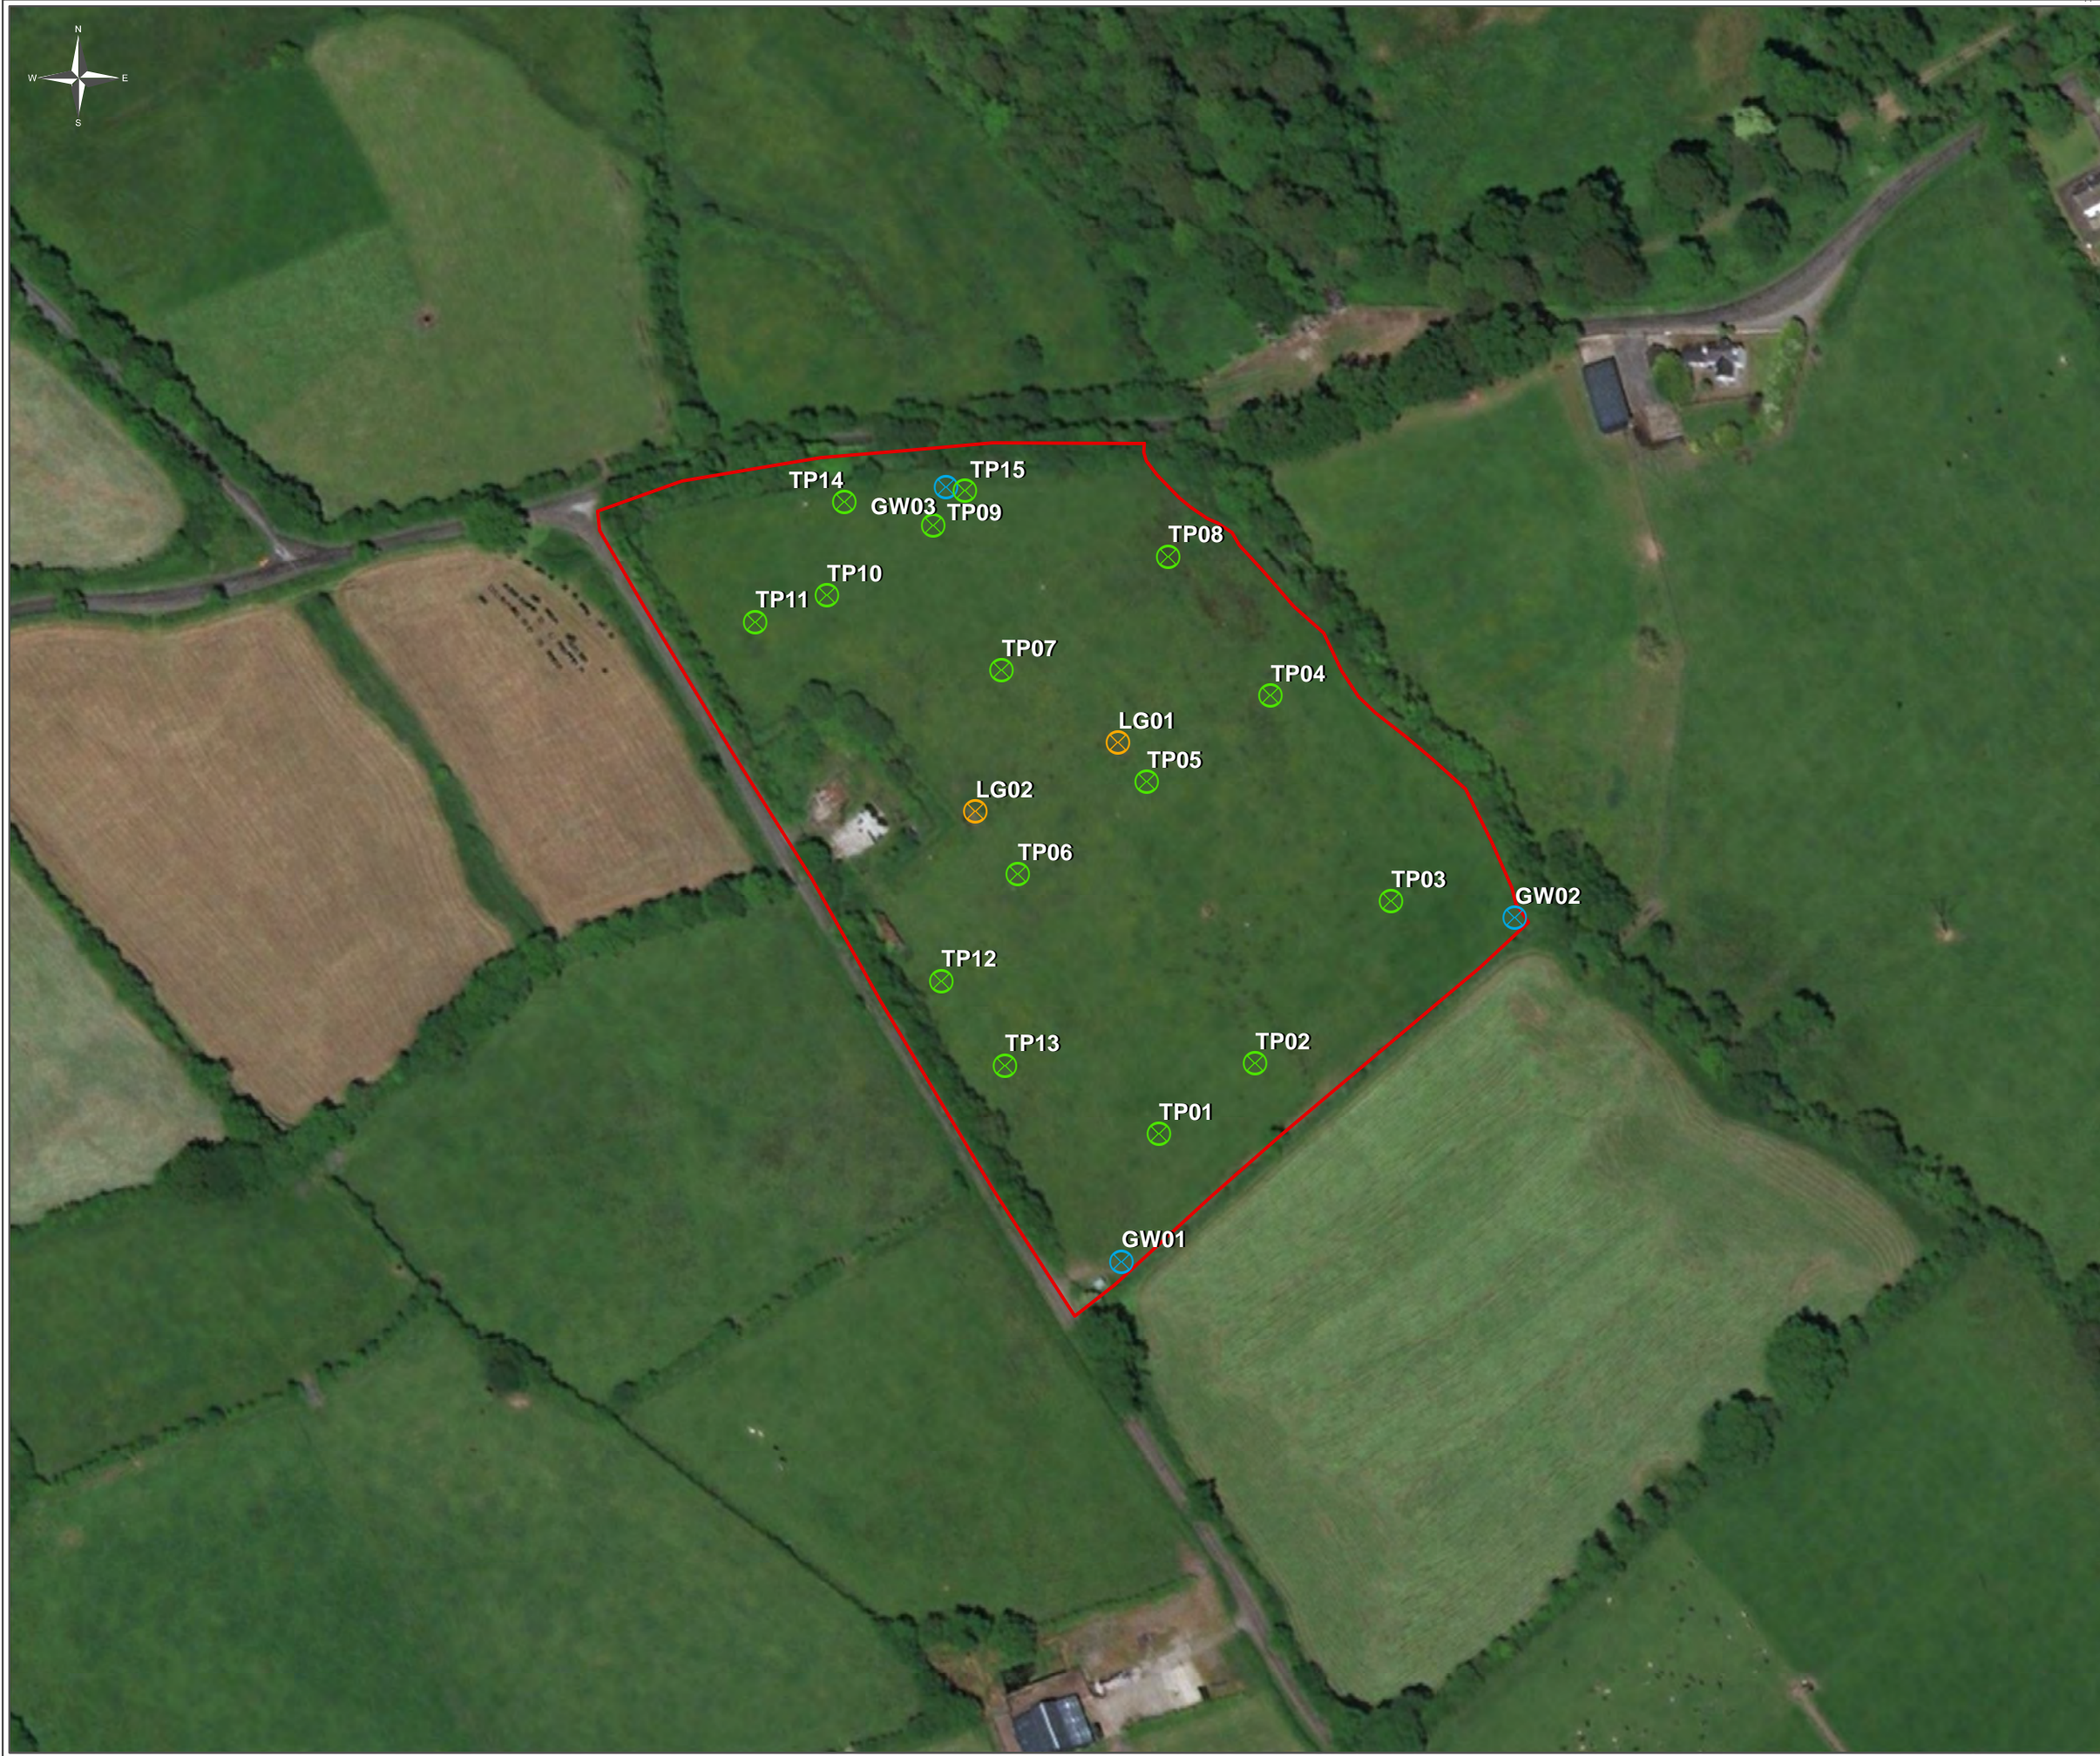
Figure Title	Site Investigation Location Plan		
Figure No.	3.1		
Project	Historical Landfills: Carton Big		
Client	Longford County Council		
Scale	1:2,000	Page Size	A3
Revision	A	Date	15/10/2018

The locations of the intrusive works at the site are presented in Figure 3.1.

- Legend**
- Groundwater Well
 - Leachate Well
 - Trial Pit
 - Site Boundary

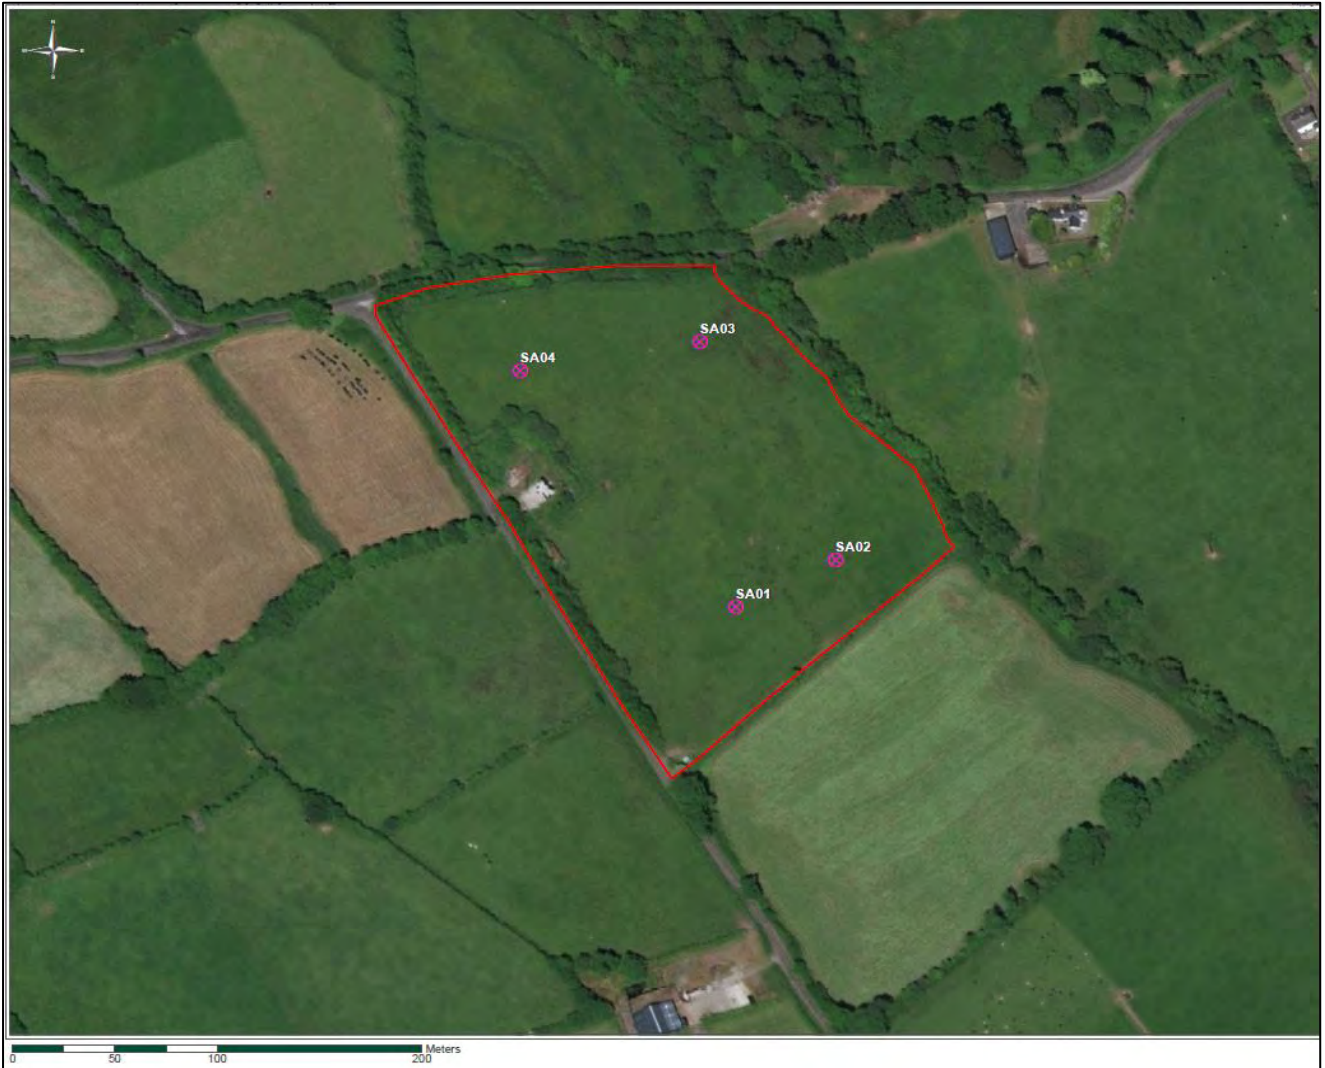
Figure 3-2: Capping Infiltration Testing Locations

Four infiltration tests were carried out in general accordance with the BRE Digest 365, 2007 Soakaway Design Standards. Single and double cycles of infiltration / drainage were undertaken. The soakaway pits failed to drain in full over the test durations of 60 minutes to 120 minutes. The calculated infiltration rates (f) for each test are presented in Table 3.2.

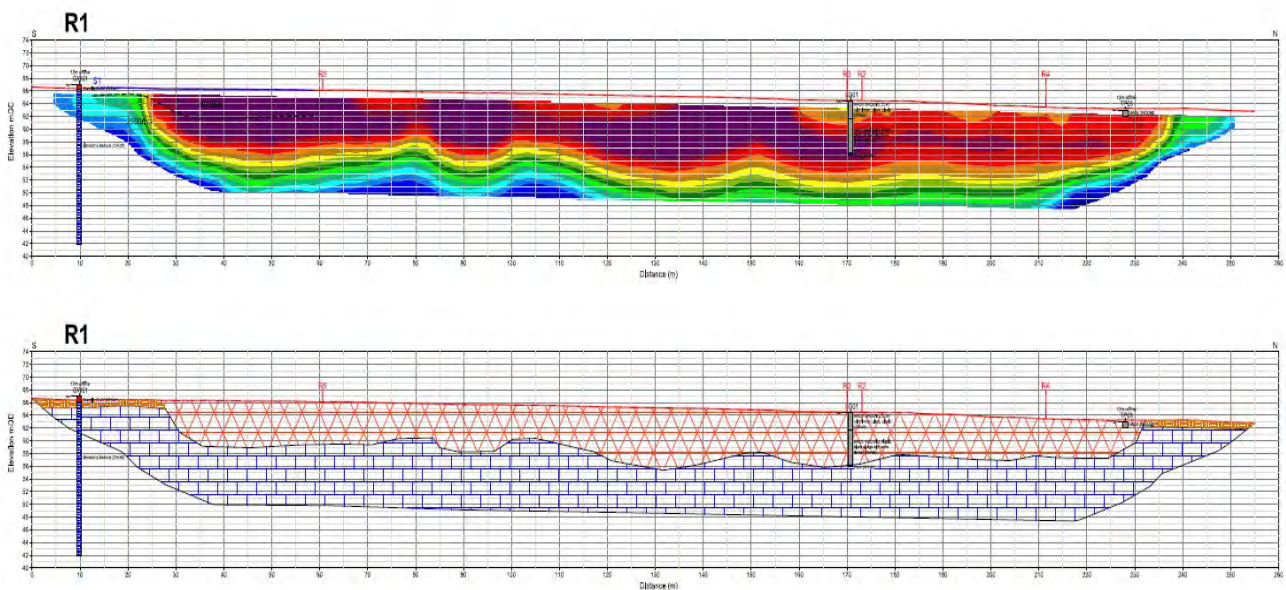
Figure 3-3: ERT Profile R1 Interpreted Cross Section

The modelled profiles and geophysical interpretations are presented in Figure 3.3 to Figure 3.7.

The geophysical results confirm the finding of the desk study and anecdotal information gathered, indicating that the quarried site was backfilled with municipal solid waste to depths exceeding 10m directly atop the underlying limestone bedrock.

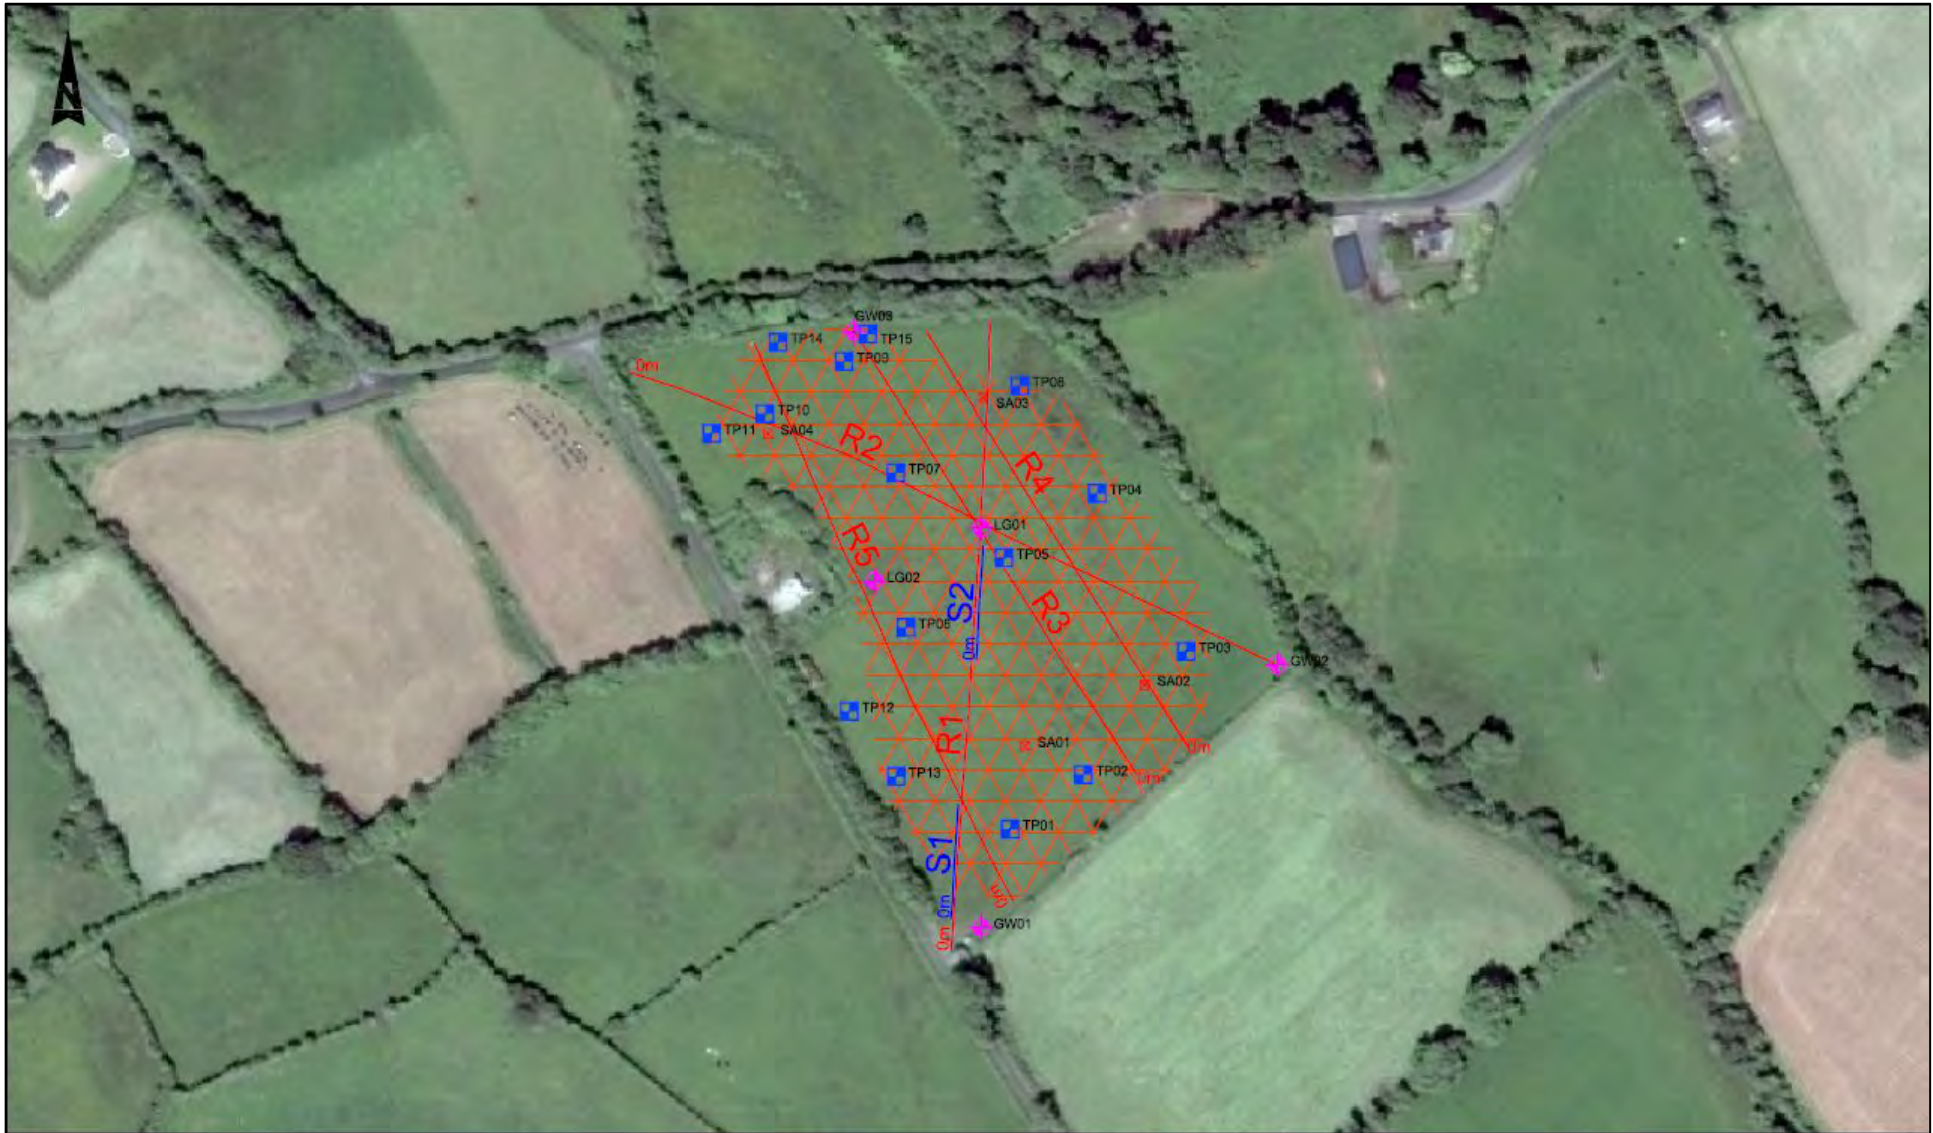
Figure 3-8: Maximum Anticipated Waste Footprint

The maximum anticipated waste footprint is presented in Figure 3.8.

AI volume calculation was conducted based on the surveyed surface profiles for the existing ground level and the base of waste as interpreted, preliminary estimates indicate an interred waste volume of approximately 206,000 m³ at the site.

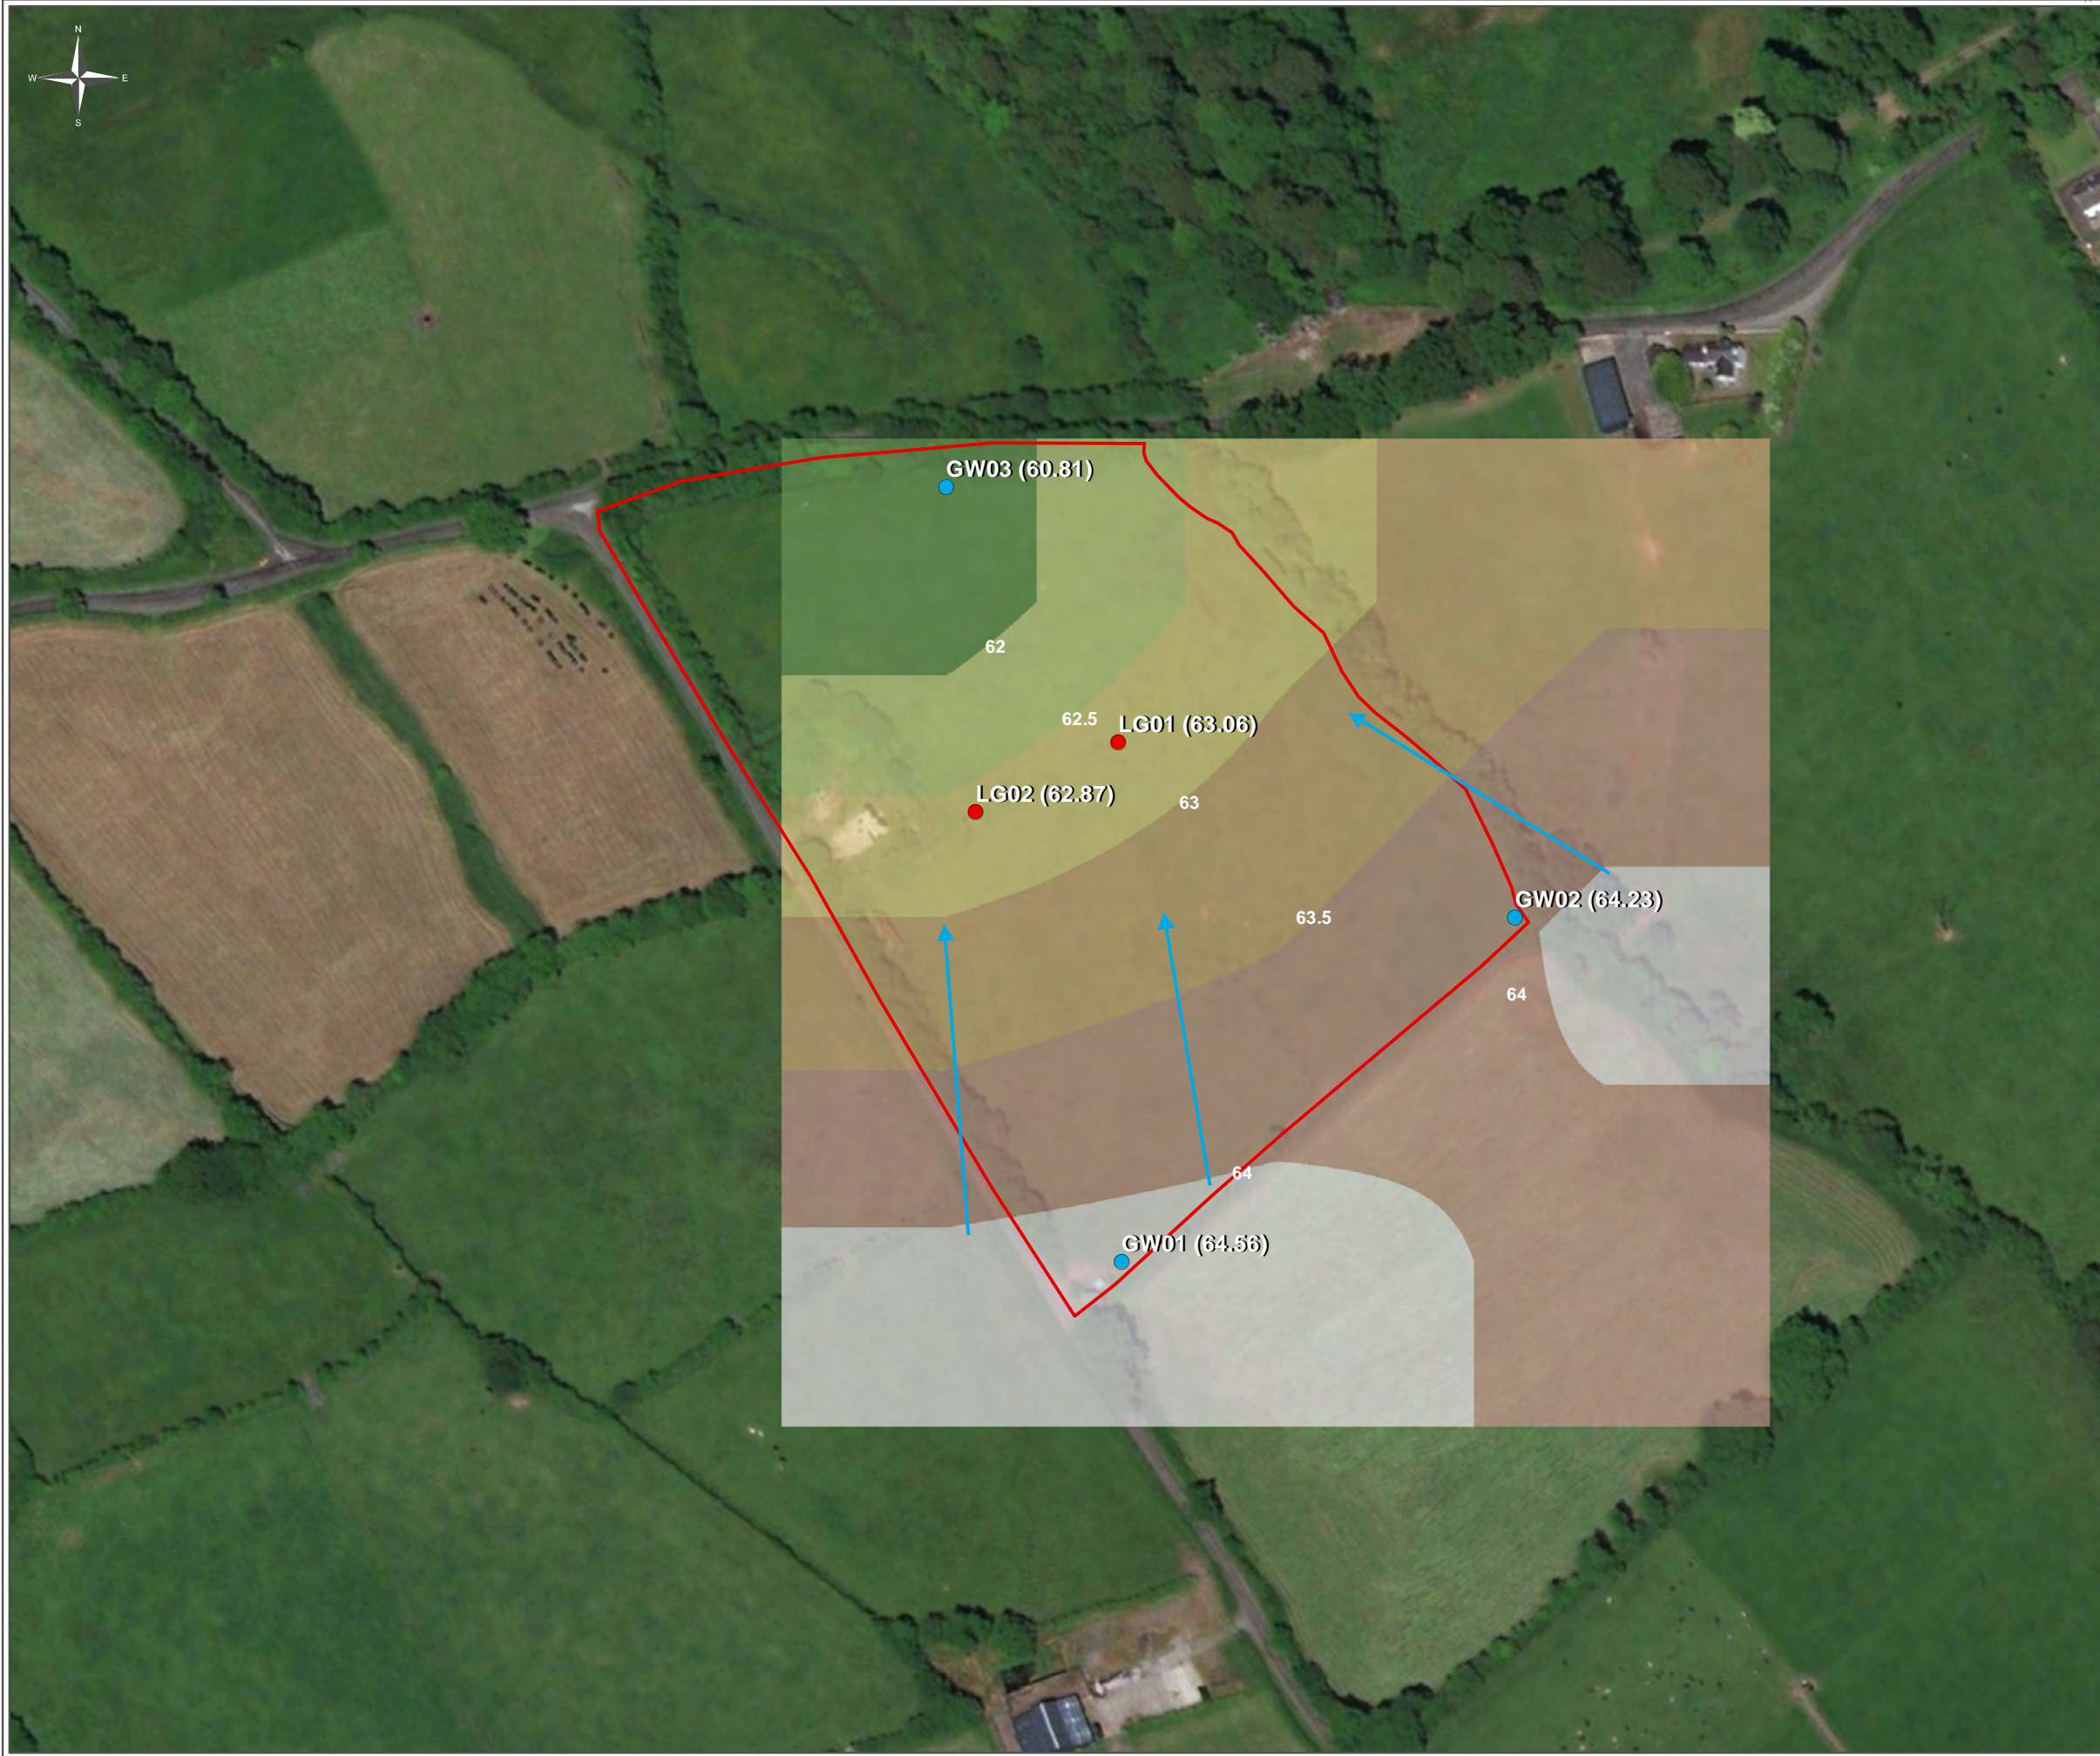
- Dipped Water Level (mAOD)
- Dipped Leachate Level (mAOD)
- Groundwater Flow Direction
- Site Boundary
