Re: Whitegate Landfill – Response to Notice in accordance with Regulation 7(4) of the Waste Management (Certification of Historic Unlicensed Waste Disposal and Recovery Activity) Regulations, 2008.

Item 1 – Clarification of extent of waste body.

Item 2 – Composition of trial pit (TP6).

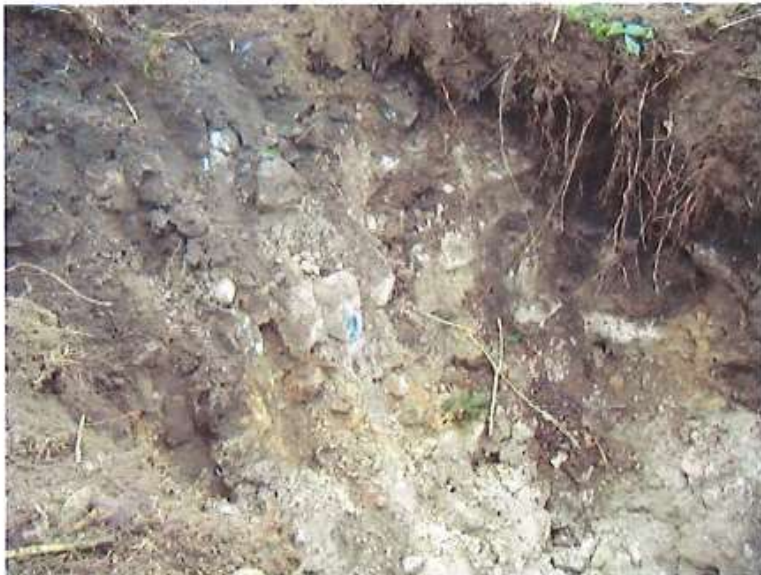
Photo 01

Based on review of the original trial pit logs, together with a recent inspection of the area in question by Council staff, it is evident that soils comprising of glacial tills, cobbles and boulders are present at the eastern boundary of the landfill body. There is no evidence of 'rubble' or other construction and demolition wastes present in or around the location of Trial Pit 6.

Furthermore, please see Photo 01, which demonstrates the composition of the original Trial Pit 6. This photo demonstrates the presence of soil, cobble and boulders, typically of glacial tills, with no evidence of construction and demolition waste.

Based upon the findings of this inspection, the Council can confirm that there is no evidence of waste material as defined under the Waste Management Act 1996, as amended at the location of Trial Pit 6 or the surrounding area.

Based upon the above referenced investigation and original trial pit logs, this area does not contain waste, and the Council is of the opinion that this area should not be considered within the landfill body. The extent of the landfill body remains 1.19Ha as previously stated.
