Re: Application for the Certification of an Unregulated Landfill Site (namely Dunmanway Landfill) as per S.I. No 524 of 2008 Waste Management (Certification of historic Unlicensed Waste Disposal and Recovery Activity) Regulations 2008.

Certificate of Authorisation Application Form

Project
**Environmental Risk
Assessment for Unregulated
Waste disposal Sites**

Tier 1 Investigation

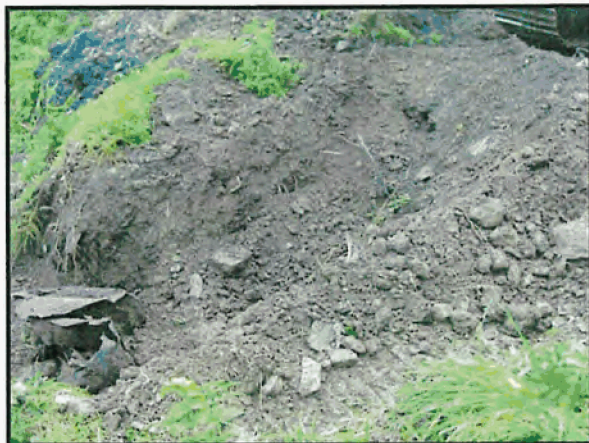
Slit Trench 1

Waste was found in all excavated areas of the site. The majority of the waste comprised of domestic waste including papers, plastics, glass, wiring, steel fragments, concrete fragments and timber. The waste was supported in most areas by a sandy gravely clay matrix. Waste was sampled for VOC's with a hand held Photo Ionisation Detector. No significant VOC readings were recorded (Highest reading of 19ppm in TP-3). Water / Leachate was found at between 2.1m and 4.5m below ground level in all Trial Pits (See Appendix 3). A Brown firm Clay with a high proportion of rootlets and organic material was found below most Trial Pits (13No. of 16No. Trial Pits, 3No. Trial Collapsed before the base was reached). This Organic Clay layer was found to be dry in all cases and appeared to be forming an effective barrier between the landfill and the groundwater.

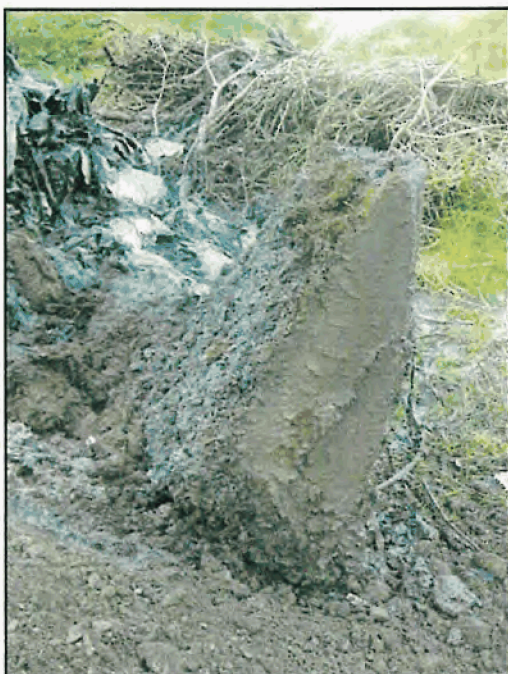
Organic Layer under TP4

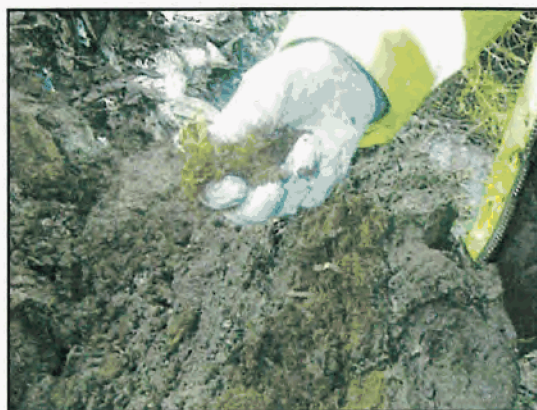
Close-Up of Organic layer under TP4

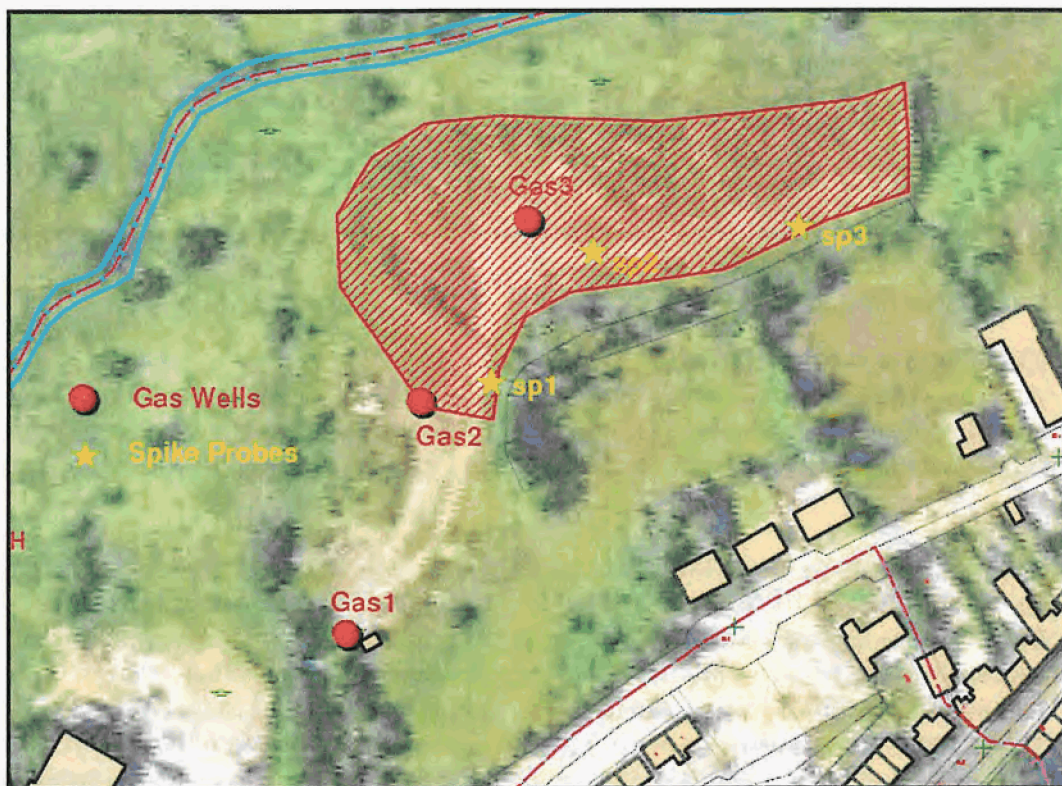
3No. Gas wells were installed on the 24th November 2009.. 1No. outside the waste mass, 1No. adjacent to the waste mass and 1No. within the waste mass. 3No. Gas Spike Probes were later installed also along the perimeter of the site (see explanation for this below). See drawing below for wells and probe locations.

Gas Well & Spike Probe Locations

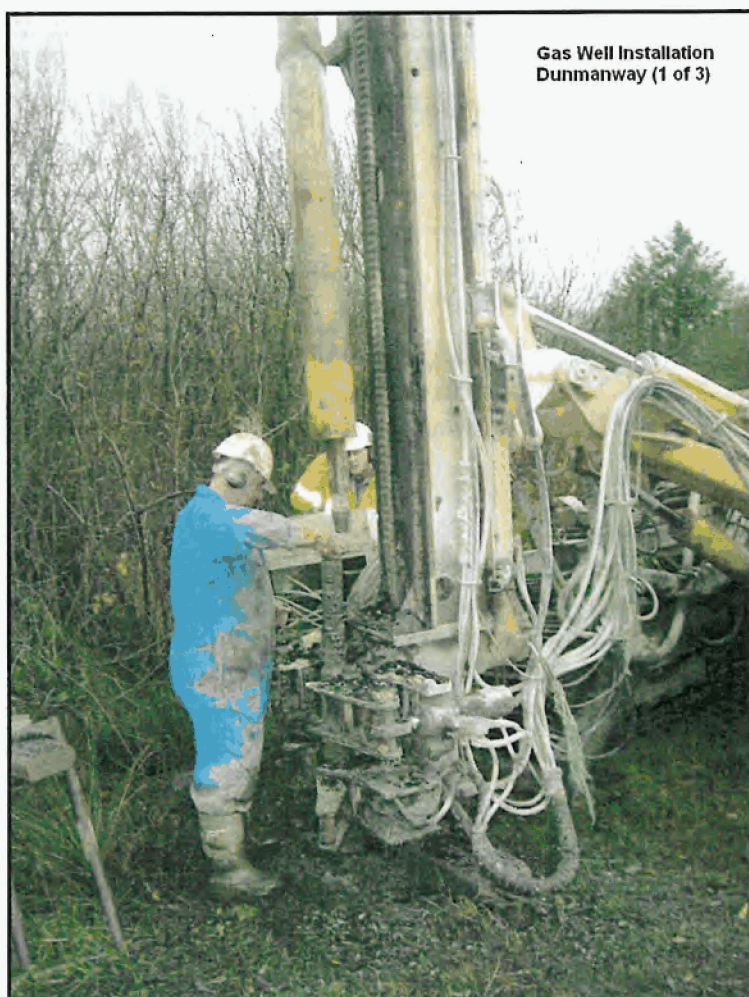
Installation of Gas Well No.2

Gas wells were constructed using high density polyethylene 50mm diameter standpipes. A gravel filter pack was inserted between the borehole and the standpipe.

While visiting the site for the first gas monitoring period on the 1st December it was noticed that the gas wells had been vandalised (Well heads hammered off their concrete mounts and polyethylene standpipes pulled out and thrown into the under growth). Due to adverse weather conditions and the danger of repeated vandalism it was decided to install Gas Spike Probes instead of re-installing the wells.

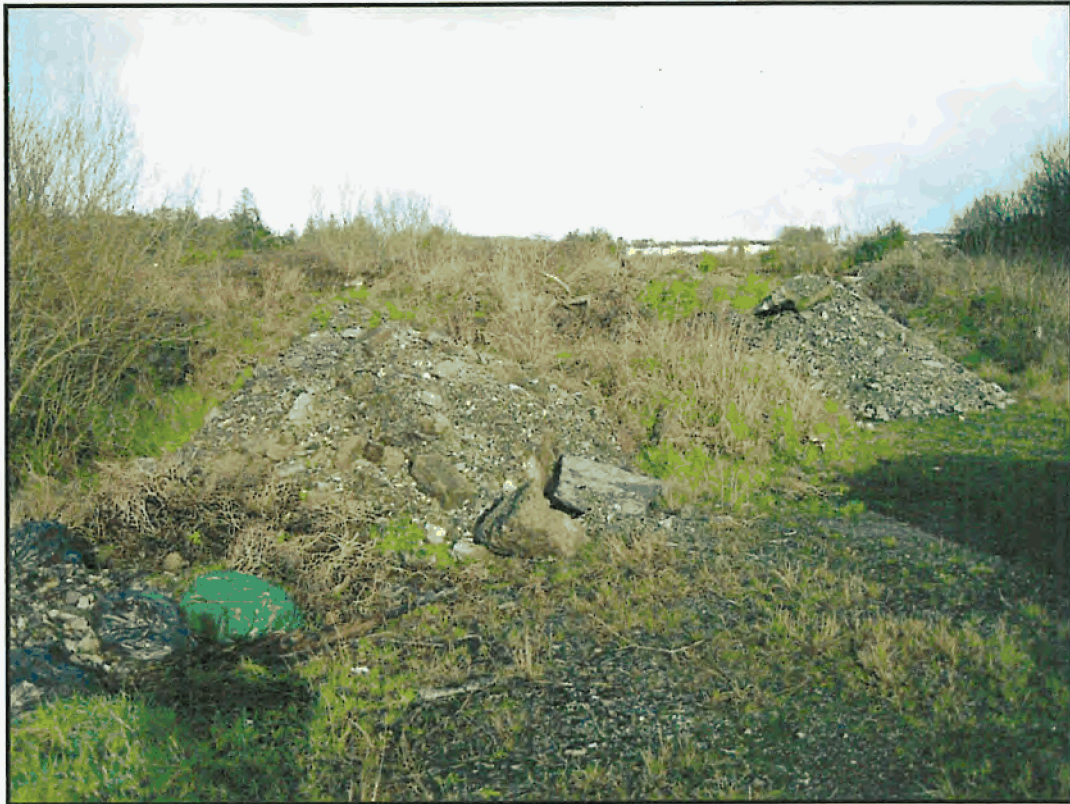
2. Mounds of C&D waste

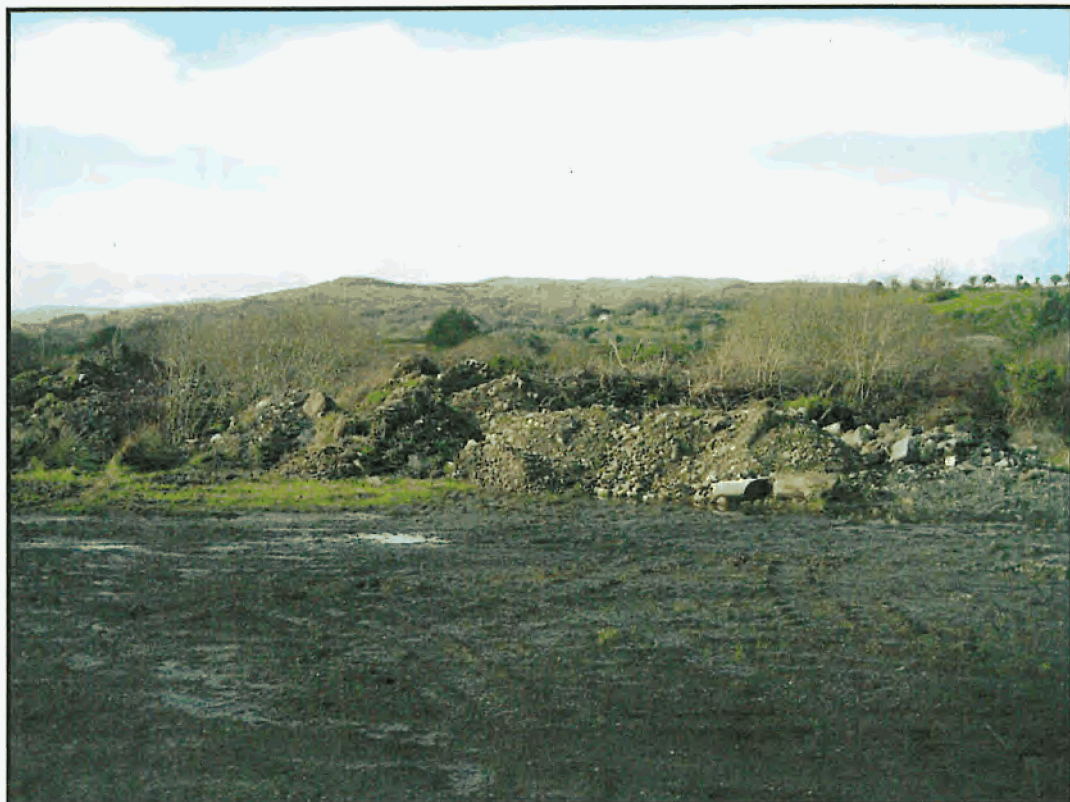
3. C&D waste (facing West)

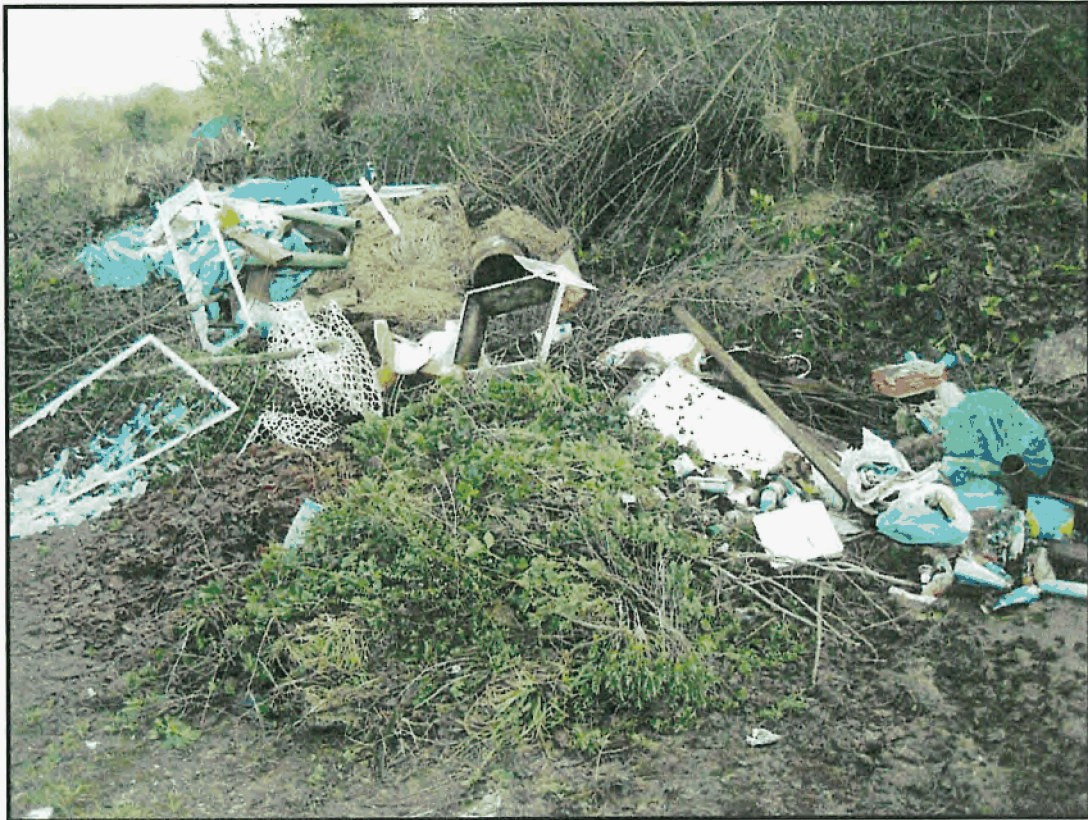
4. Surface waste
