Intended for
Vantage Data Centers DUB11 Limited

Date
January 2023

VANTAGE – DUB11 SITE CONDITION & BASELINE REPORT

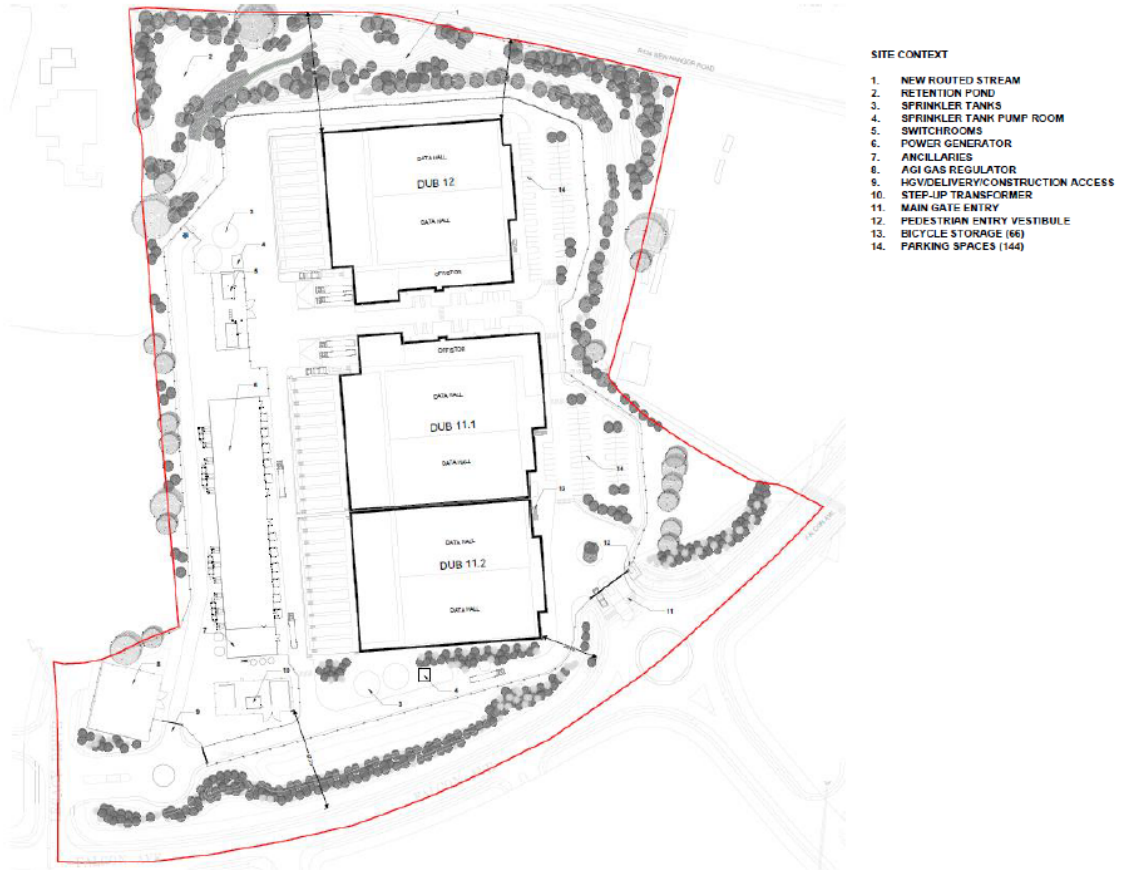
Figure 1: Development Proposal Drawing

The northern data centre (Building 12) includes a two-storey building of 12,915 sqm and comprise 11 no. standby emergency generators with associated flues, each of which are 22.3 metres in height and are to be located towards the west of the building.

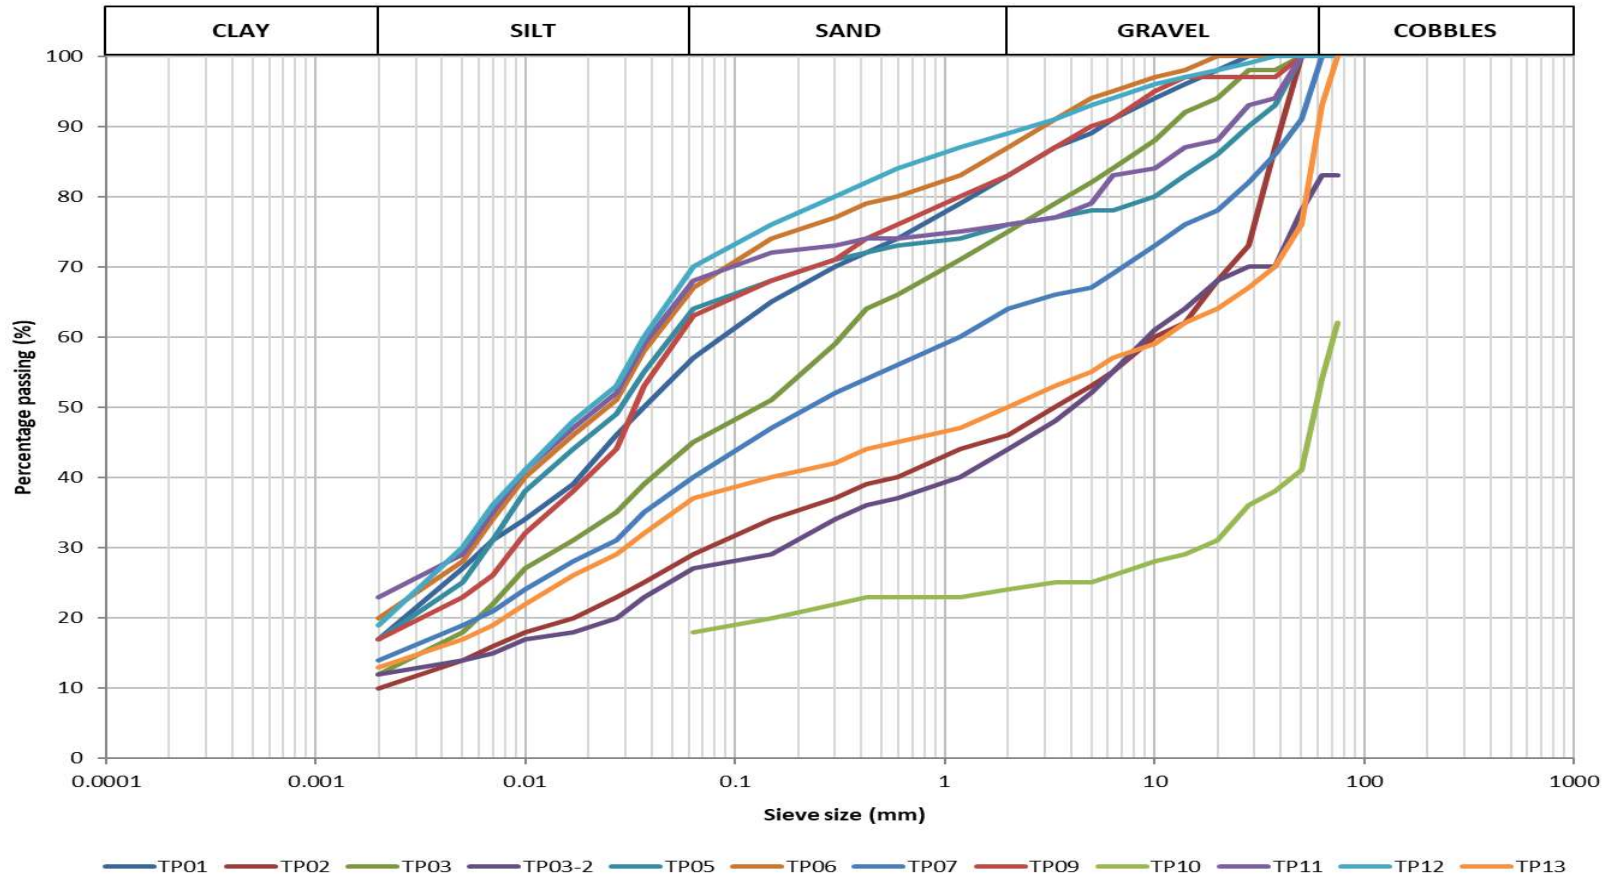
Plot No 9

Title: Particle size distribution (PSD) for Glacial Till
