**Code of Practice Environmental Risk Assessment for  
Unregulated Waste Disposal Sites**

**CLOUNTREEM  
TIER II SITE INVESTIGATION  
REPORT**

<b>Landfill Site:</b>	<b>Clountreem</b>
<b>Site Reference:</b>	<b>07/W</b>
<b>Division:</b>	<b>West Cork</b>
<b>Area Office:</b>	<b>Castletownbere</b>

**Report by:** Kieran Coffey  
Environment Directorate  
Cork County Council  
December 2009

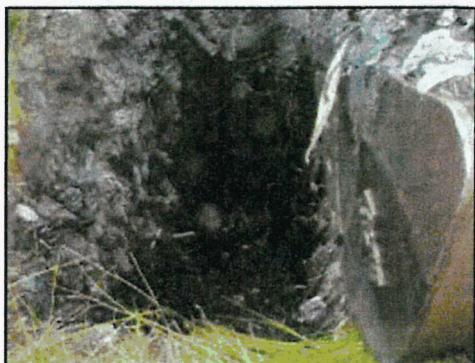
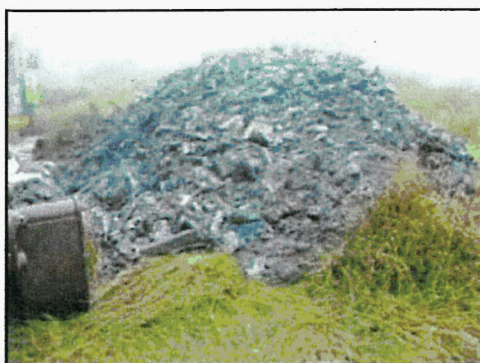
**Trial Pit No.3**

Waste was found in all areas of the site. The majority of the waste comprised of domestic waste including plastics, textiles, glass, papers, steel roof sheeting, steel pipes, concrete, fishing nets, ropes, radiators, tyres, car and truck batteries, timber, blocks etc. (See Trial Pit Logs in Appendix 3). Some Trial Pit photos can be seen below:

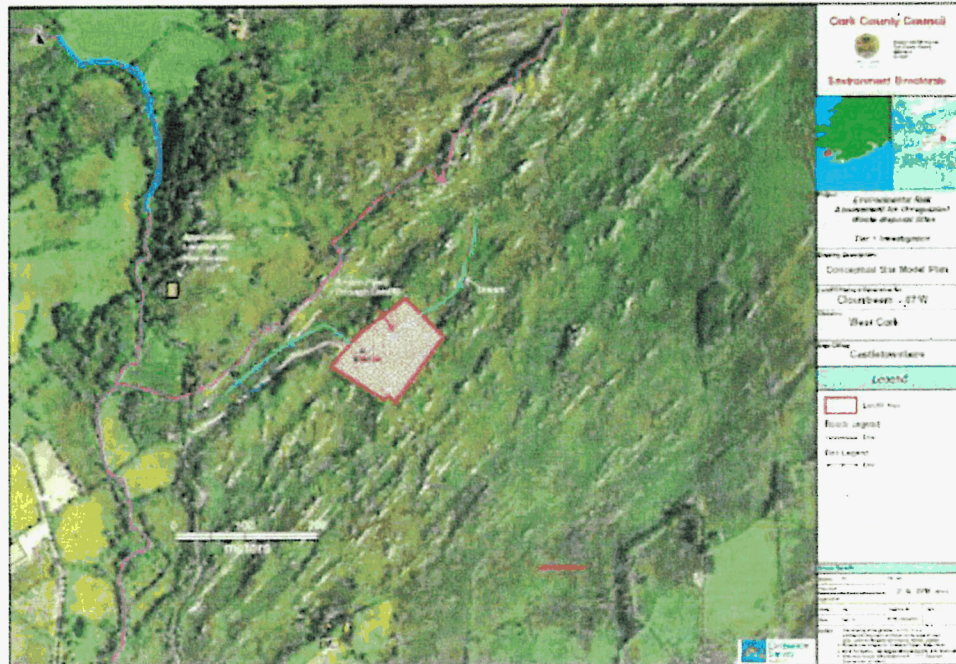
Fig 3.2: Conceptual Site Model Plan

A small mountain stream flows beneath the landfill in a North East to South West direction (see CSM Plan below). The stream is piped through the landfill in a 600mm concrete pipe.

A CCTV Survey was completed on the 600mm concrete pipe which conveys a mountain stream under the landfill (See fig 3.2 CSM Plan). There are two sections of pipe that were surveyed. The first was up-stream of the manhole. Only 46.7m of the c100m length of pipe could be surveyed before the camera encountered a blockage. Many of the pipe joints were found to be leaking leachate into the stream. At 46.7m up the pipe a 60% blockage was encountered and cracks (which were leaking) in the pipe noticed.

Comments: The main recommendation is to stop/prevent leachate migration from the landfill to the local stream. This can be achieved by either repairing the concrete pipe (possible re-lining) or diverting the stream. The latter solution would be preferable.

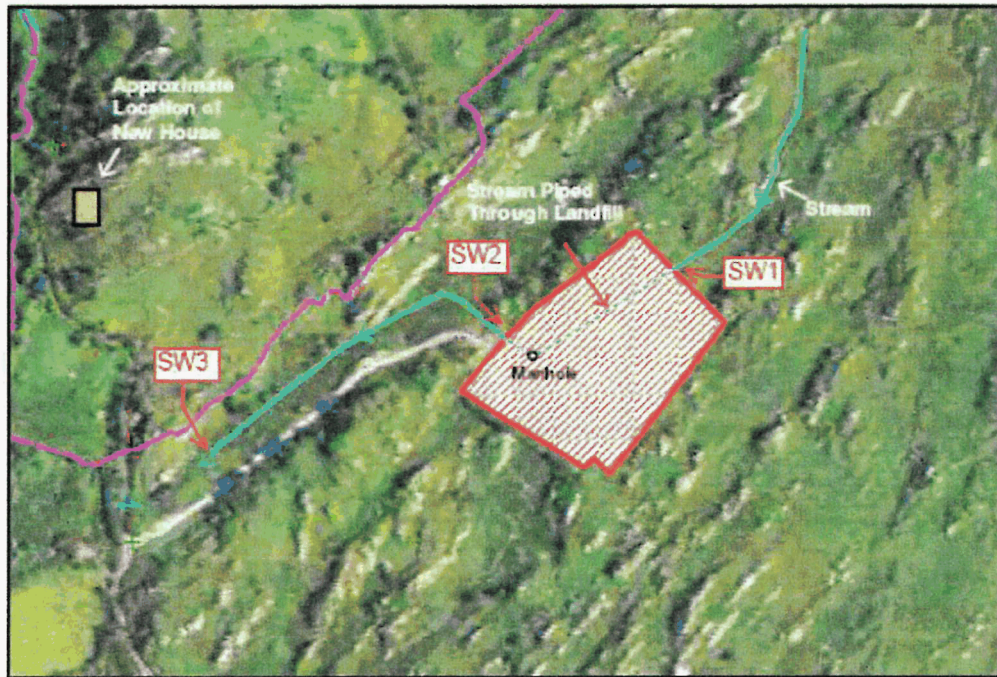
Fig 3.3: Surface Water Sample Locations

3No. Surface Water samples were taken from the stream running through Clountreem Landfill on 30<sup>th</sup> October 2009. Samples were collected and stored in accordance with BS 6068 – 6.6 Guidance on sampling of rivers and streams. Full laboratory chain of custody documentation was completed and samples dispatched to the chosen laboratory (Certificates of Analysis can be seen in Appendix 4). Samples were tested for major and minor suites in accordance with the EPA Guidance Matrix (See Appendix 2).

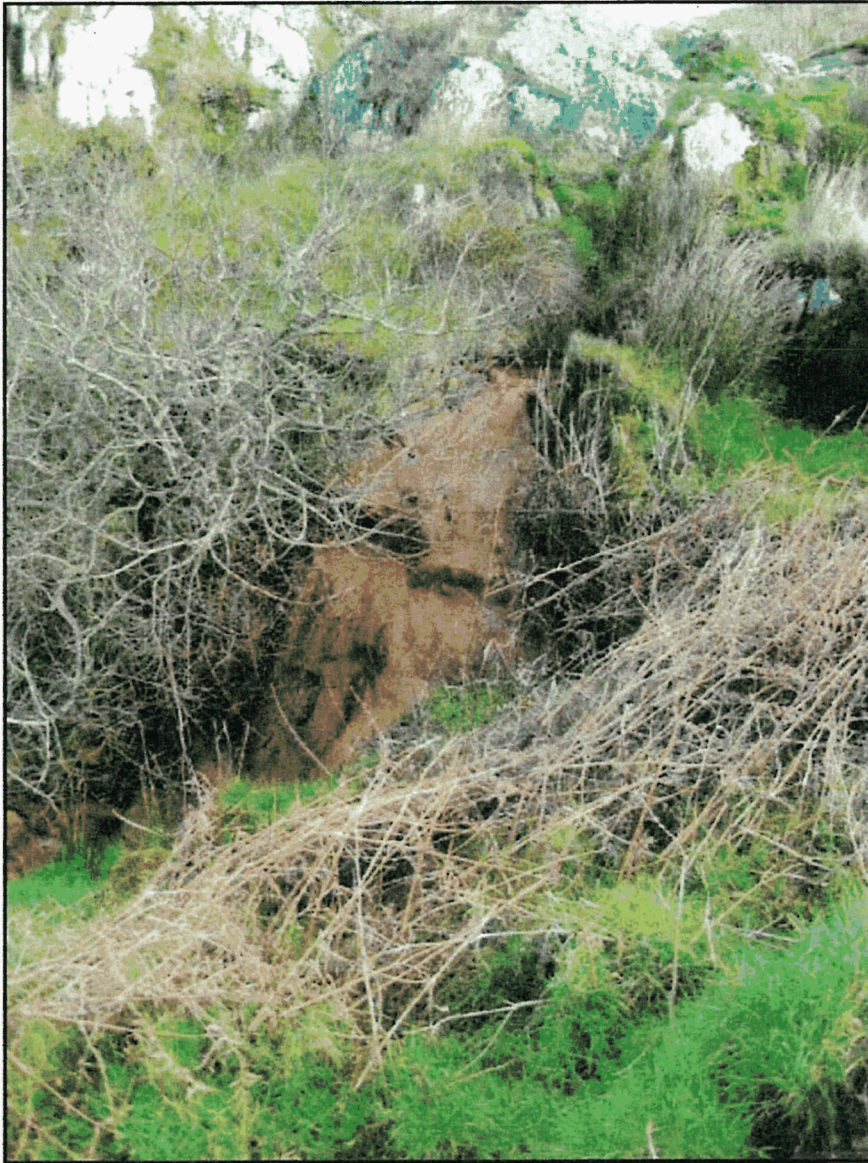
**g) Stream near site entrance (red deposits on base of stream)**

The elevated ammonia levels, yellow-ocre staining on the stream-bed and the reduction in macroinvertebrate numbers are a likely result of leachate infiltrating the culverted section of the Clountreem Stream under the landfill site.

It is recommended that measures are taken to ensure that the integrity of the stream culvert under the landfill is fully sealed and impermeable to potential leachate infiltration.
