**Code of Practice Environmental Risk Assessment for
Unregulated Waste Disposal Sites**

**CLONAKILTY
TIER II SITE INVESTIGATION
REPORT**

Landfill Site:	Clonakilty
Site Reference:	02/W
Division:	West Cork
Area Office:	Clonakilty

Tier II Report by: Kieran Coffey
Environment Directorate
Cork County Council
January 2011

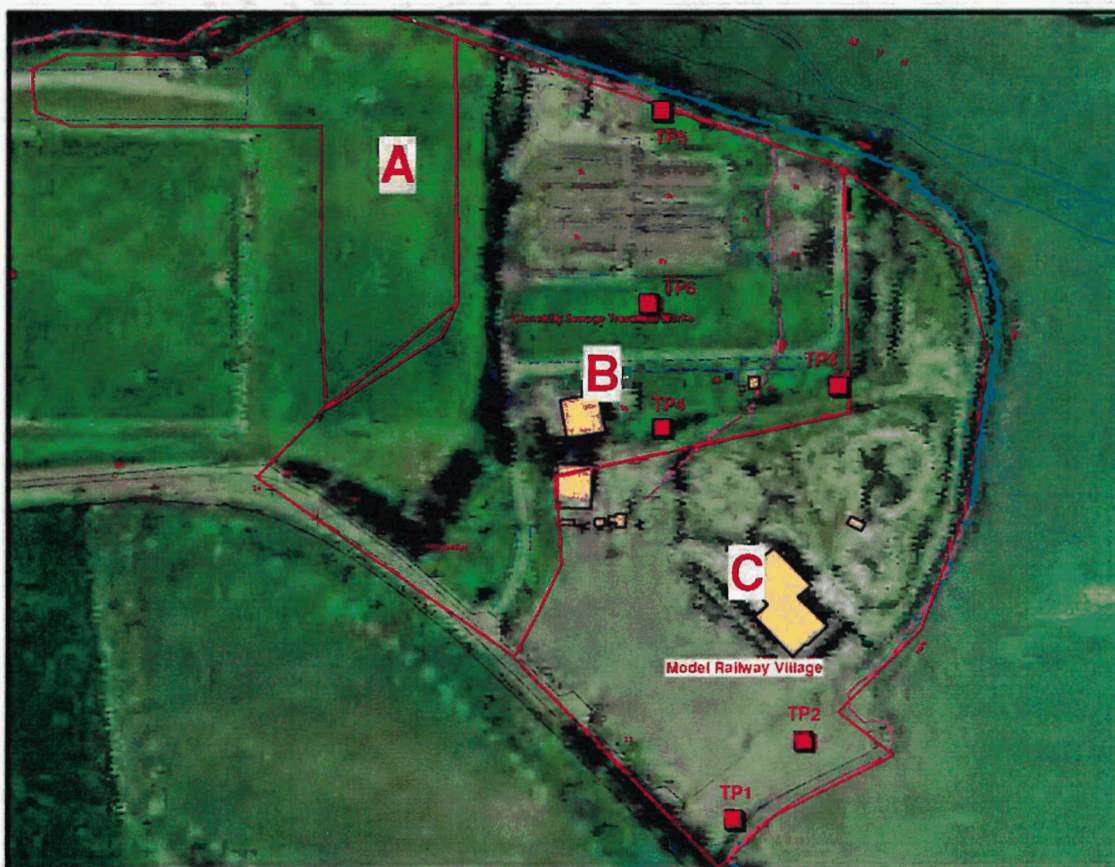
Fig 3.1: Clonakilty Landfill Trial Pit Locations

The site investigation comprised the use of a JCB to dig 6No. Trial Pits over the site. As the site is currently being used as both a Sewage Treatment Plant and a Model Railway Village **much of the old landfill is covered in hard standing** so the locations available for trial pitting were limited. The excavations were supervised and logged by a Cork County Council Environmental Engineer, Dr Cormac O'Suilleabhain. Each Trial Pit was logged in accordance with BS5930. Trial Pit locations can be seen below.

No Trial Pits were excavated in Area A because this area is not under Cork County Council ownership and the Developer was out of the country (and permission could not be secured to enter). Borehole logs from the planning application on this site were used as part of the information gathering on this site however (and have been included as a source of information in Appendix 3)

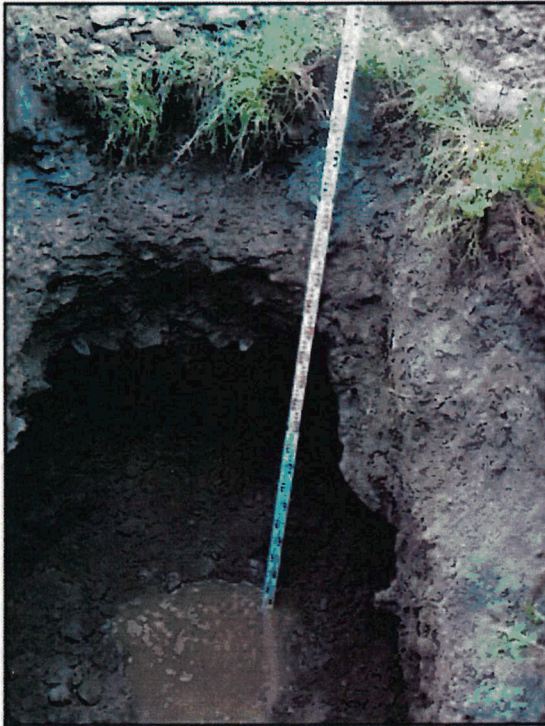
Trial Pit No.1

Waste was found in 5 of the 6 trial pits that were excavated although only minor amounts of waste was found in the Sewage Treatment Plant Area (Area B). The majority (>95%) of the material excavated in Area B was composed of clay, stones and boulders. The types of waste encountered included tarmac, clay piping, boulders, blocks, metal, plastics, glass, papers, tyres. (See Trial Pit Logs in Appendix 3). Trial Pit photos can be seen below:

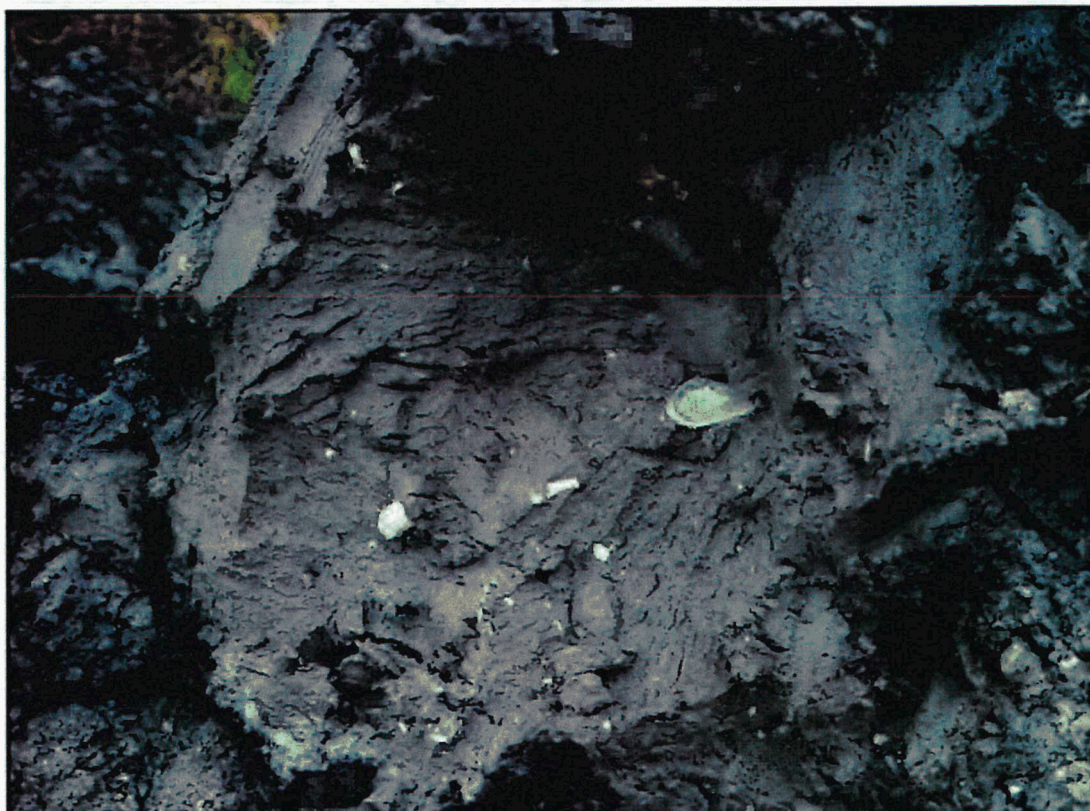
Grey/Black Silt Layer found at base of Trial Pit No.2

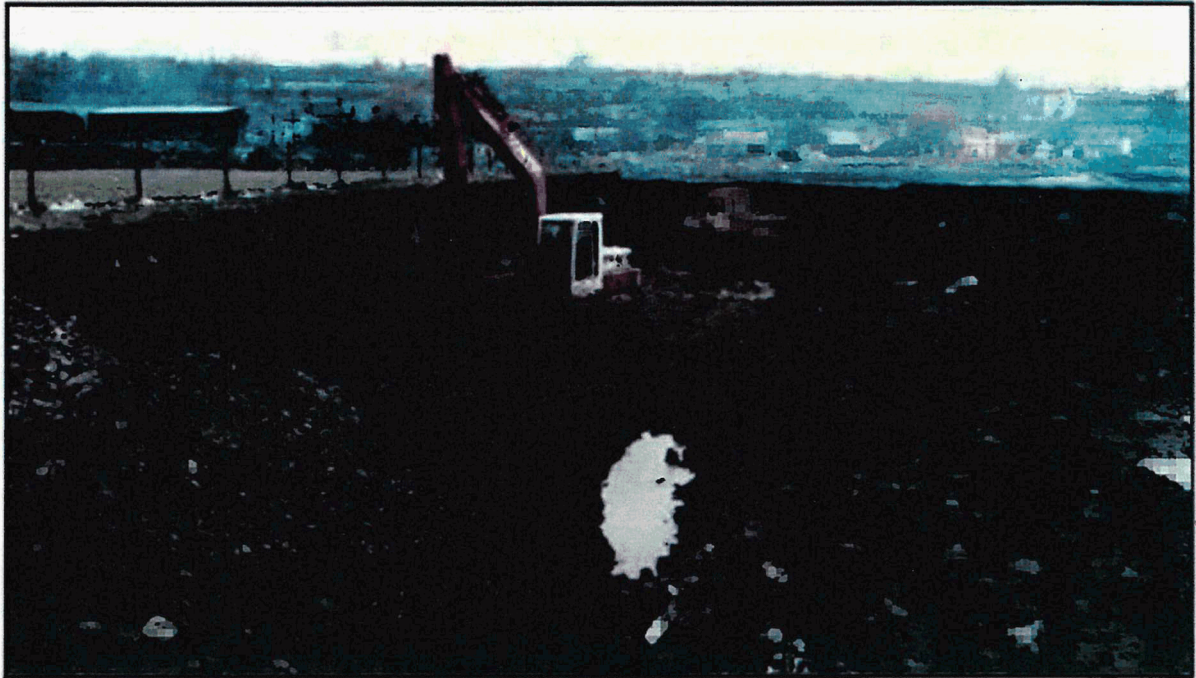
Photos and interviews held during the Tier I Risk Assessment indicate that the waste was removed from Area B and moved to Area C during the construction of the Sewage Treatment Plant in 1986. Imported fill was then used to fill in the areas around the sewage treatment plant. The findings of the Trial Pit Survey show that Trial Pits that were excavated in Area B were largely composed of soil and stone with very minor amounts of waste (see photos from the construction of the sewage treatment plant below).

Photo No. 1 from 1986 showing construction of Sewage Treatment Plant

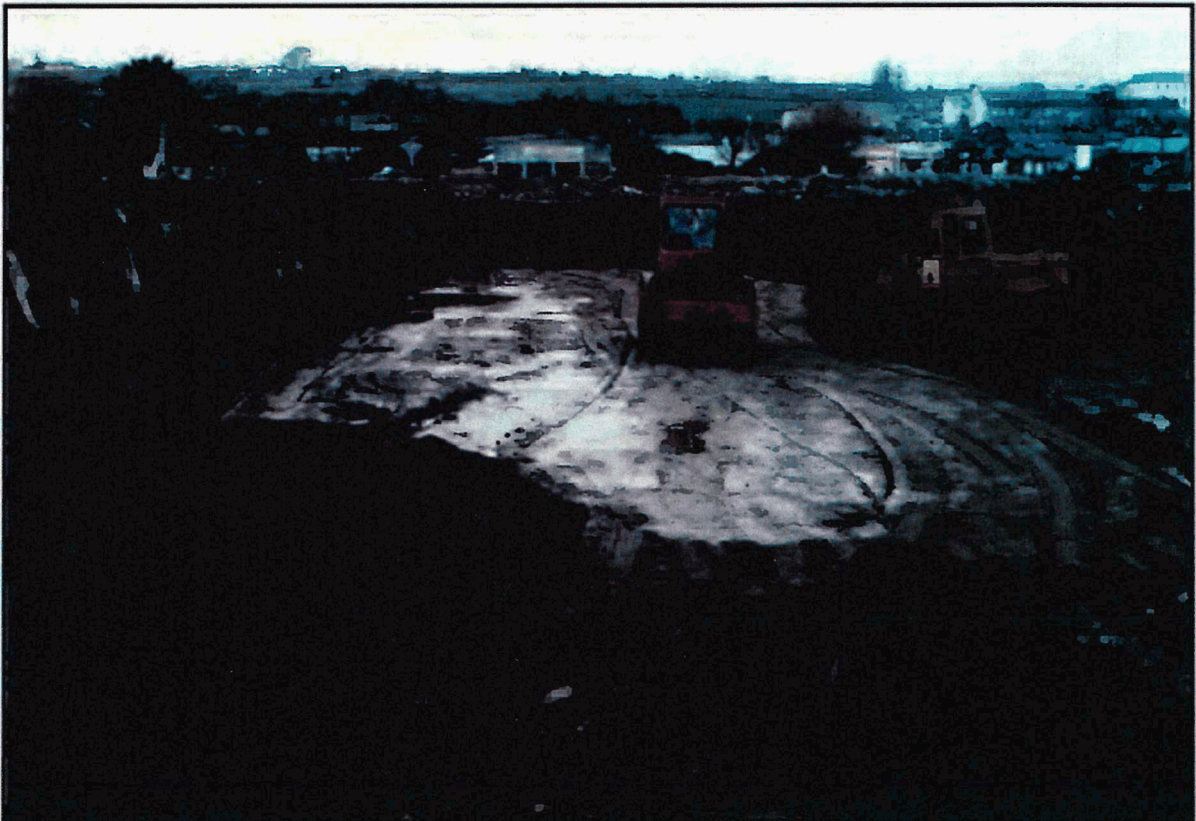
Photo No. 2 from 1986 showing construction of Sewage Treatment Plant

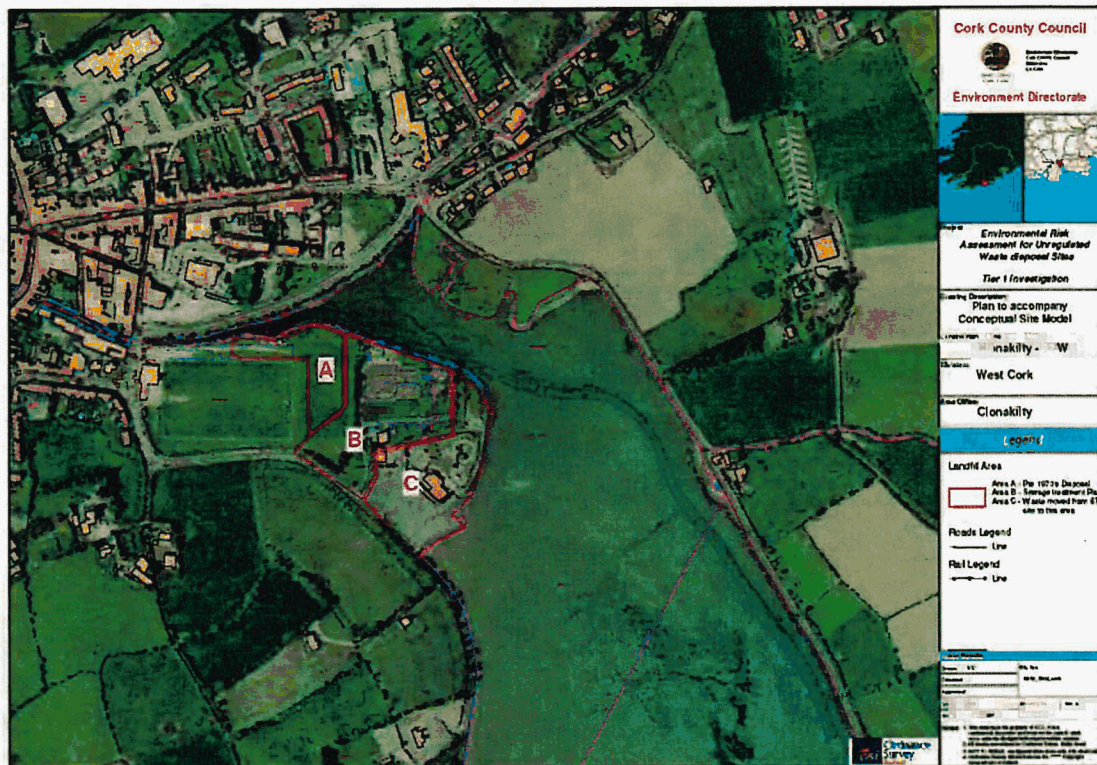
Fig 3.3: Conceptual Site Model Plan

Clonakilty Landfill is adjacent to the mouth of the Feagle River and Clonakilty Bay (see CSM Plan below).

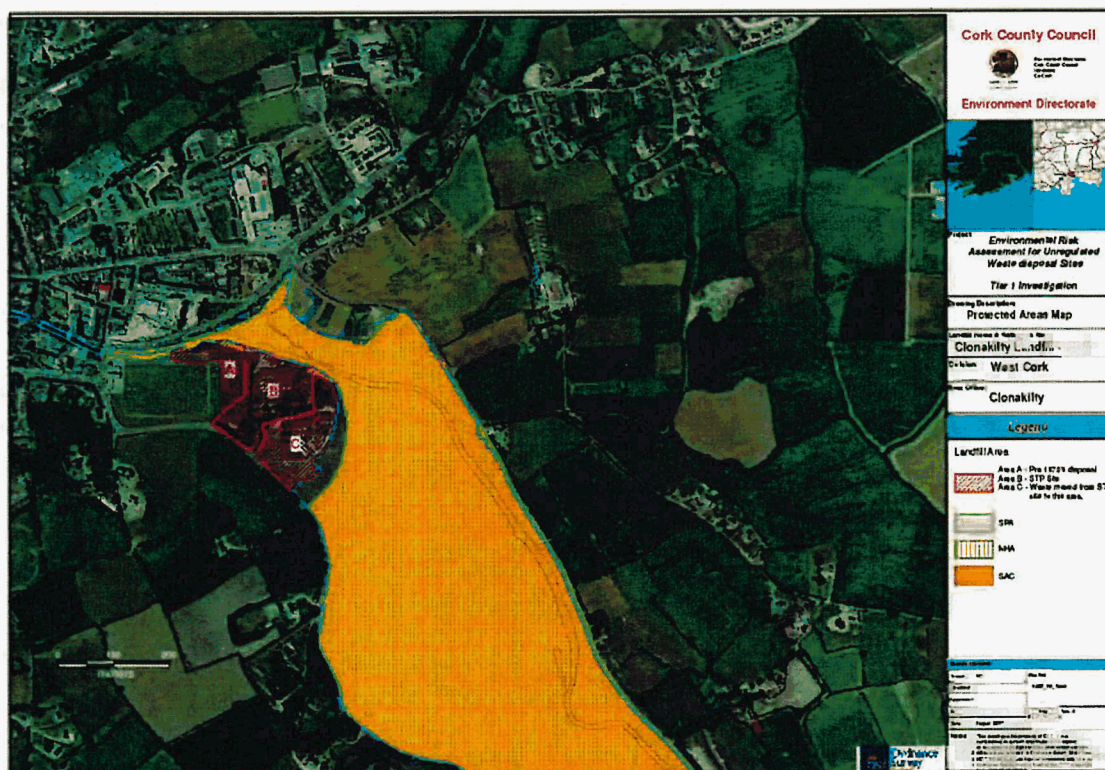
Fig 3.3: Clonakilty Protected Areas Map

The landfill is also adjacent to an SAC, NHA and an SPA.

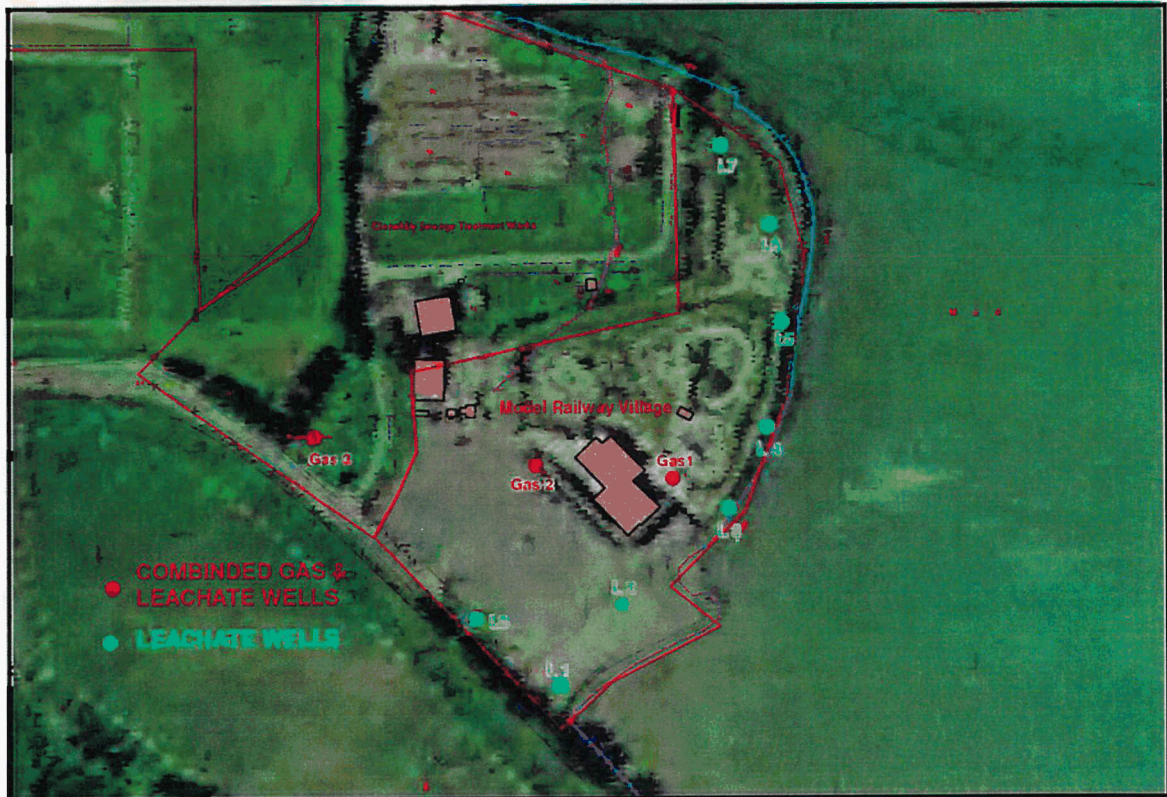
Fig 4.1: Gas & Leachate Well Locations

The installation of the leachate/Gas Wells were supervised and logged by a Cork County Council Environmental Engineer, Dr Cormac O'Suilleabhain. A "*Dando Terrier Window Sampler*" was used for obtaining window samples as well as for the installation of the wells. Each well was logged in accordance with BS5930. Well locations can be seen below.

Gas Wells 1 and 2 are located close to the Model Railway Buildings (Figure 4.1) in an area that is primarily covered by buildings and paving. Therefore the potential exists for landfill gas build up and migration into services adjacent to or within the buildings. To assess the risk of landfill gas build up, monitoring was undertaken within the Model Railway Building and along electrical service ducts. A copy of the report that was completed can be found in Appendix 8. No methane or carbon dioxide was detected at any of the monitoring locations within the building (apart from 0.2% CO₂ in one of the urinal drains).

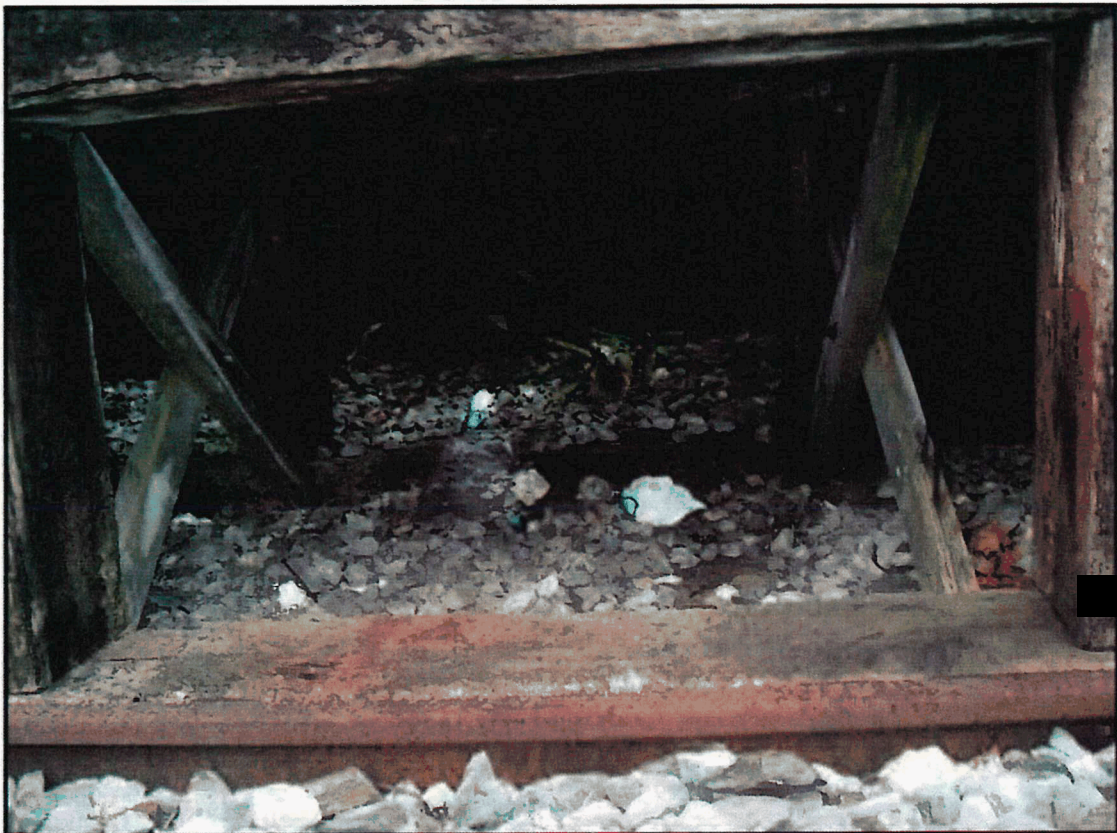
While the thickness of the granular layer is not known, it should provide a pathway for gases to vent to atmosphere, and it is probable that this has reduced the risk of landfill gas build up in the underlying waste. The monitoring carried out to date inside the buildings has not identified the presence of landfill gas, however the monitoring should be conducted on a quarterly basis to confirm the absence of gas within the structure.

Photos showing Hard Core Gravel Fill in front of Model Railway Building

The buildings appear to have been founded on a granular foundation that extends outside the building footprint. This granular foundation appears to act as a pathway for the ventilation of landfill gas thereby minimising the risk of landfill gas build up within the building services or within the building.

It is recommended that no future works are carried out that might seal off the granular layer and reduce its potential to act as a ventilation pathway for the gases.

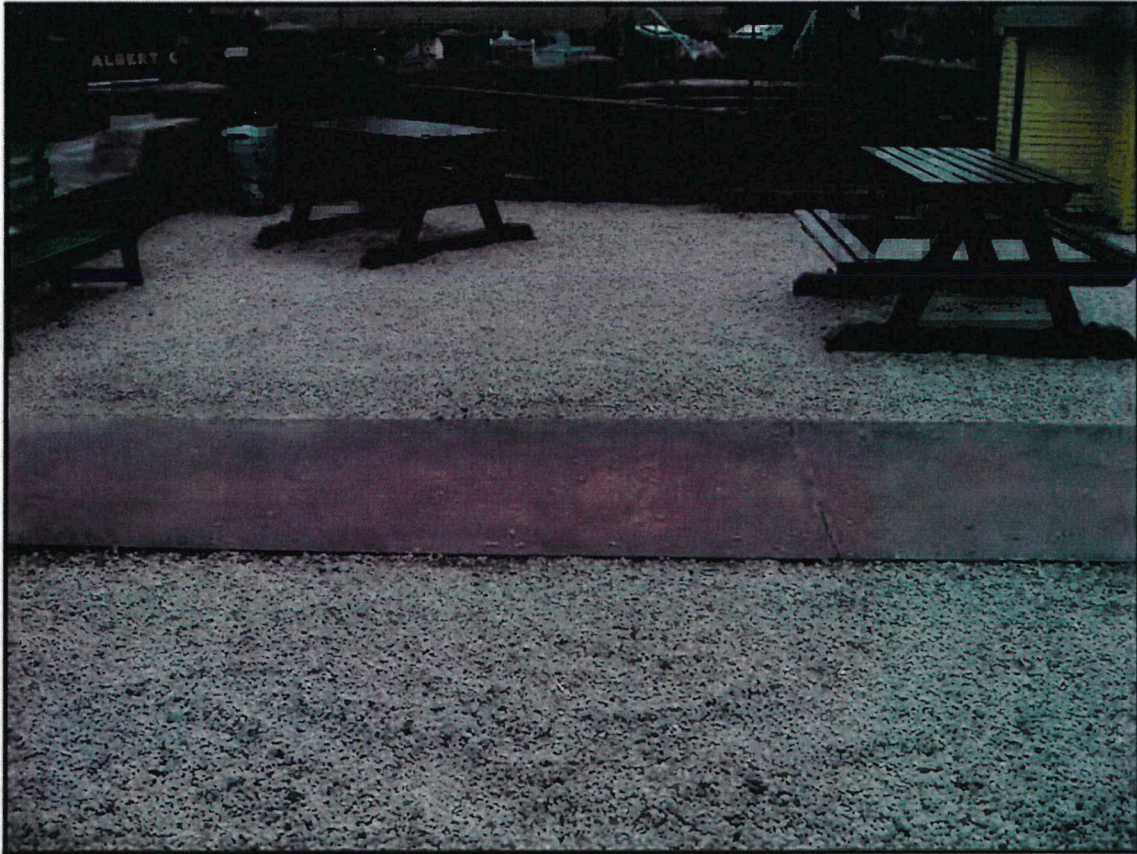
External Public Seating Areas also lined with Gravel Fill to rear of Model Railway Building
