## OFFICE OF ENVIRONMENTAL SUSTAINABILITY

### INSPECTOR'S REPORT ON AN APPLICATION FOR A CERTIFICATE OF AUTHORISATION FOR A CLOSED LANDFILL

<b>TO:</b>	David Flynn, Director	
<b>FROM:</b>	Ewa Babiarczyk, Inspector.	Circular Economy Programme
<b>DATE:</b>	5th November 2023	
<b>RE:</b>	Application by <b>Clare County Council</b> for a Certificate of Authorisation for a closed landfill at <b>Whitegate Landfill, Bargarriff, Whitegate, County Clare</b> . Certificate of Authorisation Register Number <b>H0035-01</b> .

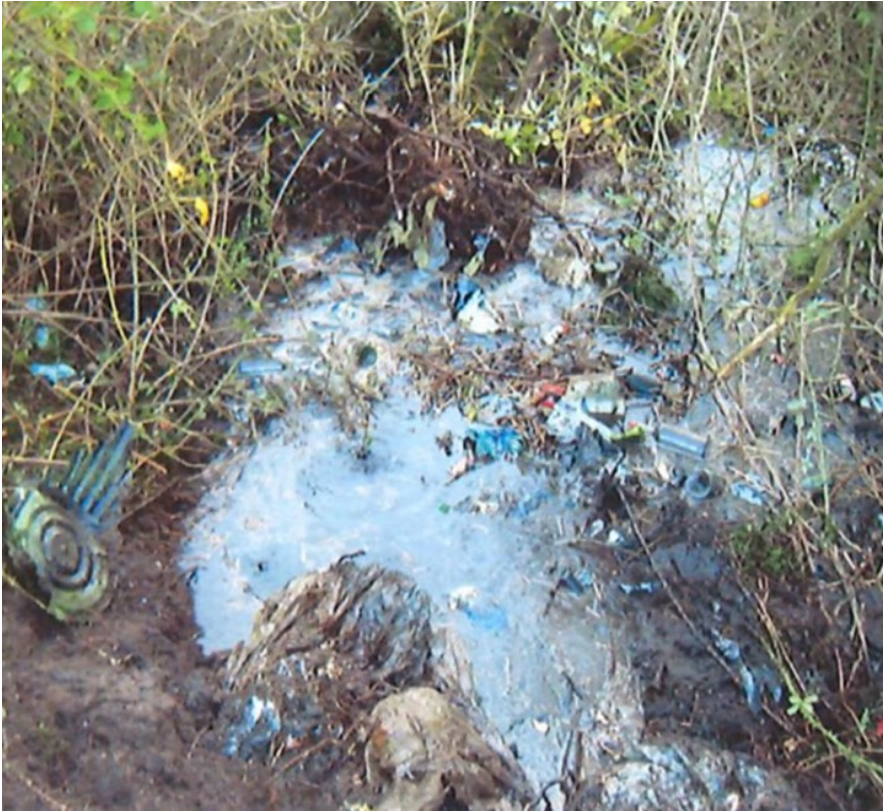
**Figure 4: Exposed waste and ponding**

Current condition and appearance of closed landfill:	<p>The landfill rises approximately 4m to 5m above the surrounding land and forms a ridge sloping west to east. The site is fenced off and densely covered with gorse.</p> <p>Exposed waste on the landfill surface and waste in the adjacent surface water drains was observed by the applicant. The Tier 3 assessment recommends the waste be pulled back from the drains and covered with a cap. Condition 3.1(a) reflects this recommendation and is further detailed in Section titled '<i>Proposed Remedial Actions</i>' below. Also, litter on the adjacent forestry land and waste, either from fly tipping or fallen waste from the main body, was observed in 'deep ponds at the base of the ridge on its southern side.' Condition 3.1(a) further requires that the local authority removes this waste and litter for disposal or recovery at an appropriate facility.</p> <p>Leachate was observed in the Northern drain in 2008, causing an orange discolouration of the water as shown in Figure 5. The Tier 2 assessment also states that leachate was also evident in the forestry drains at the eastern edge of the landfill in 2009.</p>

<p>Proposed remedial actions:</p>	<p>The applicant proposed the following remedial measures:</p> <p>1. <u>Landfill cap</u></p> <p>(i) 500mm layer of clean soil and perimeter berm;</p> <p>The applicant states that due to the nature of the waste and the low amenity use a 500mm capping layer over the waste may suffice. The applicant intends to import clean soil and build up the capping layer to achieve the 500mm thick capping layer across the site. The Tier 3 assessment further states that to prevent leachate break out along the sides, the sides of the landfill will also have to be sealed with a clay barrier, as shown in Figure 11 and 12.</p> <p>The Tier 3 assessments further recommends that the cap should be graded to achieve a fall from a central ridge, running north to south, to the sides of the capped site with a fall of 1:40, which will allow rainfall to run-off the landfill into the surrounding surface water drains rather than percolate through the waste. The Agency requires a detailed design of the cap to be submitted prior to installation.</p> <p>It is considered however that an engineered cap of 1m thickness is more appropriate for the landfill. This is due to the nature of leachate being generated that is migrating into adjacent surface water drains, the type of waste encountered during site investigations (e.g., car engine, oil drums or similar containers, animal medicine bottles, a fridge, car battery) along with the results of the surface water monitoring which indicate that the waste within the landfill is not inert. In accordance with the EPA Landfill Manuals – Landfill Site Design, a 500mm thick cap as proposed is more suited to a landfill for inert waste.</p> <p>Accordingly, Condition 3.1(c) requires a landfill cap that comprises</p>

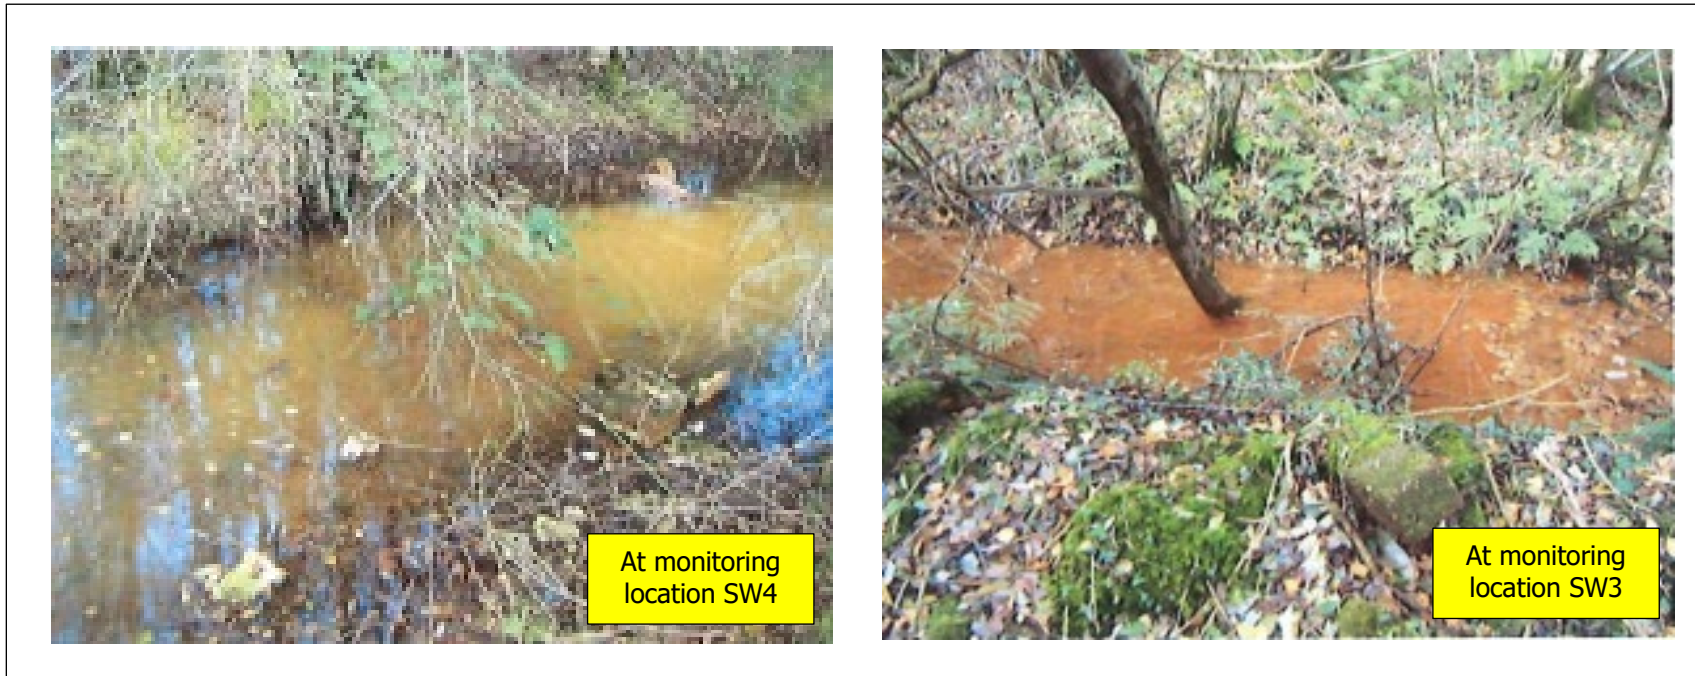
**Figure 5: Northern drain at monitoring location SW4 and c.100m downstream of SW4, at monitoring location SW3**

The Northern drain eventually discharges into the Whitegate River (waterbody code: IE\_SH\_25D100200, segment code: 25\_710) 0.8km downstream of the site, and via the Whitegate River into the Alewnaghta Lough (waterbody code: IE\_SH\_25\_189) 2km downstream of the site, as shown in Figure 1. The Slieve Aughty Mountains Special Protection Area (SPA) (Site code: 004168) is located immediately to the west (and upstream) of the site.

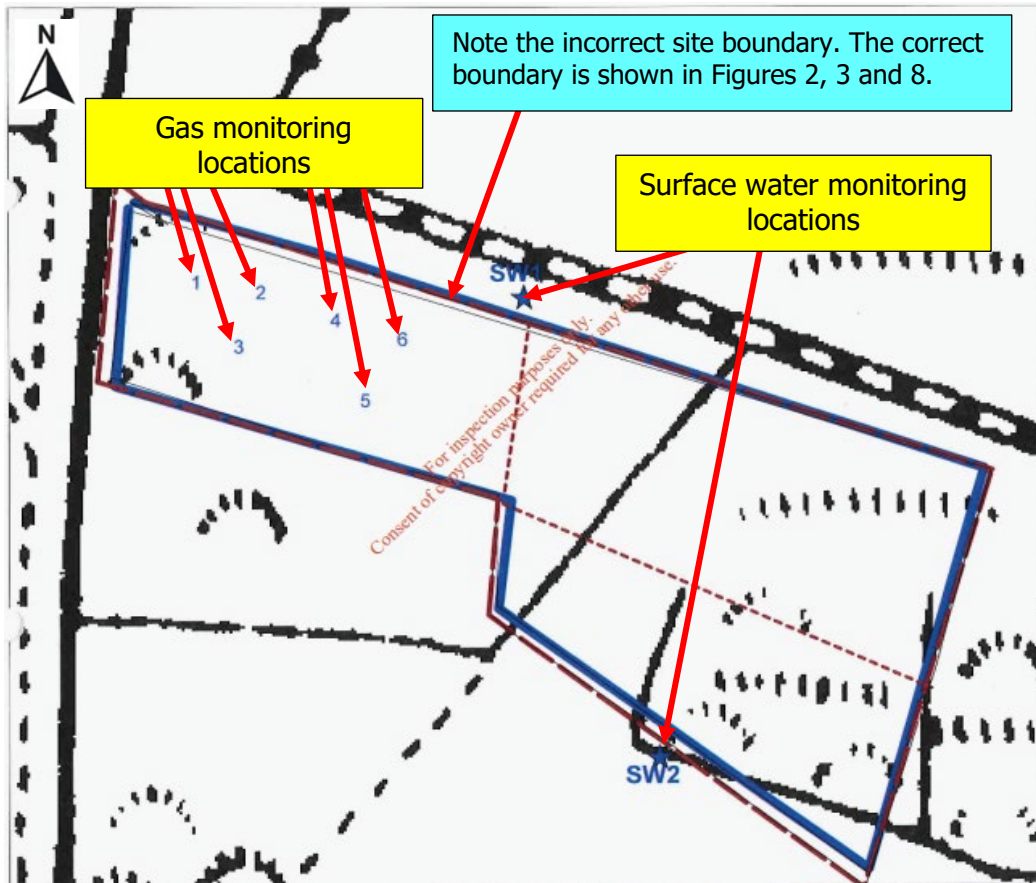
**Figure 6: Surface water monitoring and Gas monitoring locations 2008**

<b>Round &amp; monitoring date</b>	<b>Monitoring locations</b>
Round No. 1 26 <sup>th</sup> November 2008	Locations SW1 & SW2, as shown in Figure 6. <ul style="list-style-type: none"> <li>• SW1 – (d/s) on the northern drain at the site boundary.</li> <li>• SW2 – (u/s) flooded lands adjacent to the southern site boundary.</li> </ul>
Round No. 2	New Locations SW1 to SW7, as shown in Figures 7 and

One round of subsurface gas monitoring was carried out with an impact searcher bar, at 0.5m to 1m depths, at six monitoring locations 1 to 6 on 26<sup>th</sup> November 2008, as shown in Figure 6. The associated gas monitoring form states that the ground was too wet for any further sampling. No methane (CH<sub>4</sub>) was detected during this sampling event. The highest concentration of (CO<sub>2</sub>) carbon dioxide was measured at 1.7% v/v at location No. 5.

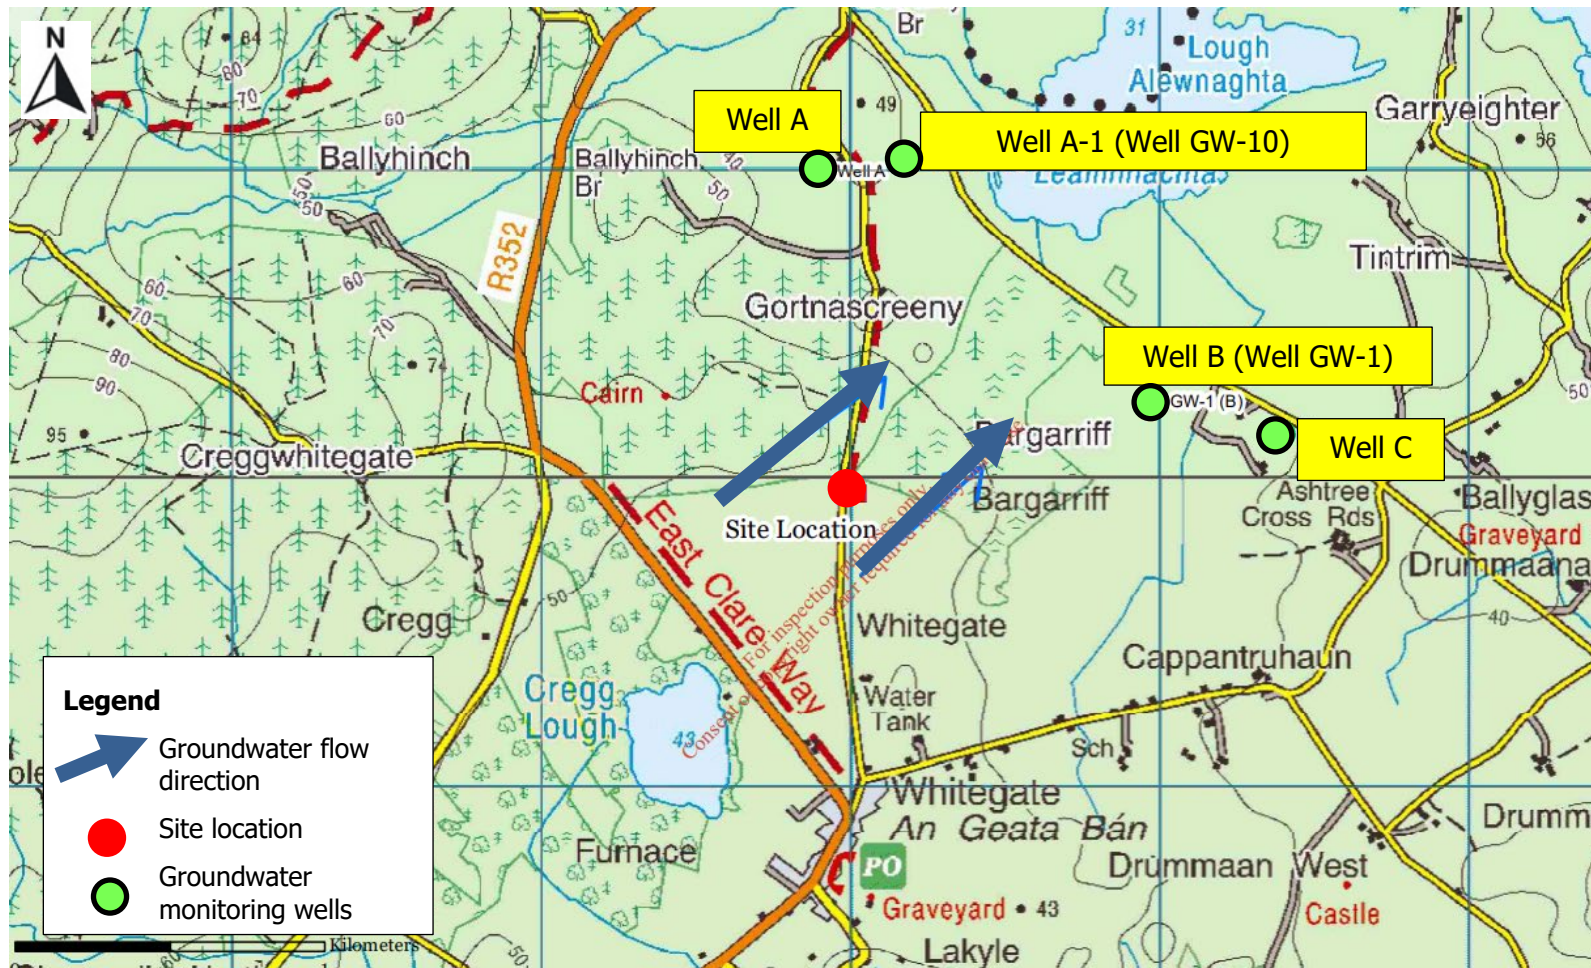
**Figure 9: Groundwater flow direction and Groundwater monitoring wells**

Round No. 1 December 2009	Wells A, Well B and Well C, as shown in Figure 9. <ul style="list-style-type: none"> <li>• <b>Well A</b> - c.950m north of the site (the applicant refers to this well as upgradient well).</li> <li>• <b>Well B</b> (also referred to as GW1) - c.980m north-east of the site, in Killkittuan townland (the applicant refers to this well as downgradient well).</li> <li>• <b>Well C</b> - c.1.2km east of the site (the applicant refers to this well as downgradient well).</li> </ul>
Round No. 2 24 <sup>th</sup> March 2021	The existing monitoring location: <ul style="list-style-type: none"> <li>• <b>Well B</b> (also referred to as GW1) and</li> </ul> New location: <ul style="list-style-type: none"> <li>• <b>Well A-1</b> (also referred to as GW10) - c. 1km north of the site (the applicant refers to this well as upgradient well)</li> </ul>
Round No. 3 24 <sup>th</sup> April 2021	The existing monitoring locations: <ul style="list-style-type: none"> <li>• <b>Well A-1</b> (also referred to as GW10) - the applicant referred to this well as upgradient well, and</li> <li>• <b>Well B</b> (also referred to as GW1).</li> </ul>

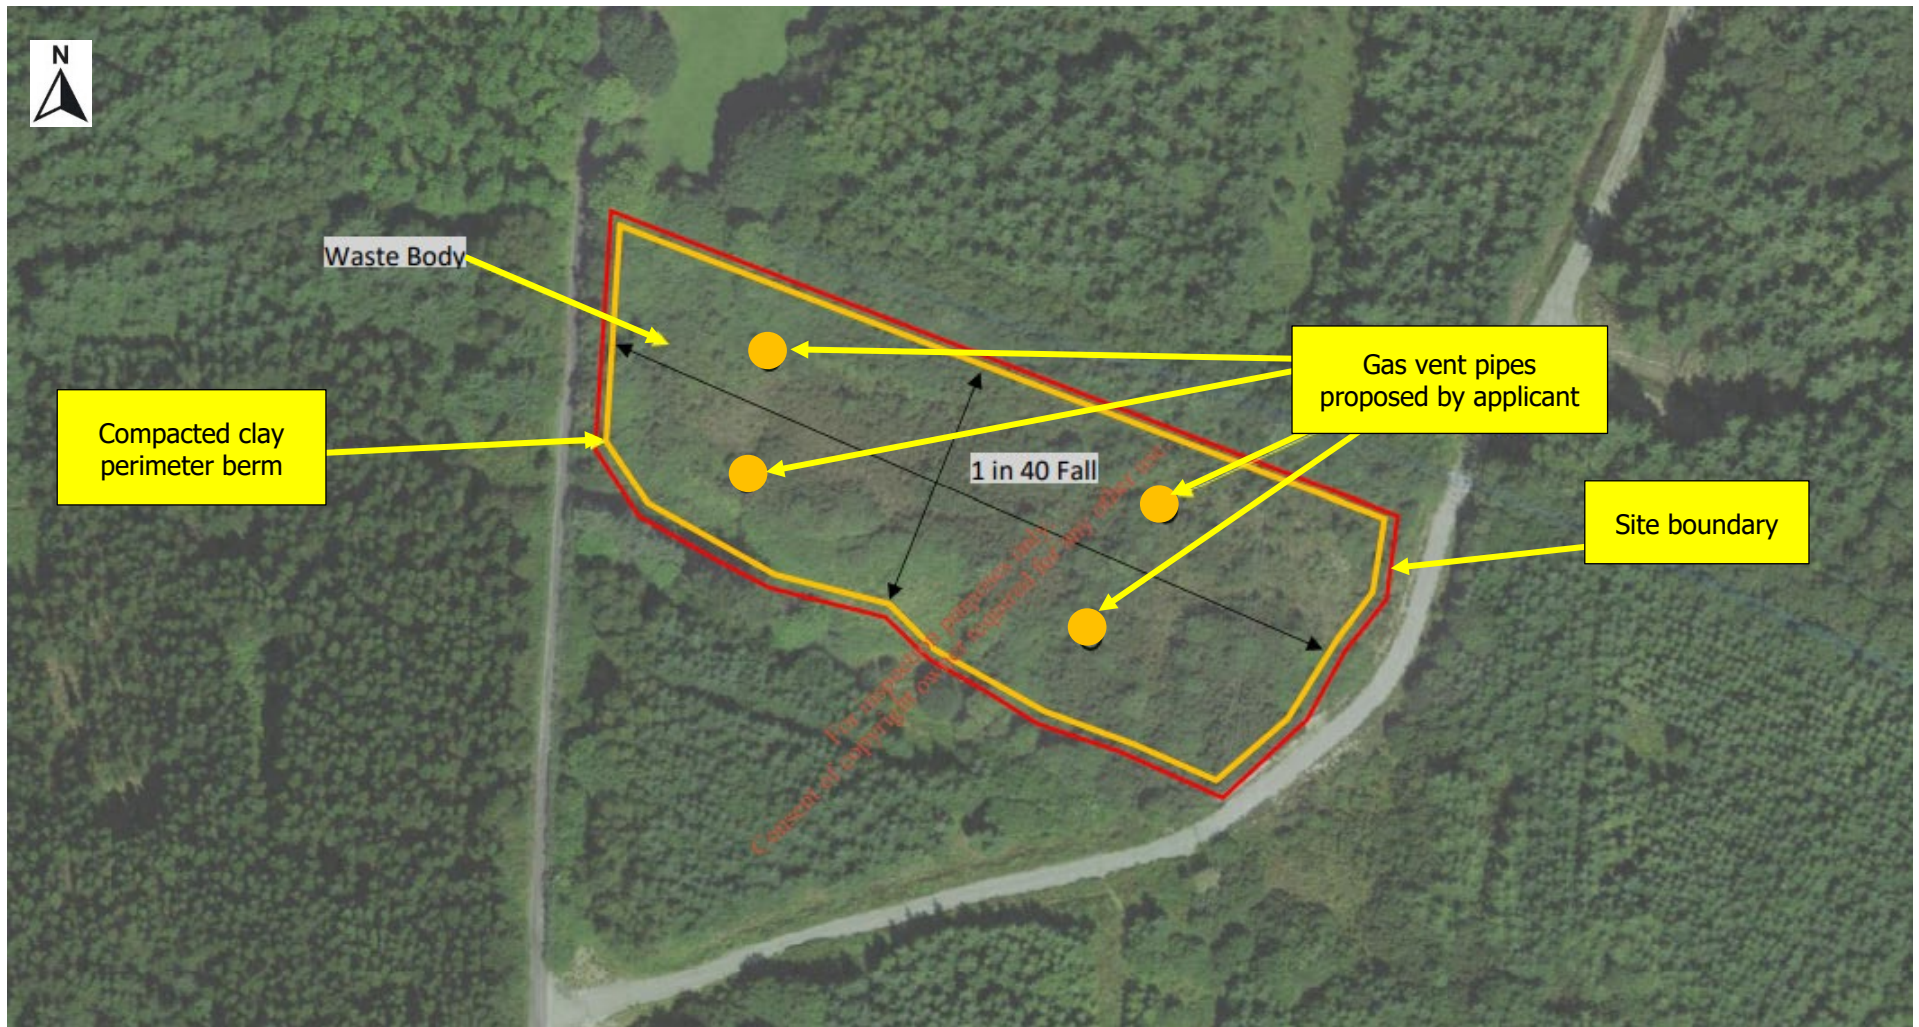
**Figure 11: Proposed gas vents and perimeter berm**

The applicant proposes installation of four gas vents in the waste body, one in each quadrant of the site to prevent lateral landfill gas migration, as shown in Figures 11 and 13.

Condition 3.1(c) requires a gas drainage layer within the cap and Condition 3.1(e) requires the installation of four gas vents in accordance with the *EPA Landfill Manuals – Landfill Site Design* and that spacing between the gas vent pipes shall be sufficient to achieve adequate gas venting.
