# DUNGLOE LANDFILL

## Tier 1 Environmental Risk Assessment for Dungloe Historical Landfill

IBR1266  
ERA Tier 1 Final  
10<sup>th</sup> May 2021

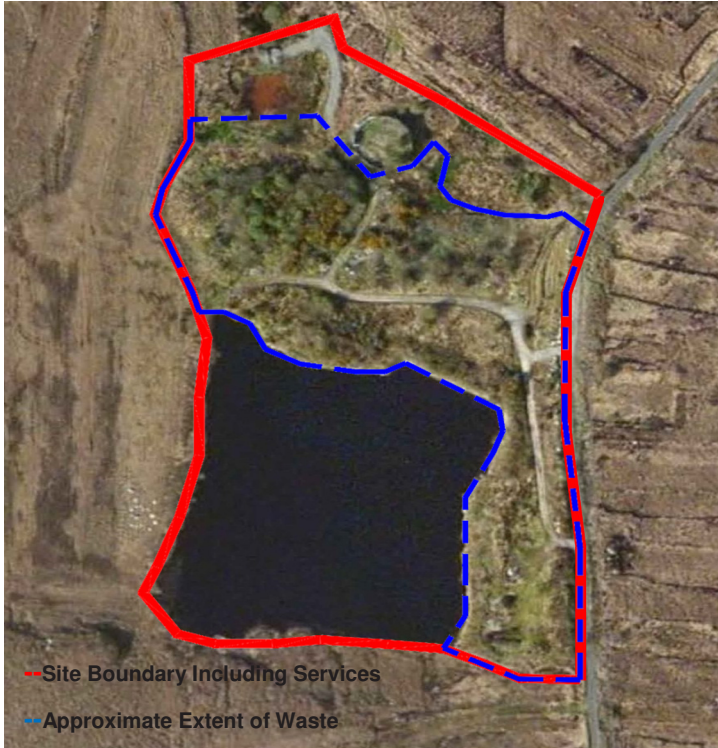
**Figure 1.1 Site Aerial Photograph <sup>1</sup>**

RPS Consulting Engineers has been requested by Donegal County Council (DCC) to undertake a Tier 1 assessment of an unregulated historical disposal site in the townland of Sheskinarone, Dungloe, Co Donegal (See Figure 1.1 below).

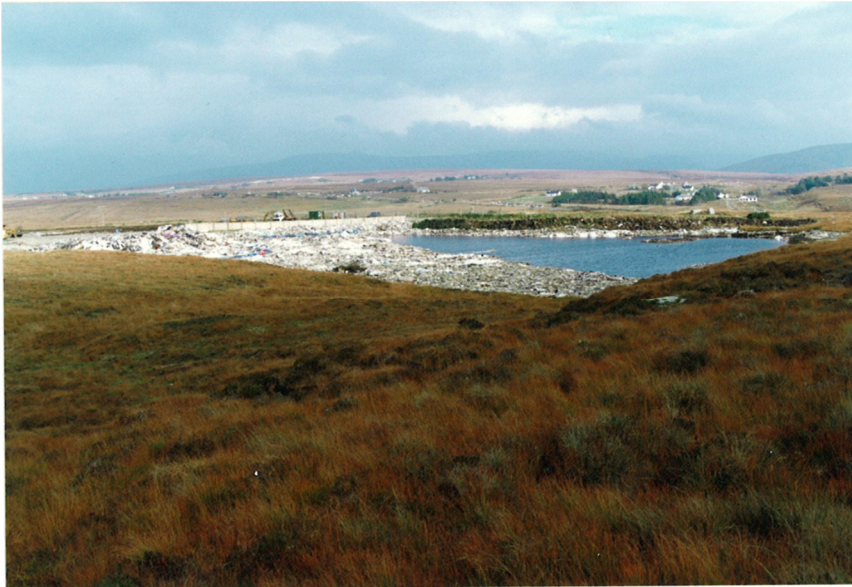
**Picture 1 Dungloe Landfill Site 1995<sup>2</sup>**

- The site encroached into Lough Nacree where domestic waste was being tipped directly into the main body of the lake (Picture 1) which obstructed the lakes natural outlet channel causing the level in the lake to rise and the spillage of contaminated water to the adjacent watercourses (June 1994). Works were undertaken by DCC at this time. At that time, Donegal County Council immediately took steps to help alleviate the problem by providing a filtration barrier at the site of the seepage. The filter consisted of stone laid in an existing channel combined with a final stone dam.

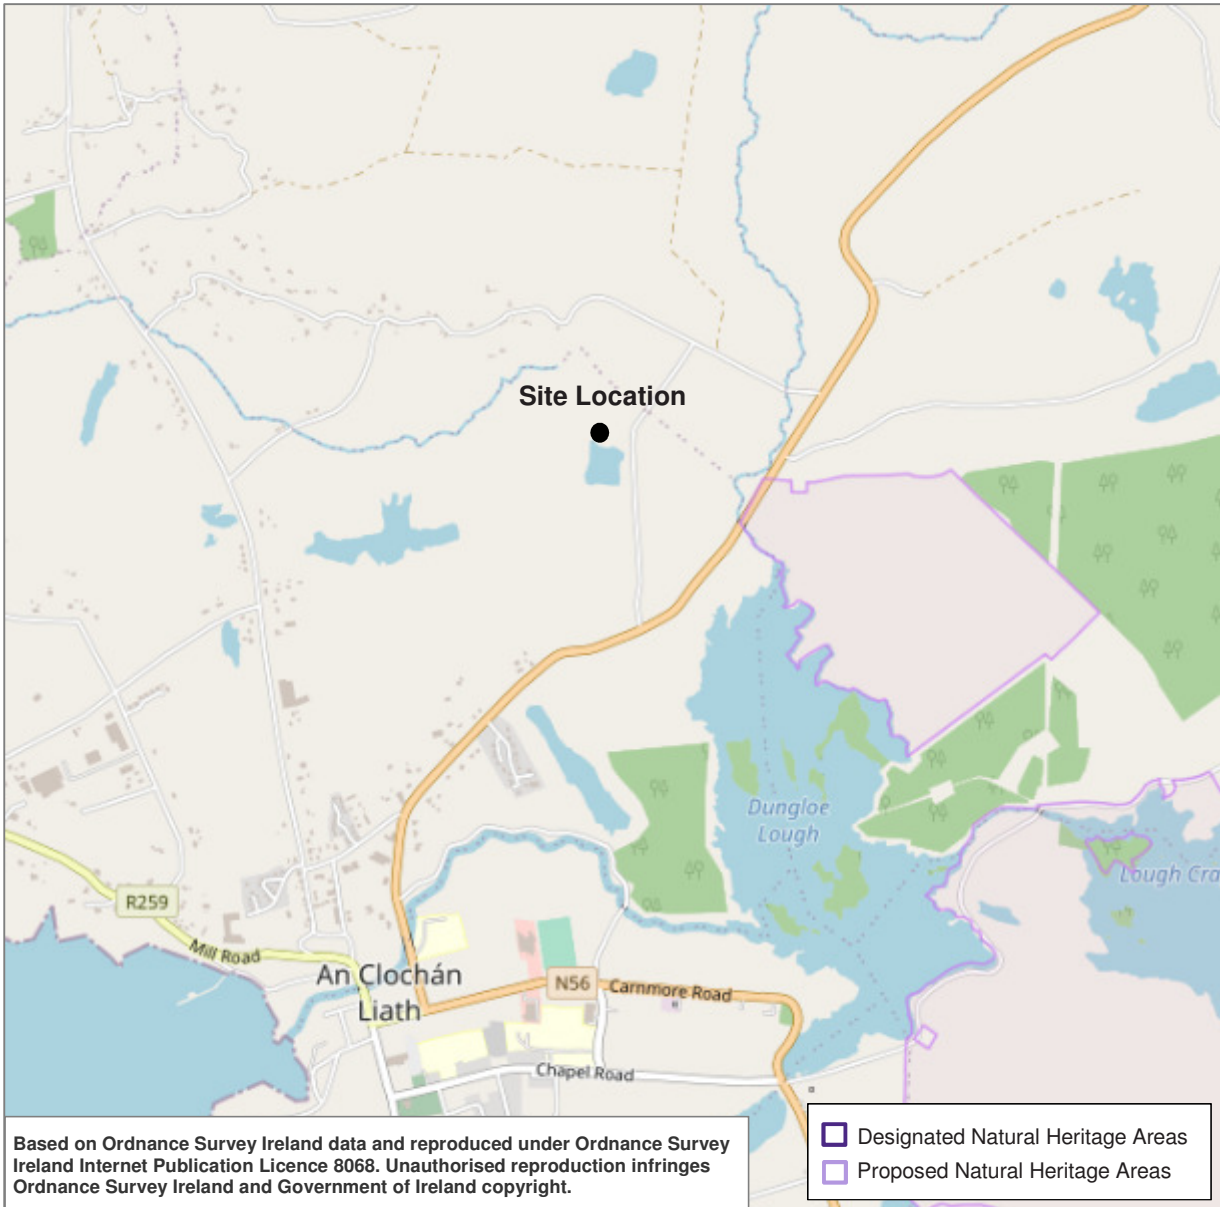
Figure 2.12 National Heritage Areas (taken from EPA Maps)

The following NHA was identified in the vicinity of the site (Figure 2.12).

- Cloghernagore Bog and Glenveagh National Park  
Site Code: 002047  
Status: Proposed National Heritage Area  
Distance from site: C.420m east

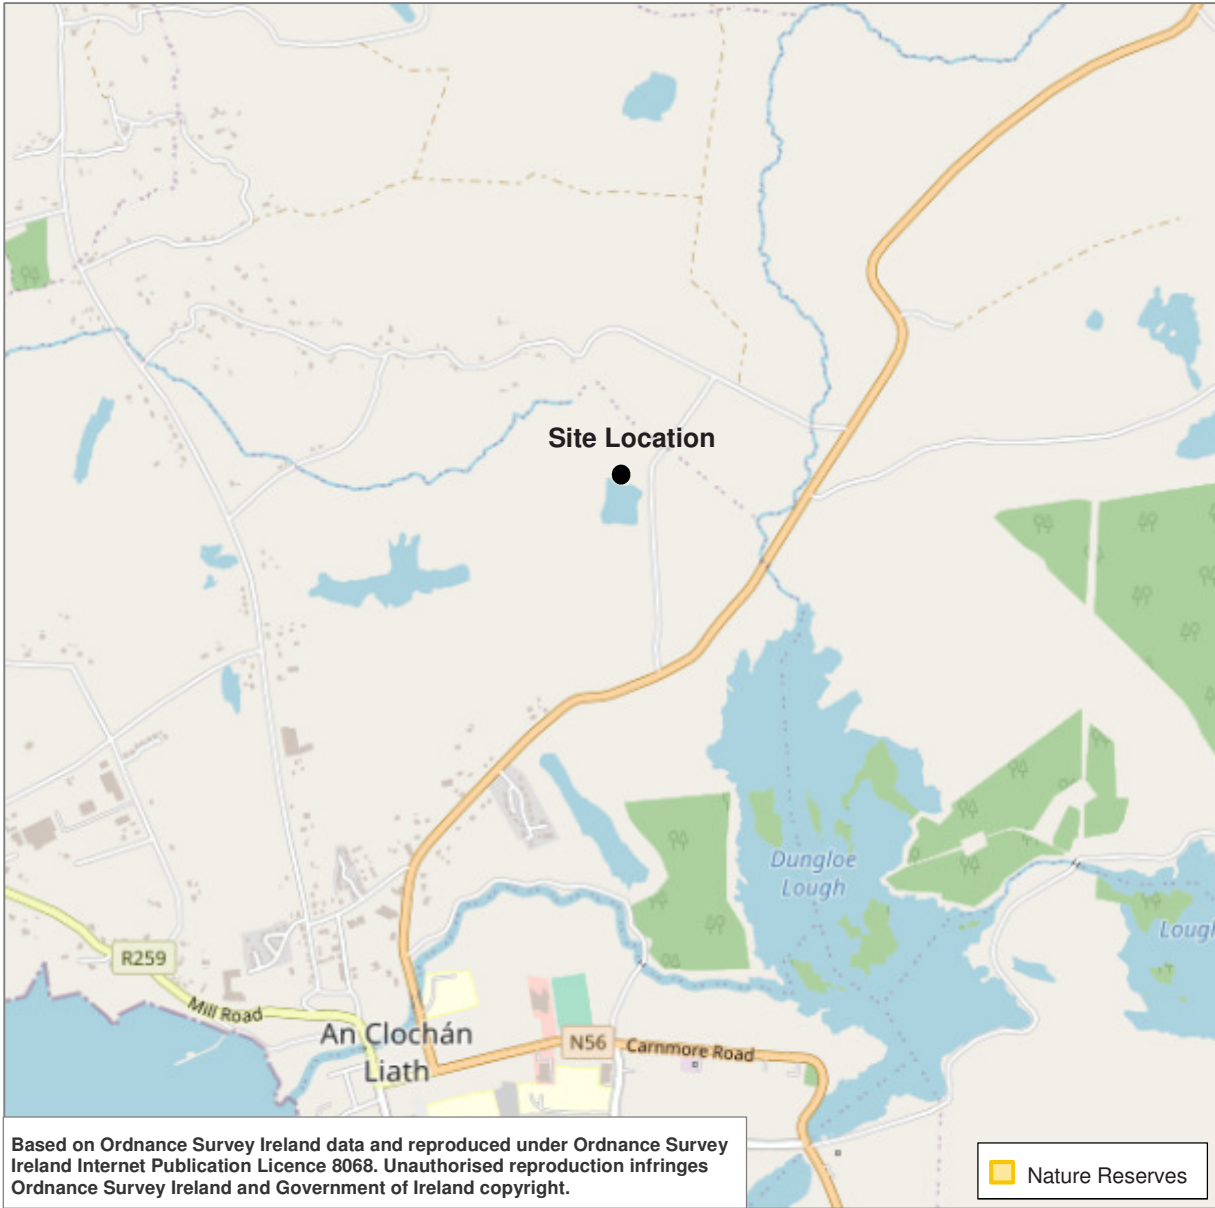
Figure 2.13 Nature Reserves (taken from EPA Maps)

No nature reserves or national parks were identified in the vicinity of the site (Figure 2.13 and 2.14).

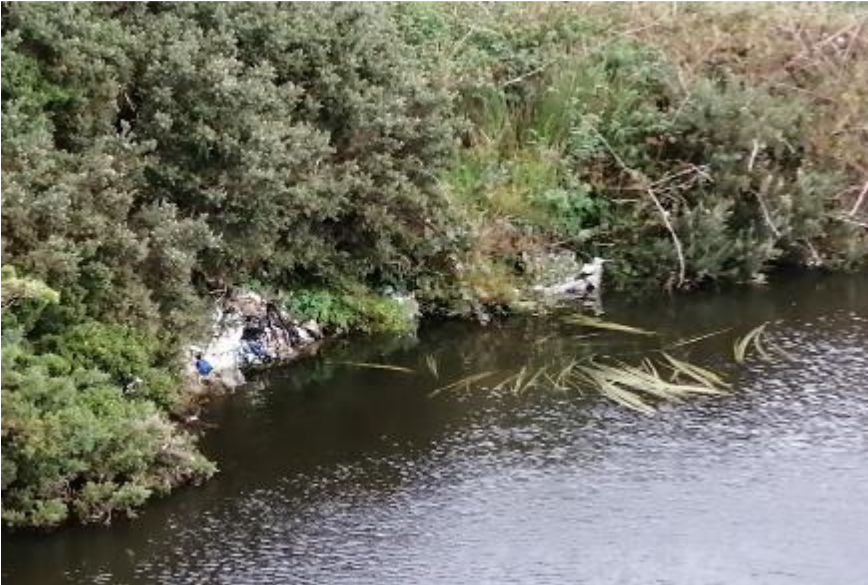
There were a number of locations where surface waste was observed during the walkover. Wastes was noted along the northern and eastern boundary of the lake where the landfill working face had encroached into the lake (Picture 3 to 5). Surface waste was also noted in a number of other areas however this is thought to be due to more recent fly tipping.

**Picture 3 Wastes noted along the northern boundary of the lake**

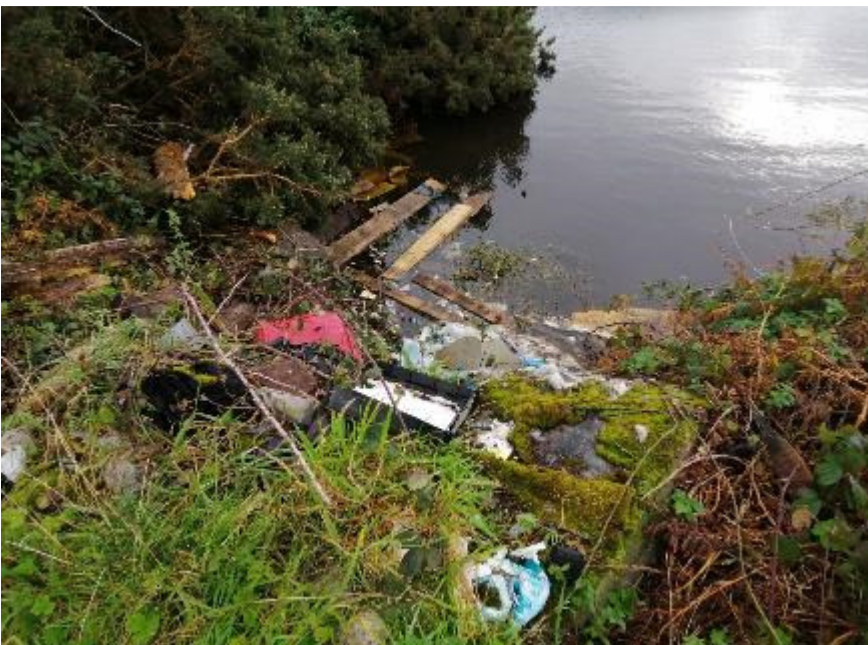
**Picture 4 Wastes noted along the northern boundary of the lake**

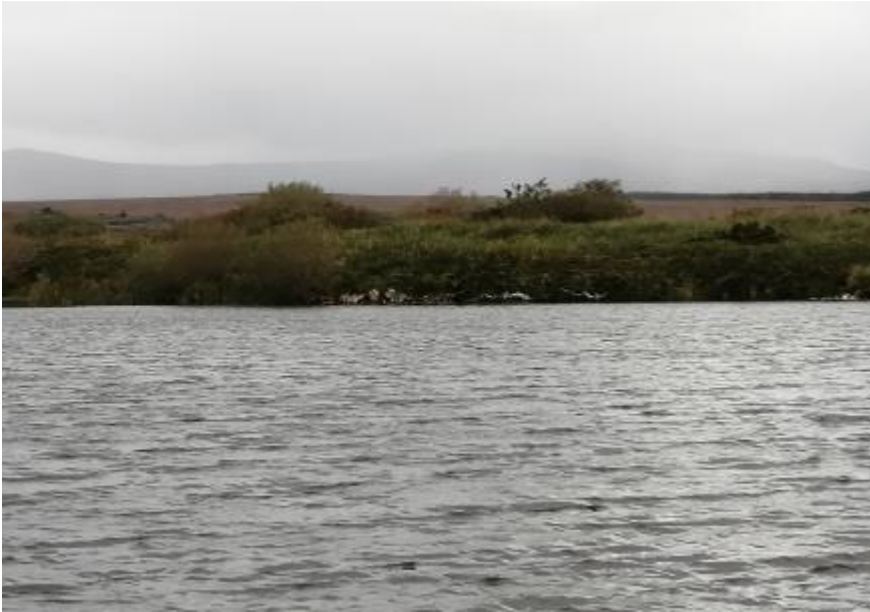
**Picture 5 Wastes noted along the eastern boundary of the lake**

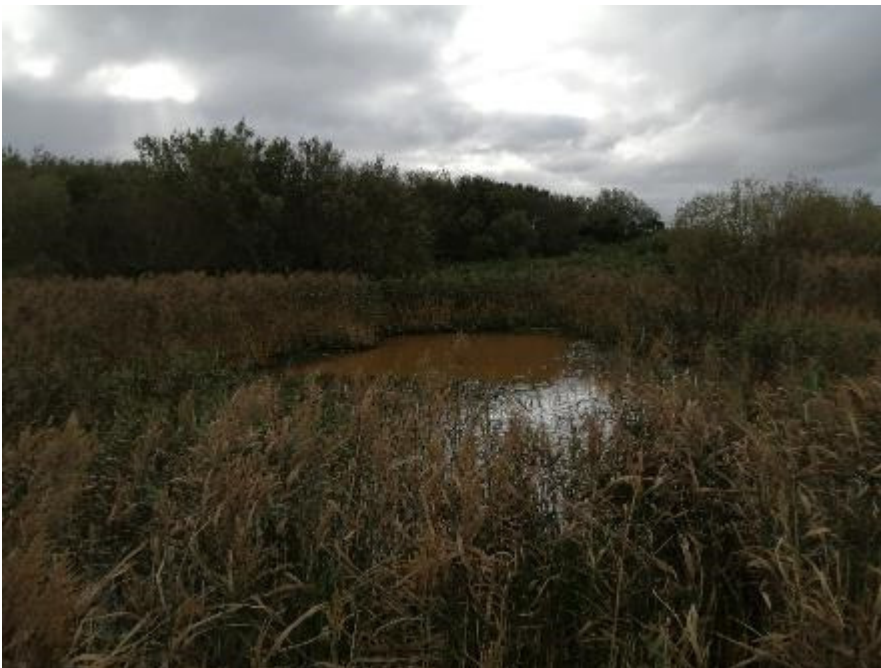
**Surface ponding of leachate:** There were no areas of surface ponding of leachate noted in the areas accessible on the day of the site visit except in the location from where leachate is pumped to the Puraflo system as shown in Picture 6.

**Picture 6 Leachate Pond/Wetland**

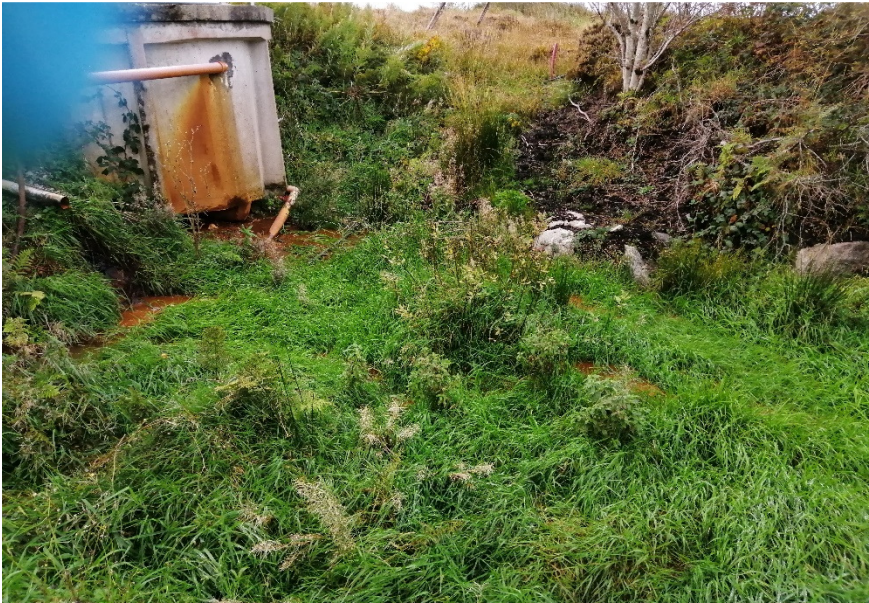
1. From overflow pipe from the leachate storage /pumping tanks (Picture 7).
2. Seepages from under the leachate storage /pumping tanks(Picture 7)
3. Outflow pipe from the Puraflo system.

**Picture 7 Overflow pipe from the leachate storage /pumping tanks**

Elevated levels of Ammonia as NH<sub>3</sub> and manganese were detected within SW3 (Wetland Area) and SW4 (Discharge from under storage tanks) which are down stream of the waste material but within the site boundary. Elevated levels of Ammonia as NH<sub>3</sub> and Manganese at these locations may be attributed to the presence of the waste material at the site. It should be noted that Manganese occurs naturally in Donegal groundwater and this may therefore also contribute to the higher concentration of Manganese detected at these locations. Elevated levels of Ammonia as NH<sub>3</sub> were not detected at SW6.

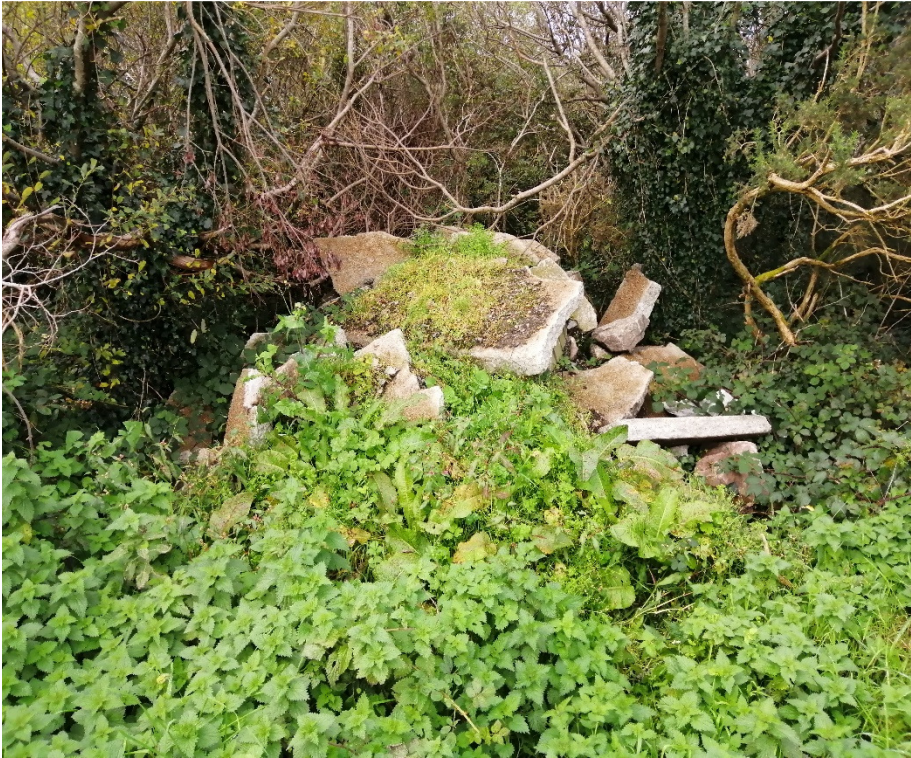
Litter: As noted in Section 210.6 above waste was noted along the northern and eastern boundaries of the lake. Wastes were also visible in other locations on site as shown in Picture 8 and 9. Some areas of the site are overgrown so no access was available.

**Picture 8 Construction and demolition waste.**

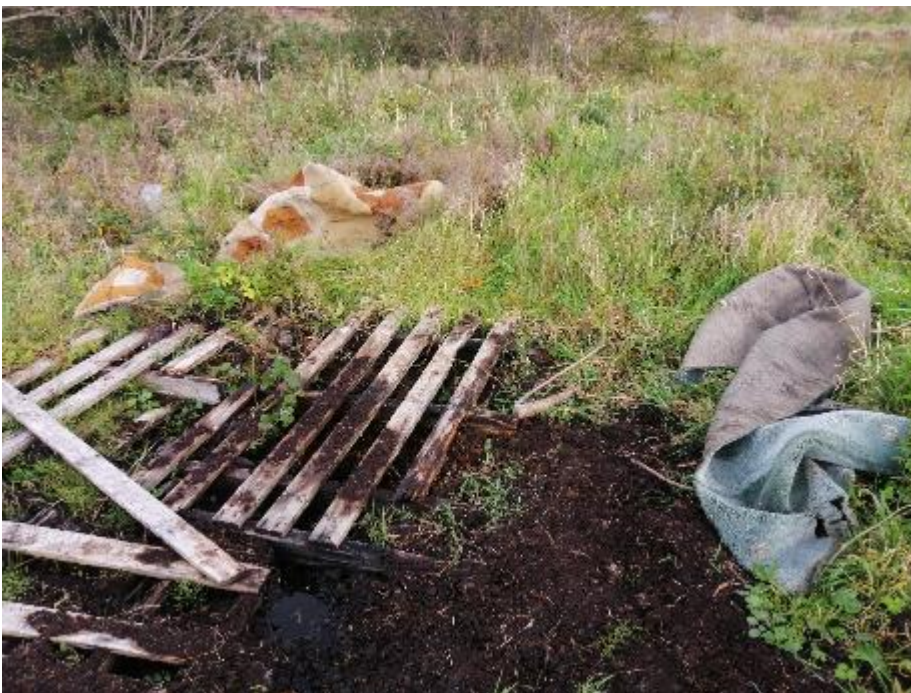
**Picture 9 Wood and carpet waste**

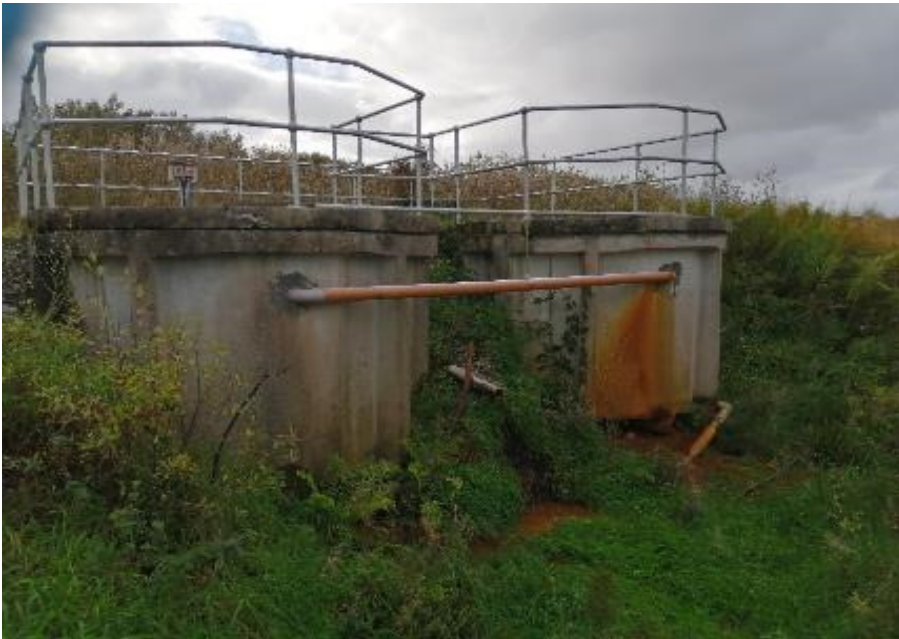
The disposed waste has been covered with a peat layer with areas of scrub and trees predominating the site. Leachate collection tanks and a Puraflo system has been installed at the facility as shown in Picture 10-12.

**Picture 10 Leachate Collection Tanks**

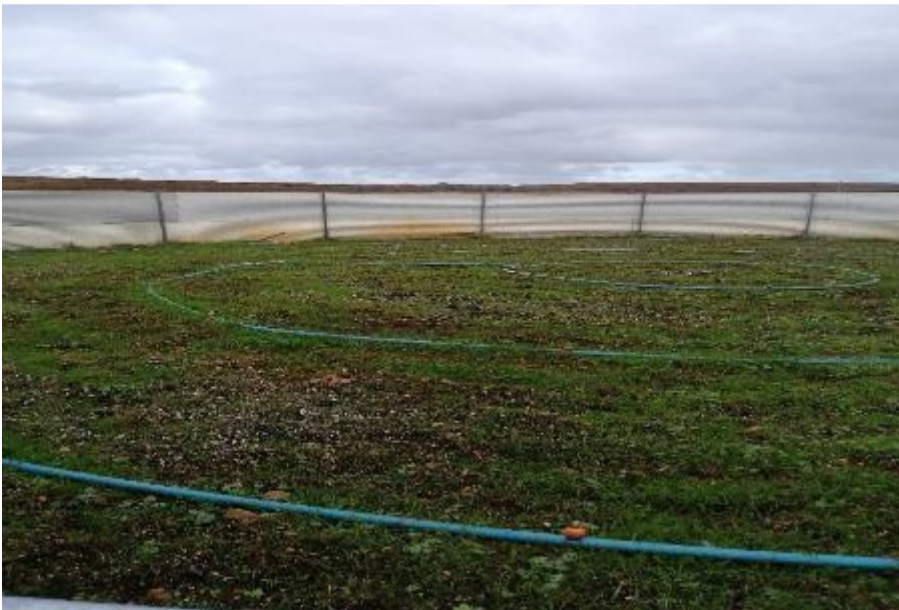
**Picture 11 Puraflo System**

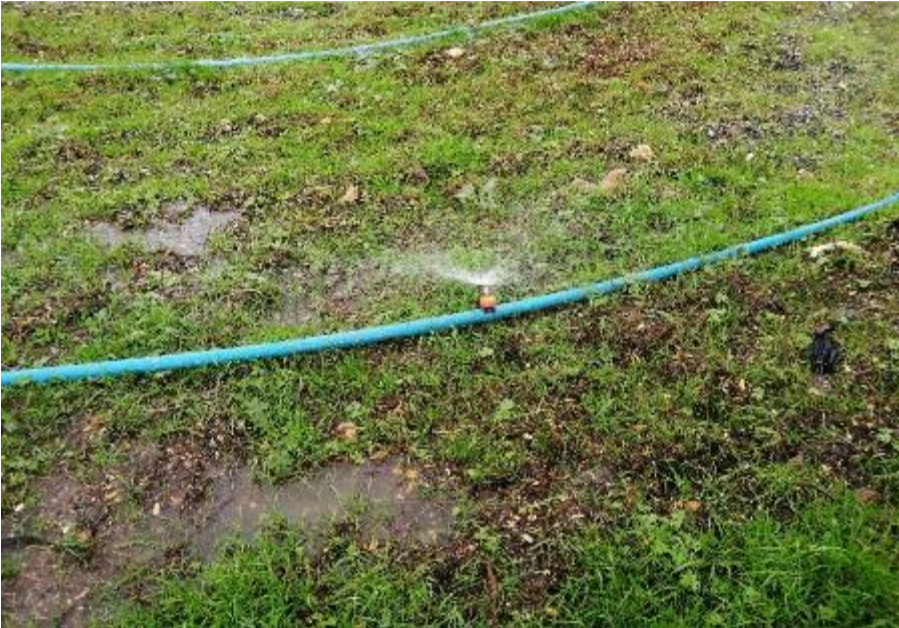
**Picture 12 Puraflo System**

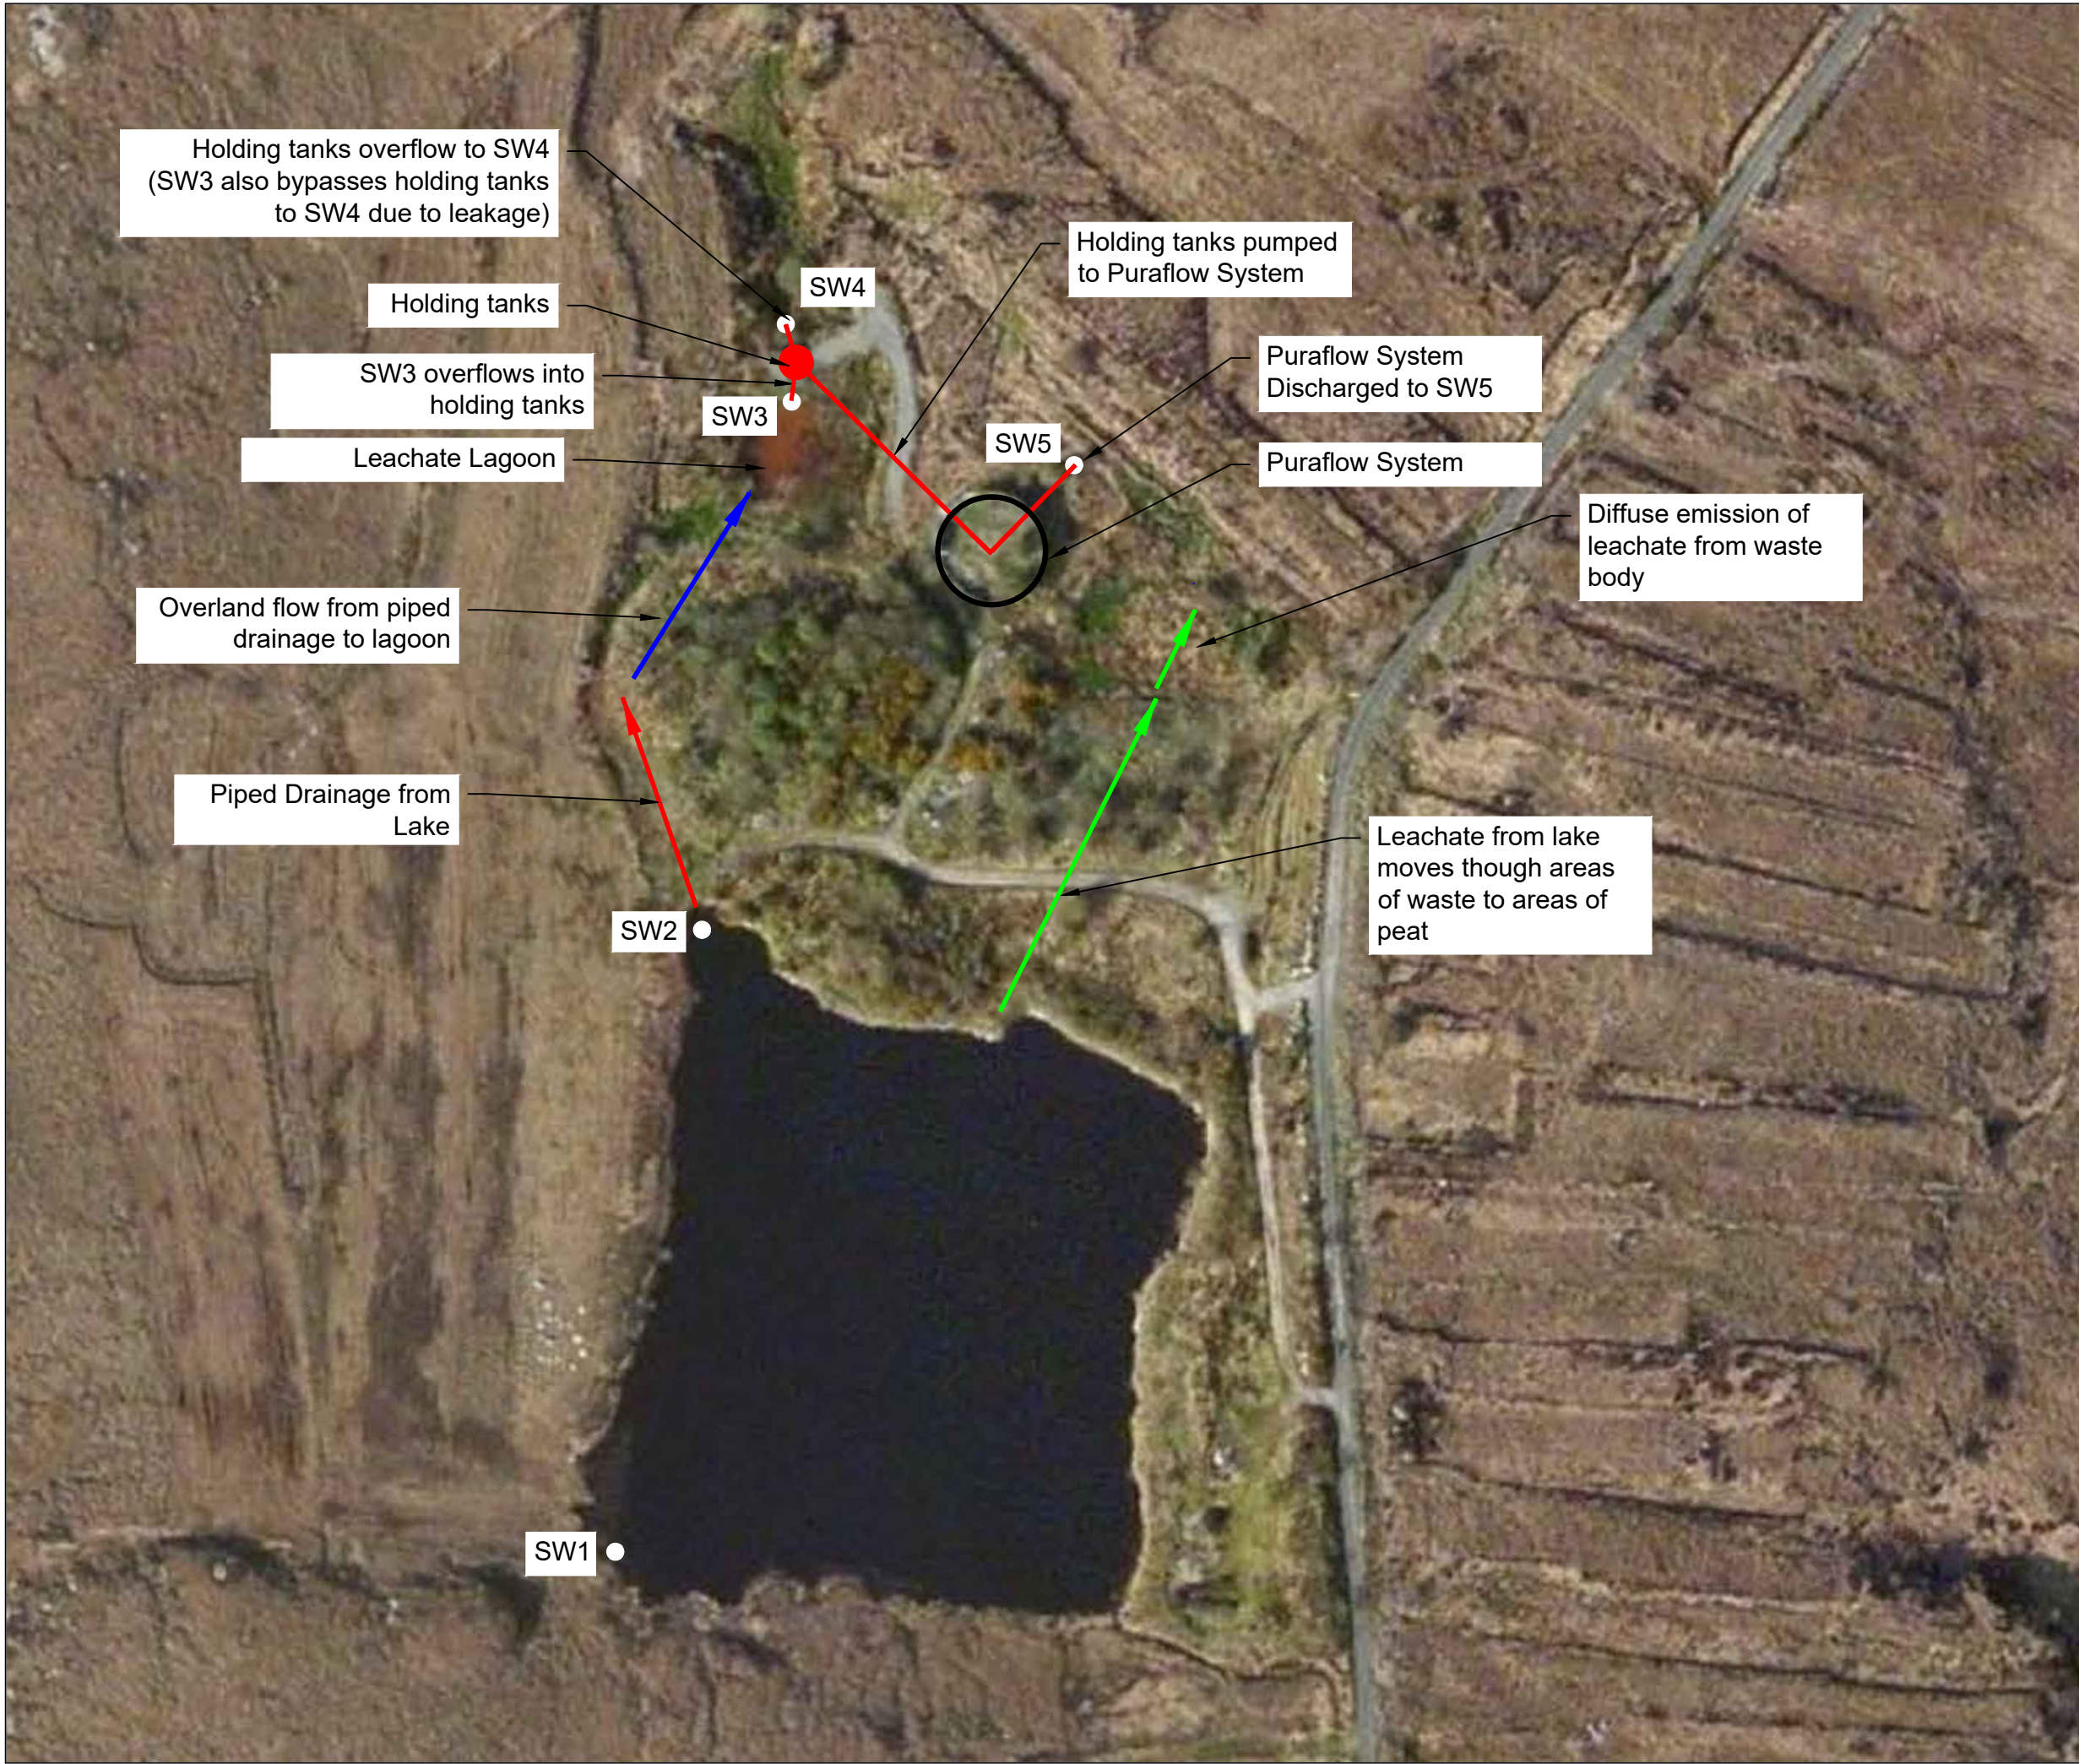
Holding tanks overflow to SW4  
(SW3 also bypasses holding tanks  
to SW4 due to leakage)

Holding tanks
