# Derrinnumera Landfill – Integrated Constructed Wetland

## Preliminary Design Report

**Mayo Co. Co.**

**Report No. B1853-BLP-R-ENV-03**

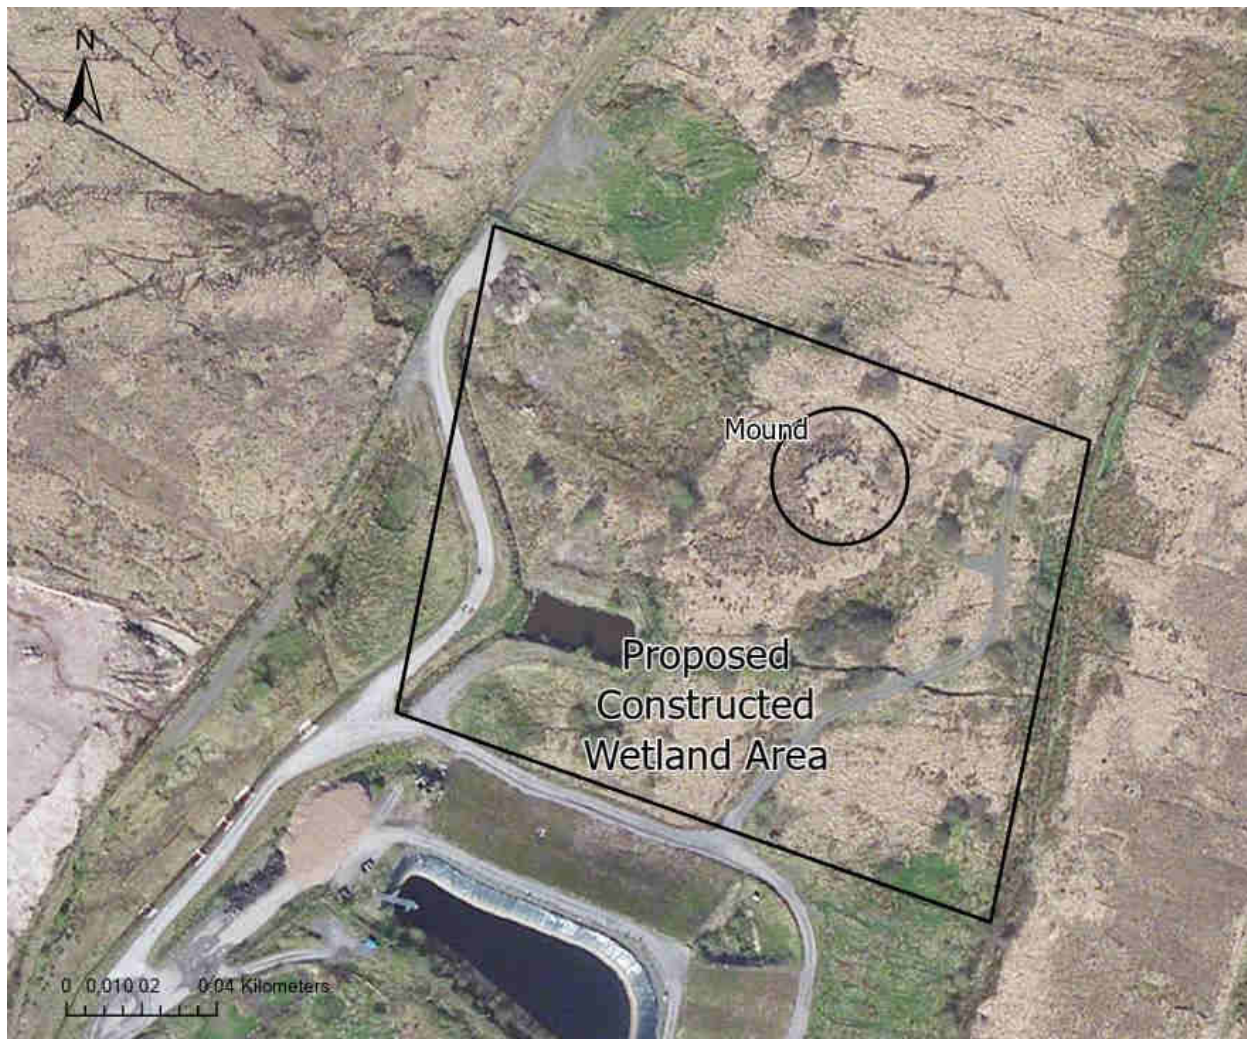
**Plate 1:** Overview of the Proposed Constructed Wetland Area with unrecorded possible Mound circled

The Derrinnumera site was subject to an archaeological assessment by Michael Gibbons in 1998, he identified a feature within this proposed wetland site as a possible burial mound. *“The Mound could be a pre-historic burial mound (2000 BC – 500 AD) or may be a natural feature”* (1998,1). It was described as sub-circular with diameter of ca. 20m and maximum height on E of about 2m. He recommended pre-development testing in advance of any future work that might impact this possible Mound. The location of the proposed wetland and the Mound within it are shown in Plates 1 and 2.

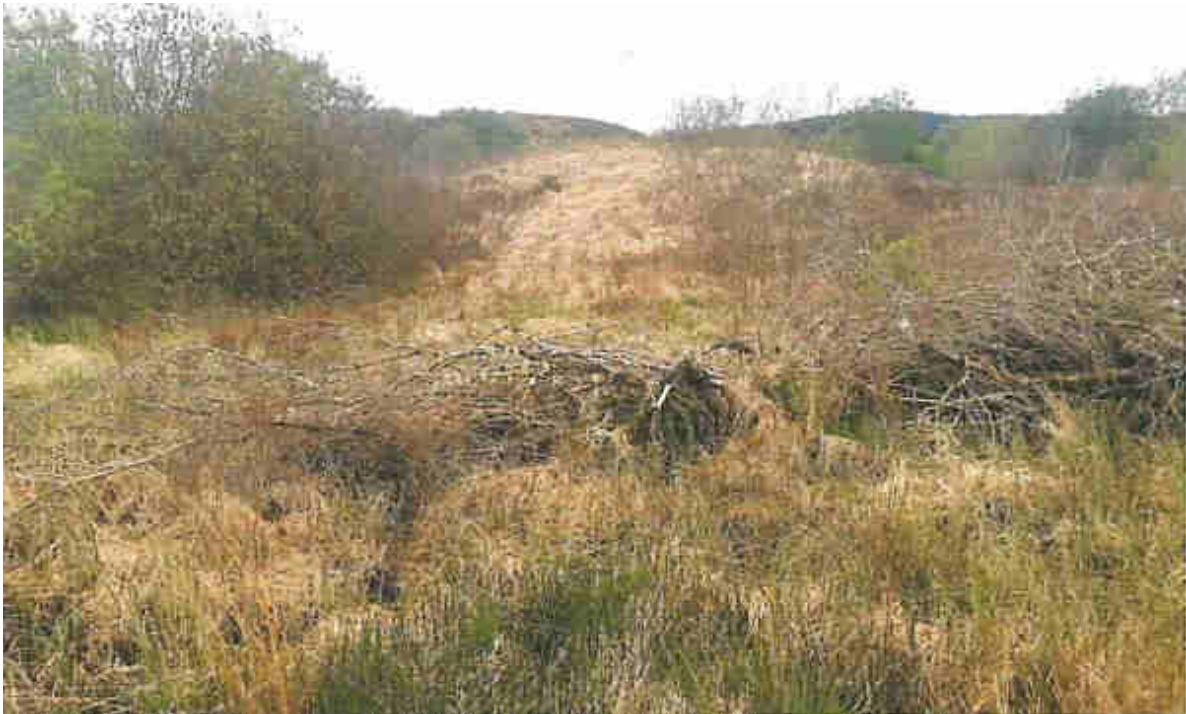
**Plate 2.** Possible Mound from ESE

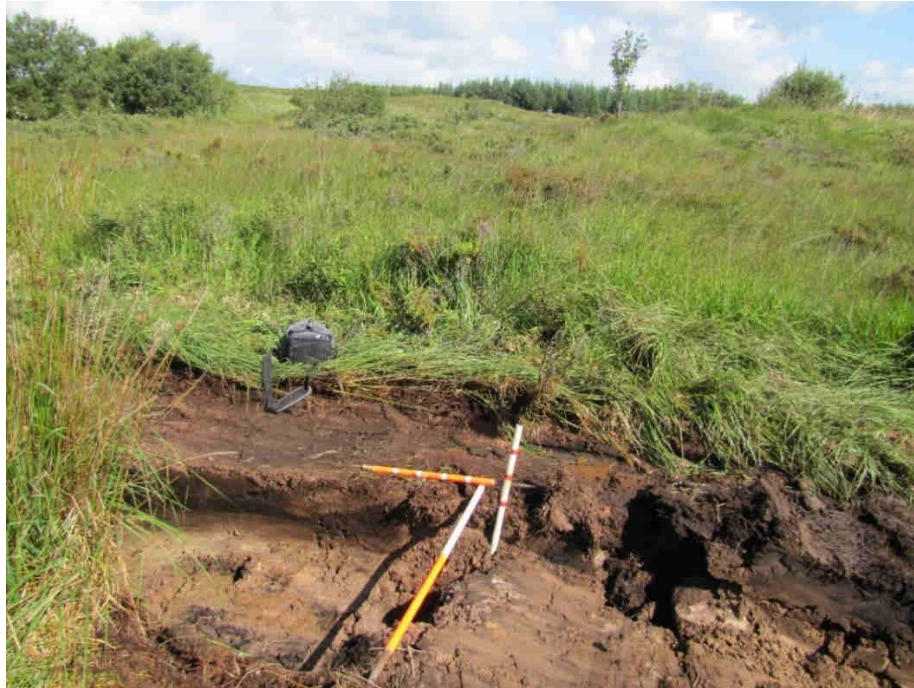
**Plate 3.1** Clay, diamict rising prominently in Tr.1. with possible Mound in background to NNE

In order to elucidate the properties of the possible Mound at the earliest, work was commenced in its vicinity. This involved digging the first trench ca 10m from its SSW edge. A 1m wide cut was made running from SE to NW across the site, it traversed rough uneven boggy ground with underlying natural clay diamict at varying depths. Throughout the site the peat was dark brown and fairly featureless. The underlying clay was initially revealed as a light brown to cream coloured boulder clay or till with occasional broken sandstone and gravel. At

NW end of the trench peat was a depth of .30m which initially deepened to .52m as it ran towards SE. Where the trench neared the vicinity of the possible Mound there was a noticeable rise in the level of the natural base. This culminated in a depth of only .10m below top of peat directly opposite to the possible Mound. It appears that this SSW end of the Mound extends to a point here giving it a teardrop or oval shape which is exposed underneath the peat covering in this trench. The material making up this end of the mound was pinkish fine-grained gravel with a few rounded stones and pebbles

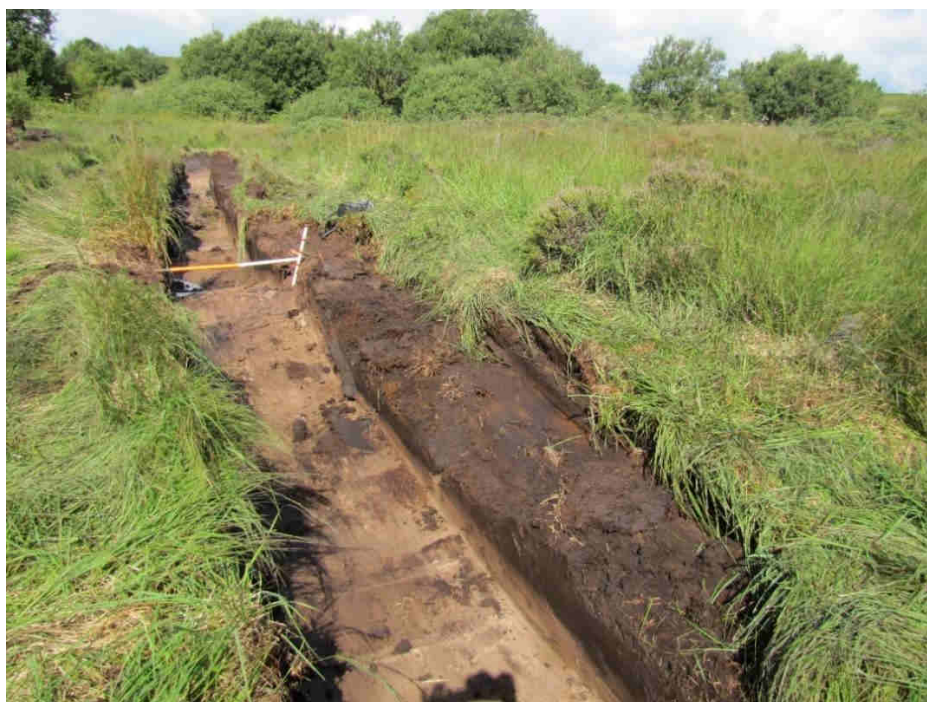
**Plate 3.2.** Significant rise in base of natural in Tr.1 as it runs towards NW

As the trench progressed beyond the area of the possible Mound towards NW the diamict base fell away to a depth of about .30m again and reverted to pale brown dauby till. Further towards NW as this natural base continued to slope downwards, the depth of peat overlying natural deepened considerably, it reached a maximum depth of 1.20m before flooding made it impossible to continue. The trench had to be stopped at a length of *ca.* 125m.

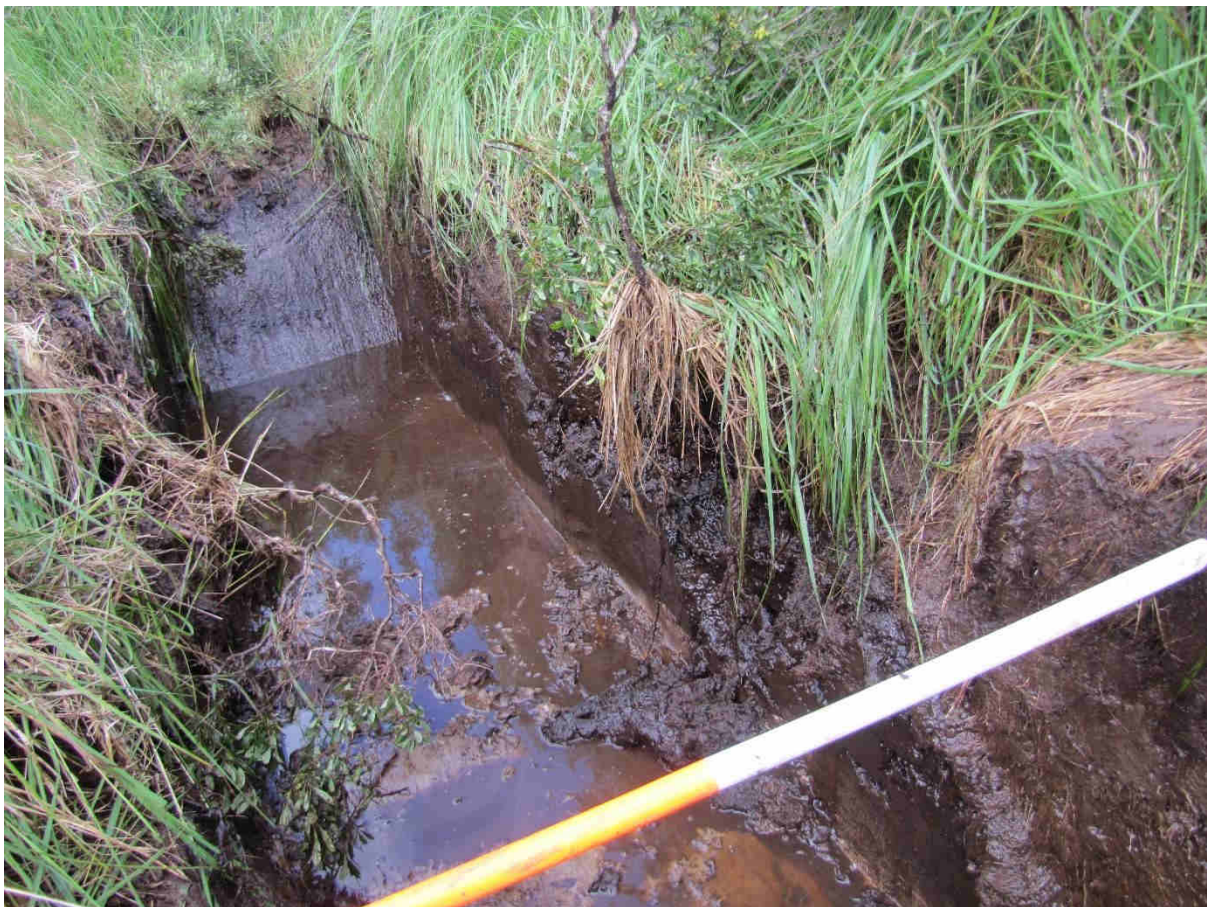
**Plate 4.** Trench 2 at NW end filling with water

This second trench (also 1m wide) was commenced from NW and ran towards SE across the top of the Mound. Where the work was adjacent to and on this possible Mound, excavation was very carefully carried out. The digging was very gradual and shallow to ascertain the depth of peat and carefully reveal any Mound-related features it might contain. Similar to the previous trench the NW end contained very deep peat (maximum depth 1.05m) and the trench filled with water very quickly. As it progressed towards SE and the Mound, the clay and diamict natural base of the trench rises to a depth of .45m, the base here is a pale brown or cream dauby boulder clay with no features indicating activity associated with the Mound.

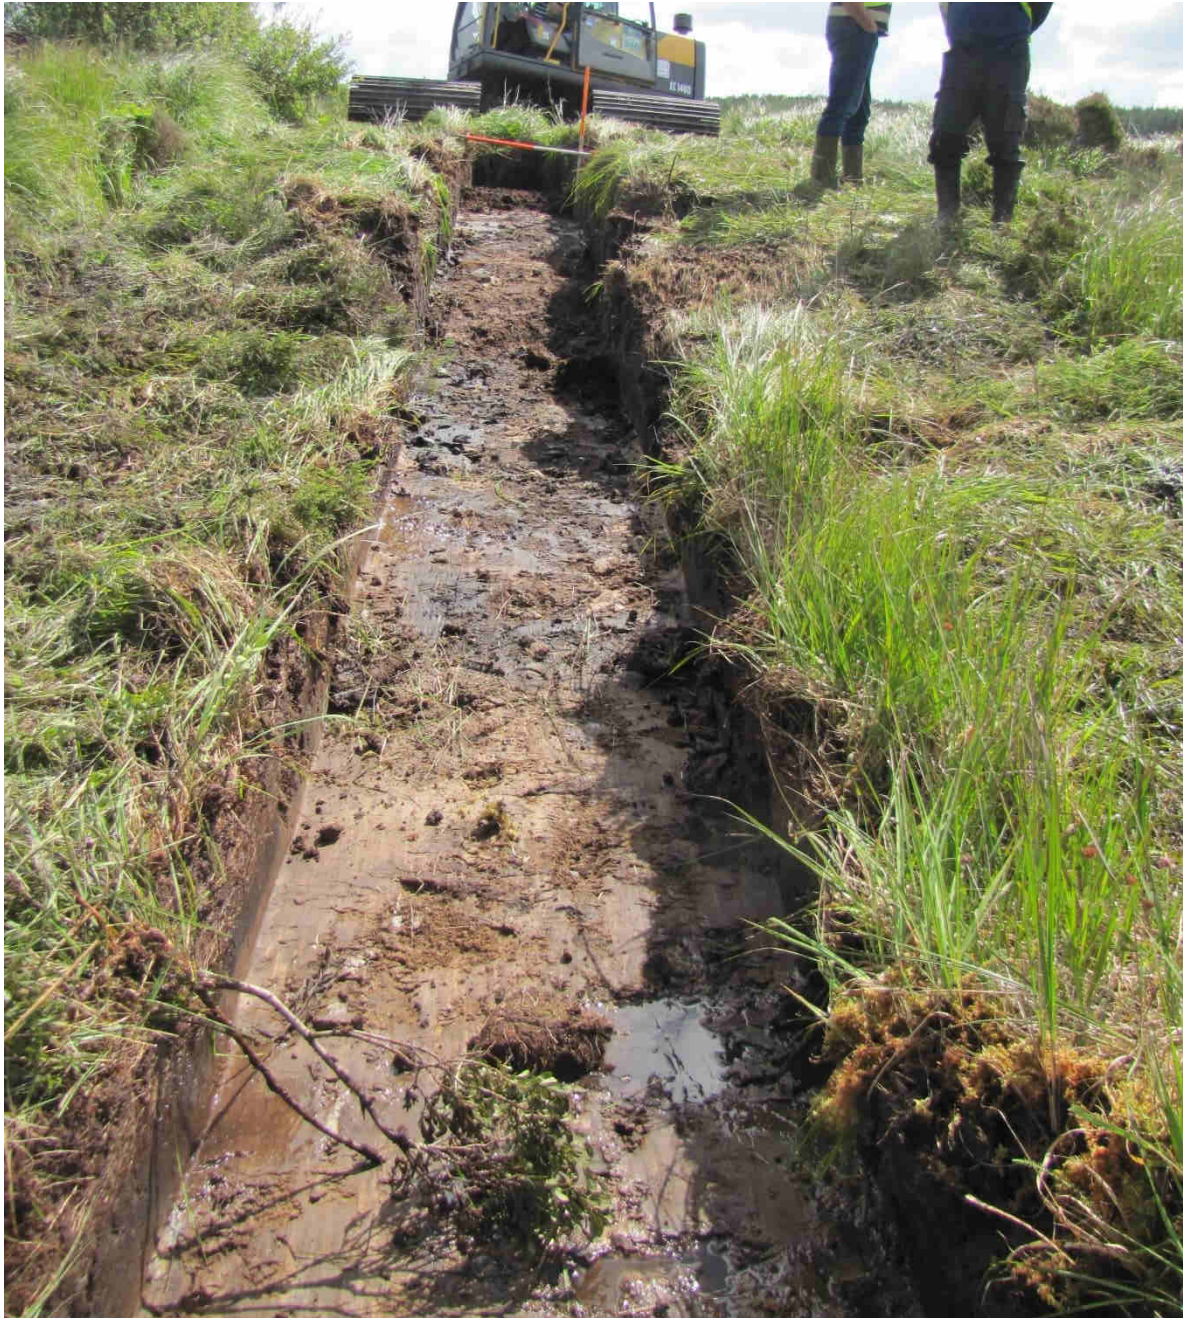
**Plate 5.** Trench 2 as it runs up the NW side of the Mound

Where the trench gets nearer the possible Mound its base of natural clay gets shallower and at the Mound there is a higher proportion of stones mixed through it. On the side of the Mound the peat was about .30m in depth, this was up to .50m depth on the flat top of the Mound. Across the area of the Mound the peat was underlain by orange/brown fine gravel with decayed sandstone inclusions, indicating a different makeup in the Mound to the boulder clay / till across the wider site.

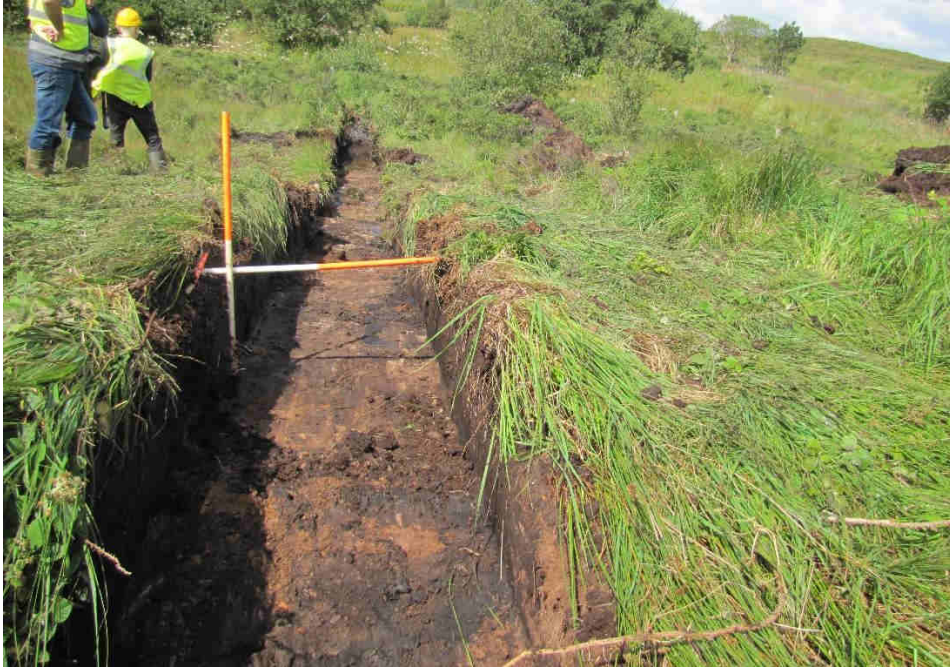
**Plate 6.** Test Trench 2 from top of possible Mound running towards NW

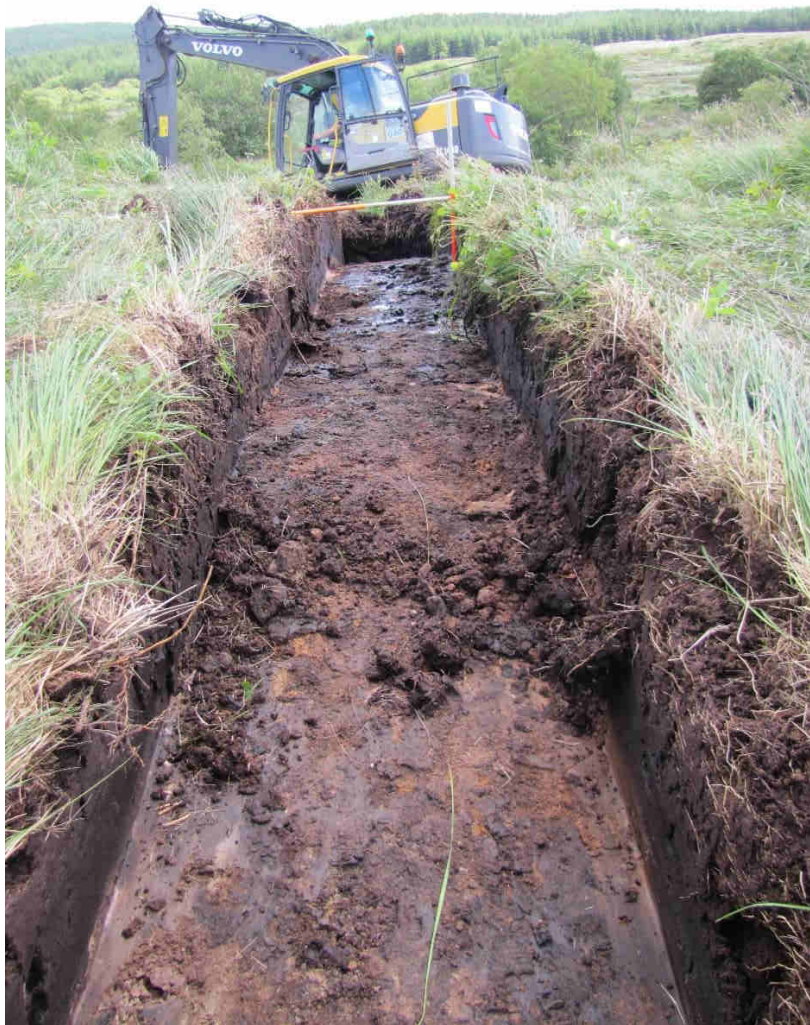
**Plate 7.** Test Trench 2 on top of possible Mound running towards SE

The SE-facing side of the possible Mound slopes downhill steeply, peat depth on top of it varies from .30m - .40m. Towards the SE end of this trench deep peat again develops.

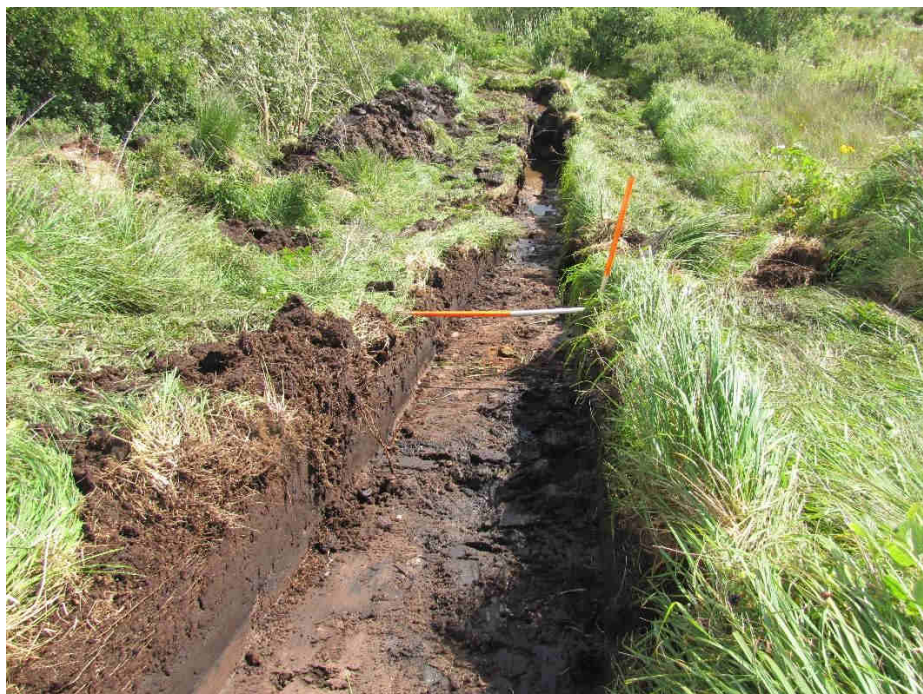
**Plate 9.** Trench 2 running towards SE from top of possible Mound. Flooded at SE end

At the SE end of this trench again getting into very deep peat so the trench very quickly filled with water. As it was so steep it wasn't possible to get a depth measurement.

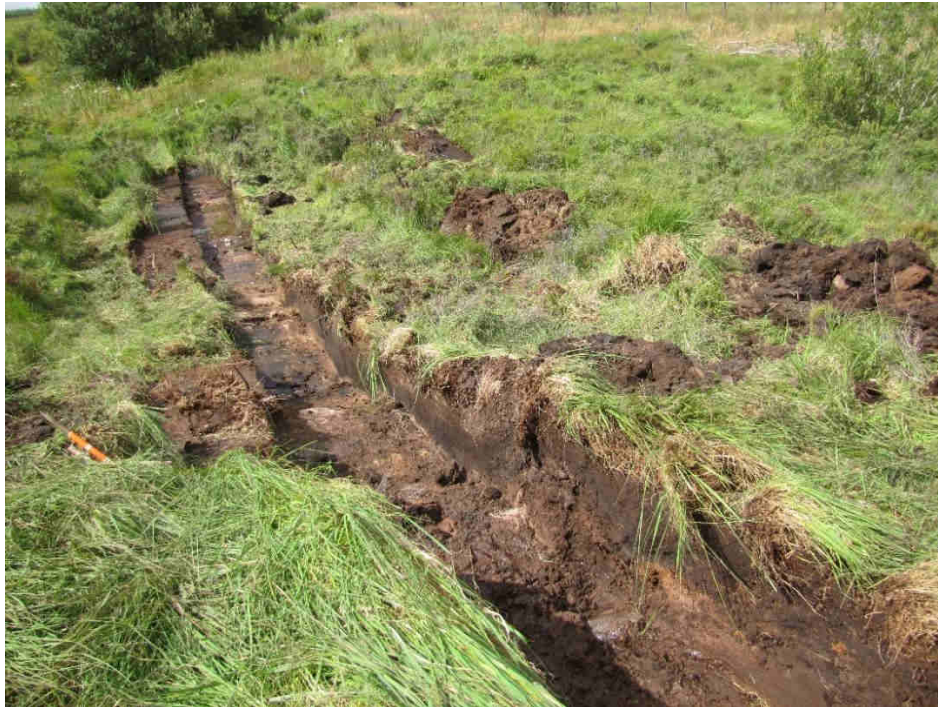
**Plate 10.** Trench 3 running from NW and up face of possible Mound

The third trench was again dug across the possible Mound to confirm the findings from the previous trench. It ran from NW to SE, 1m in width and was commenced ca. 15m NW of the possible Mound, peat depth varied between .30m and .40m. Peat removal revealed brownish grey to cream coloured boulder clay or diamict with some decayed sandstone inclusions. There were some larger flattish stones in the base of the trench where it was near the possible Mound.

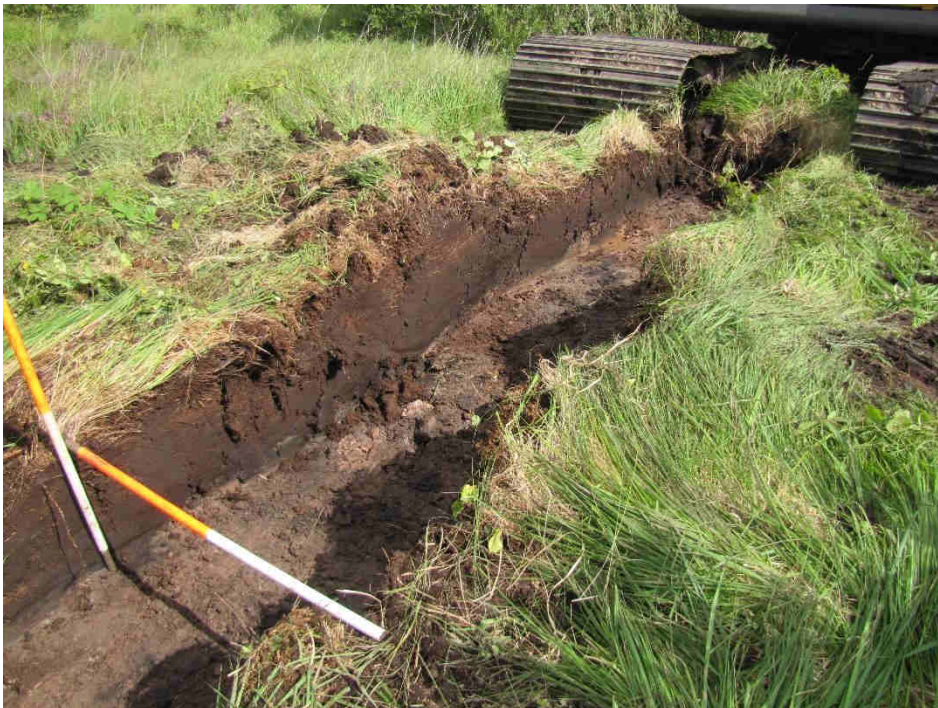
**Plate 11.** Natural clay & gravel base of Trench 3 is stonier and orange-stained at Mound top

Where the trench crossed the top of the mound peat depth was *ca.* .30m, the basal clay and gravel was orange-stained with a greater stone content than seen across the site. As the possible Mound slopes steeply downhill to SE the peat cover deepens to about .40m

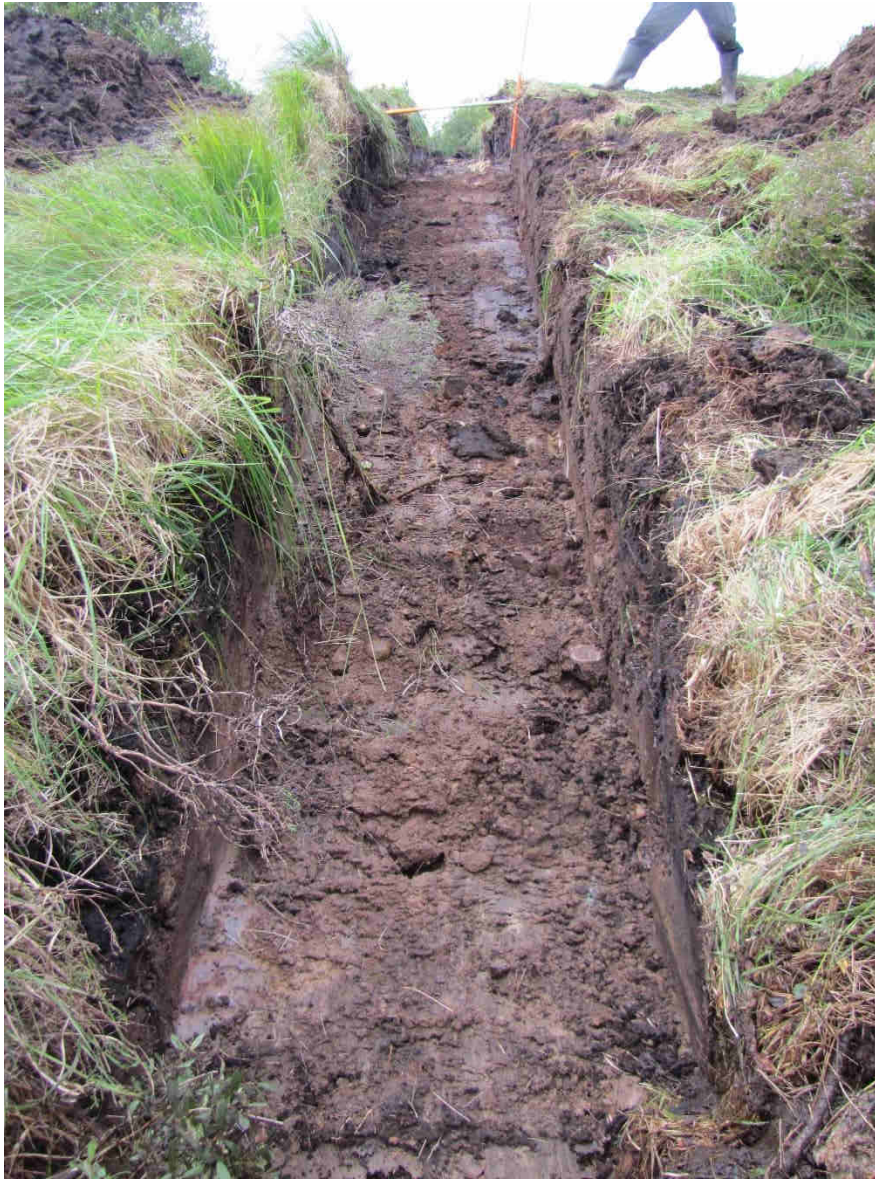
**Plate 12.** Trench 3 as it runs down SE side of possible Mound.

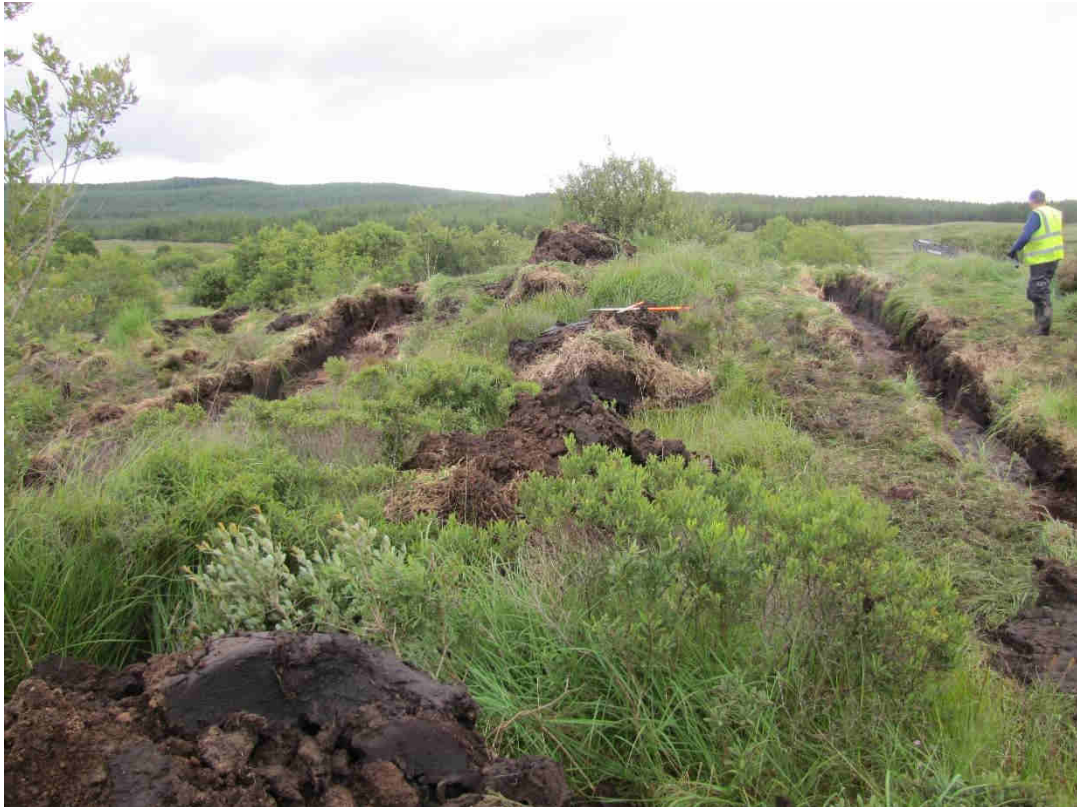
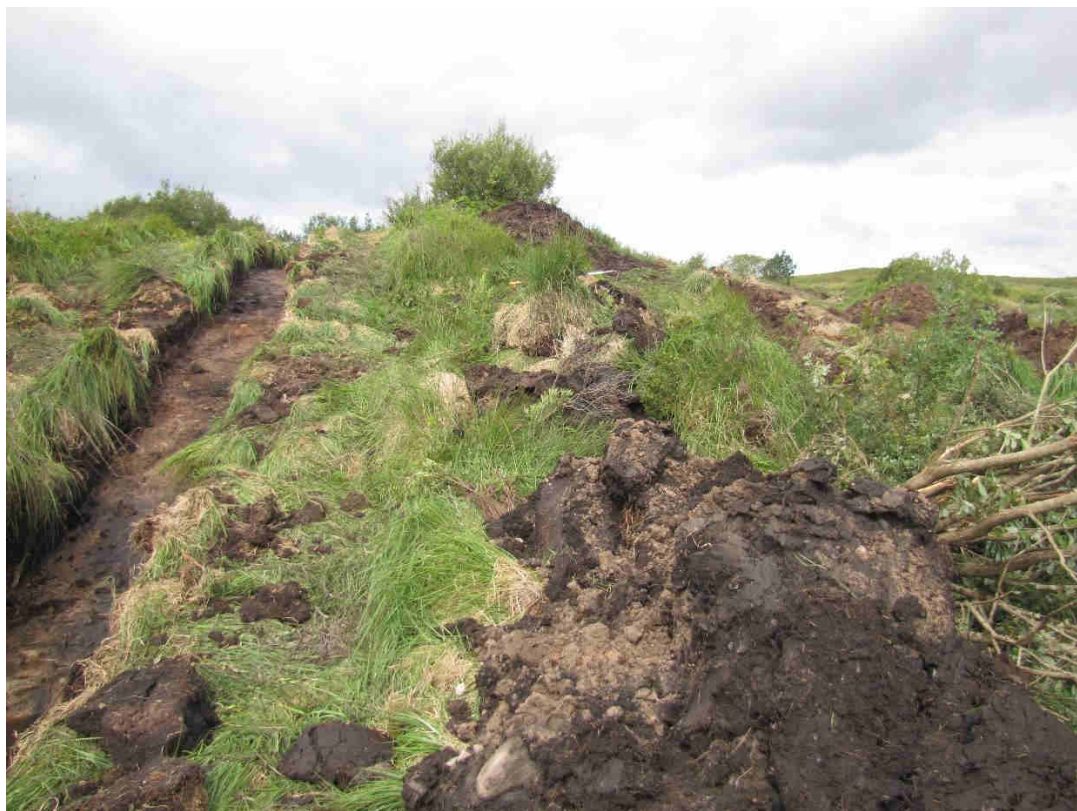
The results from both these trenches indicate the possible Mound is comprised of naturally occurring pinkish orange-stained fine gravel with mainly rounded sandstone inclusions. It differs in composition from the rest of the tested area where the underlying natural clay was pale brown or cream-coloured diamict which has a more fine-grained dauby consistency. These differences could indicate that the possible Mound feature was created in a separate deposition event (by ice-transport processes) than when the boulder clay was laid down.

**Plate 13.** Trenches 2 & 3 crossing possible Mound, from NW.

**Plate 14.** Trenches 2 & 3 crossing possible mound from SE

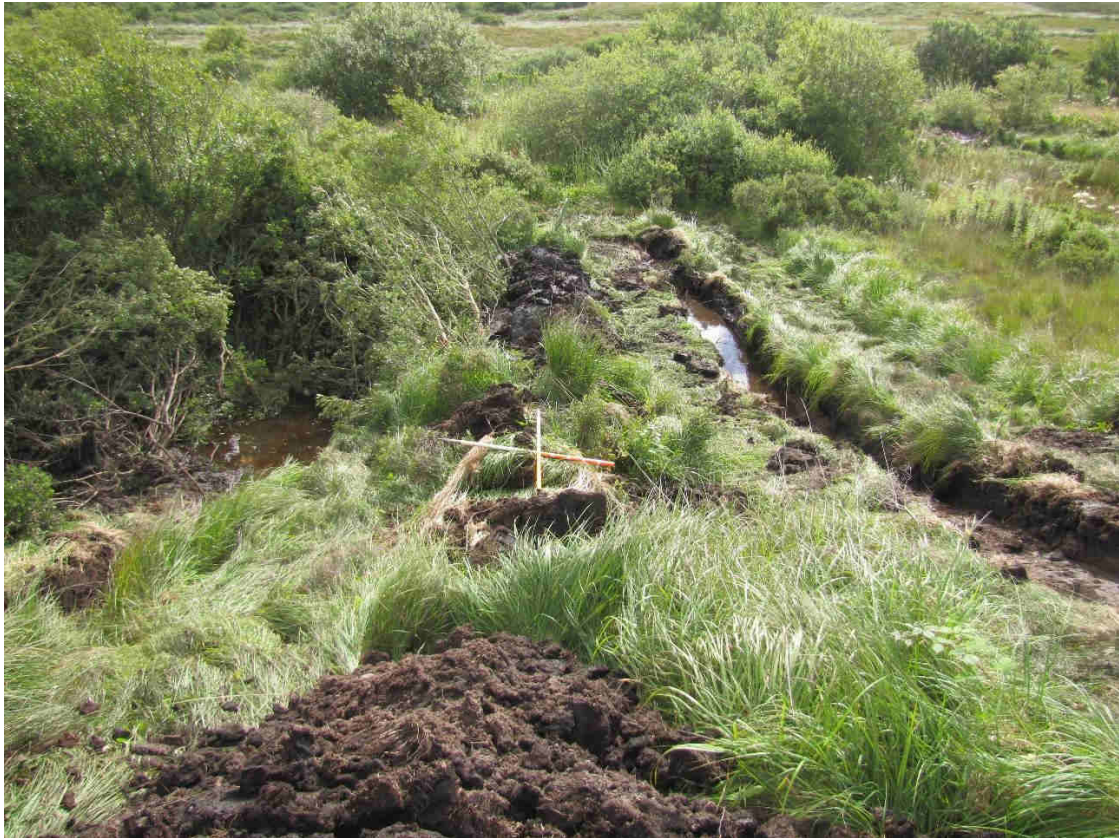
**Plate 15.** SE end of trenches 2 & 3 showing flooding in deeper peat.

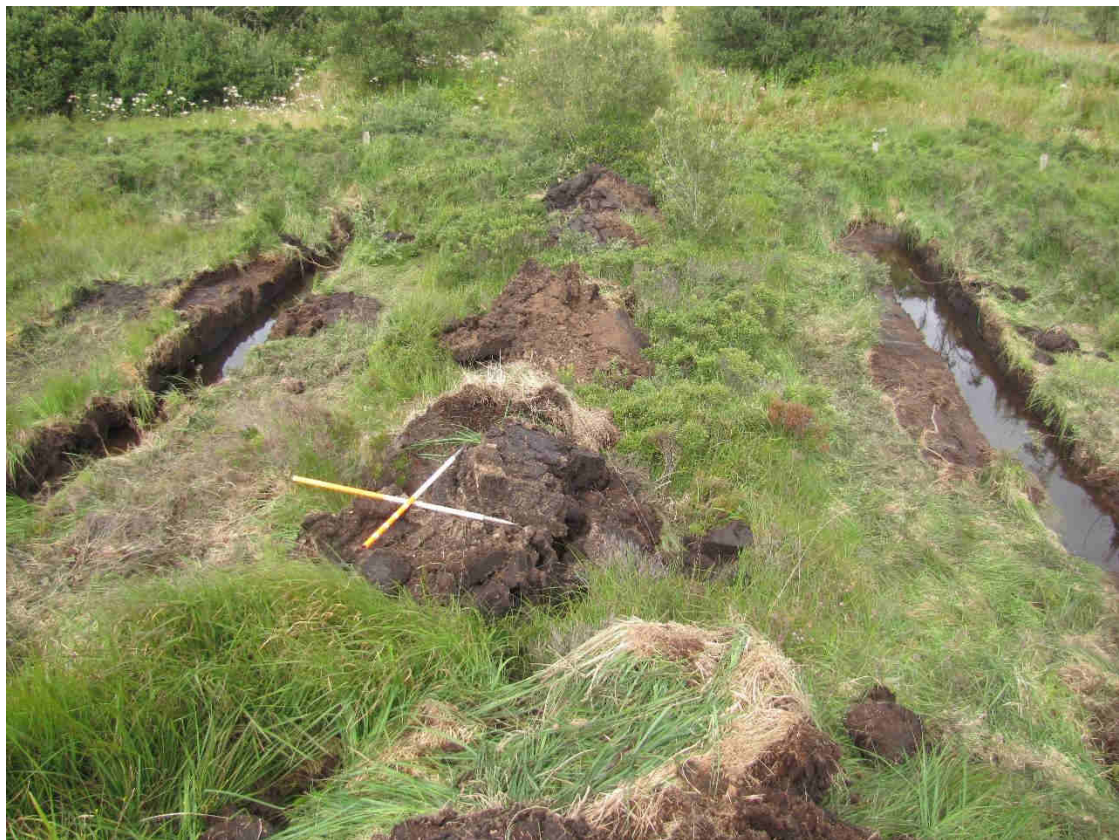
**Plate 16.** NW end of trenches 2 & 3 filled with water from deep peat.

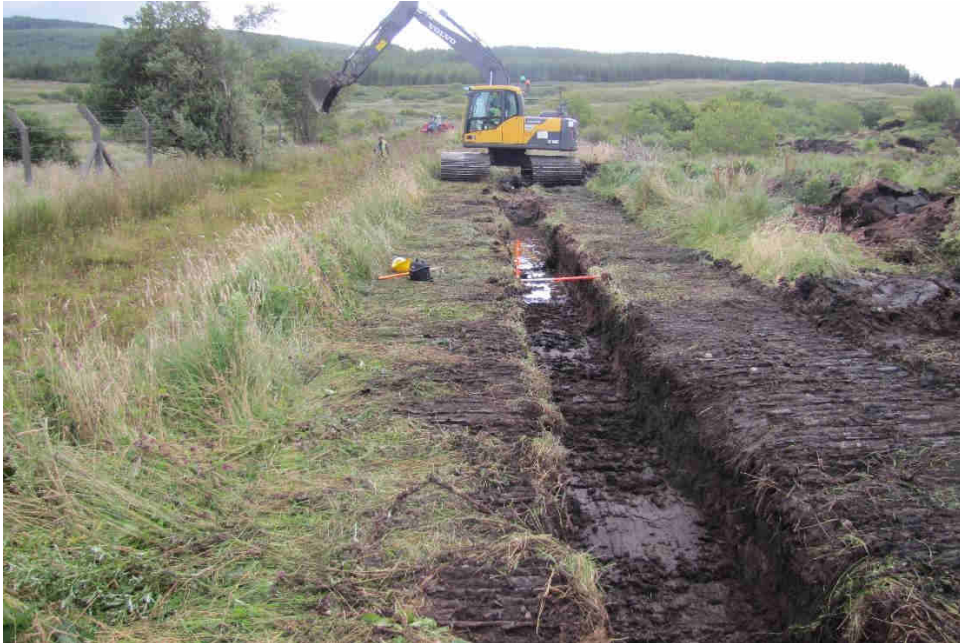
**Plate 17.** Trench 4 from NNW, firebreak obvious beside NNE side of trench

Trench 4 was dug as part of testing the wider site across the NNE edge of the site (see Plate 1) and running from NNW towards SSE. This 1m wide trench is adjacent to a constructed firebreak on its NNW side which has impacted the nature of the peat deposits here. The NNW end of the trench commenced below a raised area that has been truncated by this firebreak

Peat varied in depth in this trench, initially it appeared very shallow at no more than .10m depth and exposing pinkish gravel with rounded sandstone inclusions.

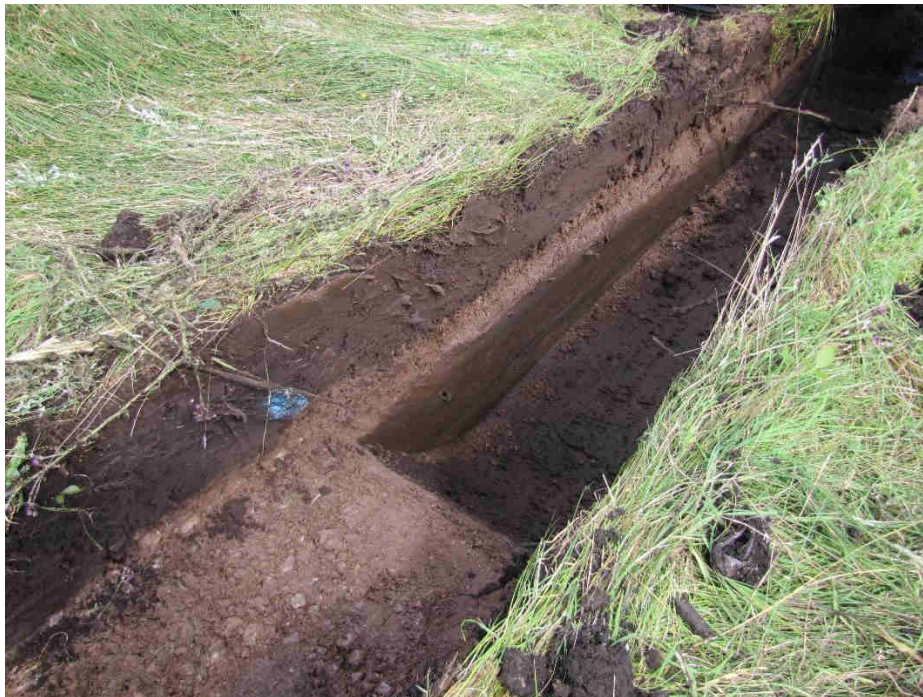
**Plate 19.** Varying levels of peat and gravel “natural” in Trench 4 and plastic in trench side.

As the trench progressed towards SSE the peat deepened and shallowed sharply between depths of .75m and .30m. Plastic inclusions were also noted within the trench sides.

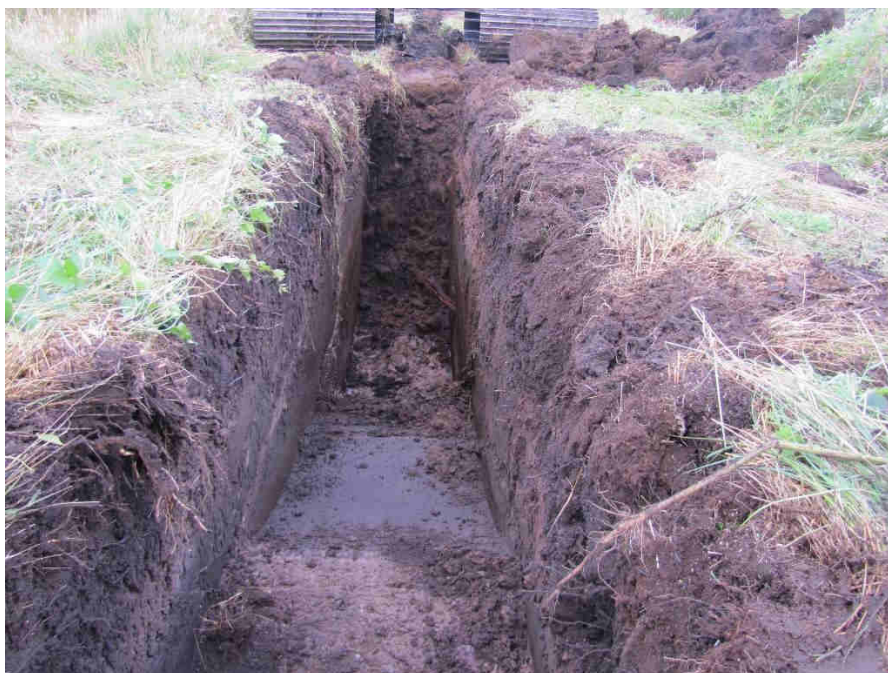
**Plate 20.** Redeposited gravel and stony diamict mixed through peat in Trench 4

Midway along the length of this trench very deep bog was encountered which was up to 2.50m in depth. This was initially not obvious as it was overlain by a layer of what was assumed to be the trench base of gravelly “natural” diamict. It became obvious that there was dumped material in this area probably associated with the construction of the firebreak area.

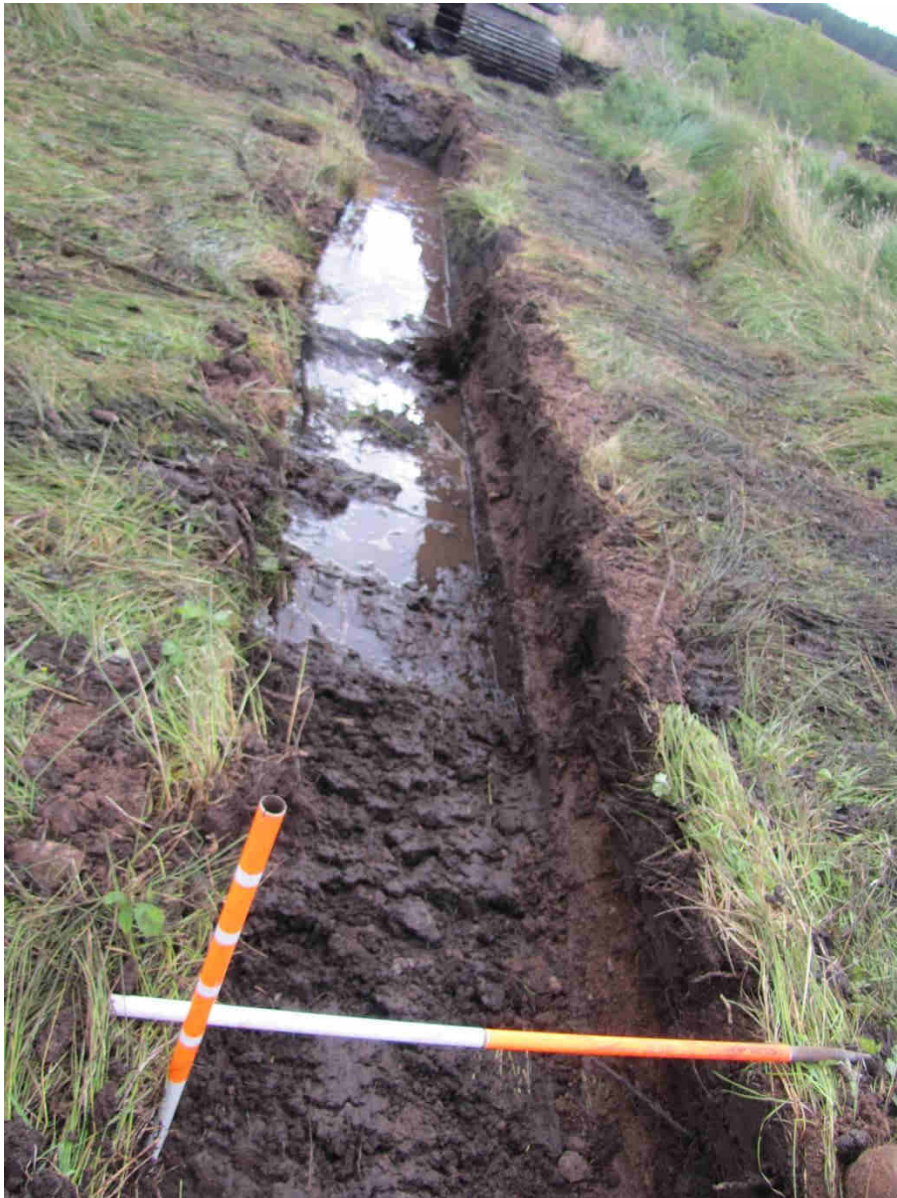
**Plate 21.** Backfilling and water rising in Trench 4

As this mixed material was removed to reveal peat the trench kept filling with water which required constant backfilling to prevent it from collapsing under the digger. The redeposited fill encountered in this trench is similar to the gravelly material which made up the possible Mound. It may derive from the truncated elevated area at the NNW end of the trench where a road has been built (see Plate 1) and from the dugout area for the firebreak to NNE of trench.

Trench depth was up to 2.50m and due to flooding its contents were no longer visible. Trench 4 was suspended at about two thirds of its planned length

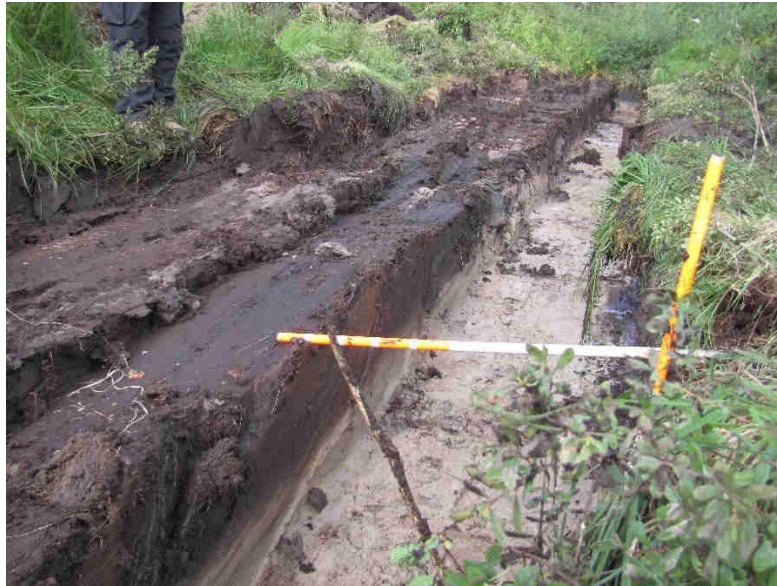
**Plate 22.** Trench 5 from South showing boulder-clay base.

A fifth 1m wide trench was commenced about 20m to NE of the possible Mound (also to NE of Trench 1), it ran from NW to SE and cut through featureless black peat. At the beginning of the trench there was some pinkish-coloured natural gravel which changed towards SE to

pale cream-coloured boulder clay or fine-grained marly till with some grey and orange staining.

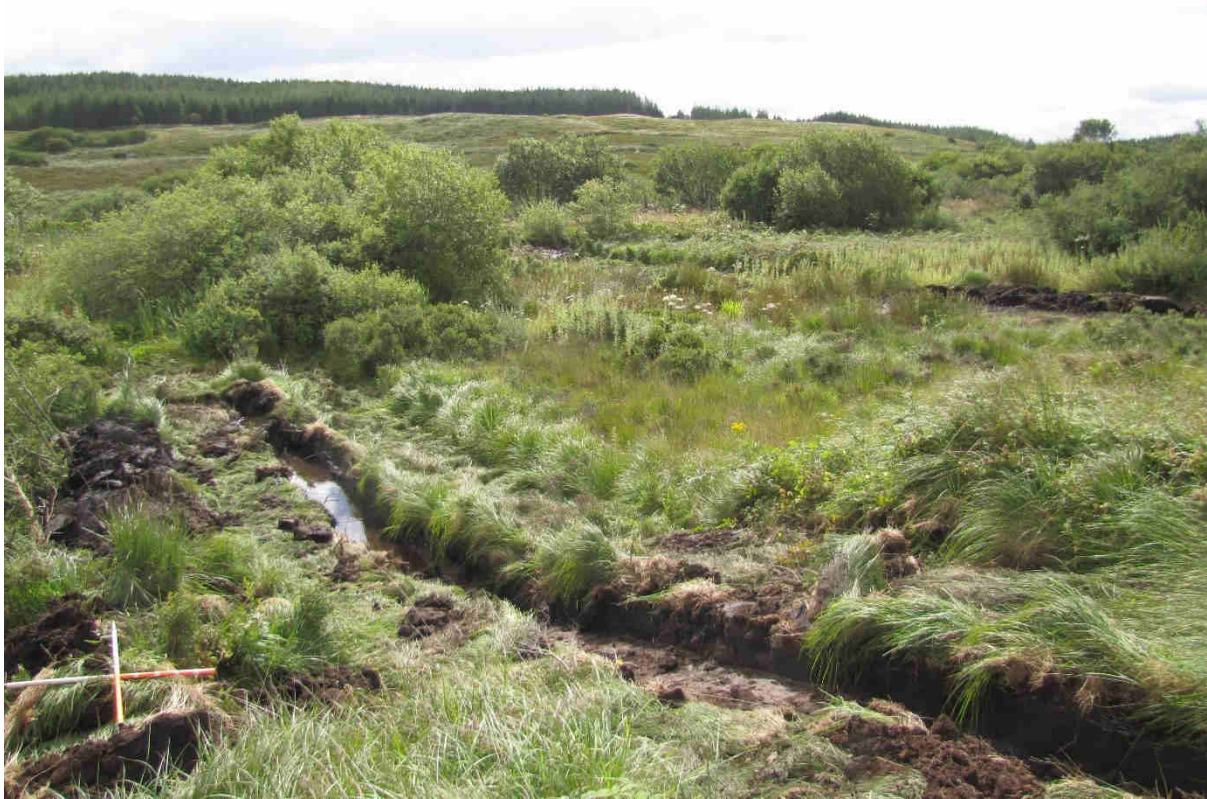
**Plate 24.** Drumlin and ribbed moraine topography in the background of Trench 3.

The wider landscape around the Proposed Wetland site contains small oval shaped drumlins partially buried in the later developed peat (see Plate 24). This mound is similar in its morphology; fairly low with an oval-shaped outline. The Mound is not out of place in this landscape.
