Appendix C – Invasive Species Report

Invasive Plant Management & Herbicide Treatment Plan – Including Biosecurity Documents

Site Address: Derrinnumera Landfill Newport Co. Mayo

Project Name: Derrinnumera Landfill ICW	Project No. B1853	Co-ords: 504589.00 - 794070.00 Level:	Date 08/08/2022
---	-------------------	--	-----------------

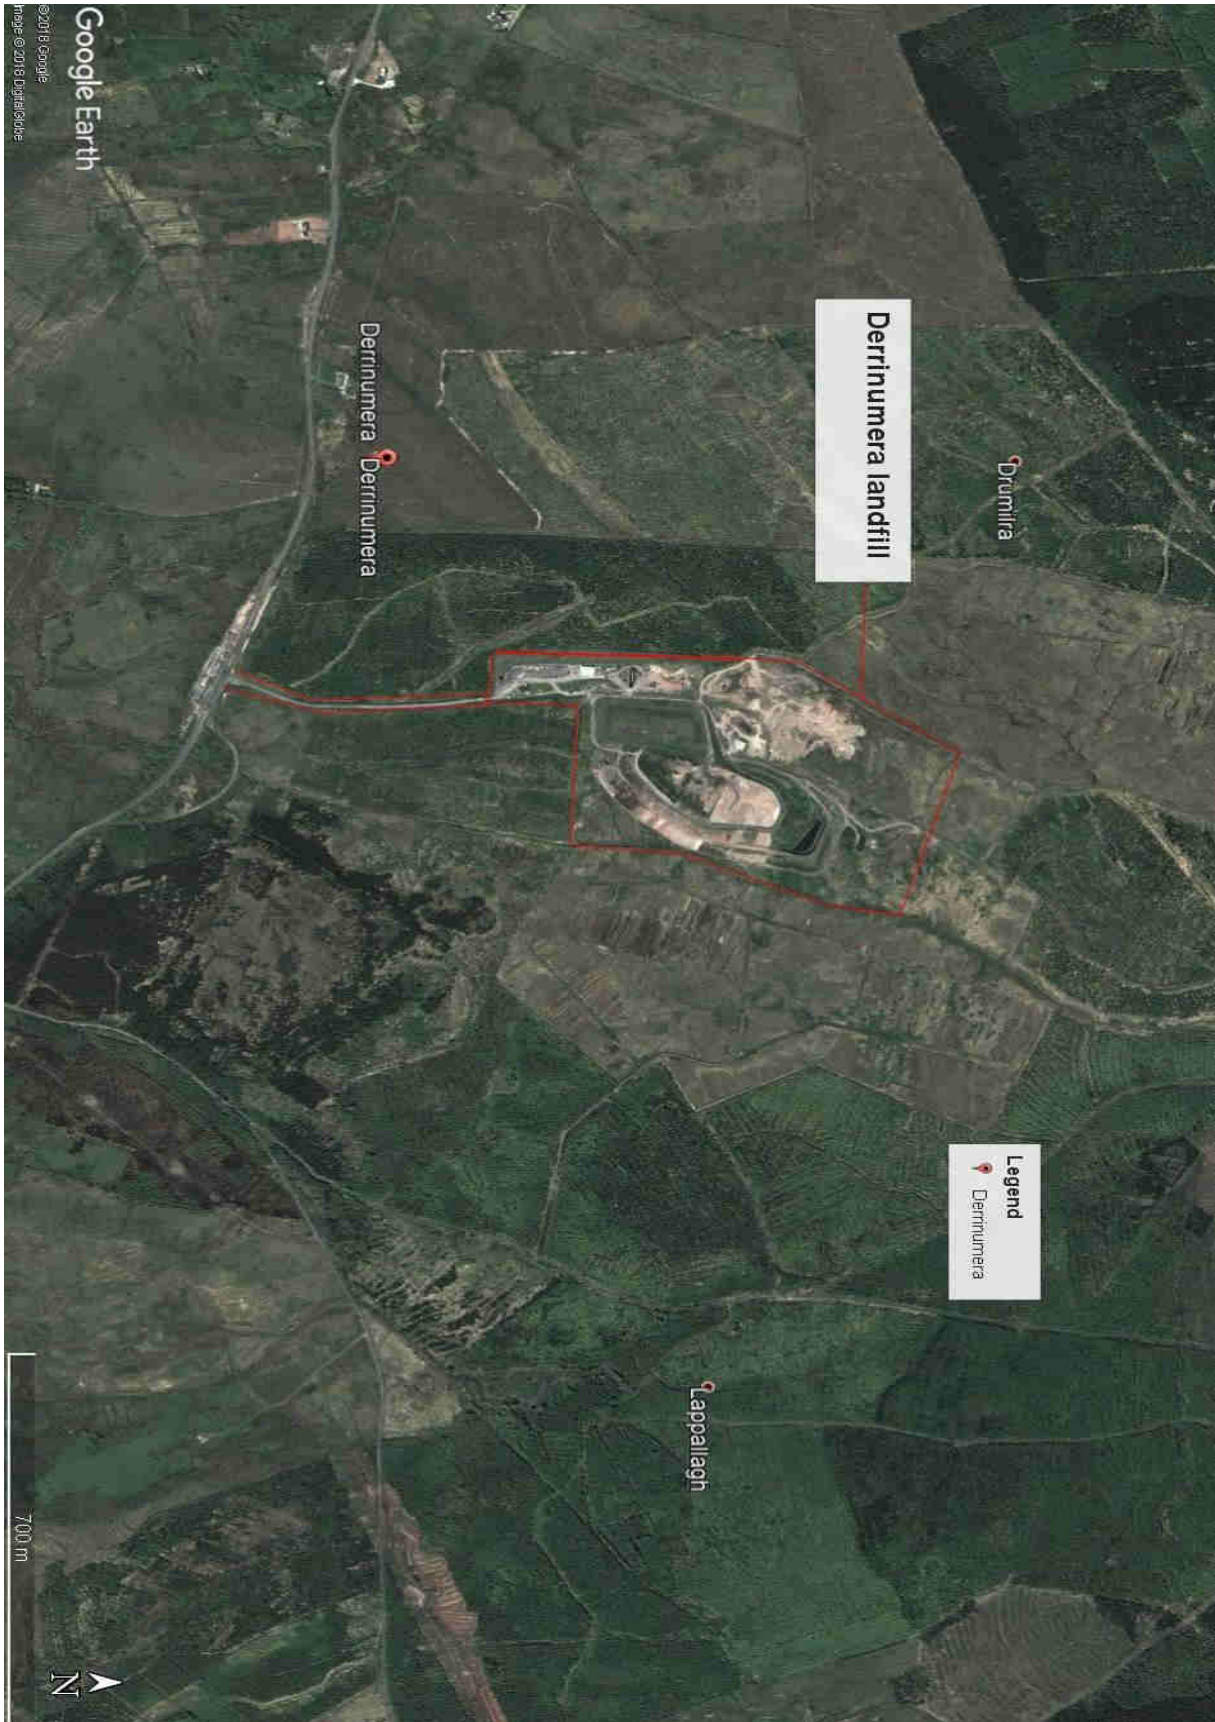
Appendix E – Site Map

The western area of this site has a mature infestation of Gunnera, at some point in the past soils were removed from this area and utilised to cap the landfill area to the south east. During the soil removal process the Gunnera was unwittingly spread throughout the site. All of the Gunnera that has been located at the south east of the site is young in nature, should this non-native invasive plant be left untreated it has the capacity to rapidly colonise this site.

Approximately 200m² of Himalayan Knotweed was located in 3 separate locations to the north of this site, the condition of the crown material of the plant suggests that this Himalayan Knotweed is over 4 years old.

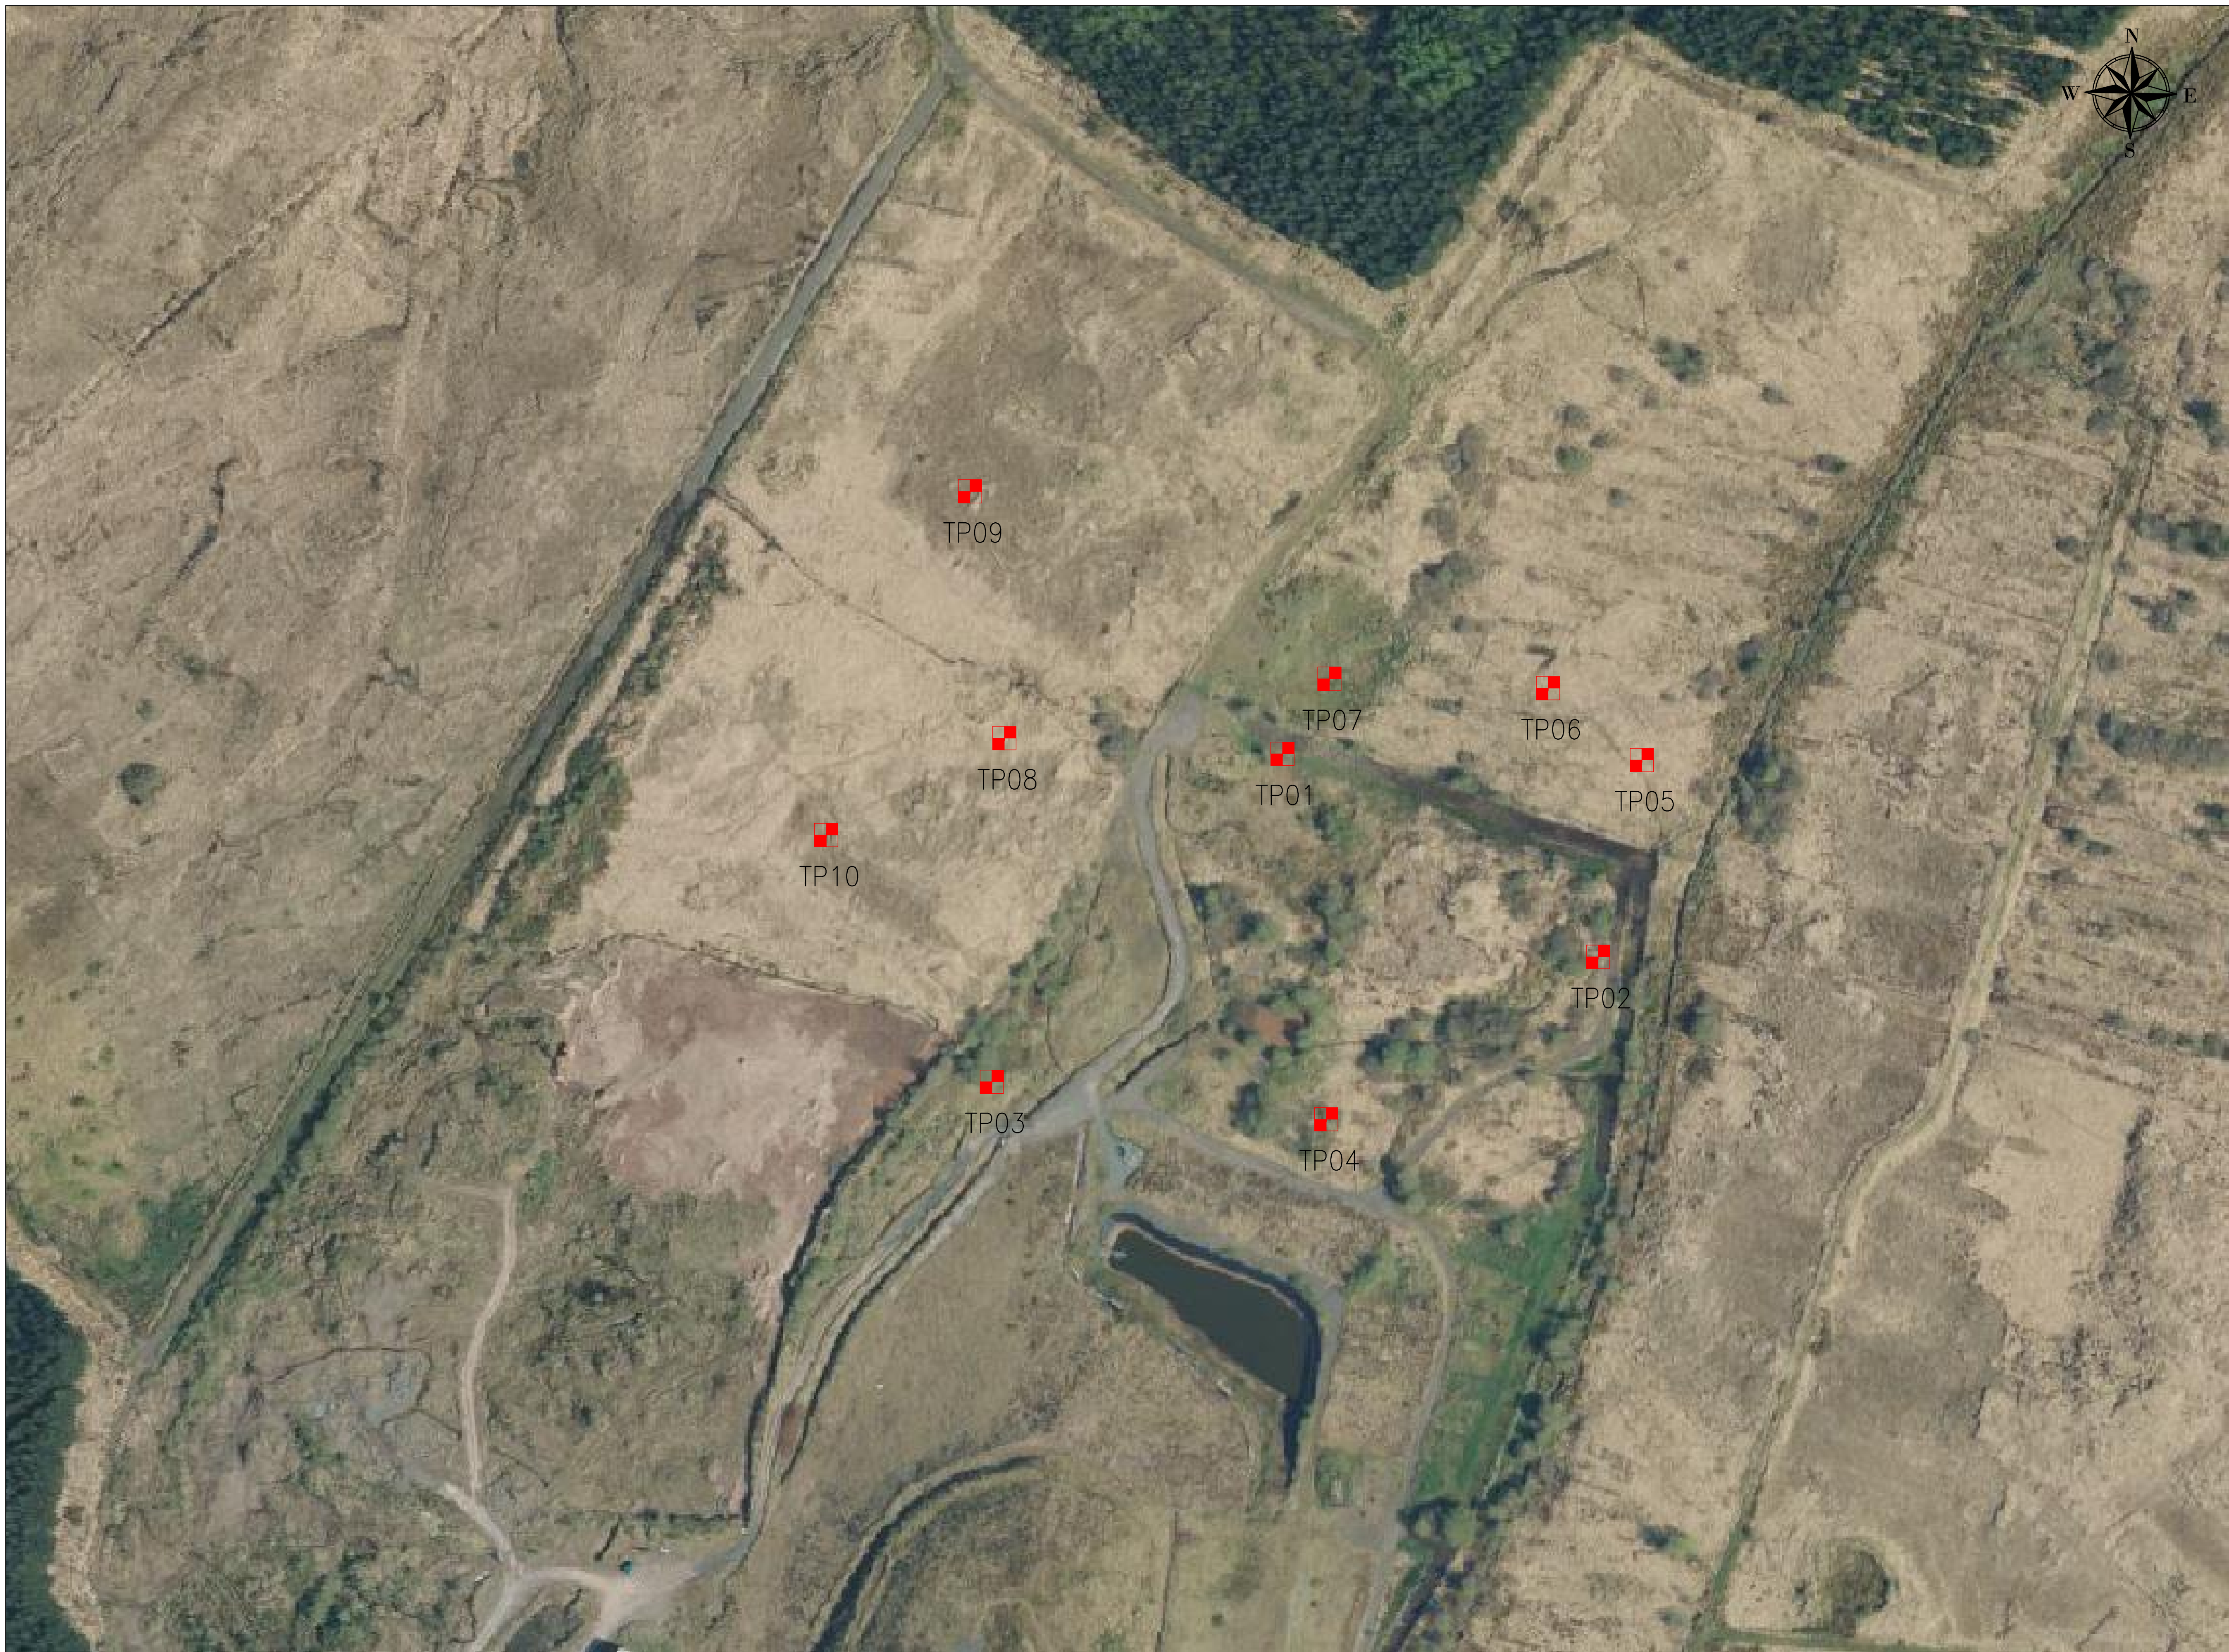
S.I COORDINATES		
Value	Position X	Position Y
TP01	504589.000	794070.000
TP02	504690.000	794005.000
TP03	504496.000	793965.000
TP04	504603.000	793953.000
TP05	504704.000	794068.000
TP06	504674.000	794091.000
TP07	504604.000	794094.000
TP08	504500.000	794075.000
TP09	504489.000	794154.000
TP10	504443.000	794044.000
