Ringaskiddy Basin and Berths, Port of Cork Capital
Dredging, 2024-2030

Underwater Archaeological Impact Assessment (UAIA)

Caitlyn Haskins

January 2024

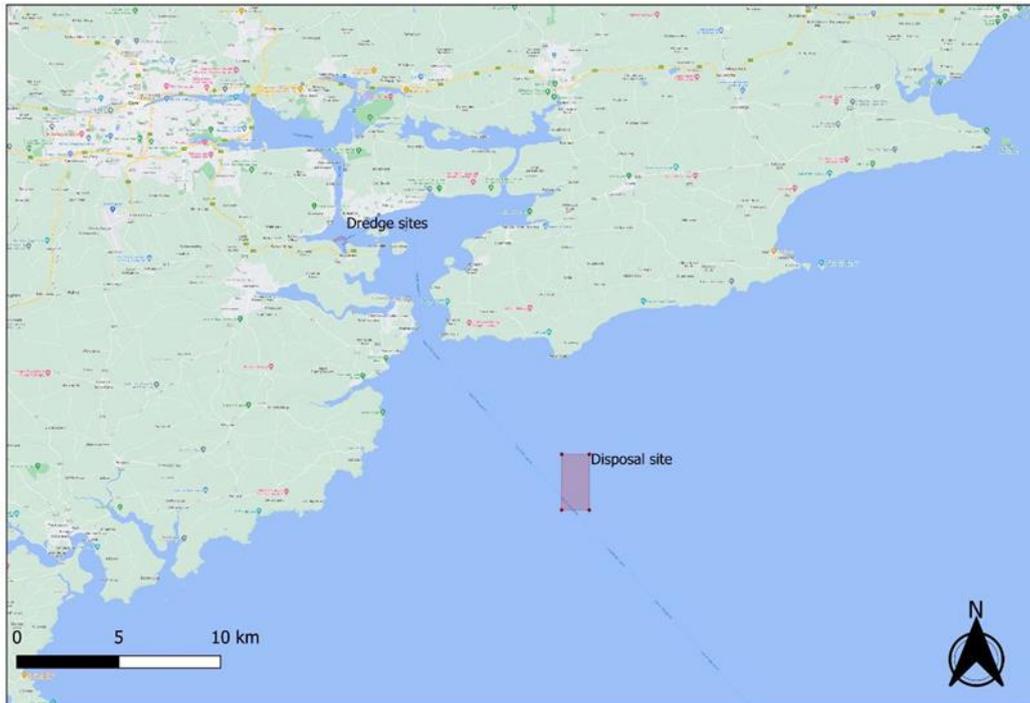
Figure 1 Location of proposed dredge sites and disposal site.

Ringaskiddy Port is situated on the western side of Cork Harbour, 15km from Cork City. Ringaskiddy is a major ferry port for Ireland. Two dredge pockets are proposed within Ringaskiddy Basin, bordering the northwest and the southeast of the entrance (Figures 1 & 2).

The licensed dredge disposal site (Figure 1) is located approximately 4.5km south of Power Head and the mouth of Cork Harbour. From 1978 to 1996, the current licence area formed the eastern half of the full dumpsite, which was reduced to its current size in 1996, and has been in operation within those boundaries since. The dumpsite has received considerable amounts of dredge spoil since 1996.

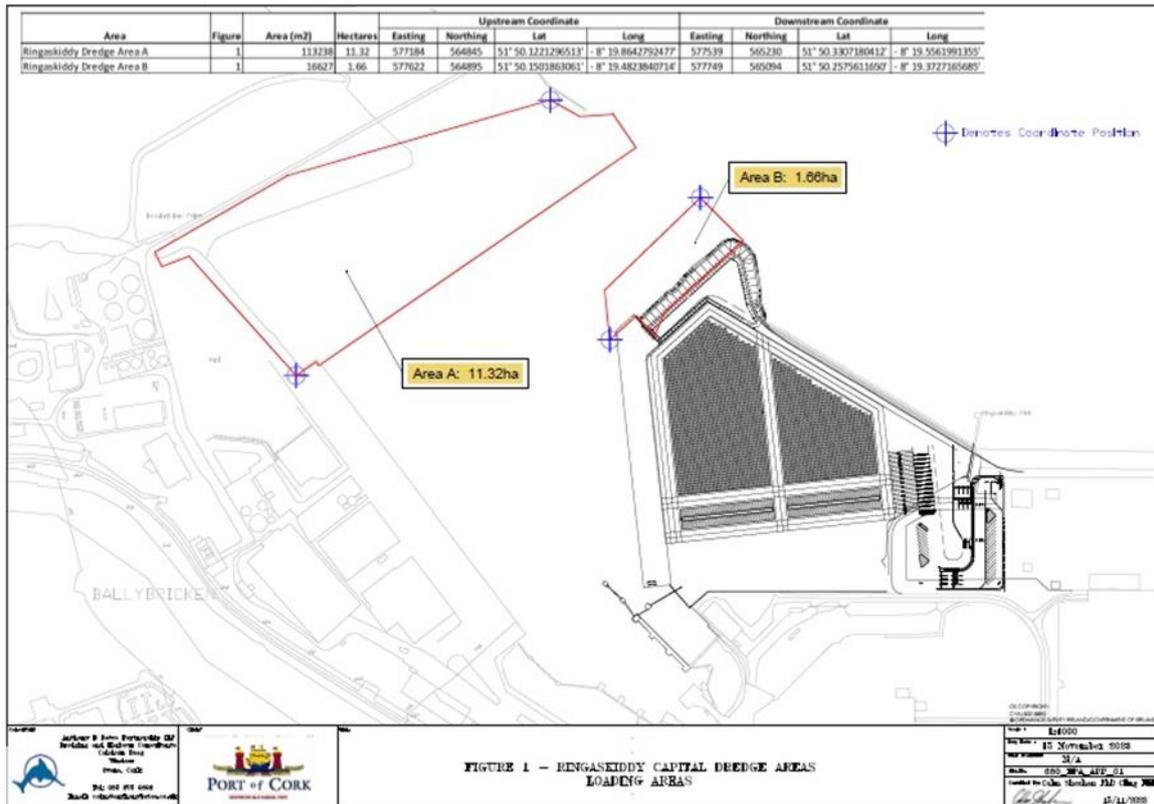
Figure 2 Outline of proposed dredge sites for assessment.

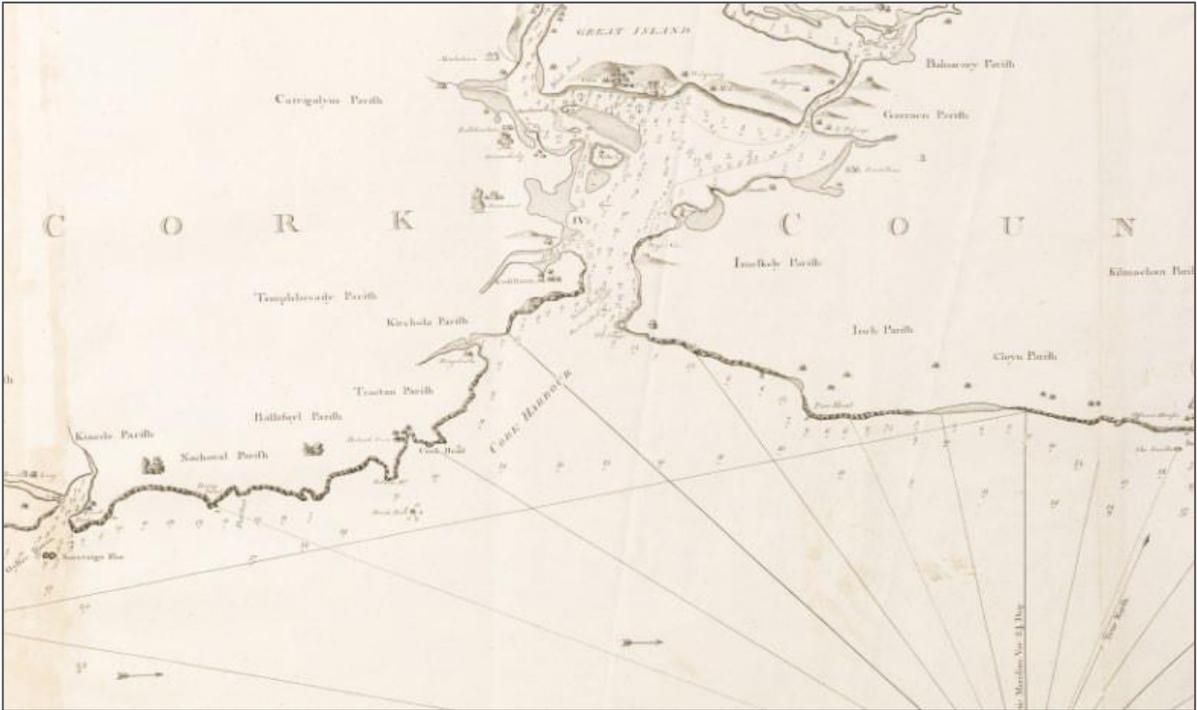
Figure 3 Extract from a 'The South Coast of Ireland from Cable Island to Gally Head' (Mackenzie, 1775).

A survey carried out by Murdoch Mackenzie in 1775 charted the coast of Ireland, including the proposed disposal site and dredge sites (Figure 3). This survey shows a large house at 'Ballybricken' and a small settlement at 'Grinaskedy'. It does not show any improvements along the foreshore. This map does not record any features within the proposed disposal site.

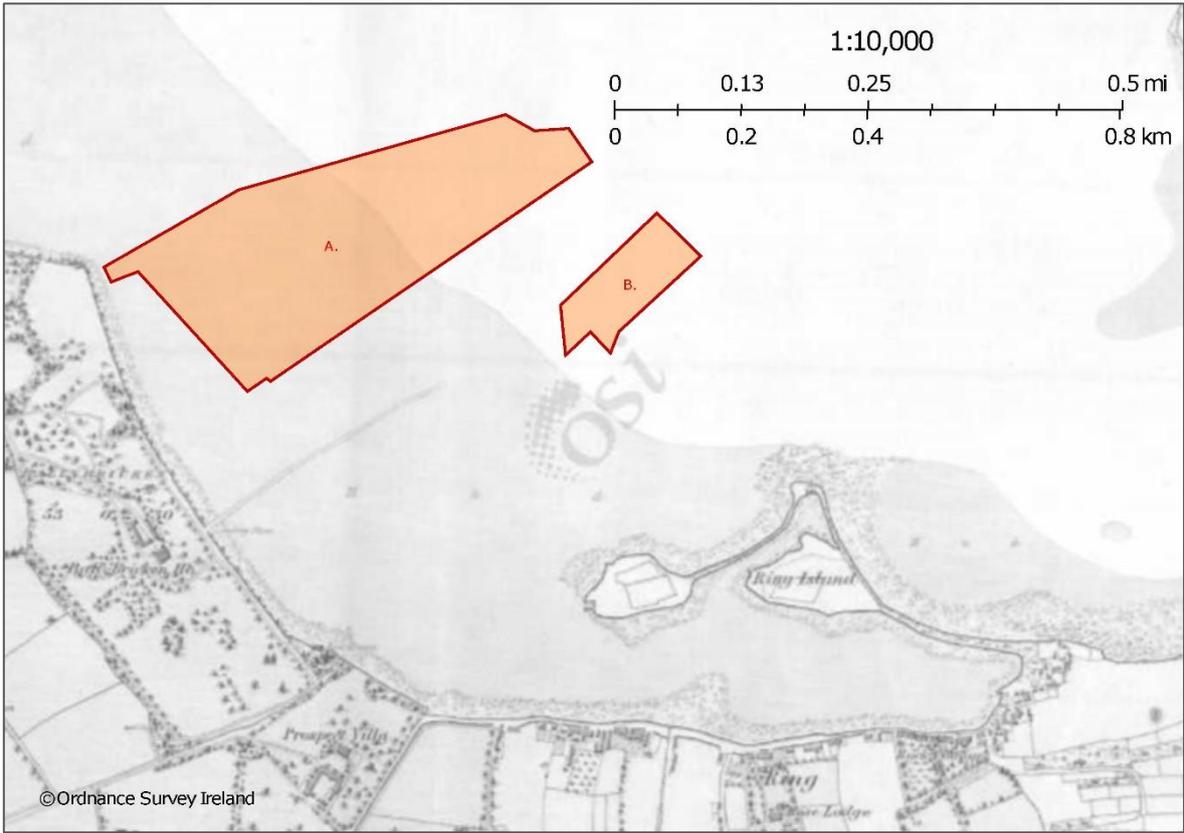
Figure 4 Extract from OS 6-inch map (1841-2), showing the proposed dredge locations.

The OS 6-inch map (1841-2) (Figure 4) shows a landing place extending out from the foreshore adjacent to Ballybricken House. This landing place extends almost to the southwestern limit of the proposed southeast dredge pocket. The footprint of the proposed northwest dredge pocket does not contain any features. Much of the reclaimed land that now makes up Ringaskiddy Port was not yet in existence, and 'Ring Island' is clearly shown to the southeast, with causeways connecting it to the mainland.

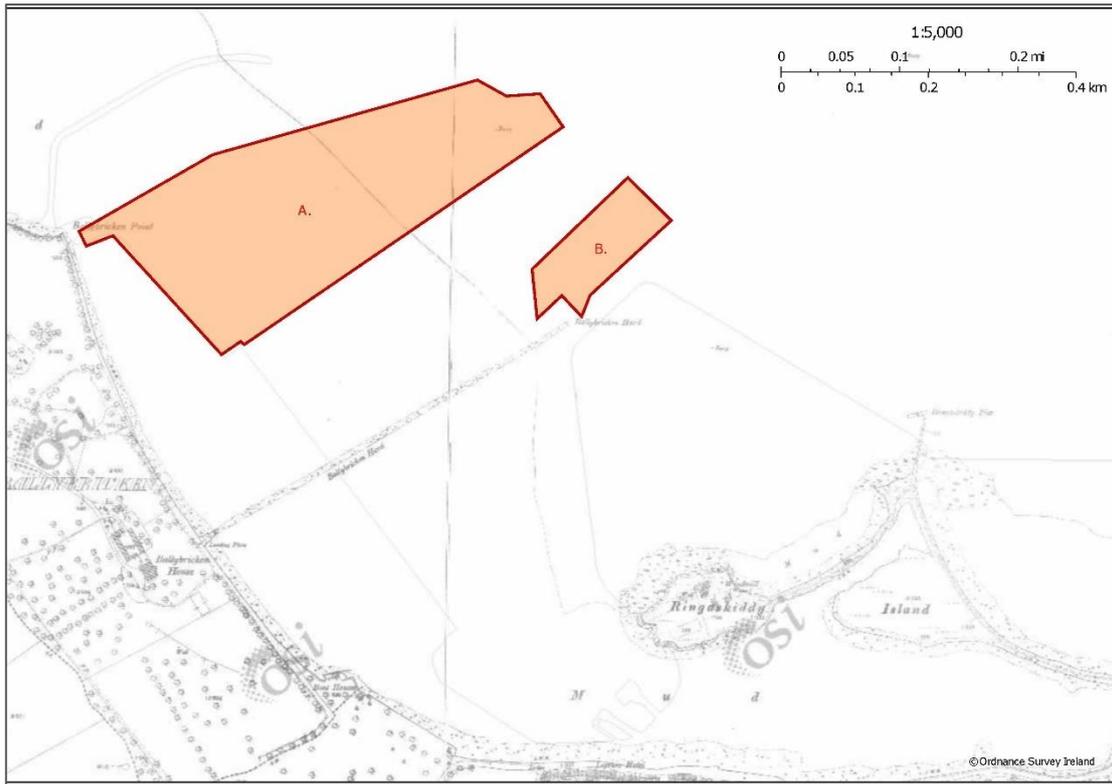
Figure 5 Extract from the 25-inch OS map (1928-9), showing the proposed dredge locations.

The OS 25-inch map (1928-9) (Figure 5) also shows the landing place, though it appears to extend out further, reaching all the way to the proposed southeast dredge pocket, and it is annotated 'Ballybricken Hard'. An arm is shown jutting out from Ballybricken Point, close to the proposed northwest dredge pocket, though this arcs to the northwest, outside of the proposed works area. The only feature shown within the proposed northwest dredge pocket is a buoy, near the southeast corner. 'Ringaskiddy Island' is also shown, with a windmill visible on the western portion of it.

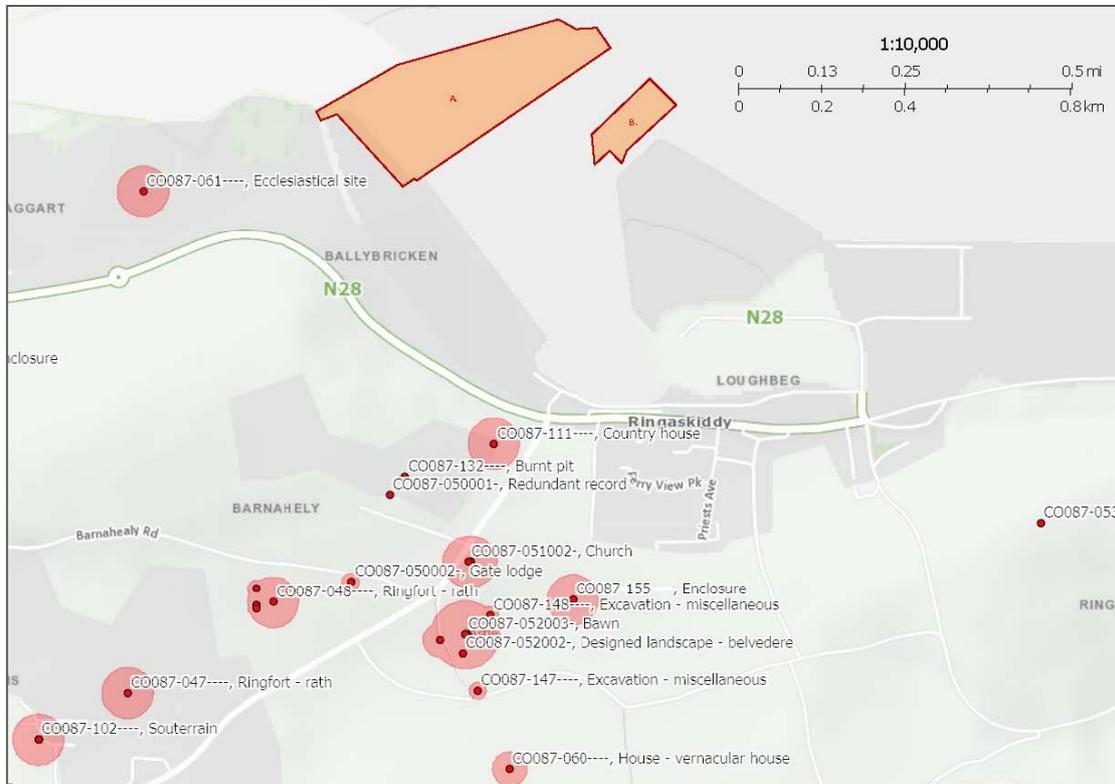
Figure 6 Locations of RMPs and SMRs surrounding proposed dredge pockets.

There are no SMR/RMP listings within the proposed dredge pockets. There are six listings within a 1km radius (Appendix 9.3). The closest of these was an ecclesiastical site, located c. 550m to the west of the proposed northwest dredge pocket, which was recorded to date back to c. 1100 AD, although it now lies in an industrial complex with no surface traces recorded.

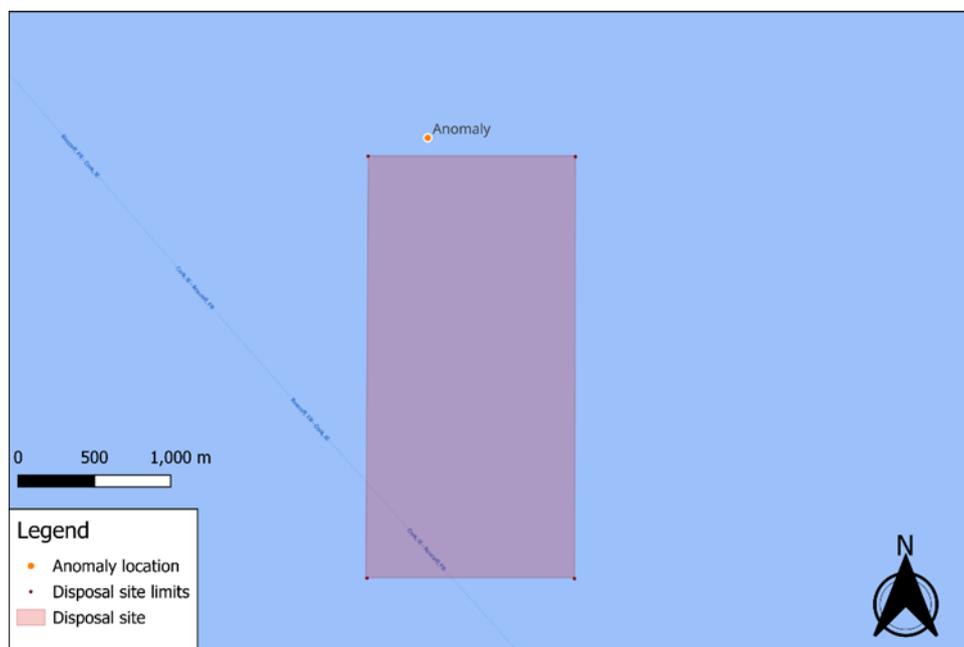
Figure 7 Location of previously identified anomaly in relation to the proposed disposal site.

A previously-identified anomaly is located c. 122m outside the northern edge of the disposal site (ITM E 588674m, N 554504m) (Figure 7).

At the historic dumping site, there is one anomaly (188723.5, 54463.1) with potential archaeological value located outside the northern border. Dumping material directly onto this anomaly has a high potential for significant negative impact. As such, it is recommended that an exclusion zone with a c. 250m radius be employed around the anomaly.

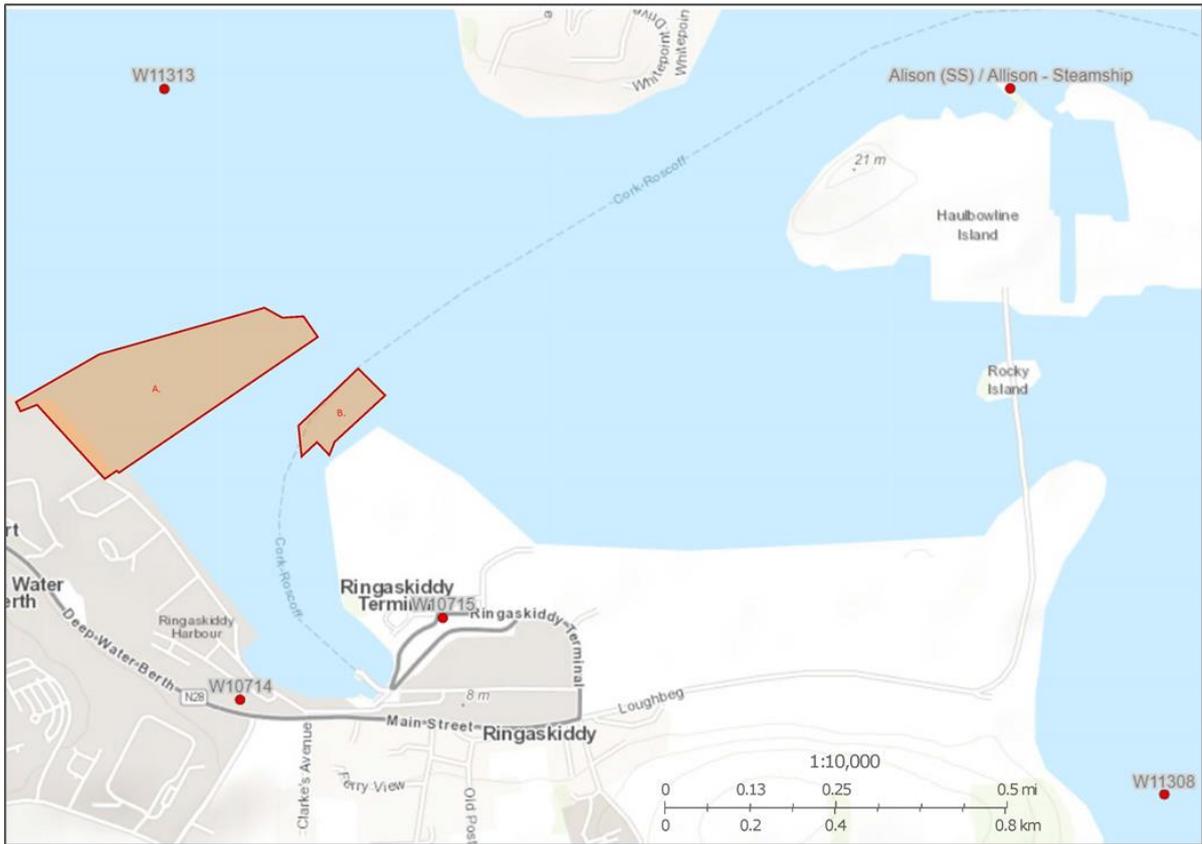
Figure 8 Recorded wreck sites (red) in the vicinity of the proposed dredge areas (orange).

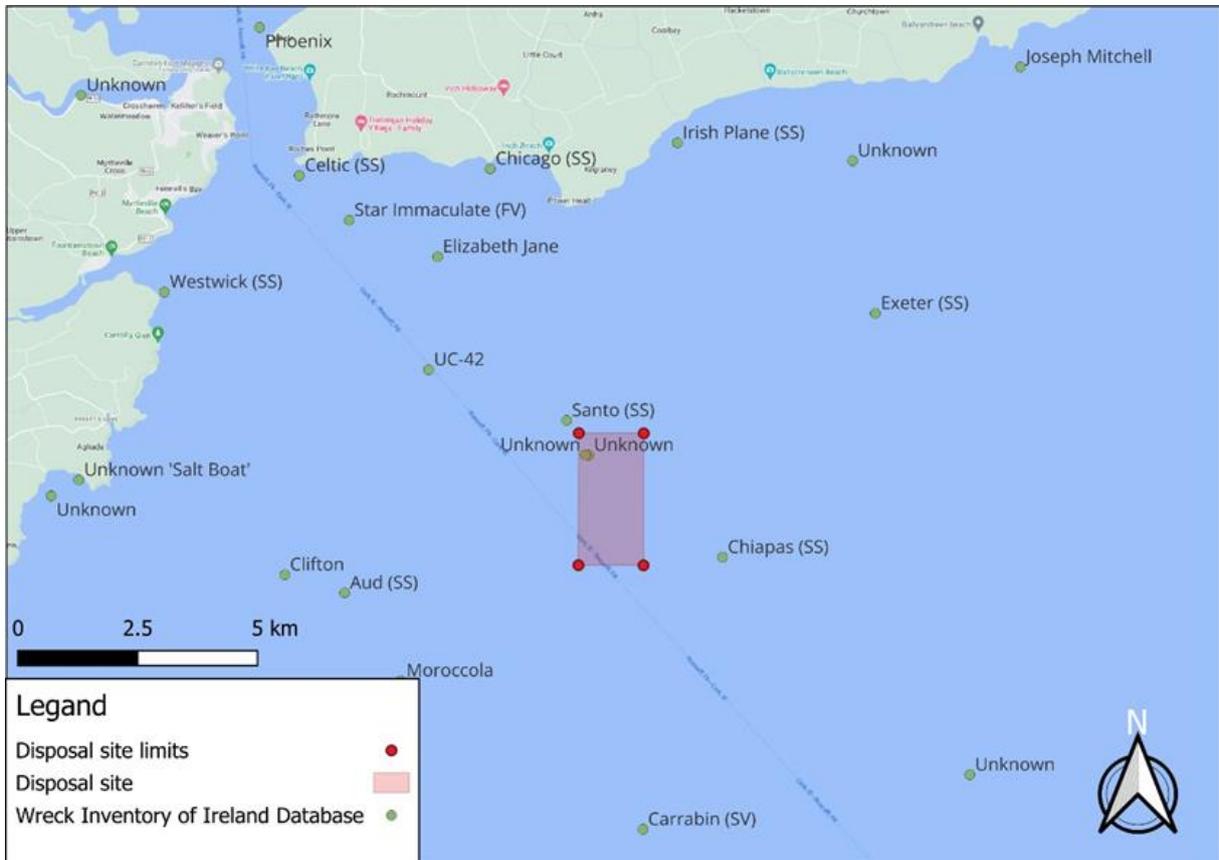
Figure 9 Recorded wreck sites (green) within and surrounding the disposal site (red).

Two underwater obstructions fall within the northwest limit of the proposed disposal site (Table 1; Figure 9). Admiralty charts noted an 'obstruction' in the area, which was confirmed by the UK Hydrographic Office (UKHO) survey, and it appears that these two separate records refer to the same anomaly. The UKHO records it as an anomaly, measuring 35m long x 20m wide and rising 1.6m from the seabed. The record also states that it is a probable natural feature (Port of Cork 2015, Section 6.6.3). Multiple geophysical surveys have been carried out at the disposal site (Irish Hydrodata, 1999; INFOMAR 2008; and Irish Hydrodata 2013), which confirm the obstruction as a natural feature, possibly a high-relief exposure of bedrock.

In addition, the Santo (SS) is located c. 350m northwest of the disposal site. The Santo (SS) was a 205-ton steel steam dredger from Glasgow, which encountered bad gales and foundered on the 26th December 1900. Of the 17 crew onboard, 12 were lost, and the dredger itself was a total loss (WreckViewer).
