Kerdiffstown Landfill Remediation Project

Environmental Impact Assessment Report (EIAR) Volume 4 of 4: Appendices (Part 2)

Groundwater and Surface Water Monitoring Report - Quarter 1 2017

32EW5604-8-GWSWQ1 | RevB

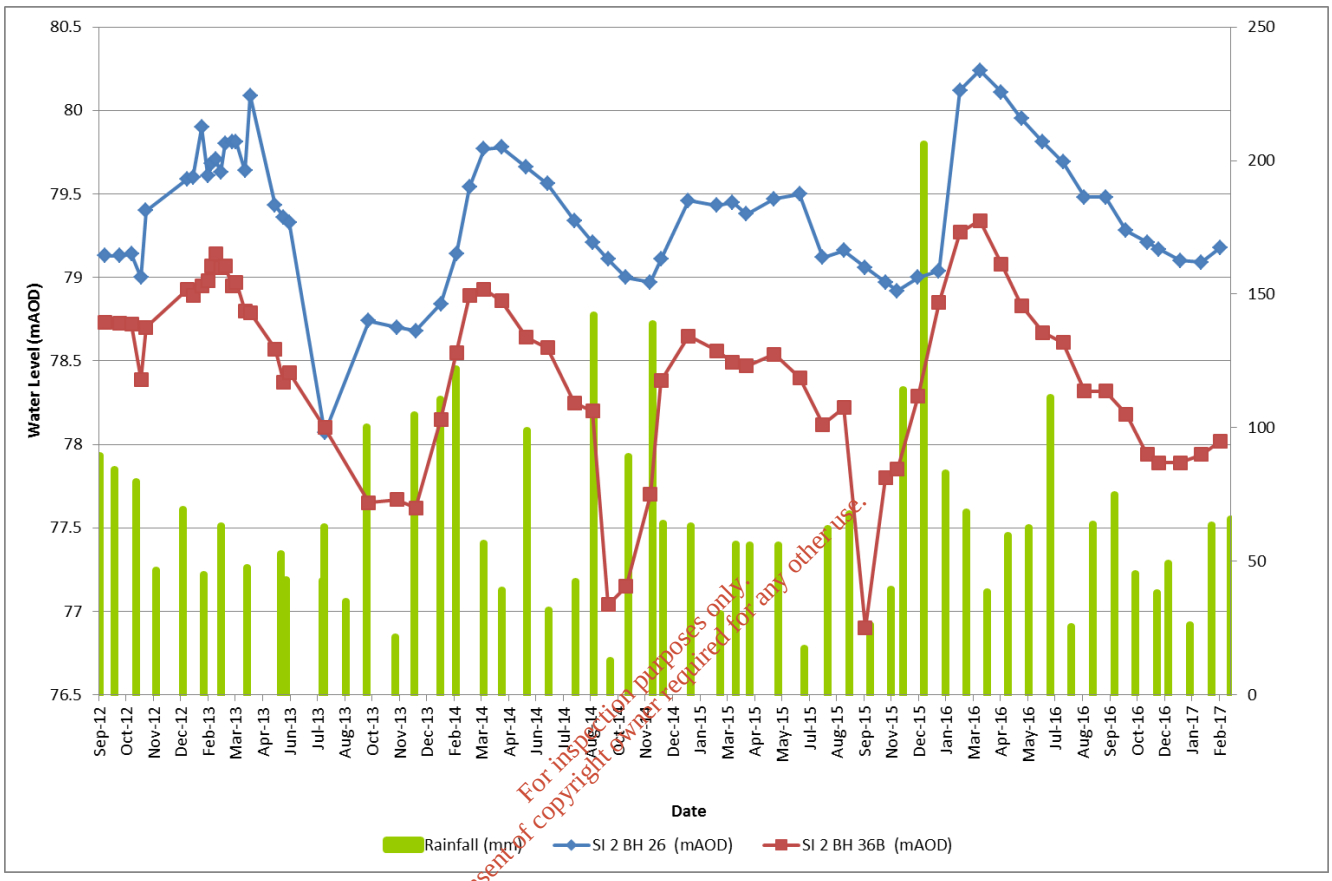
Graph 2.3: Variations in Water Levels in BH26 and BH36B (showing rainfall)

Graph 2.3 shows the groundwater levels recorded in BH26 and BH36B, situated in the north-eastern part of the site (Zone 1) since their installation in August 2012. It can be seen that the groundwater levels began to recover in both wells during the quarter, having been continually reducing since the highest levels recorded in March 2016. The above average rainfall from November 2015 to February 2016 (including almost three times the average in December 2015) is likely to have caused those high groundwater levels. The below average rainfall

for the second half of 2016 caused the downward trend in levels since March 2016. The increase in rainfall during February and March 2017 have caused the groundwater levels at these wells to begin increasing again.

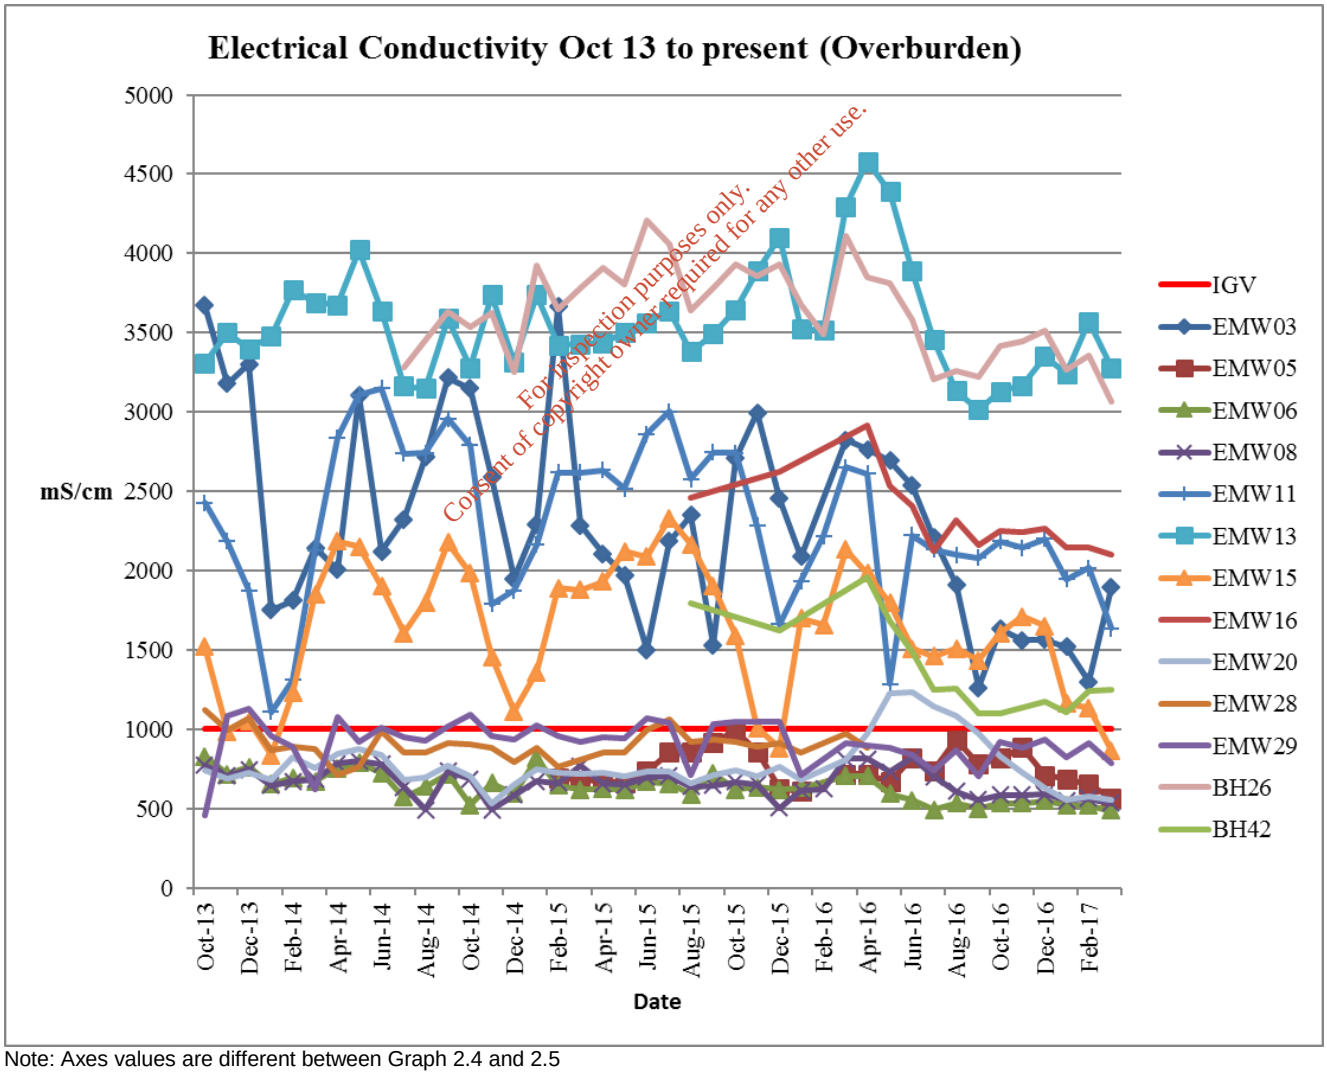
Graph 2.4: Overburden Electrical Conductivity Variations (Oct 2013 to present)

As previously, BH26 recorded the highest EC value at 3,268 µS/cm in January 2017, which is a decrease on December 2016. However, in February 2017, EMW13 recorded the highest EC of all of the wells sampled at 3570 µS/cm, while new well DB02 had the highest EC value in March 2017 at 3448 µS/cm (DB02 was only sampled in March 2017 in Quarter 1 2017). All three of these wells are to the north, with BH26 and EMW13 being in Zone 1 of the site and DB02 being just to the north of Zone 1.

Some of the north-eastern boundary well readings were above the IGV in some instances. The highest of these was recorded in new northern boundary monitoring well DB02 (3448 µS/cm in March 2017). This monitoring well is very close to the northern boundary of the landfill and the result is consistent with readings from nearby on-site well EMW13.

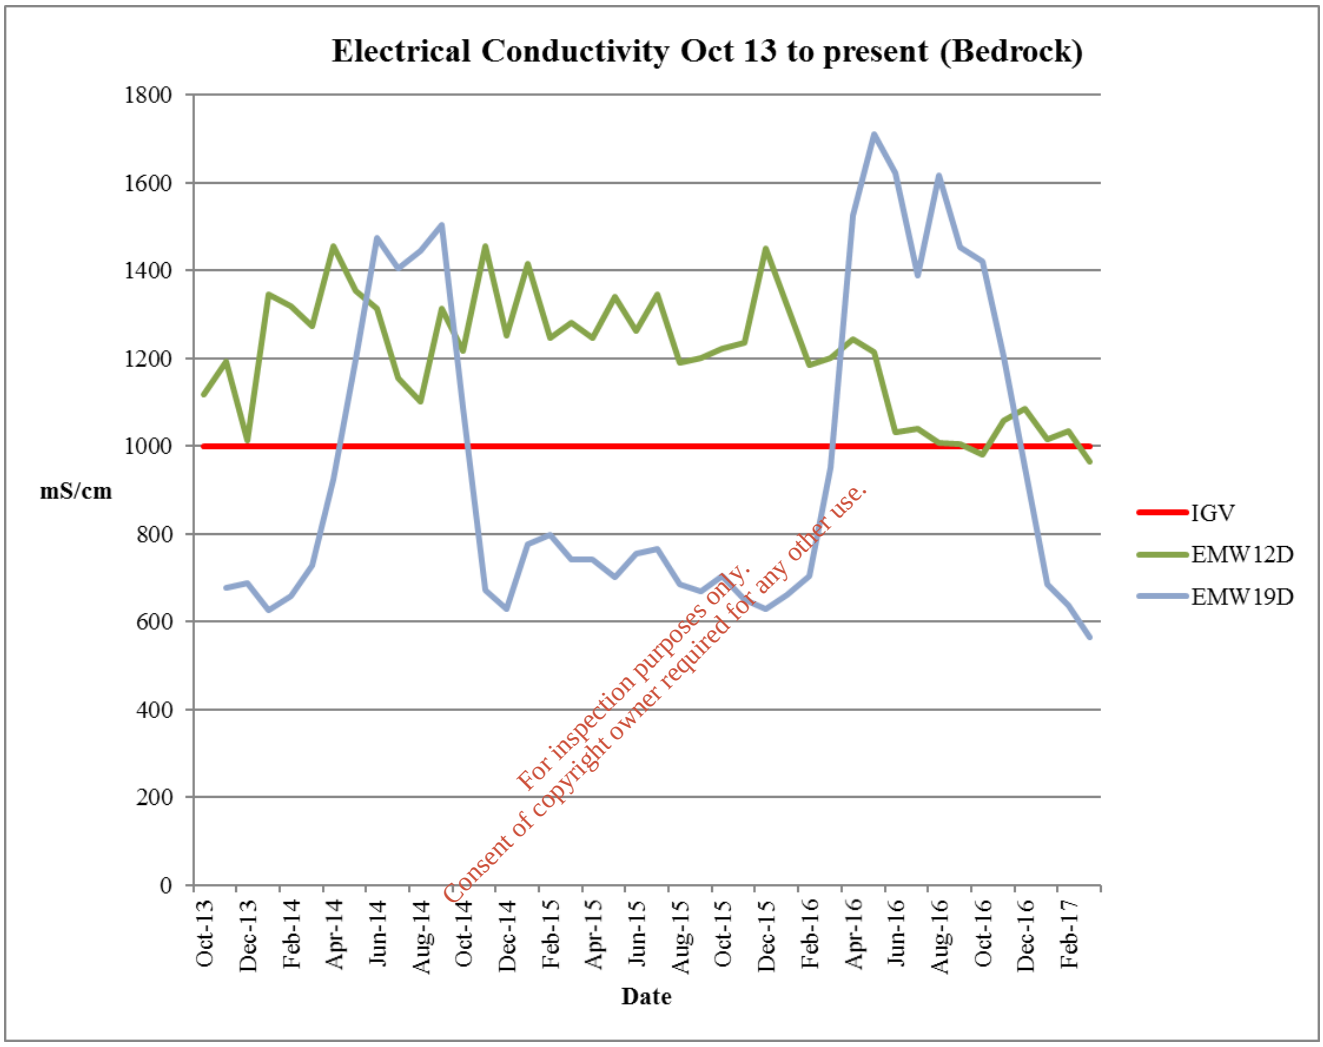
Graph 2.5: Bedrock Electrical Conductivity Variations (Oct 2013 to present)

Of the new wells, only BH68, located within the site, had an EC value above the IGV of 1000 µS/cm. The value was approximately 1200 µS/cm for both February and March 2017 in this well. All other new bedrock wells had EC values significantly below the IGV, ranging between 497 µS/cm and 748 µS/cm.

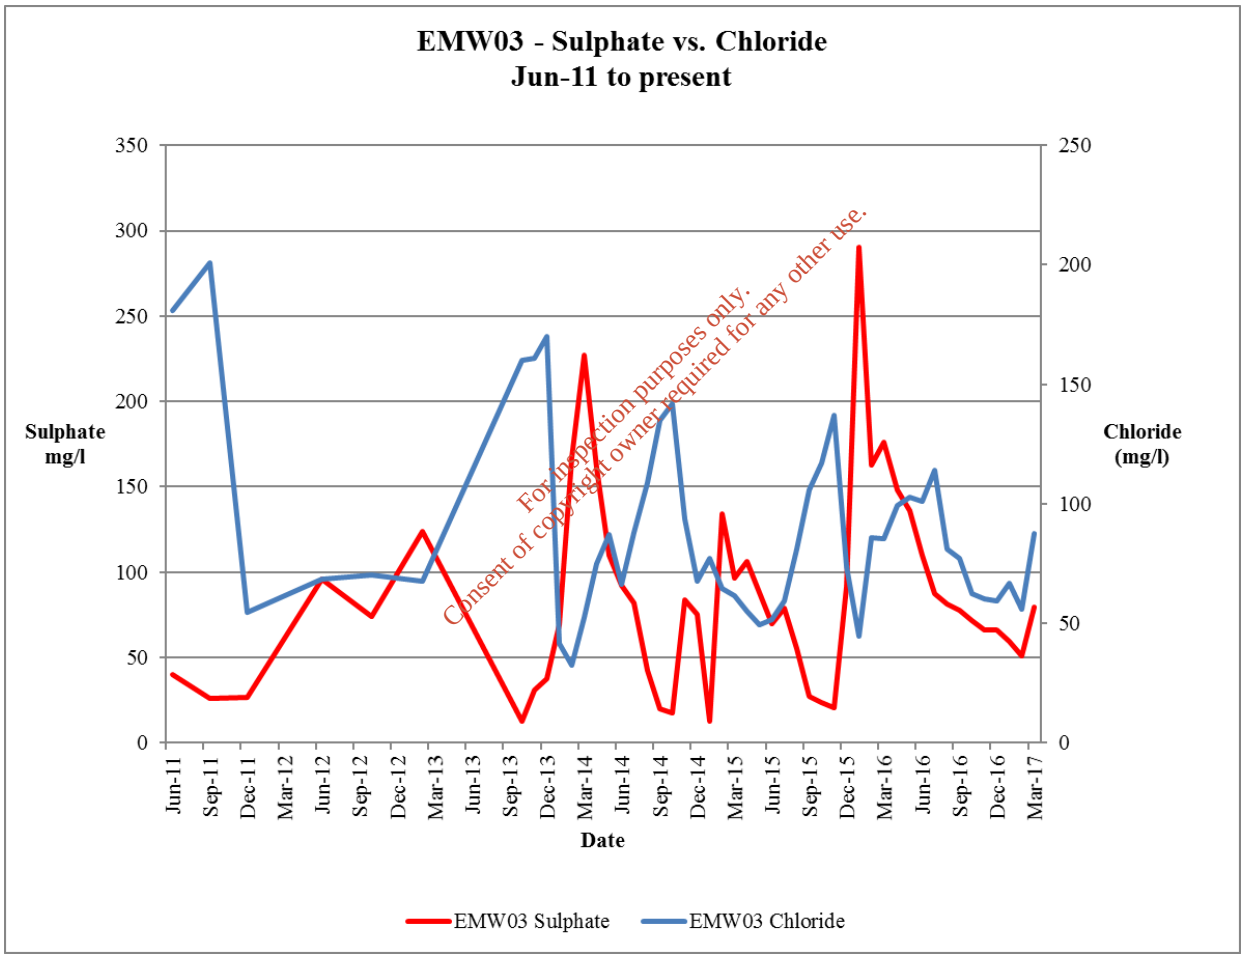
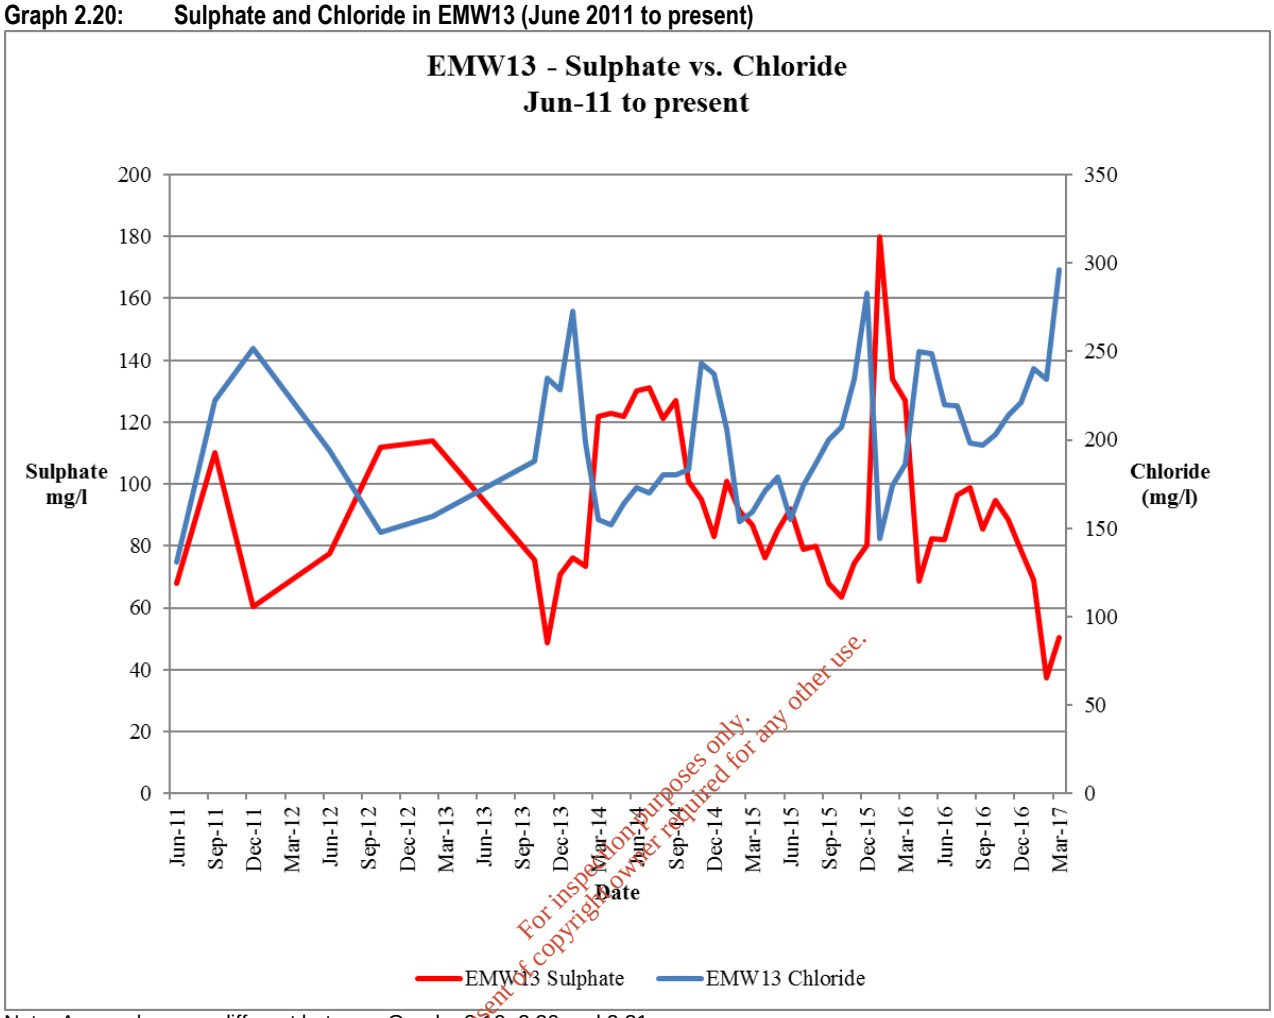
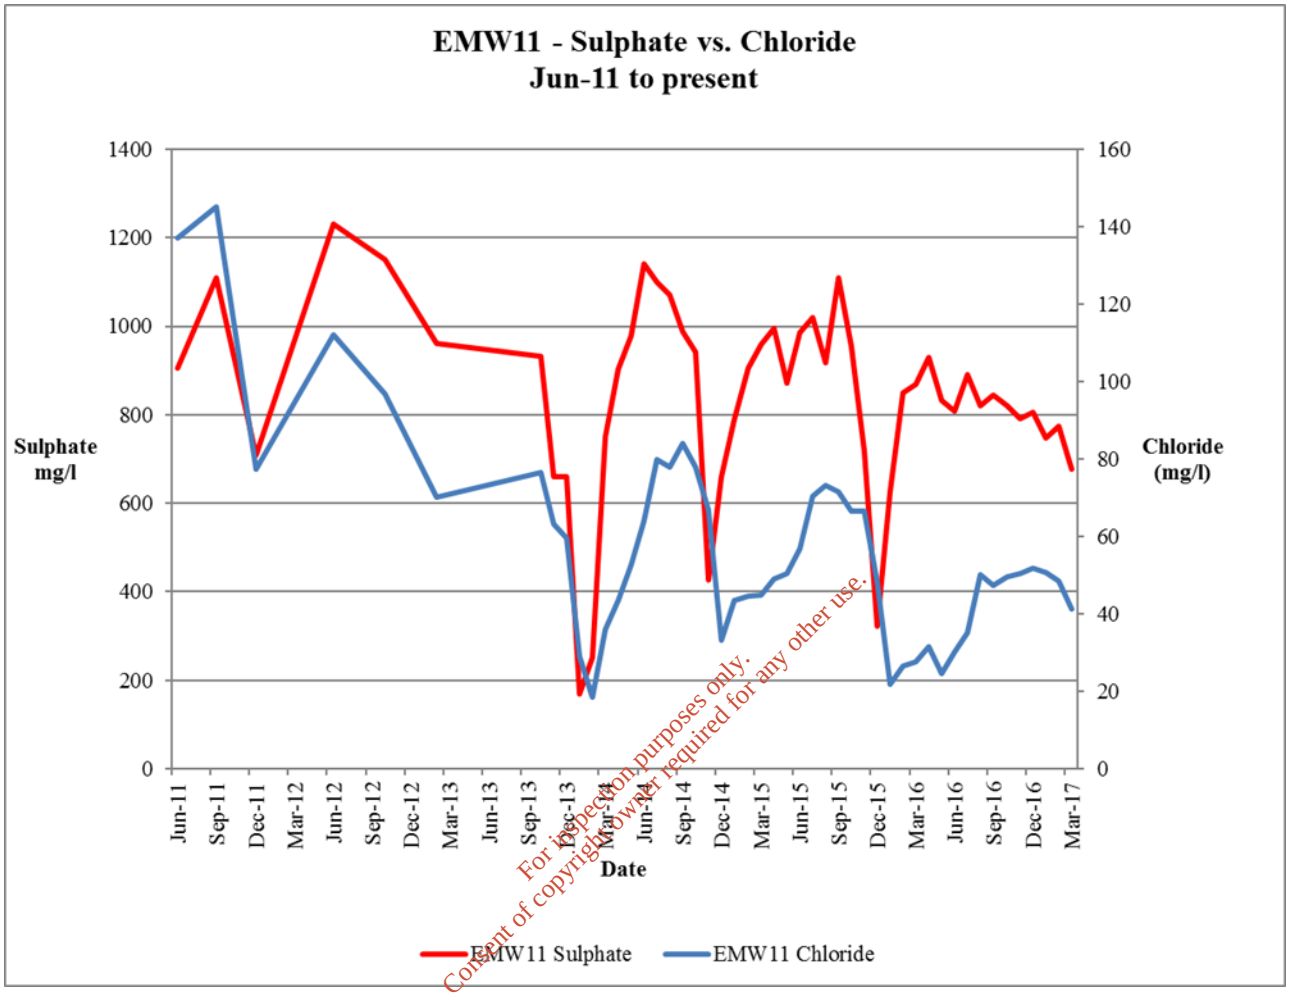
As noted above, low sulphate concentrations may be indicative of landfill leachate as sulphate is reduced to sulphide. As such, an increase in parameters such as chloride and a reduction in sulphate concentrations may indicate the presence of landfill leachate and comparing the two determinands may show impacts from leachate. In EMW03 and EMW13, there has been an observed seasonal change when concentrations of sulphate are compared to chloride as can be seen in Graphs 2.19 and 2.20.
