Cavan County Council

Annual Environmental Report 2015

Bailieborough Landfill WL0091-1

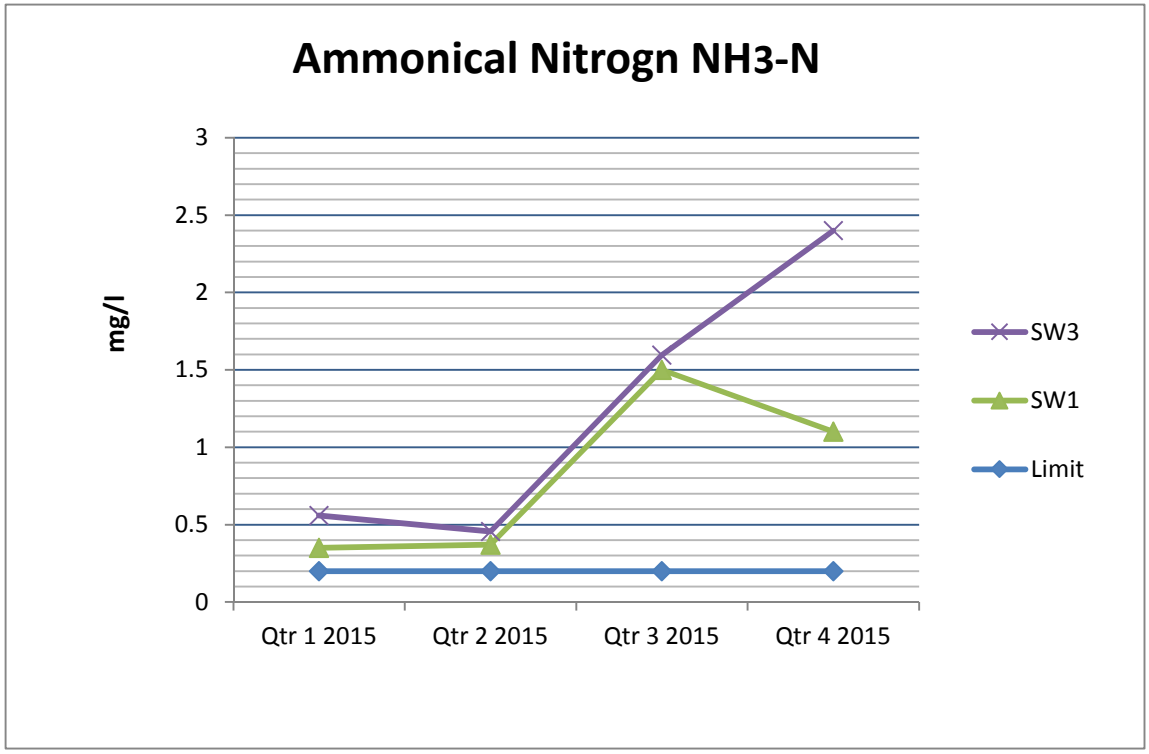
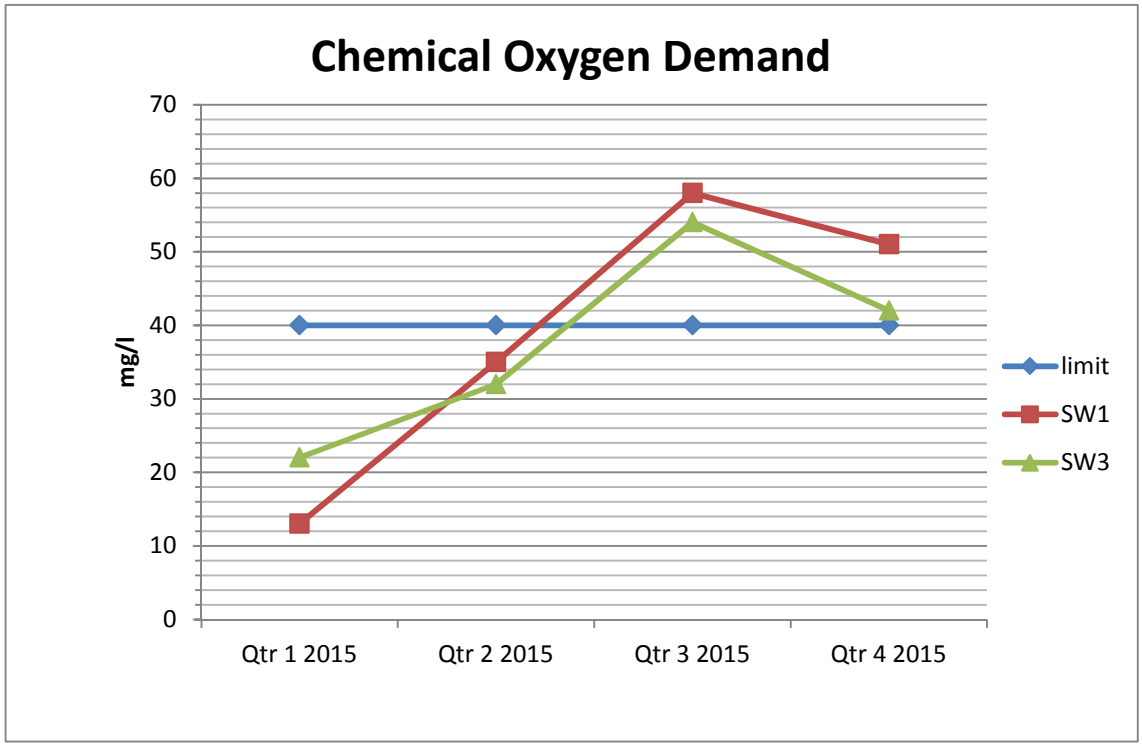
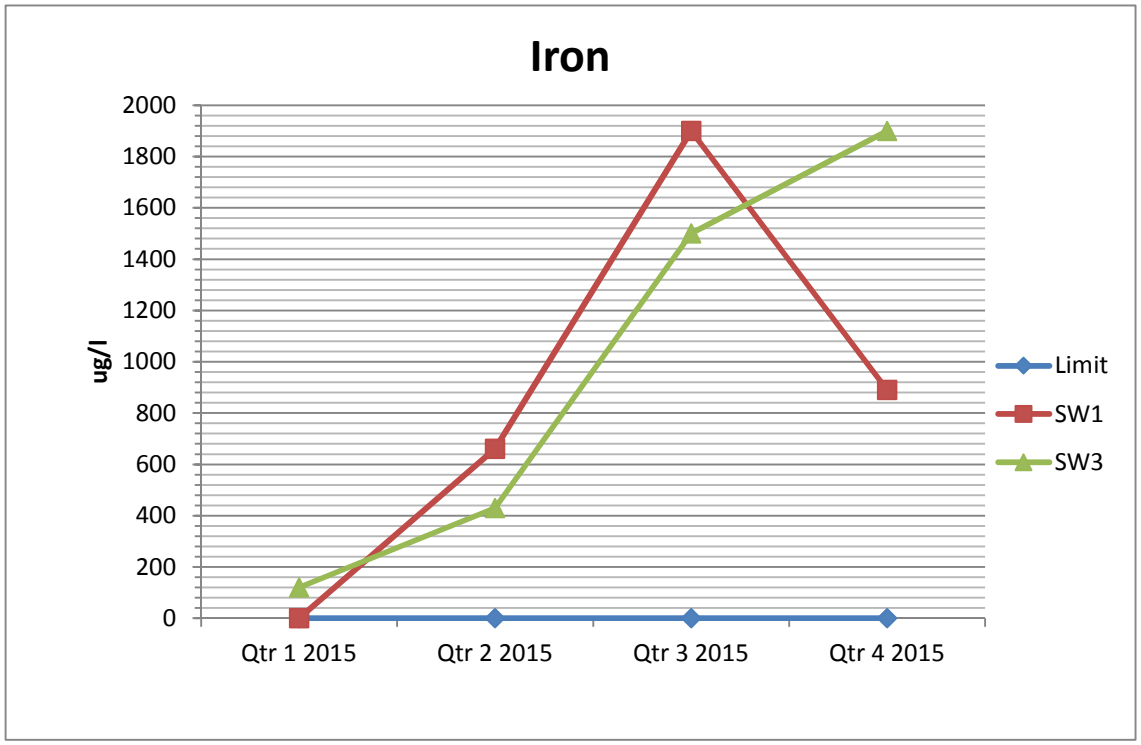
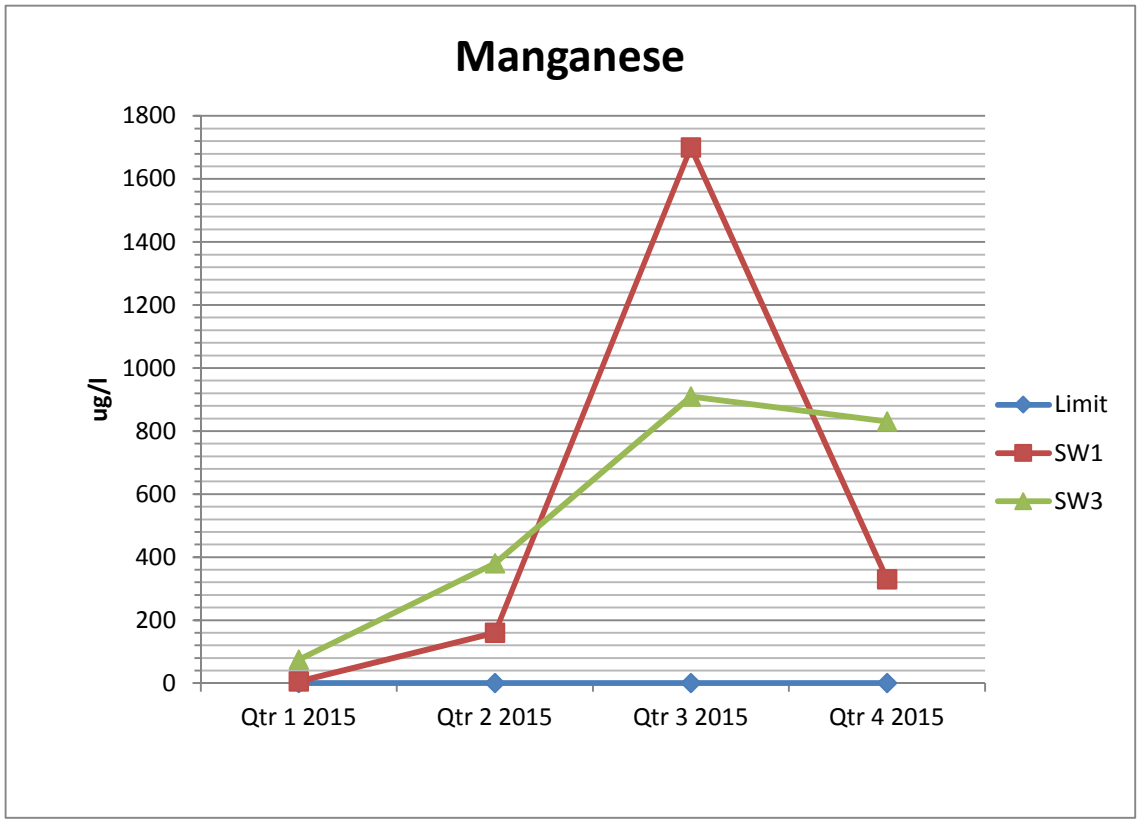
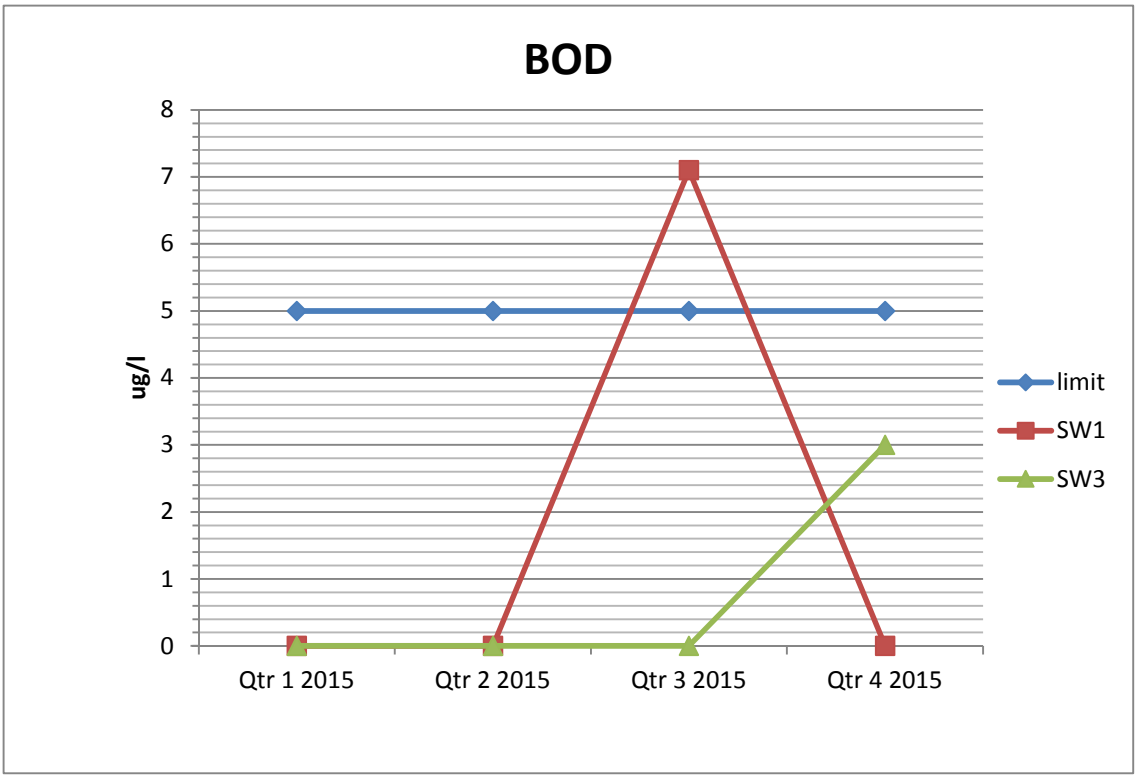
As table 5.1 reveals, there were elevated levels of Ammonia, COD, Iron and Manganese levels recorded in the samples taken at the SW1 and SW3. SW1 is located downstream of the landfill while SW3 is located further downstream at the new monitoring location SW3 "Chapel Lough".

Elevated levels of Iron and Manganese can be attributed to the natural composition of the underlying geology however it is not uncommon to encounter high levels of both parameters in the vicinity of landfills. The elevated levels of Ammonia and COD encountered at SW1 and SW3 are attributed to low flows during which time the water may have become stagnant.

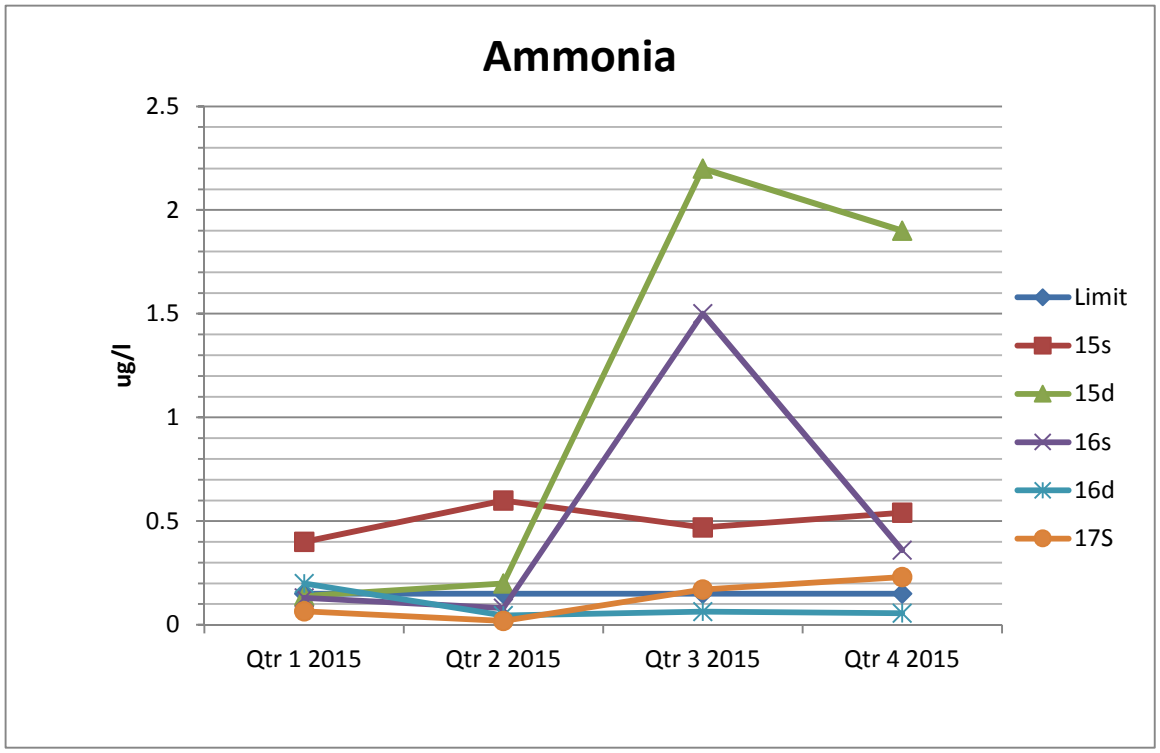
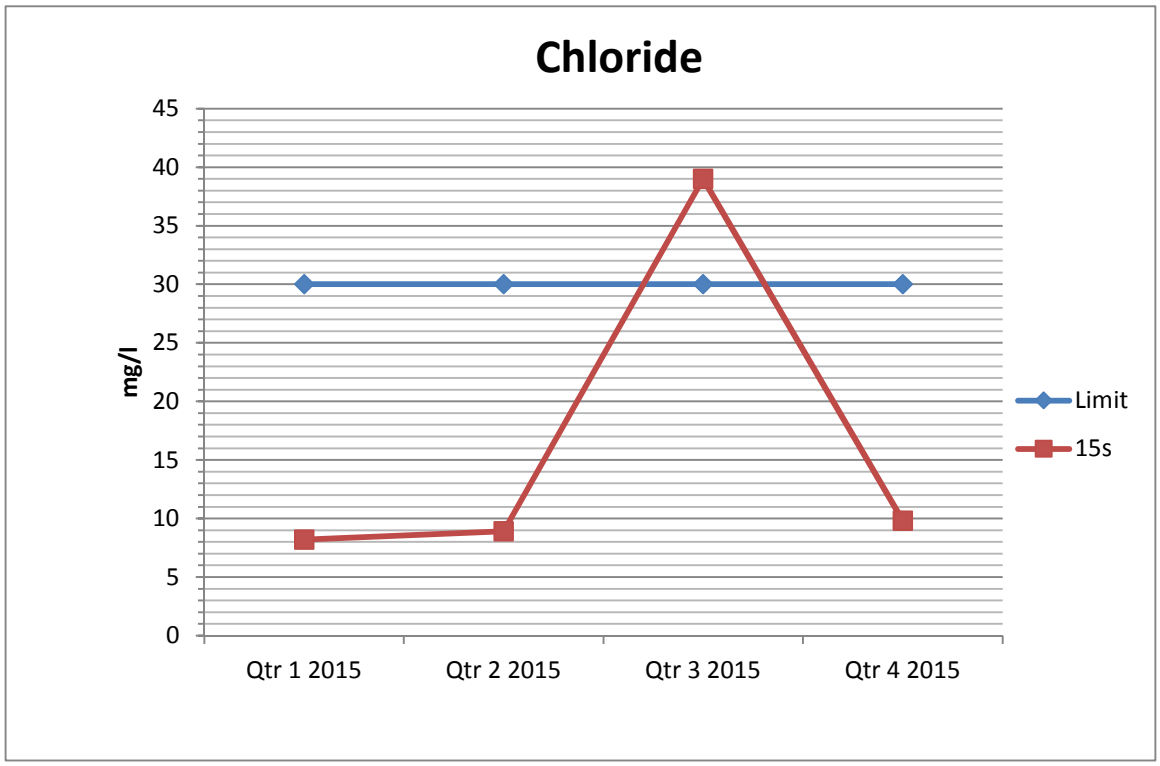
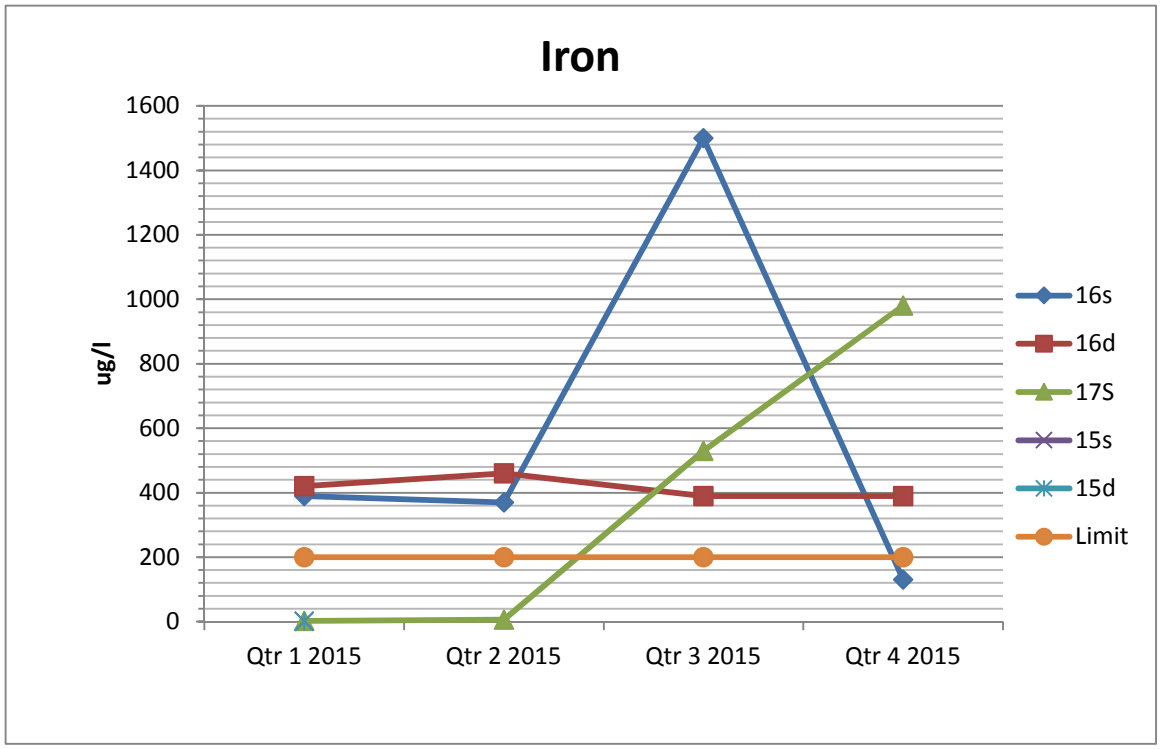
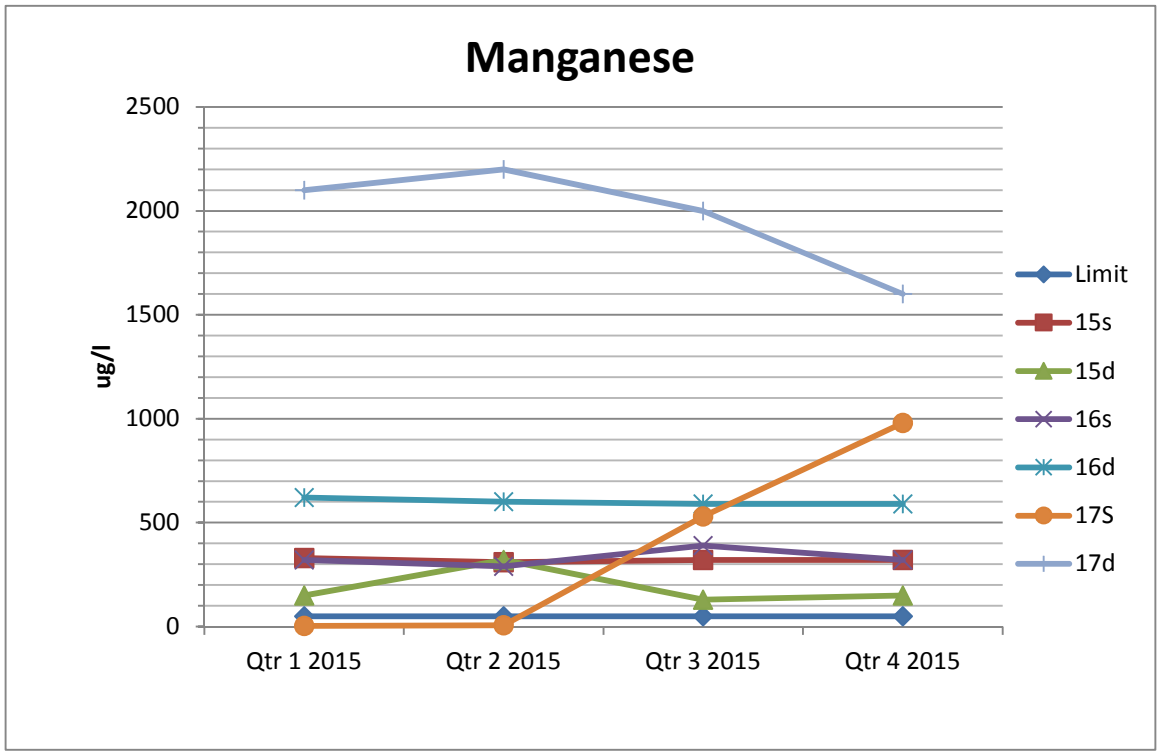
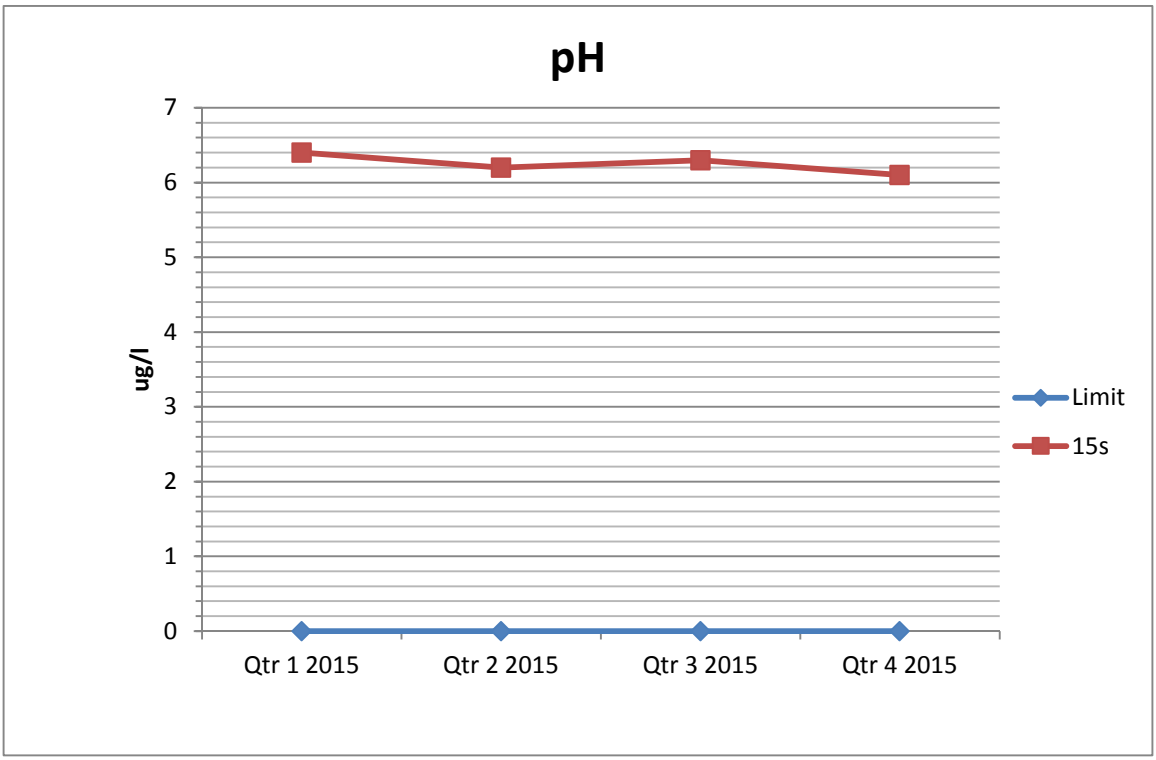
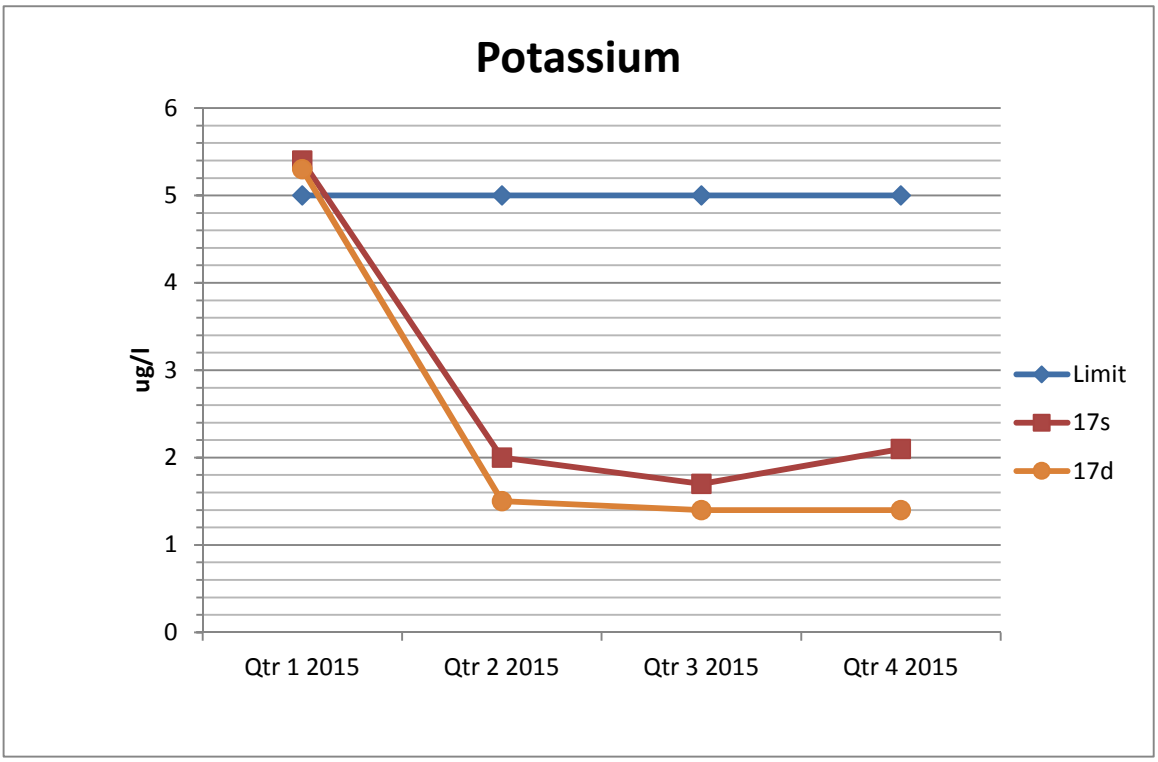
As detailed in the above graphs, there were numerous ground water elevations in the vicinity of this landfill during 2015 when results were compared to the Interim Guide Values.

As there are no emission limits for ground water specified by the waste licence, the parameters are compared to the Interim Guide Values, elevatiosn occurred in the following parameters:

- **Ammonia**: Elevated levels of this parameter were prevalent during 2015. Elevated levels of ammonia are strongly associated with pollution from waste water treatment systems as well as agricultural activates and so contamination of these wells by the landfill cannot be definitively concluded.

- **Iron**: Although increased Iron levels can be attributed to contamination from landfills, it is also strongly associated with the native soils of the Cavan area and therefore cannot be directly linked to the landfill.

- **Chloride**: This parameter is an indication of contamination from a landfill source. In 2015 there was an elevated level of this parameter encountered at well MW15S. This elevation was reported to the EPA and was attributed to contamination from an external source such as road salt. It can be seen that the level of chloride has shown a sharp decrease from its peak recording in quarter 3.

- **Manganese**: Elevated levels of Manganese can be associated with landfill contamination but in this instance they are attributed to the natural composition of the underlying soils.

- **Potassium**: There were slight exceedances recorded at wells 17s and 17d in conjunction with interim guideline values, however it must be noted, no limits are specified in the license for groundwater contamination. This parameter will be closely monitored in the next quarter.

- **pH**: Well 15s recorded an exceedance during monitoring in 2015. This reading was minimal and cannot be linked to the landfill.

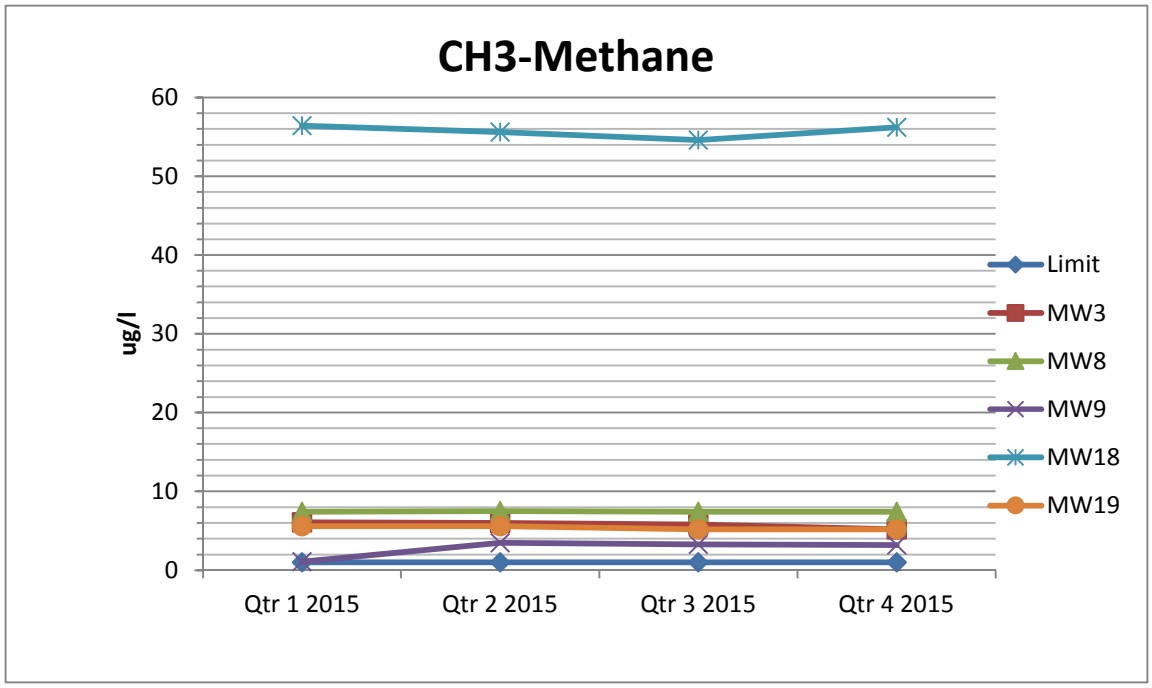
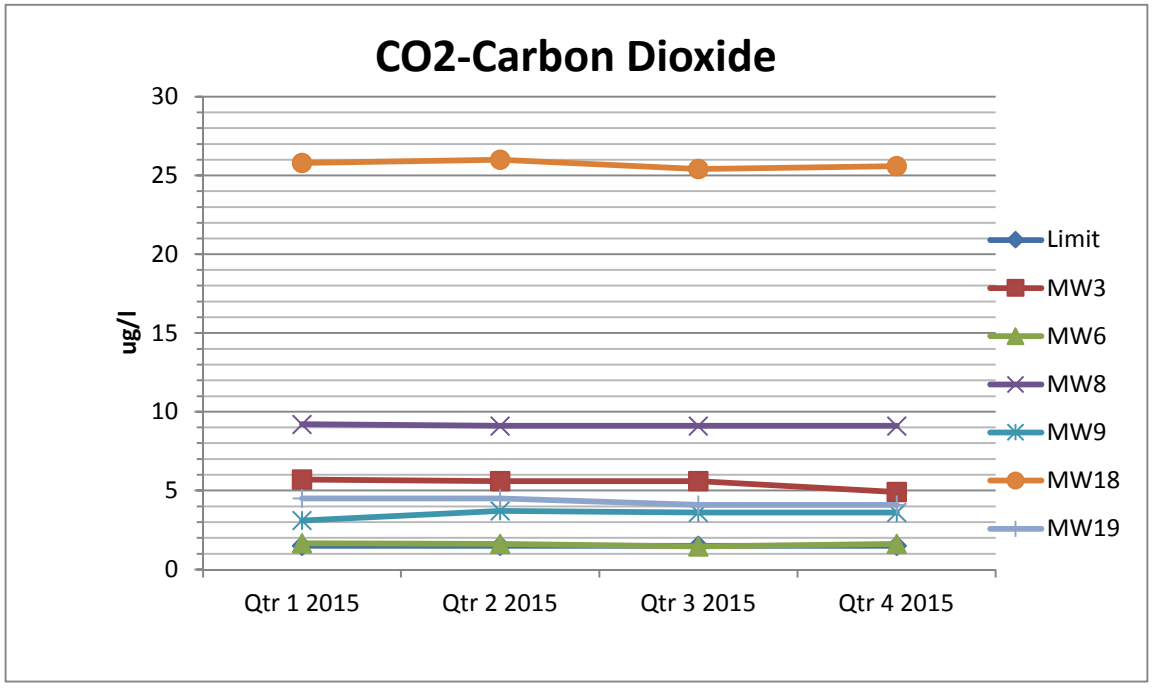
Gas Monitoring on the site reveals typical low levels of Methane & Carbon Dioxide and higher levels of Oxygen. There were some high readings encountered at MW8 and MW18 and which are all located in the centre of the waste body. There was no significant gas migration recorded in monitoring wells outside of the waste body. The results are typical of a closed landfill.
