Cavan County Council

Annual Environmental Report

2015

Ballyjamesduff Landfill WL0093-1

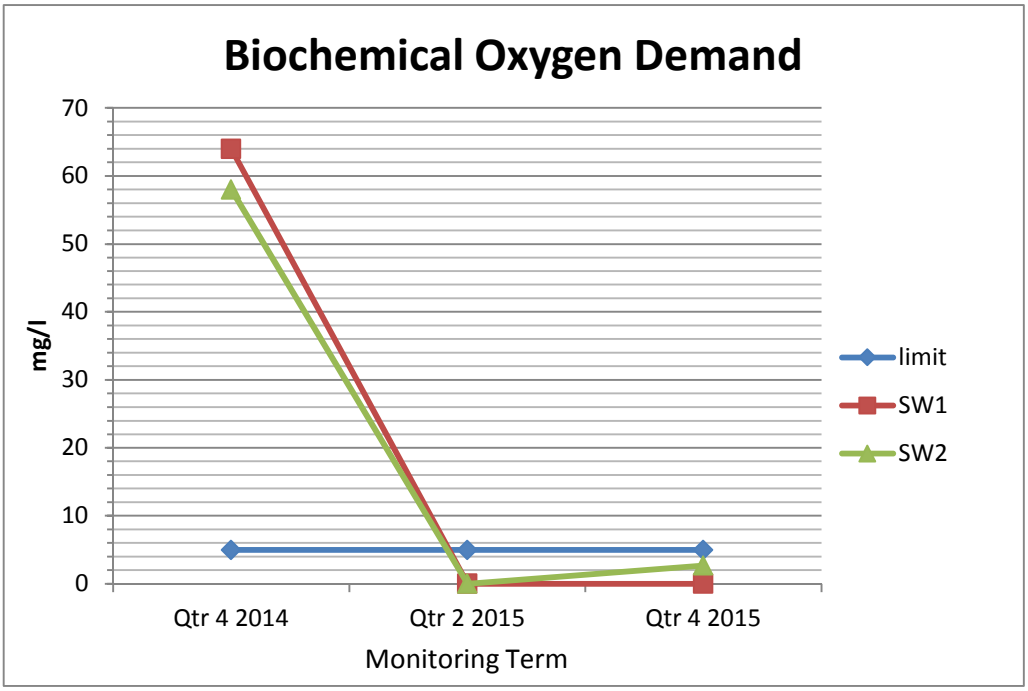
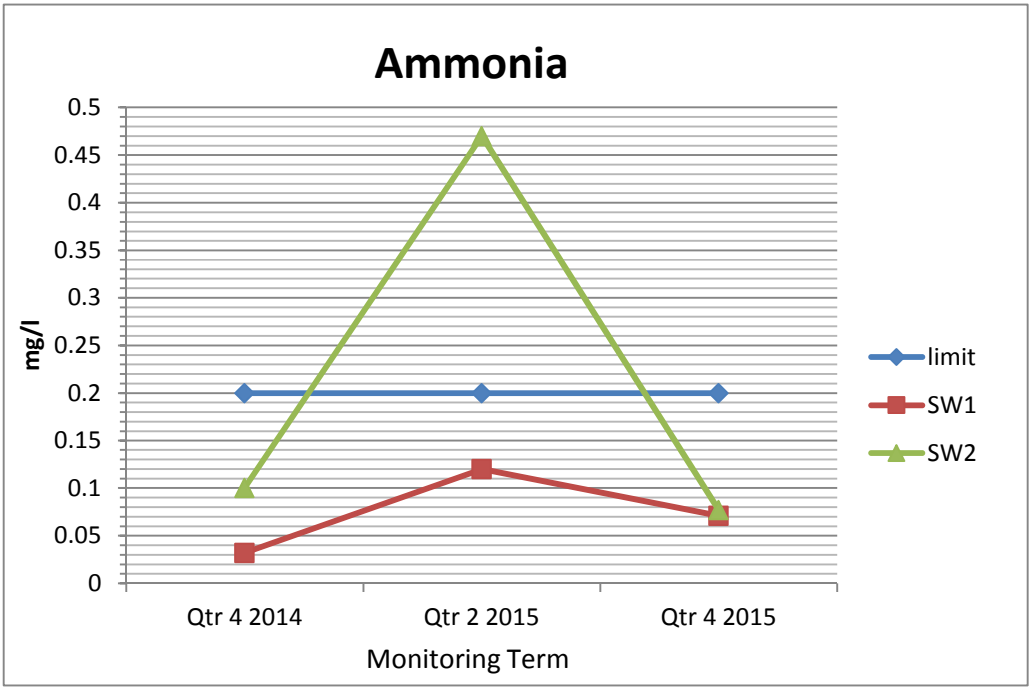
Graph 5.1

All surface water locations were found to be within limits specified in the above regulations with the exception of BOD and Ammonia. Elevations from these parameters cannot be definitively associated to the landfill due to the presence of increased decaying organic matter in the form of decaying vegetation due to the winter season.

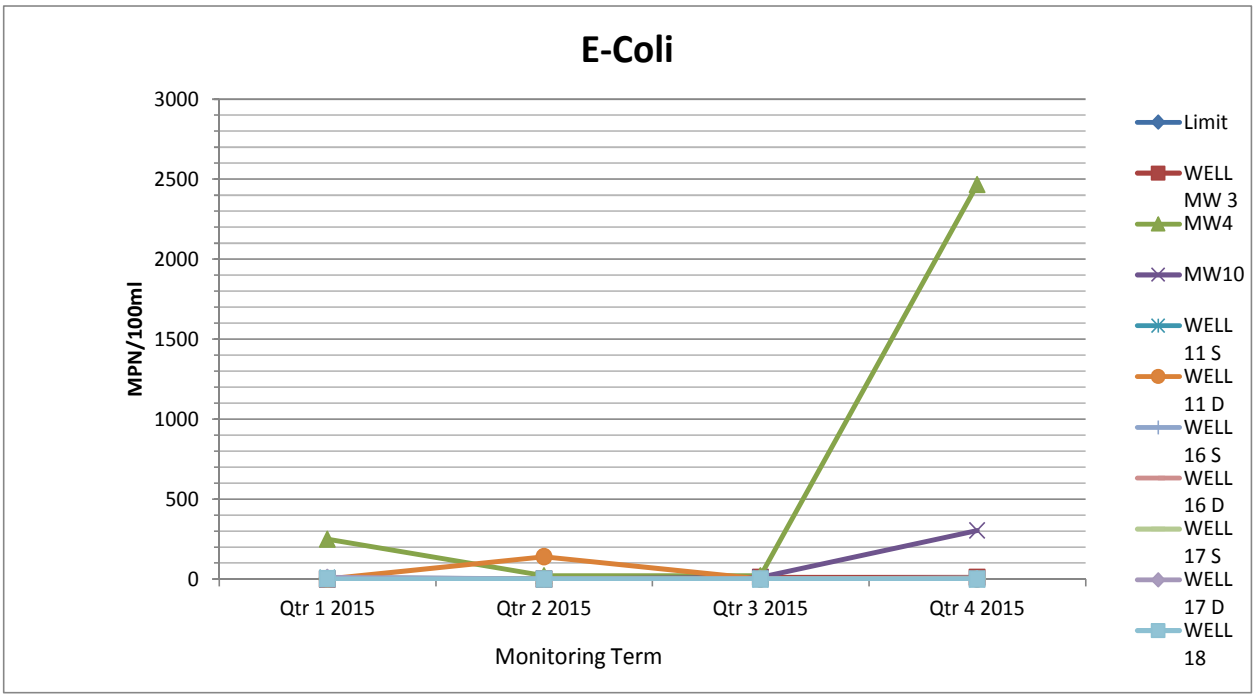
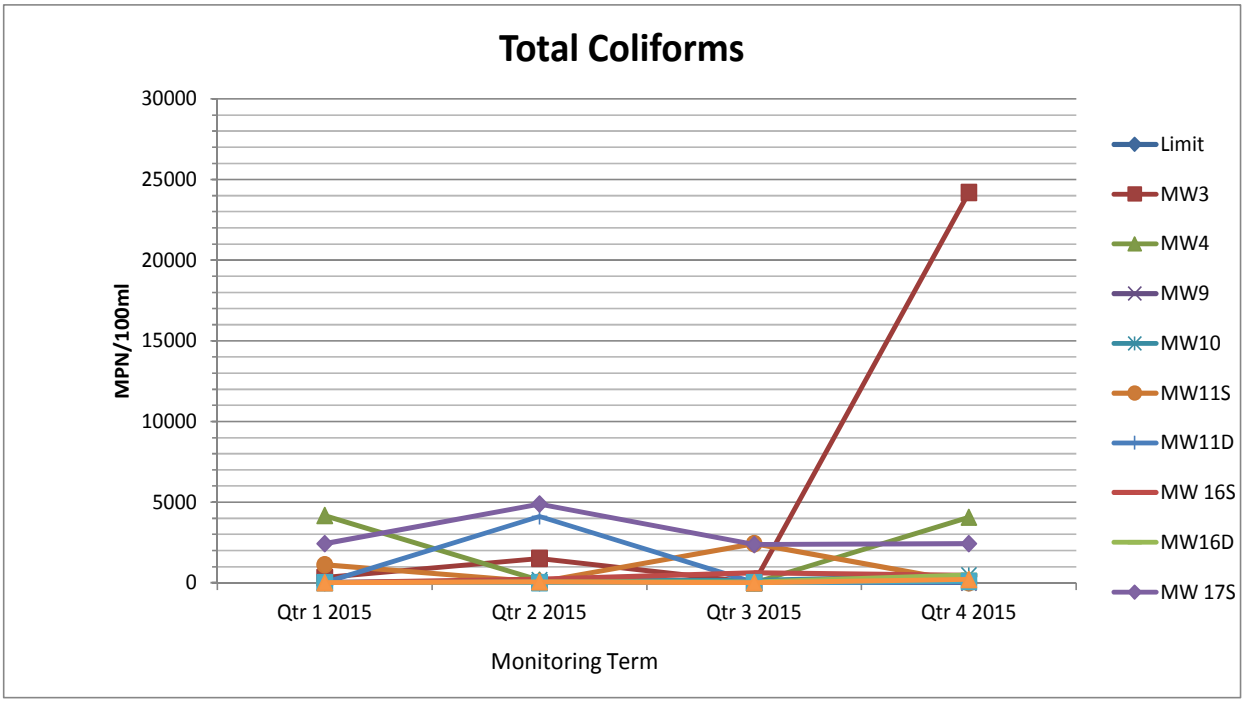
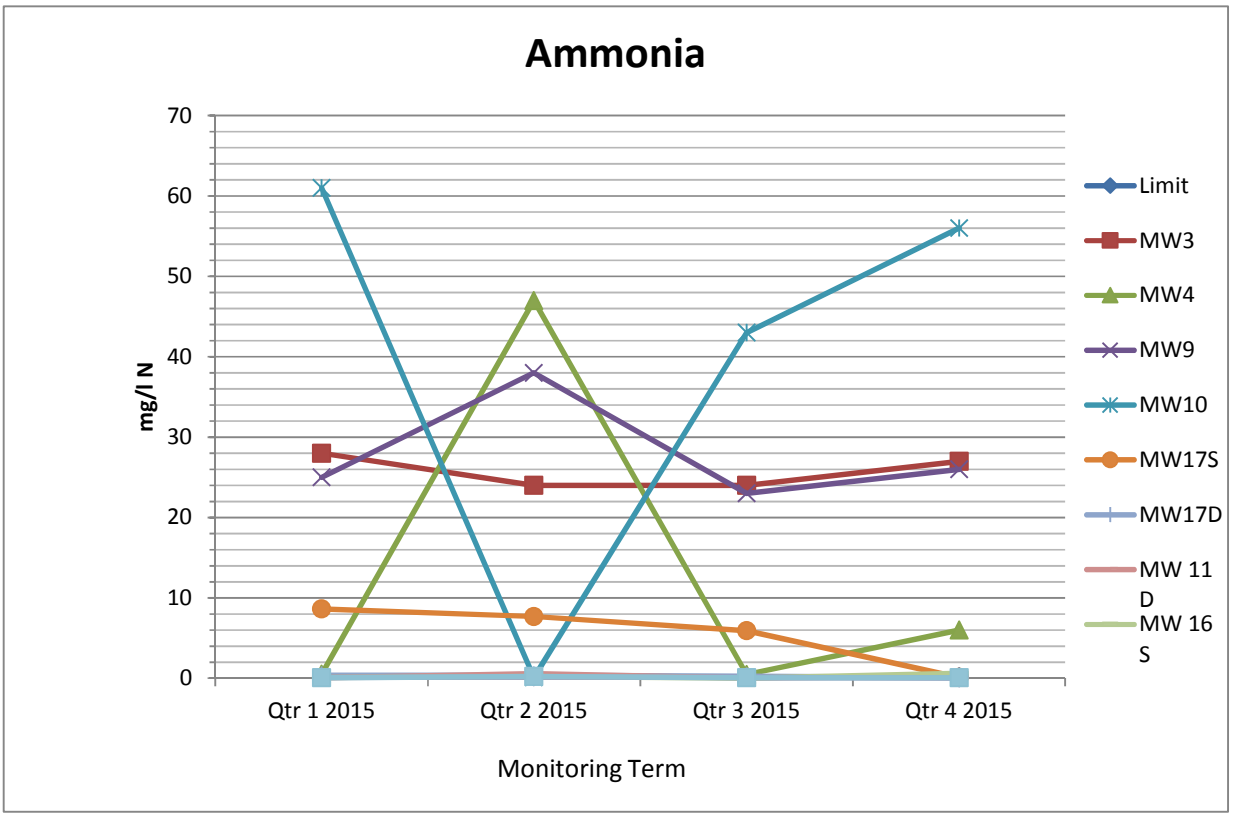
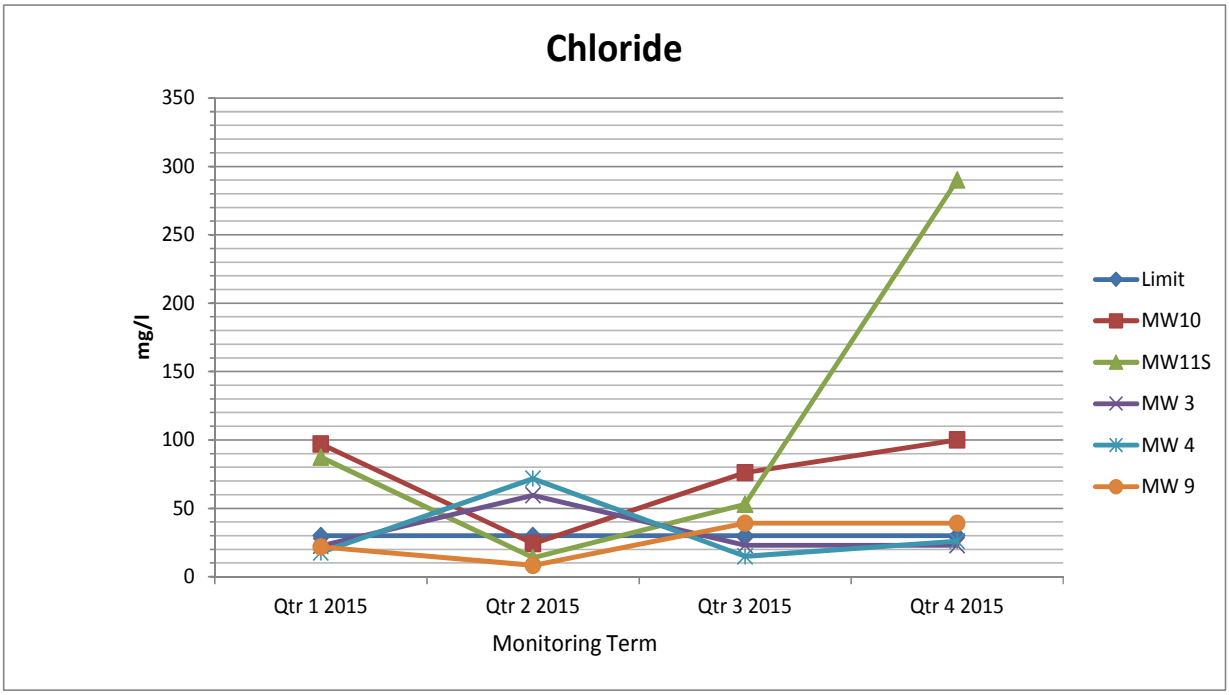
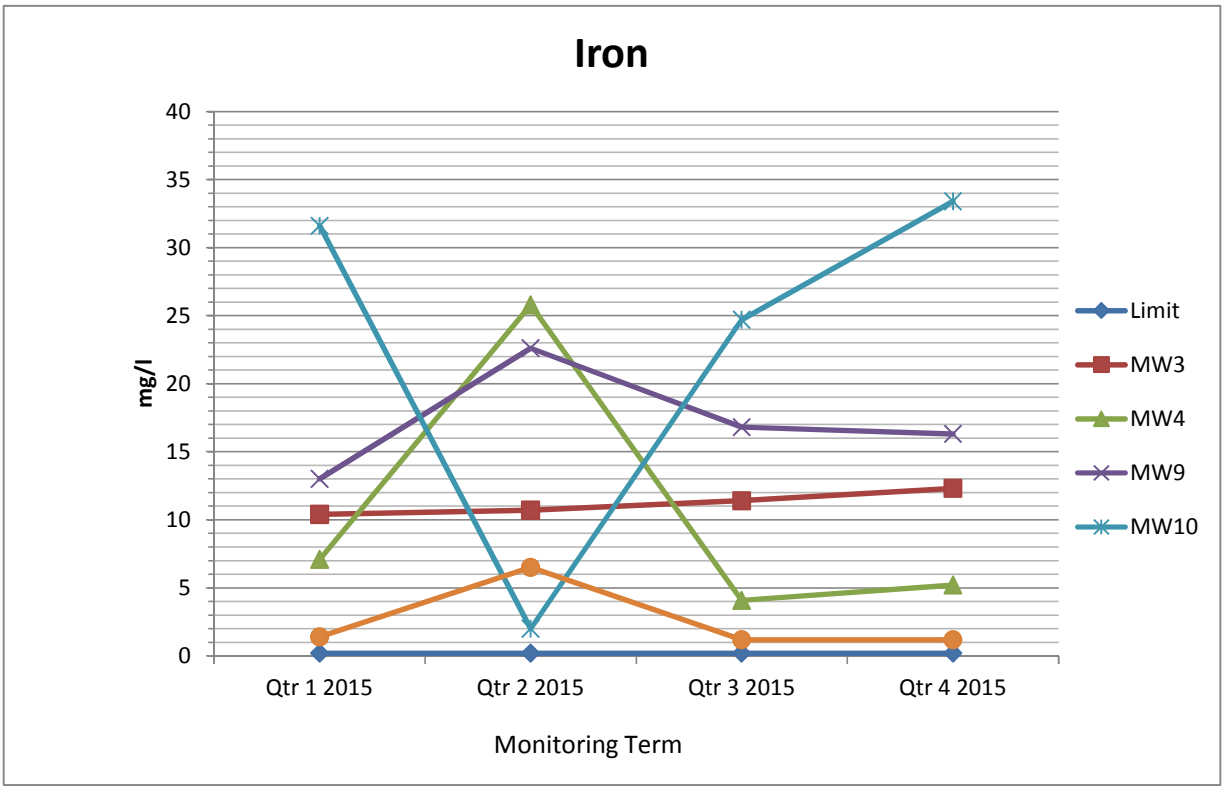
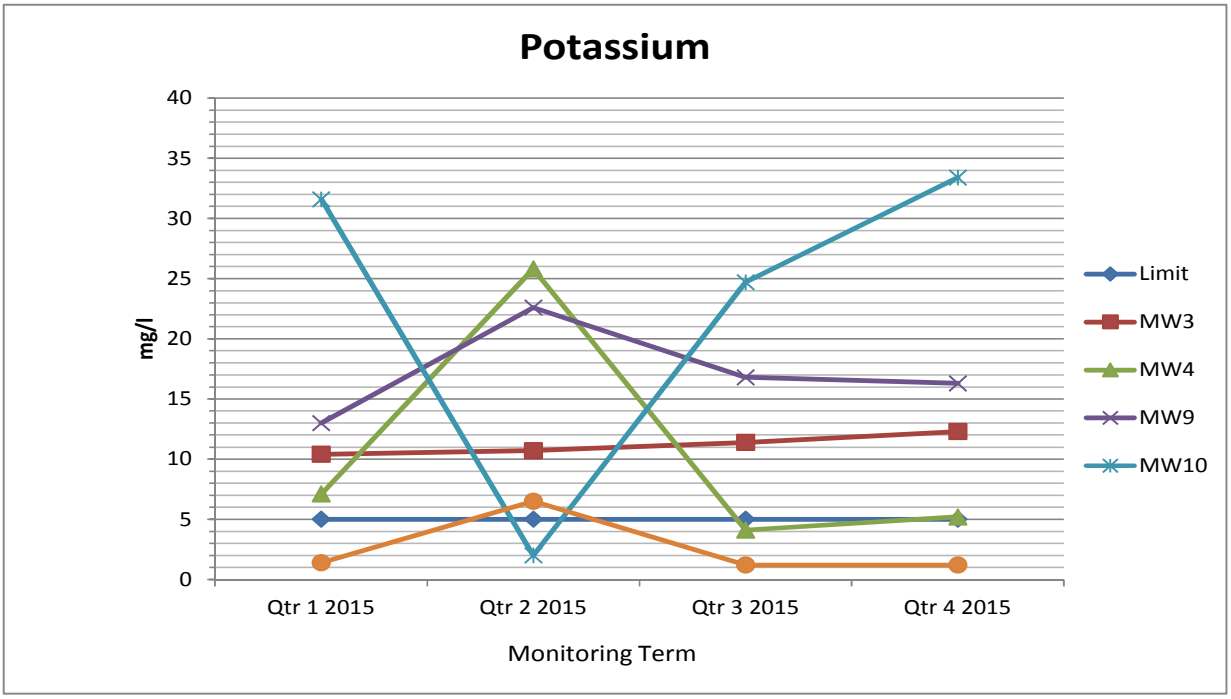
As detailed in the above graphs, there were numerous ground water exceedances at this landfill during 2015.

- ***Escherichia coli:*** Elevated levels of this parameter were found in samples MW3, MW4, MW10, MW11S, MW11D, MW16S, MW16D & MW17S and 17D. It is not uncommon for wells in the vicinity of a landfill to be contaminated with *E. coli.* It is also attributed to influx of contamination from other sources such as septic tanks, slurry spreading and animal faecal contaminations. It should be noted that there were numerous horses present on the landfill for the most part of 2015 and as such the E.Coli contamination cannot be solely attributed to the landfill itself.

- **Ammonia:** Elevated levels of this parameter were prevalent during 2015. Elevated levels of ammonia are strongly associated with pollution from waste water treatment systems and so contamination of these wells by the landfill cannot be definitively concluded.

- **Total Coliforms:** elevated levels of this parameter can be attributed to contamination from organic matter; therefore exceedances in this parameter may not be directly linked to the landfill.

- **Iron:** Although increased iron levels can be attributed to contamination from landfills, it is also strongly associated with the native soils of the Cavan area and therefore cannot be directly linked to the landfill.

- **Chloride:** Historical results obtained from this parameter show frequent elevations when compared to the Interim Guide Values for Ground Water. However, contamination of well 11S from the landfill is impossible due to MW11S being located up gradient of the landfill itself. Therefore an alternative source of chloride contamination should be investigated in this instance.

- **Potassium:** Elevated levels of potassium can be associated with landfill contamination but it can also be associated with contamination from agricultural sources such as fertilizers. Therefore direct contamination from the landfill cannot be concluded.

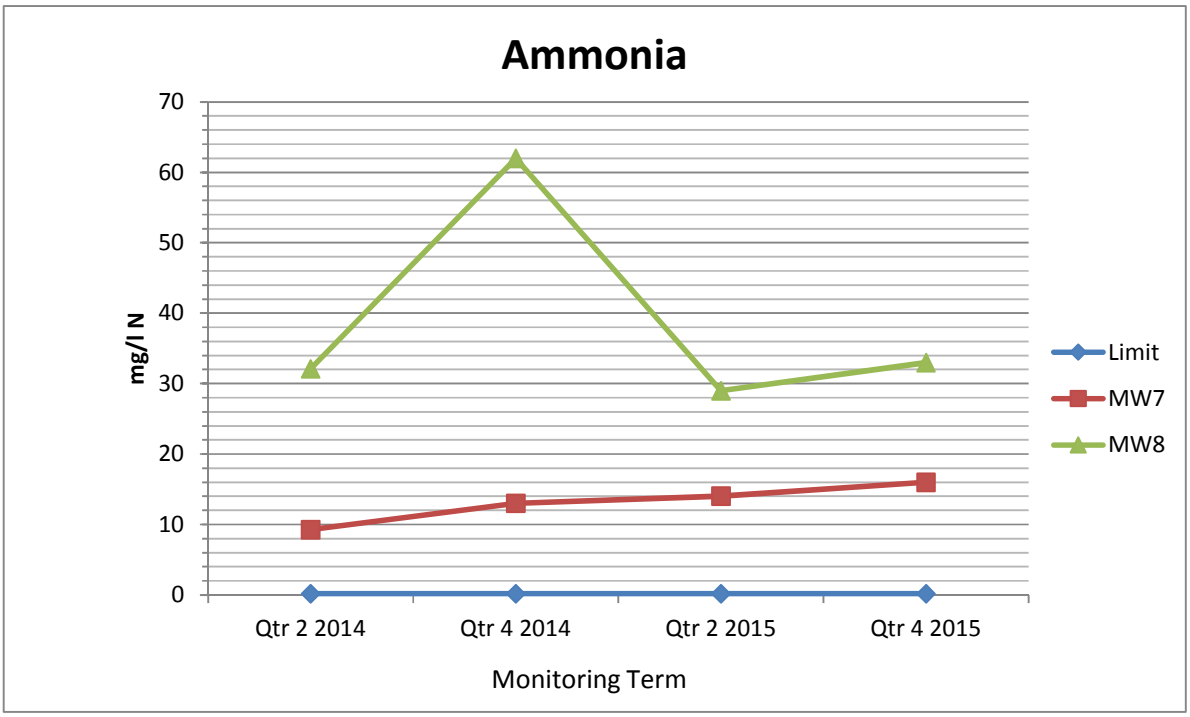
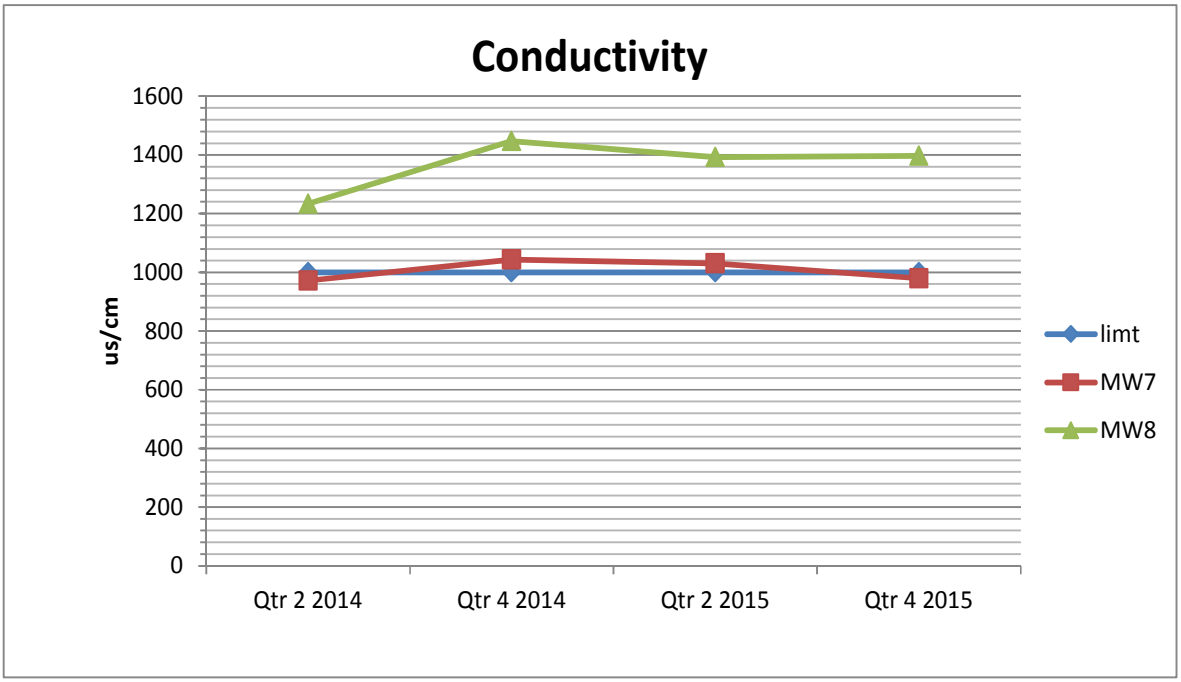
Graph 5.9

As can be seen from the above figures the conductivity reading at this landfill remain steady and are typical of those associated with a mature landfill.

Results obtained for ammonia at these wells are elevated in comparison to Interim Guide Values for groundwater. Although ammonia is associated with leachate, it is also strongly associated with agricultural activities such as manure spreading, an activity which is prevalent in the surrounding area. As such the elevated levels cannot be solely attributed to the landfill at this time.

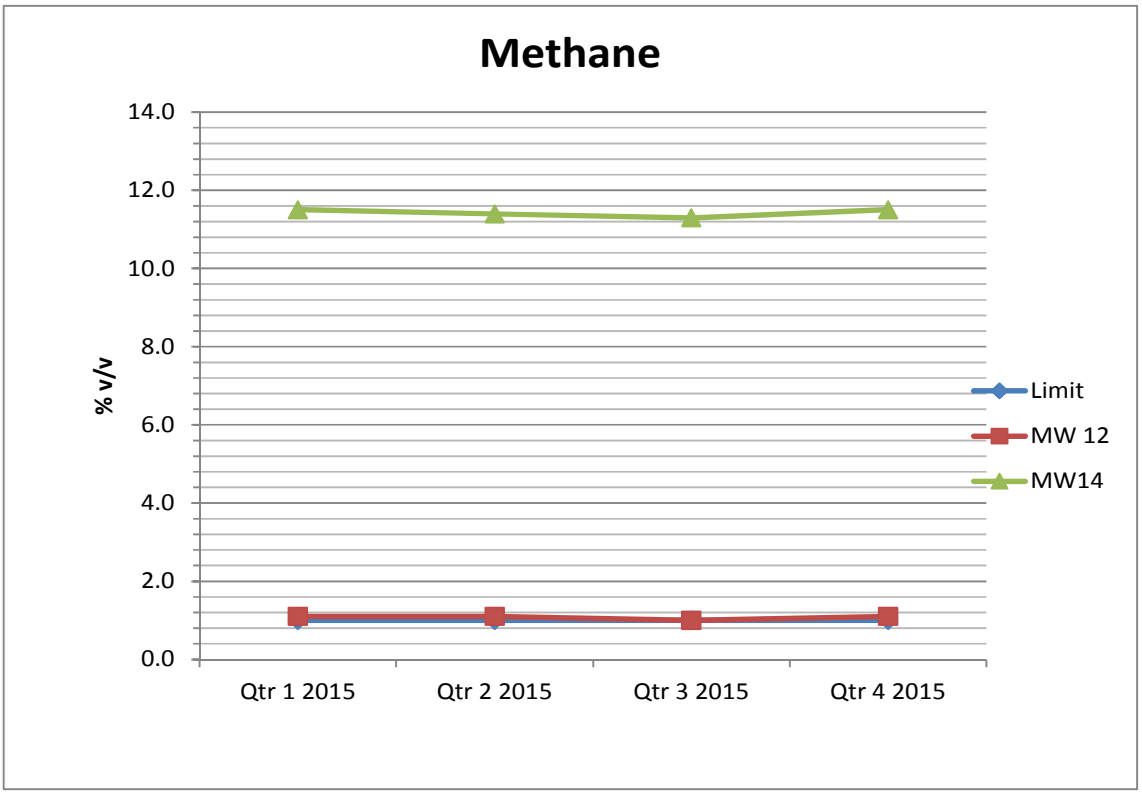
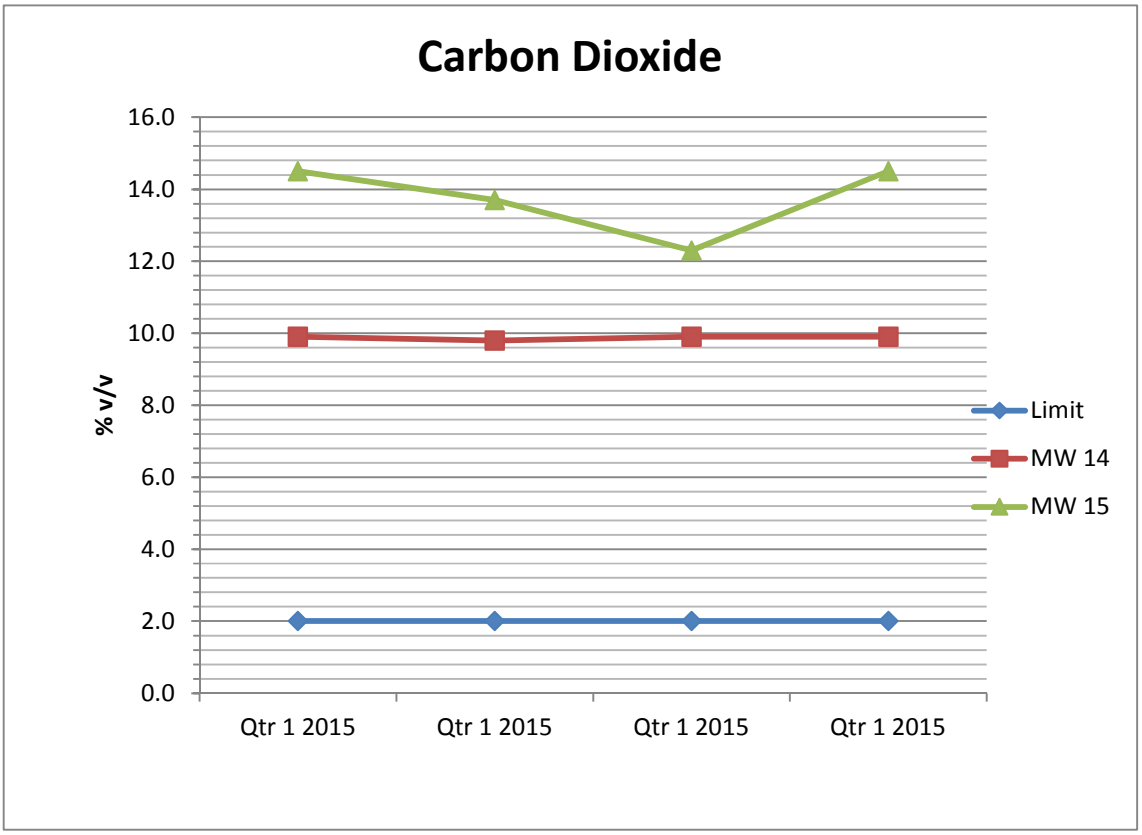
Graph 6.1

Gas Monitoring on the site reveals typical low levels of Methane & Carbon Dioxide and higher levels of Oxygen. There were no exceedances in licence limits for wells located outside the waste mass. The results are typical of a closed landfill.
