Cavan County Council

Annual Environmental Report 2016

Bailieborough Landfill WL0091-1

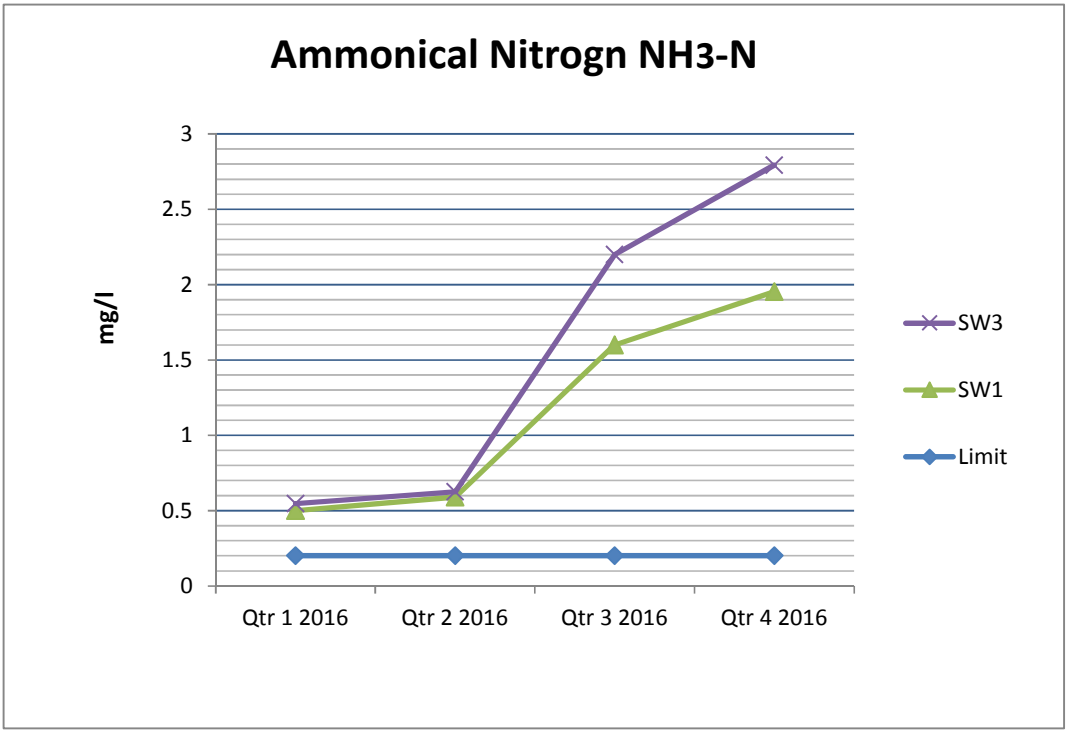
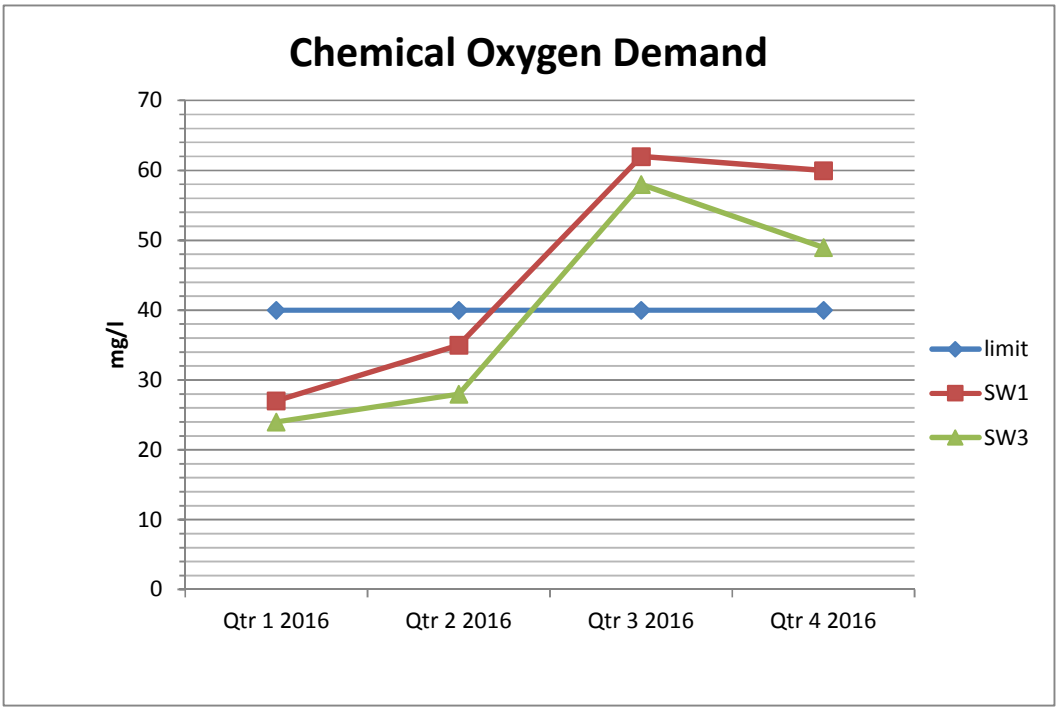
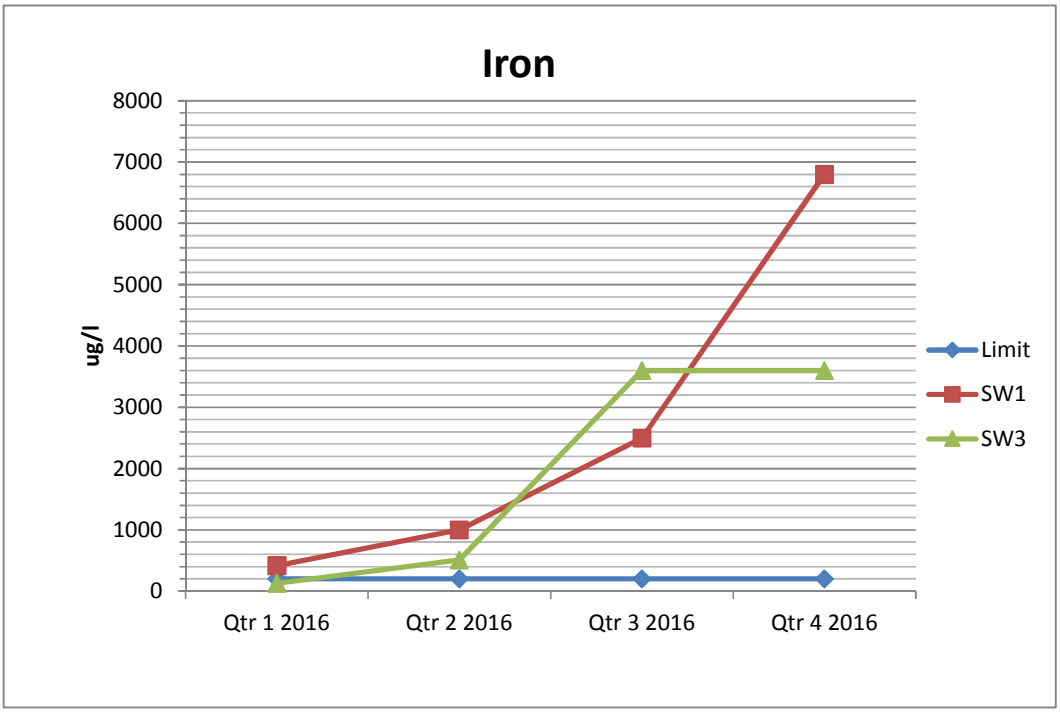
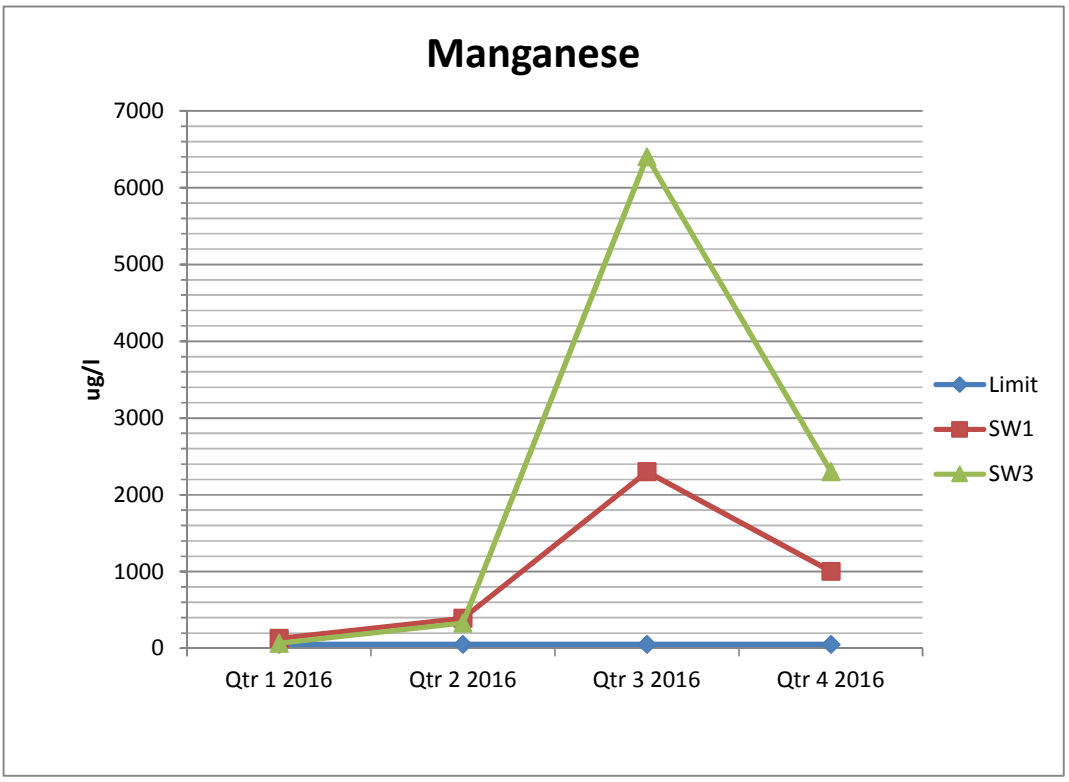
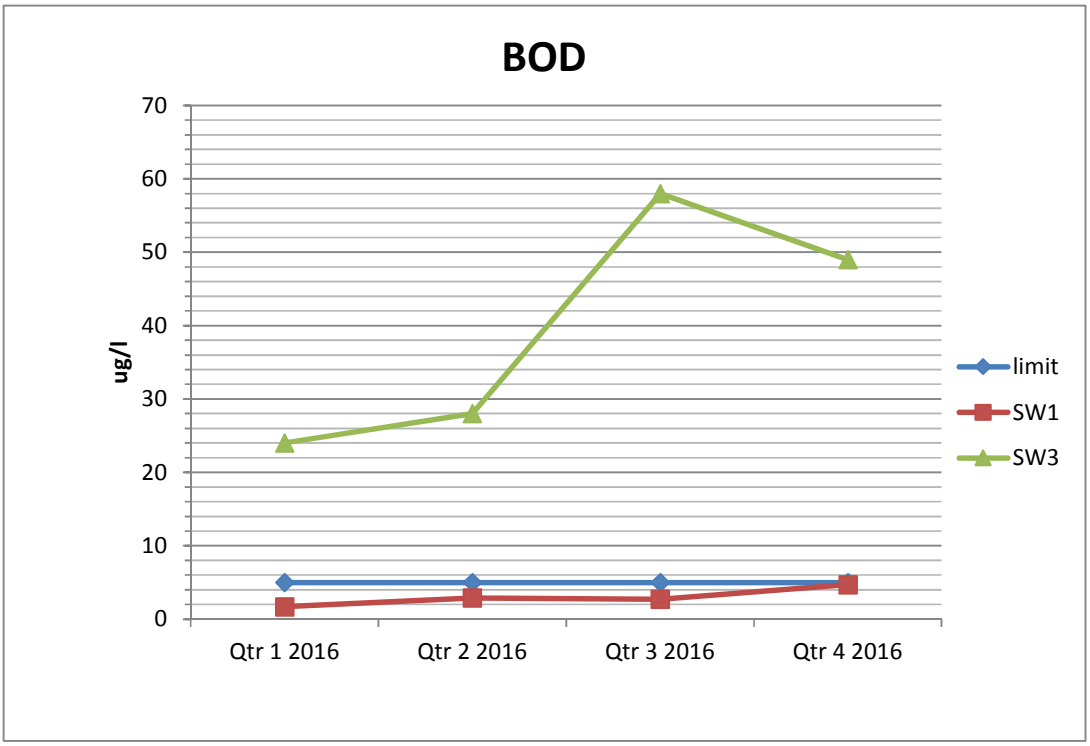
As table 5.1 reveals, there were elevated levels of Ammonia, COD, Iron and Manganese levels recorded in the samples taken at the SW1 and SW3. SW1 is located downstream of the landfill while SW3 is located further downstream at the new monitoring location SW3 "Chapel Lough". As indicated from the results, elevations are lower at the discharge cap than further downstream which indicates alternative sources of contamination.

Elevated levels of Iron and Manganese can be attributed to the natural composition of the underlying geology however it is not uncommon to encounter high levels of both parameters in the vicinity of landfills. The elevated levels of Ammonia and COD encountered at SW1 and SW3 are attributed to low flows during which time the water may have become stagnant.

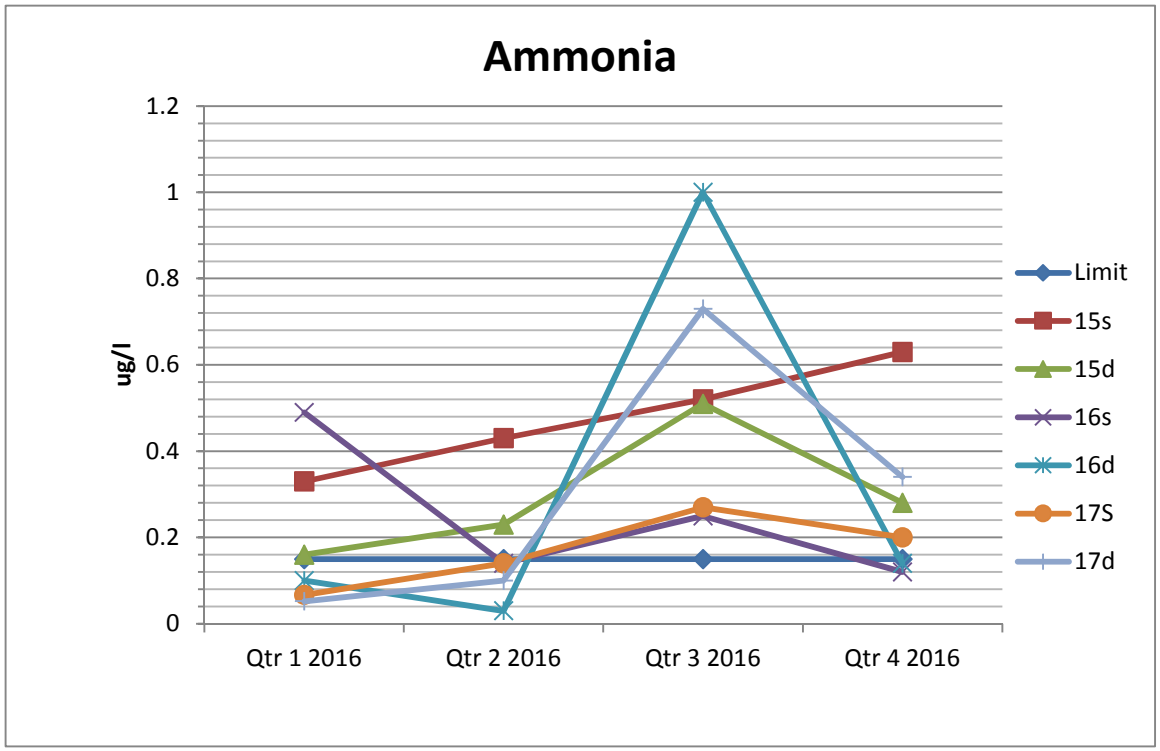
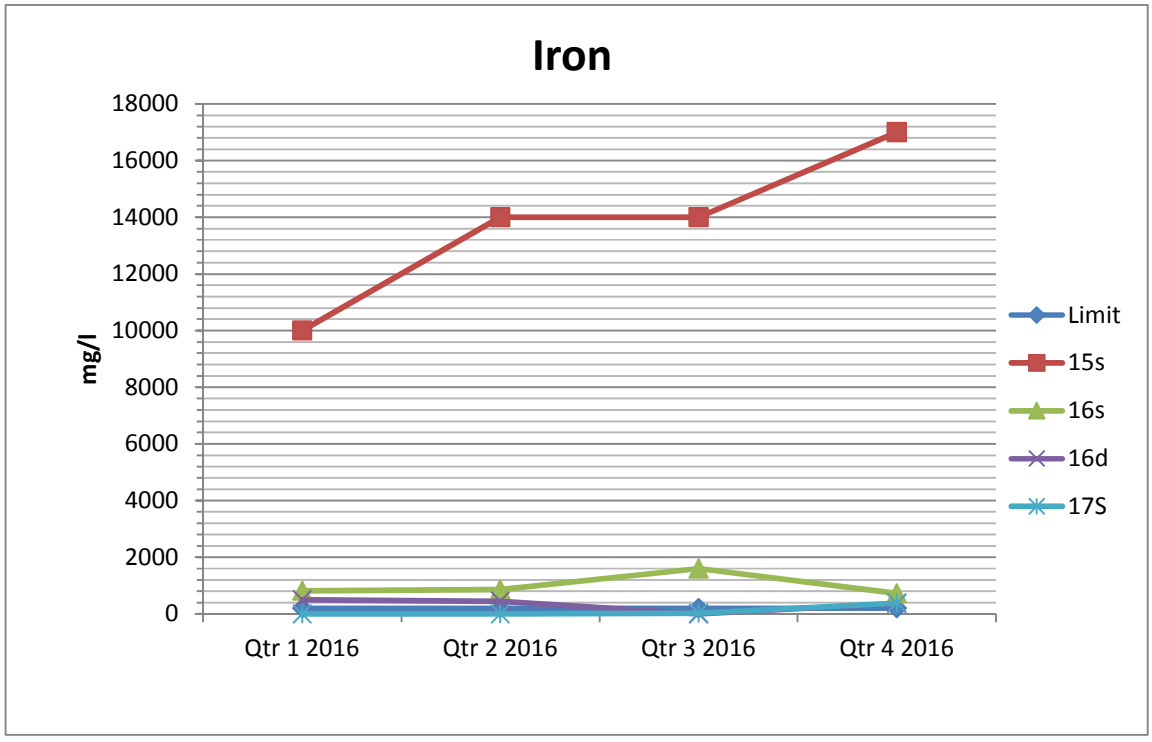
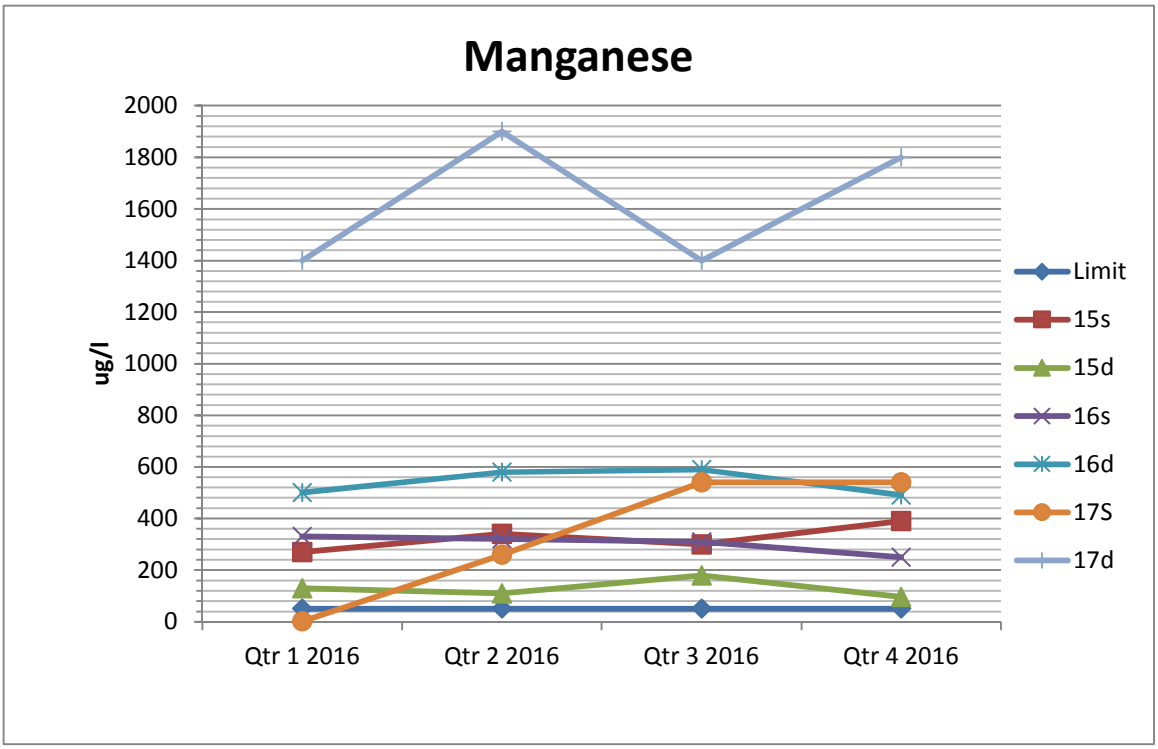
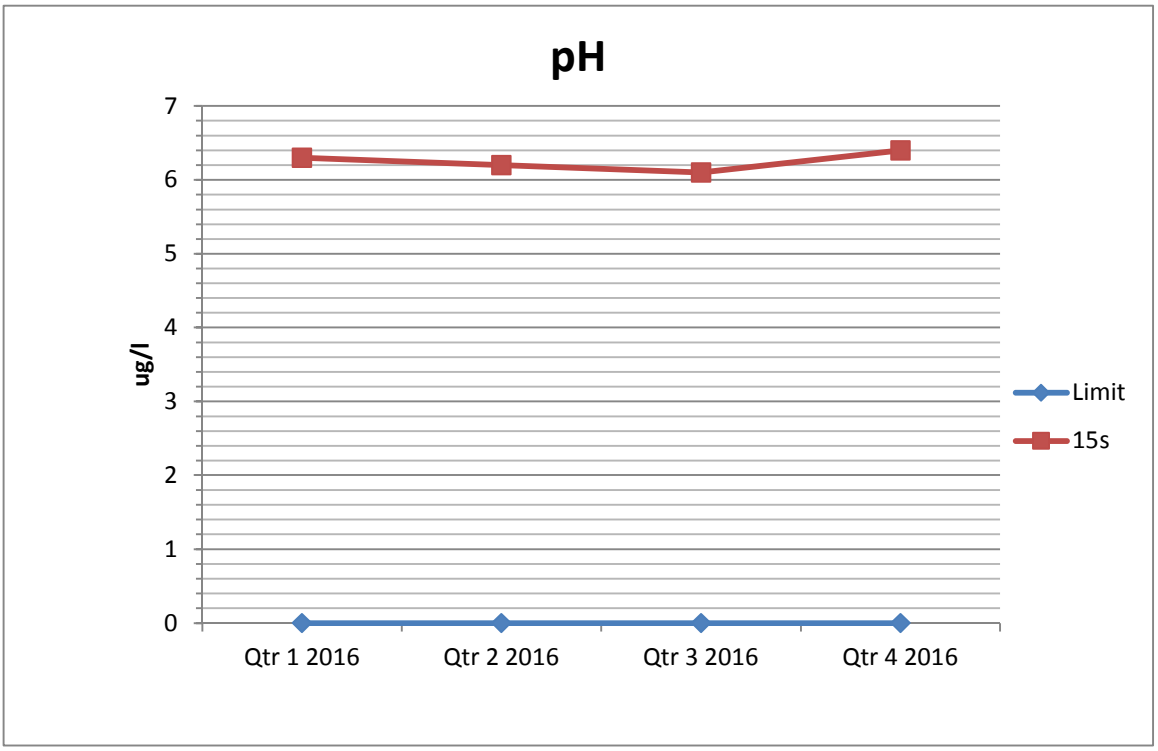
As detailed in the above graphs, there were numerous ground water elevations in the vicinity of this landfill during 2016 when results were compared to the Interim Guide Values.

- **Ammonia**: Elevated levels of this parameter were prevalent during 2016. Elevated levels of ammonia are strongly associated with pollution from waste water treatment systems as well as agricultural activates and so contamination of these wells by the landfill cannot be definitively concluded.
- **Iron**: Although increased Iron levels can be attributed to contamination from landfills, it is also strongly associated with the native soils of the Cavan area and therefore cannot be directly linked to the landfill.
- **Manganese**: Elevated levels of Manganese can be associated with landfill contamination but in this instance they are attributed to the natural composition of the underlying soils.
- **pH**: Well 15s recorded an exceedance during monitoring in 2016. This reading was minimal and cannot be linked to the landfill.

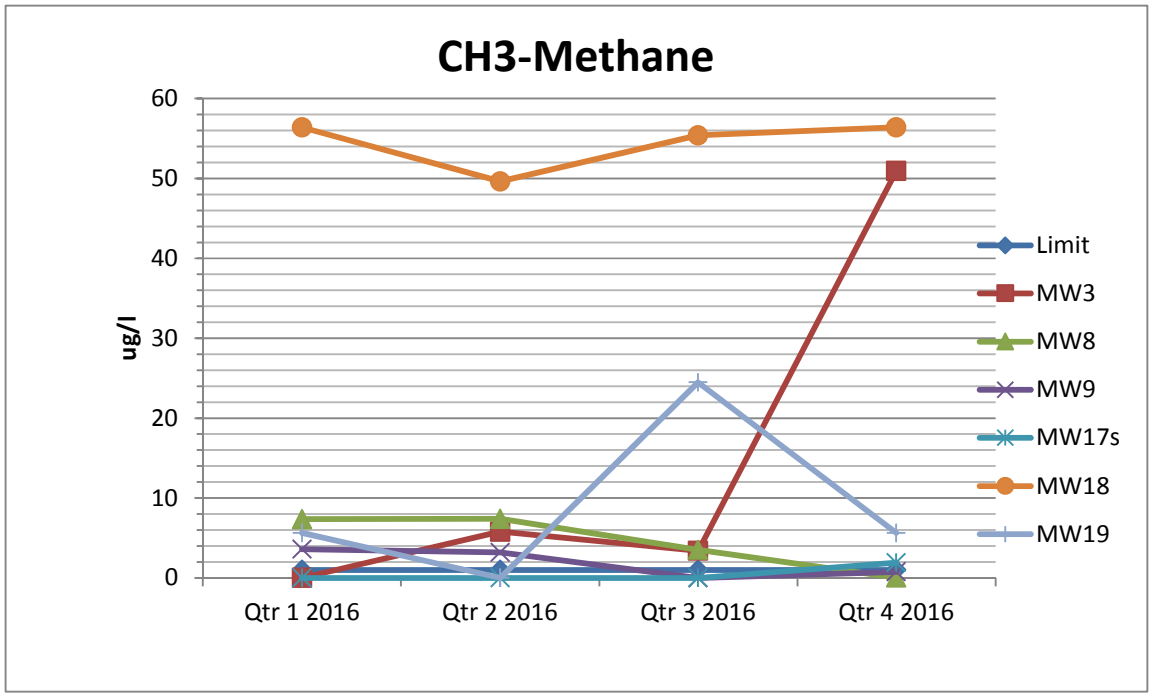
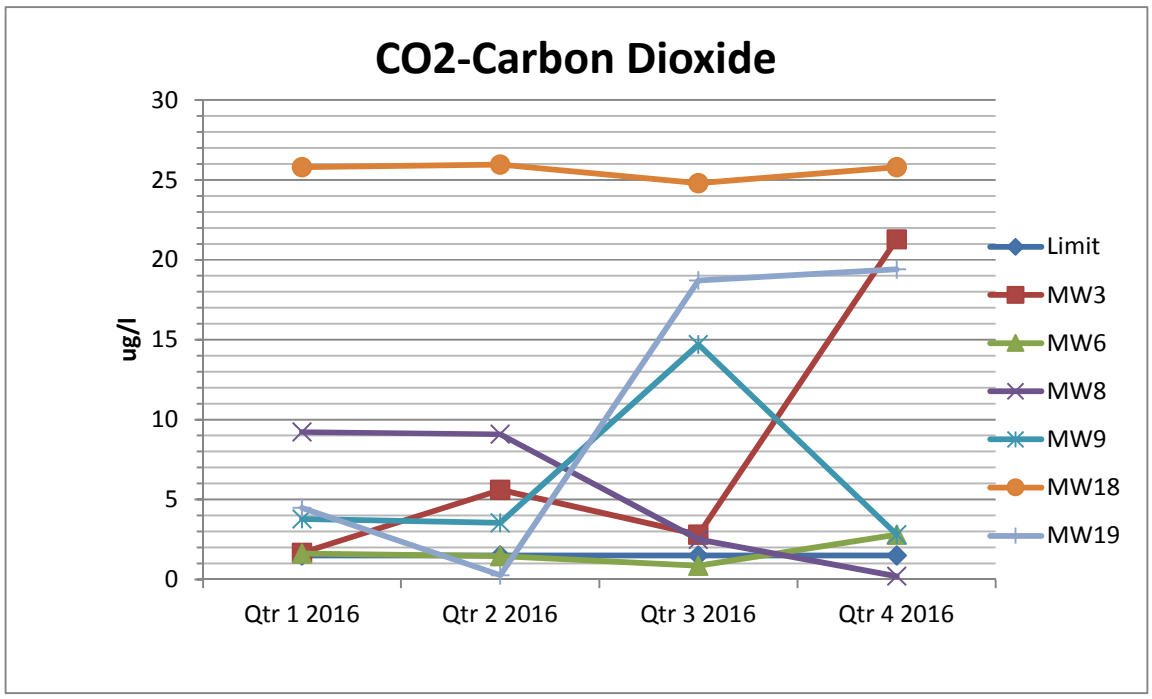
Gas Monitoring on the site reveals typical low levels of Methane & Carbon Dioxide and higher levels of Oxygen. There were some high readings encountered at MW8 and MW18 and which are all located in the centre of the waste body. There was no significant gas migration recorded in monitoring wells outside of the waste body. The results are typical of a closed landfill.
