Subject: FW: H0306-01 Carlingford Landfill
Attachments: Appendix 1.pdf; Appendix 2.pdf; Appendix 3.pdf; Appendix 5.pdf; Appendix 6.pdf; Carlingford Certificatation Rev A.pdf; Carlingford town dump Risk assessment Tier 1.pdf; New Eden Message - Landfill - Valid Application Submitted - 1 EPA043304 received 14 Jan 2014.txt; Sean Moran CoP Authorisaiton.pdf

From: Pamela Dagg [mailto:pamela.dagg@louthcoco.ie]
Sent: 23 July 2018 15:09
To: Magnus Amajirionwu
Subject: RE: H0306-01 Carlingford Landfill

Carlingford Boreholes

Groundwater Source Protection Zones
Draft report

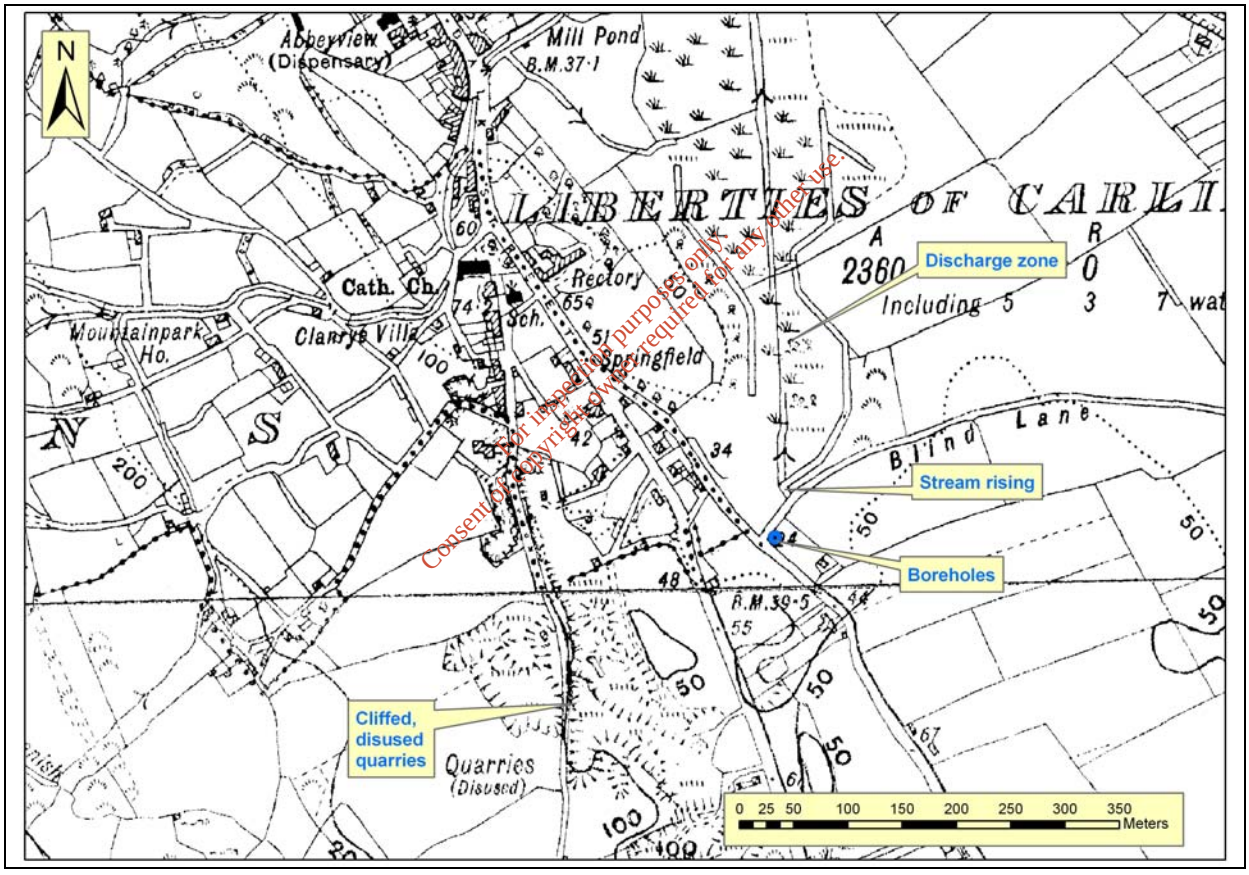
Figure 1: Location of the boreholes, as well as the rising stream and interpreted discharge zone to their immediate north. The deep, cliffed, disused quarries up-slope are also shown.

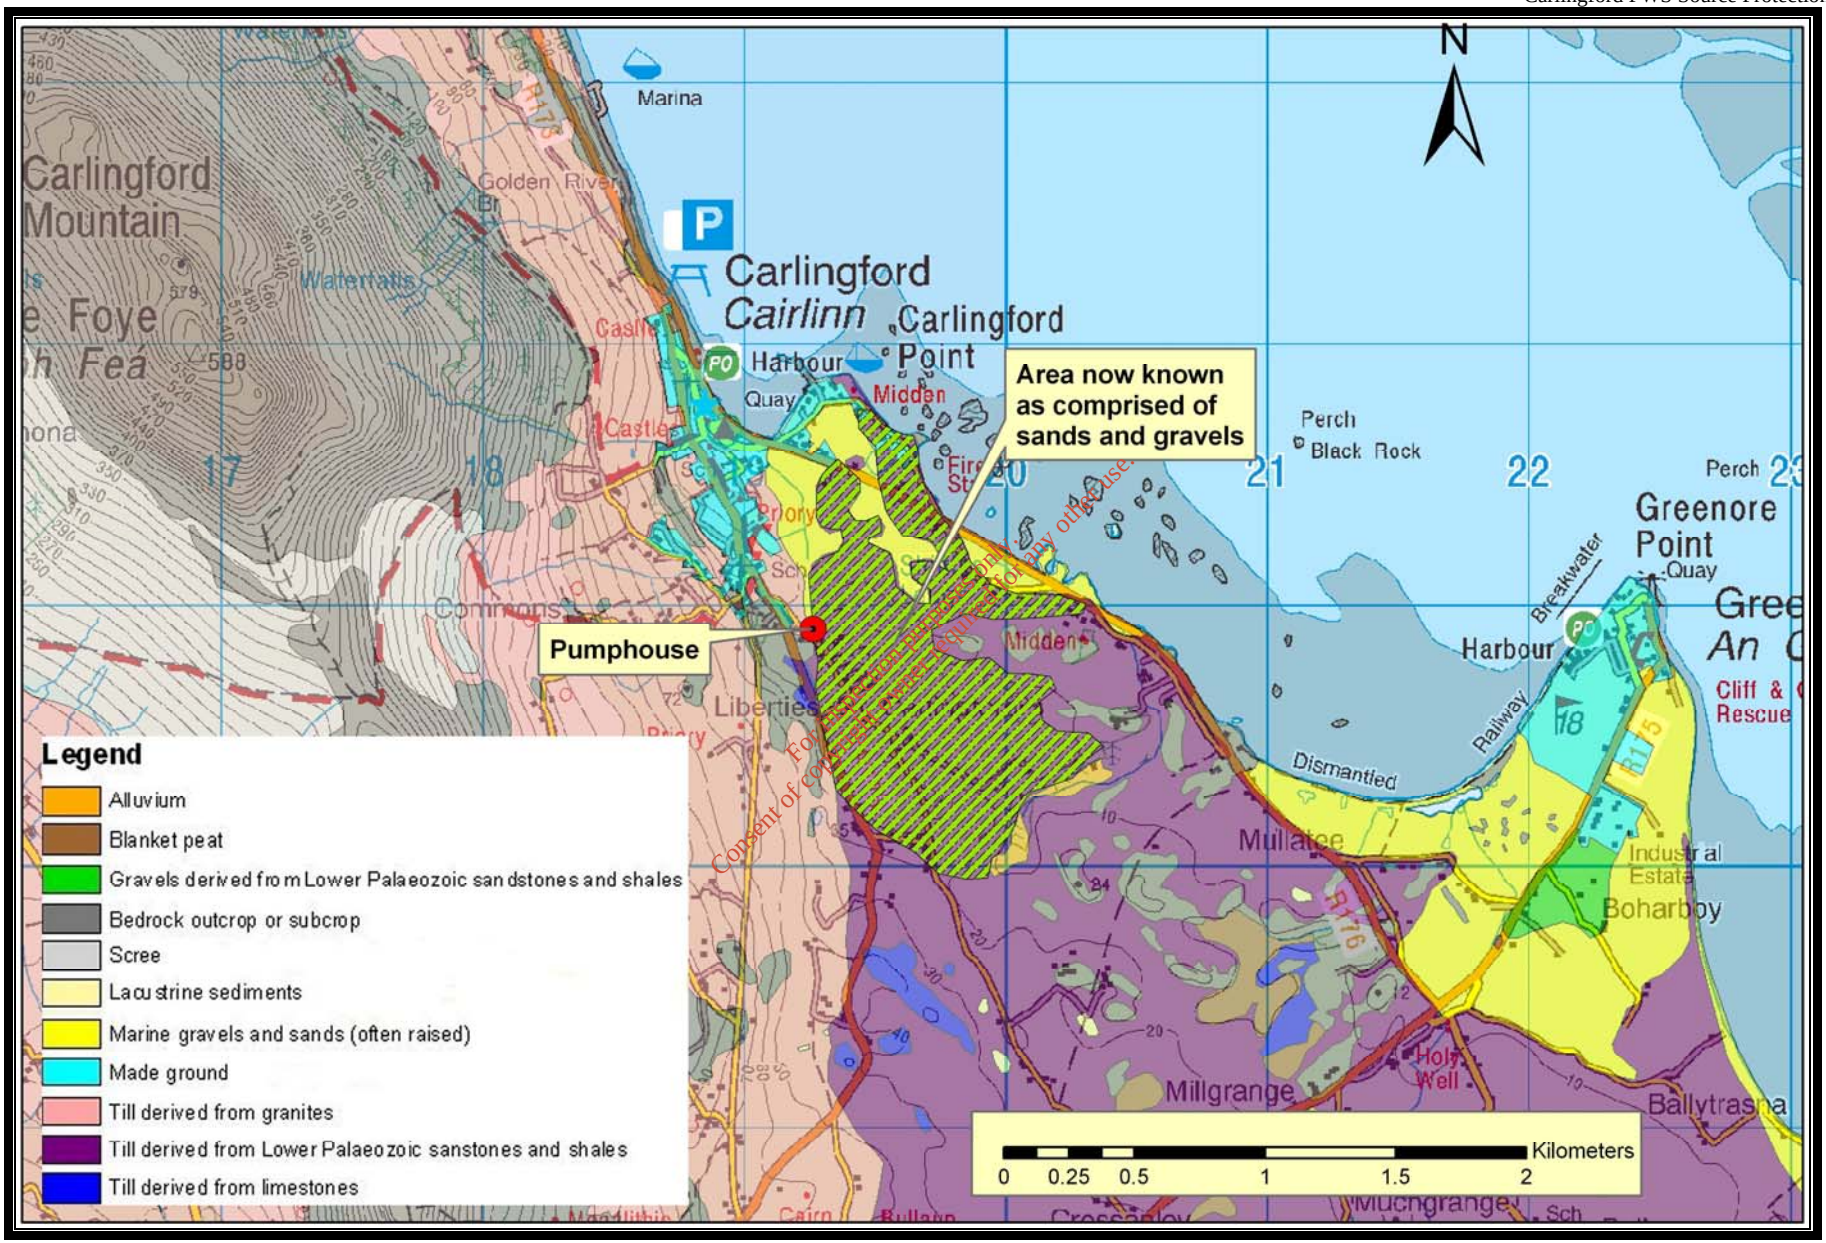
Figure 4: Subsoils geology map of the area around the Carlingford Source. The area now known to be sands and gravels is also shown.

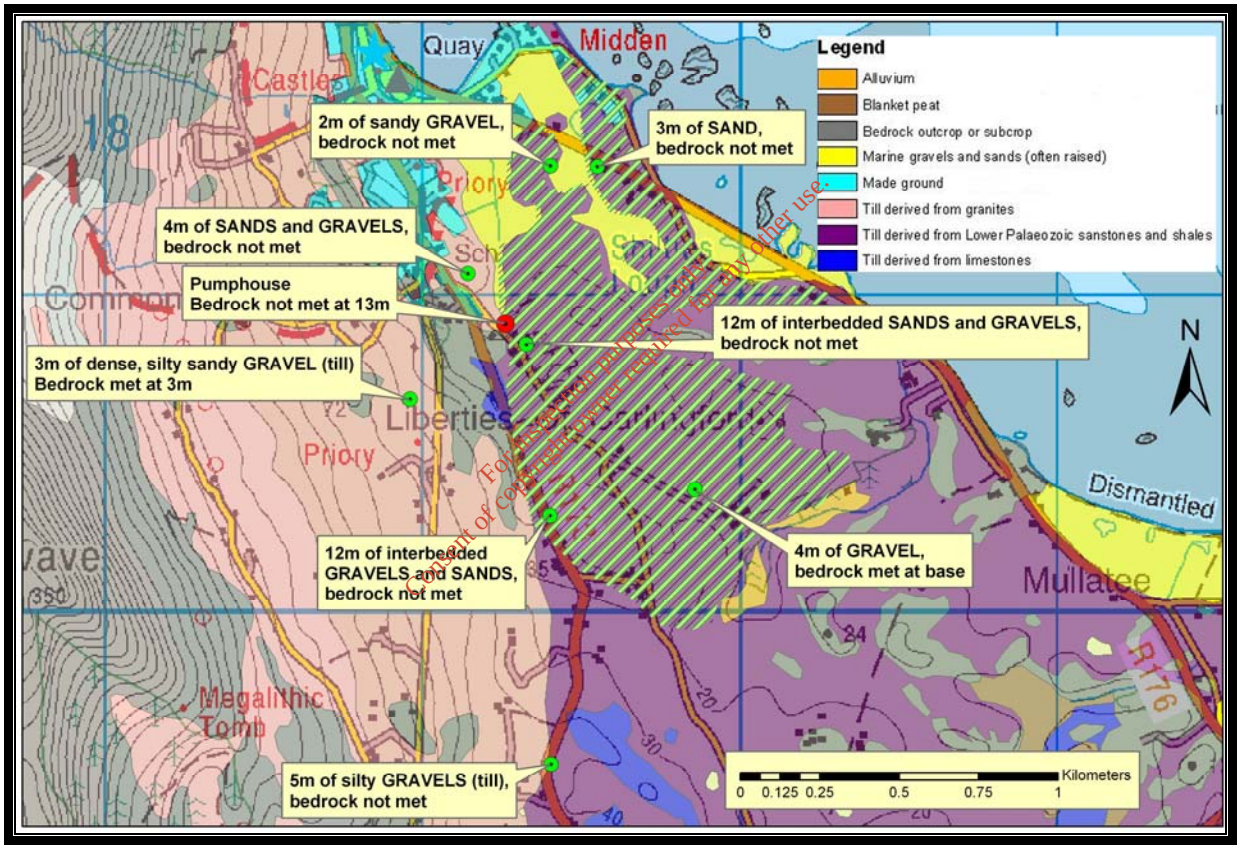
Figure 5: Details of boreholes bored by GSI in summer 2007 around the source. The logs from these, along with mapping of exposures in the locality around the source, were used to delineate the area of sands and gravels constituting the source aquifer (shown as green hatch).

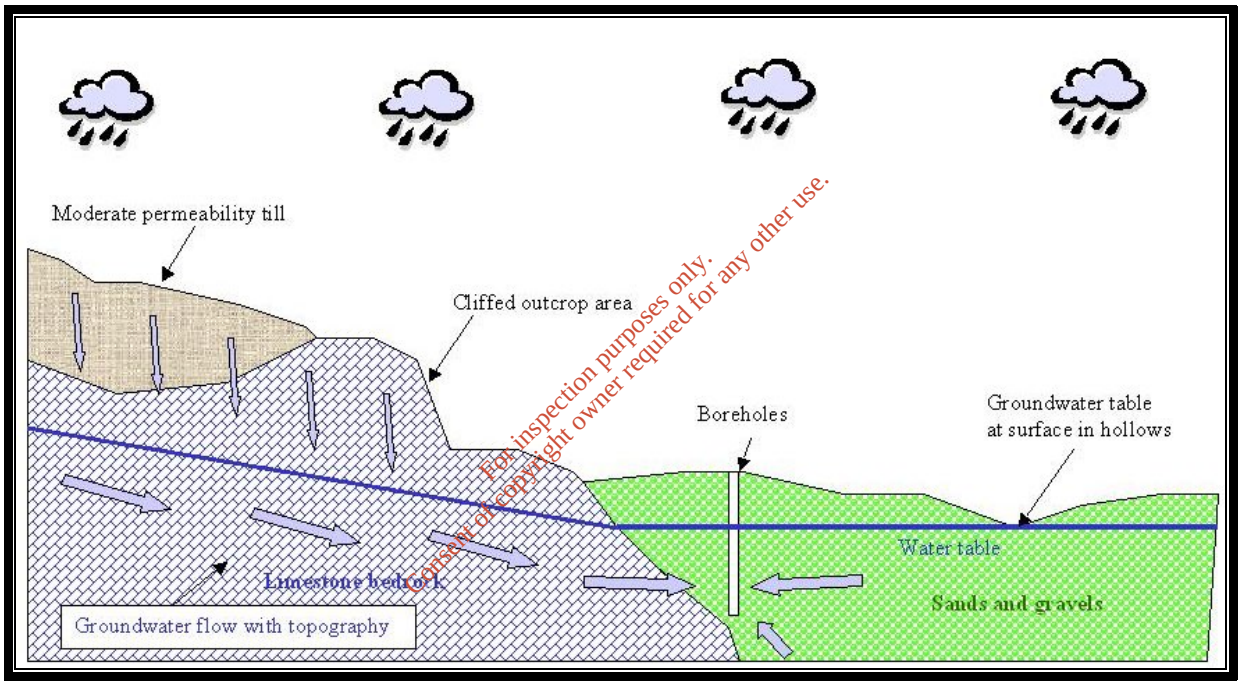
Figure 6: Three-dimensional conceptual model for the Carlingford boreholes source, with groundwater being fed into the permeable sands and gravels from the vertically higher bedrock to the west and southwest.

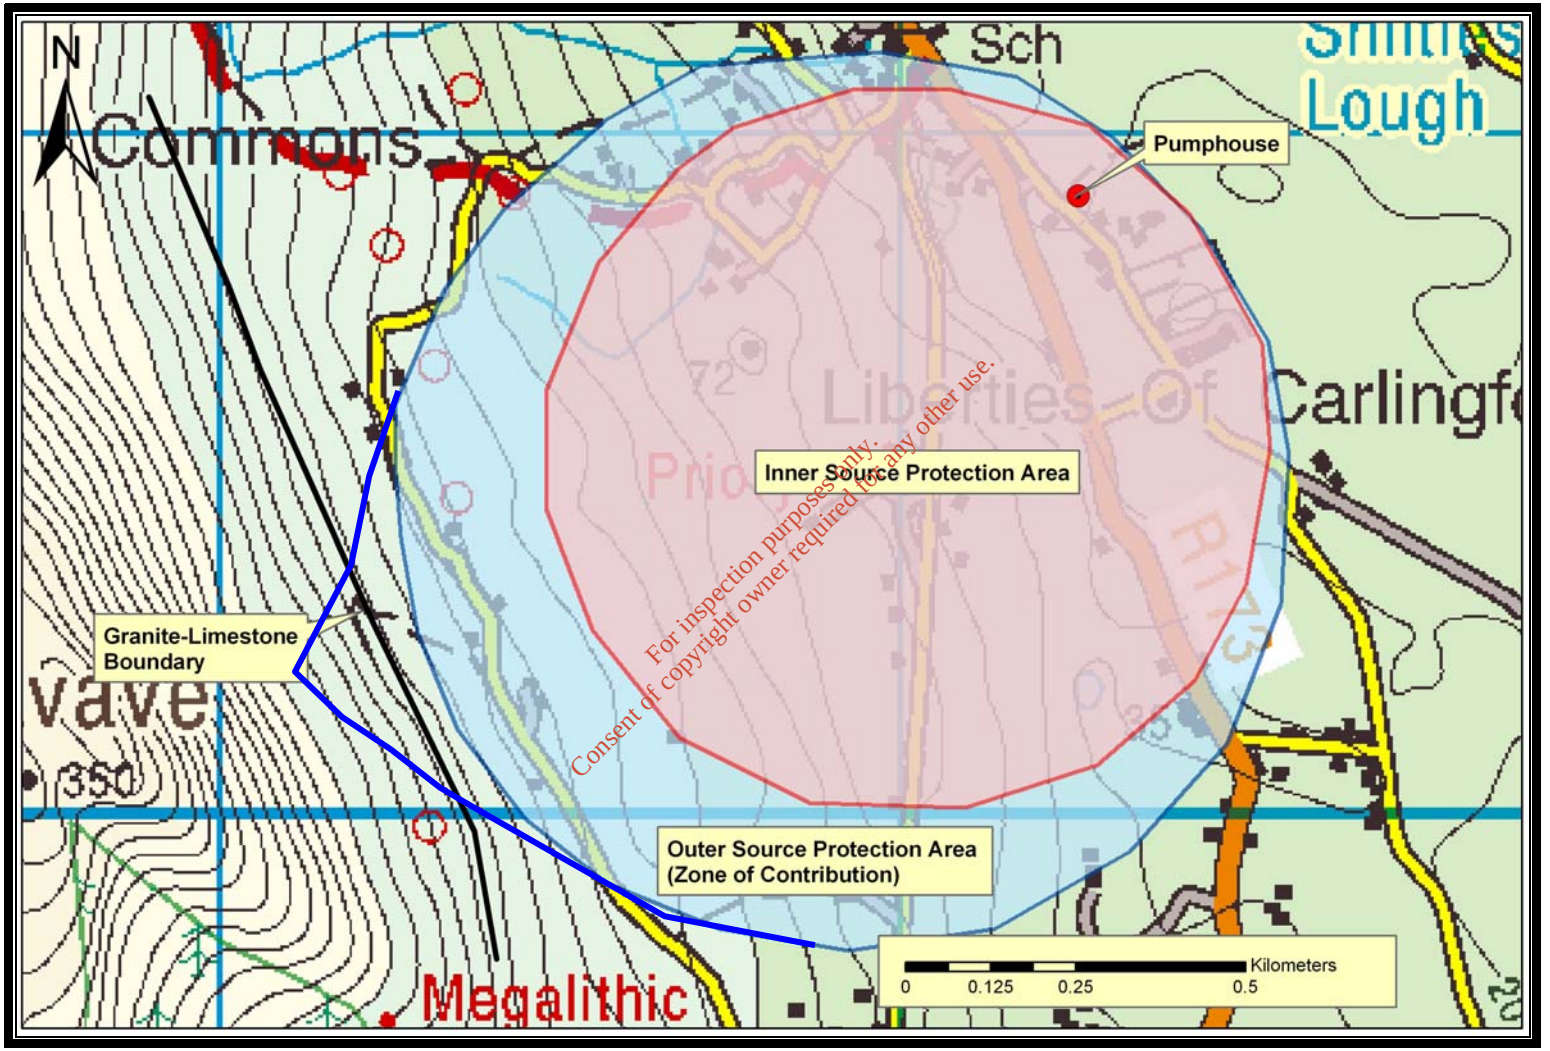
Figure 7: Source Protection Areas for the Carlingford Boreholes Source.

This section describes the delineation of the areas around the source that are believed to contribute groundwater to it, and that therefore require protection. The areas are delineated based on the conceptualisation of the groundwater flow pattern, as described in section 8.2 and presented in Figure 7.

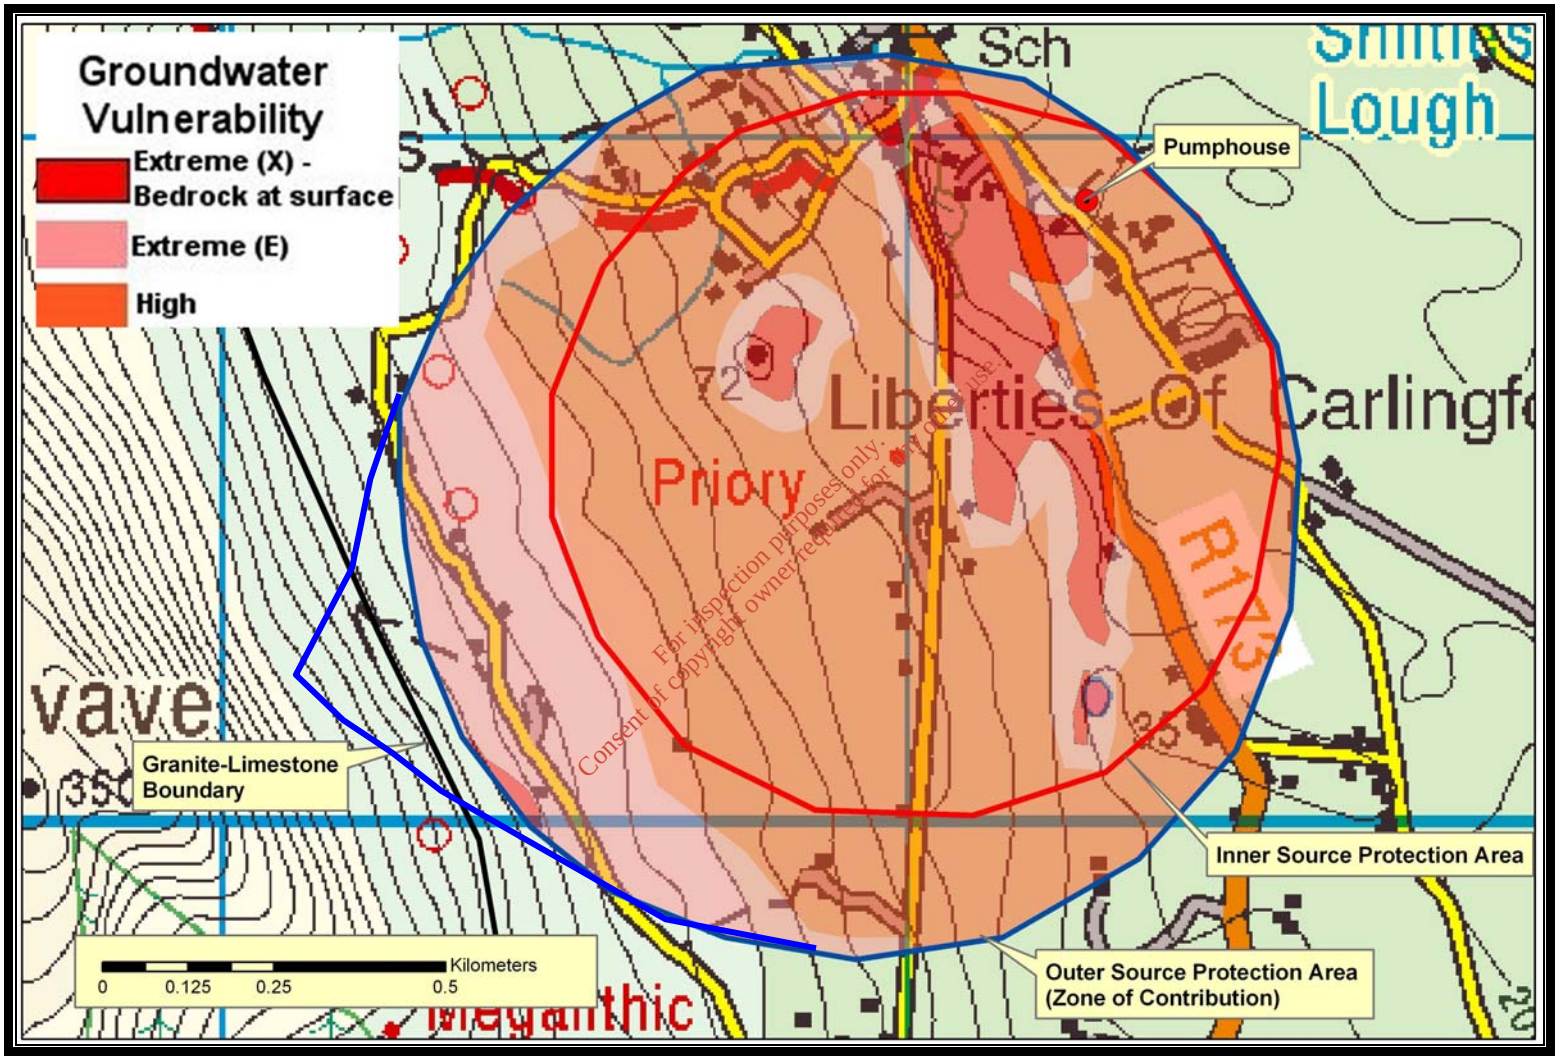
Figure 8: Groundwater Vulnerability within the Source Protection Areas for the Carlingford Boreholes Source.

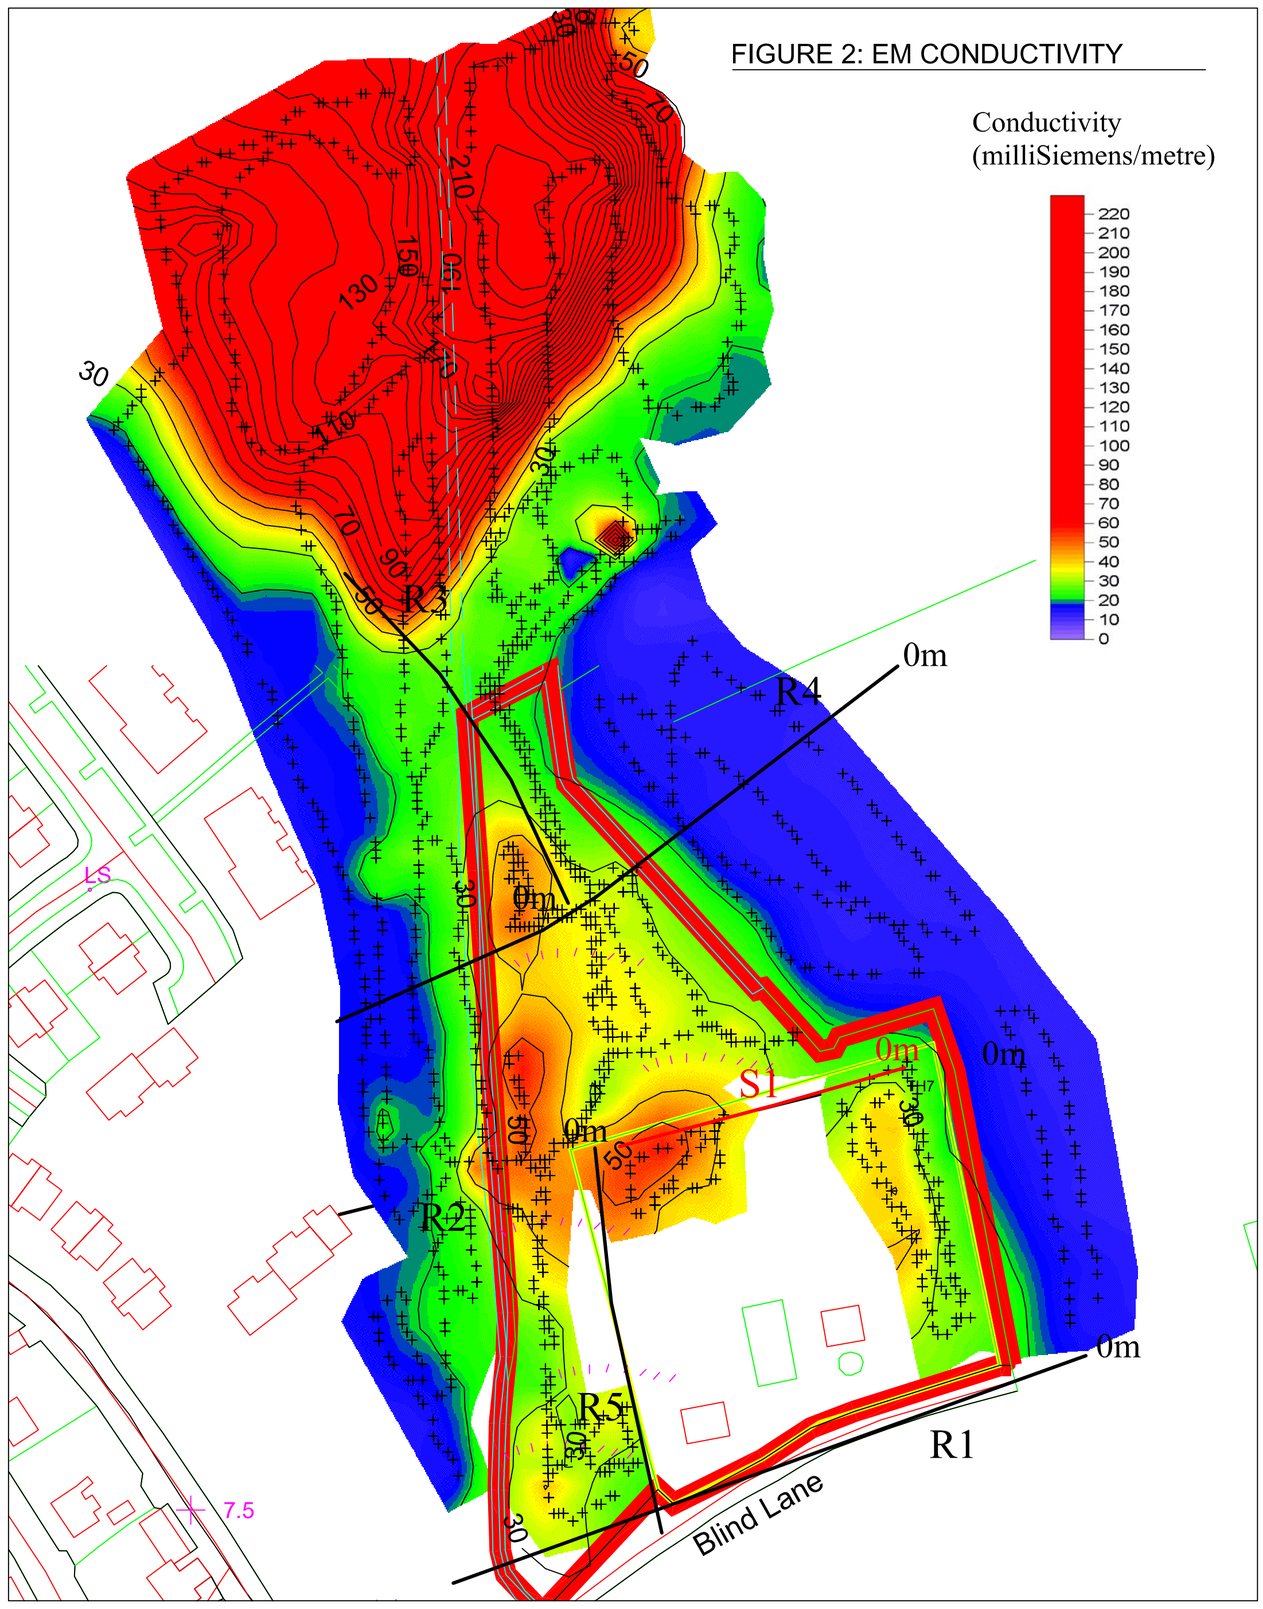
FIGURE 2: EM CONDUCTIVITY

The recorded EM31 conductivity values are contoured on Drawing 9301-01, Figure 2. The conductivity values ranged from 3 to 254 milliSiemens/metre (mS/m). The EM31 conductivity values have been broadly interpreted on the following basis:

The data were downloaded and plotted. Assignation of material types and possible anomaly sources was carried out, with cross-reference to other data. A scaled plot of conductivity against distance was prepared (Drawing 9301-01, Figure 2). The contoured in phase results are also shown (Drawing 9301-01, Figure 3).

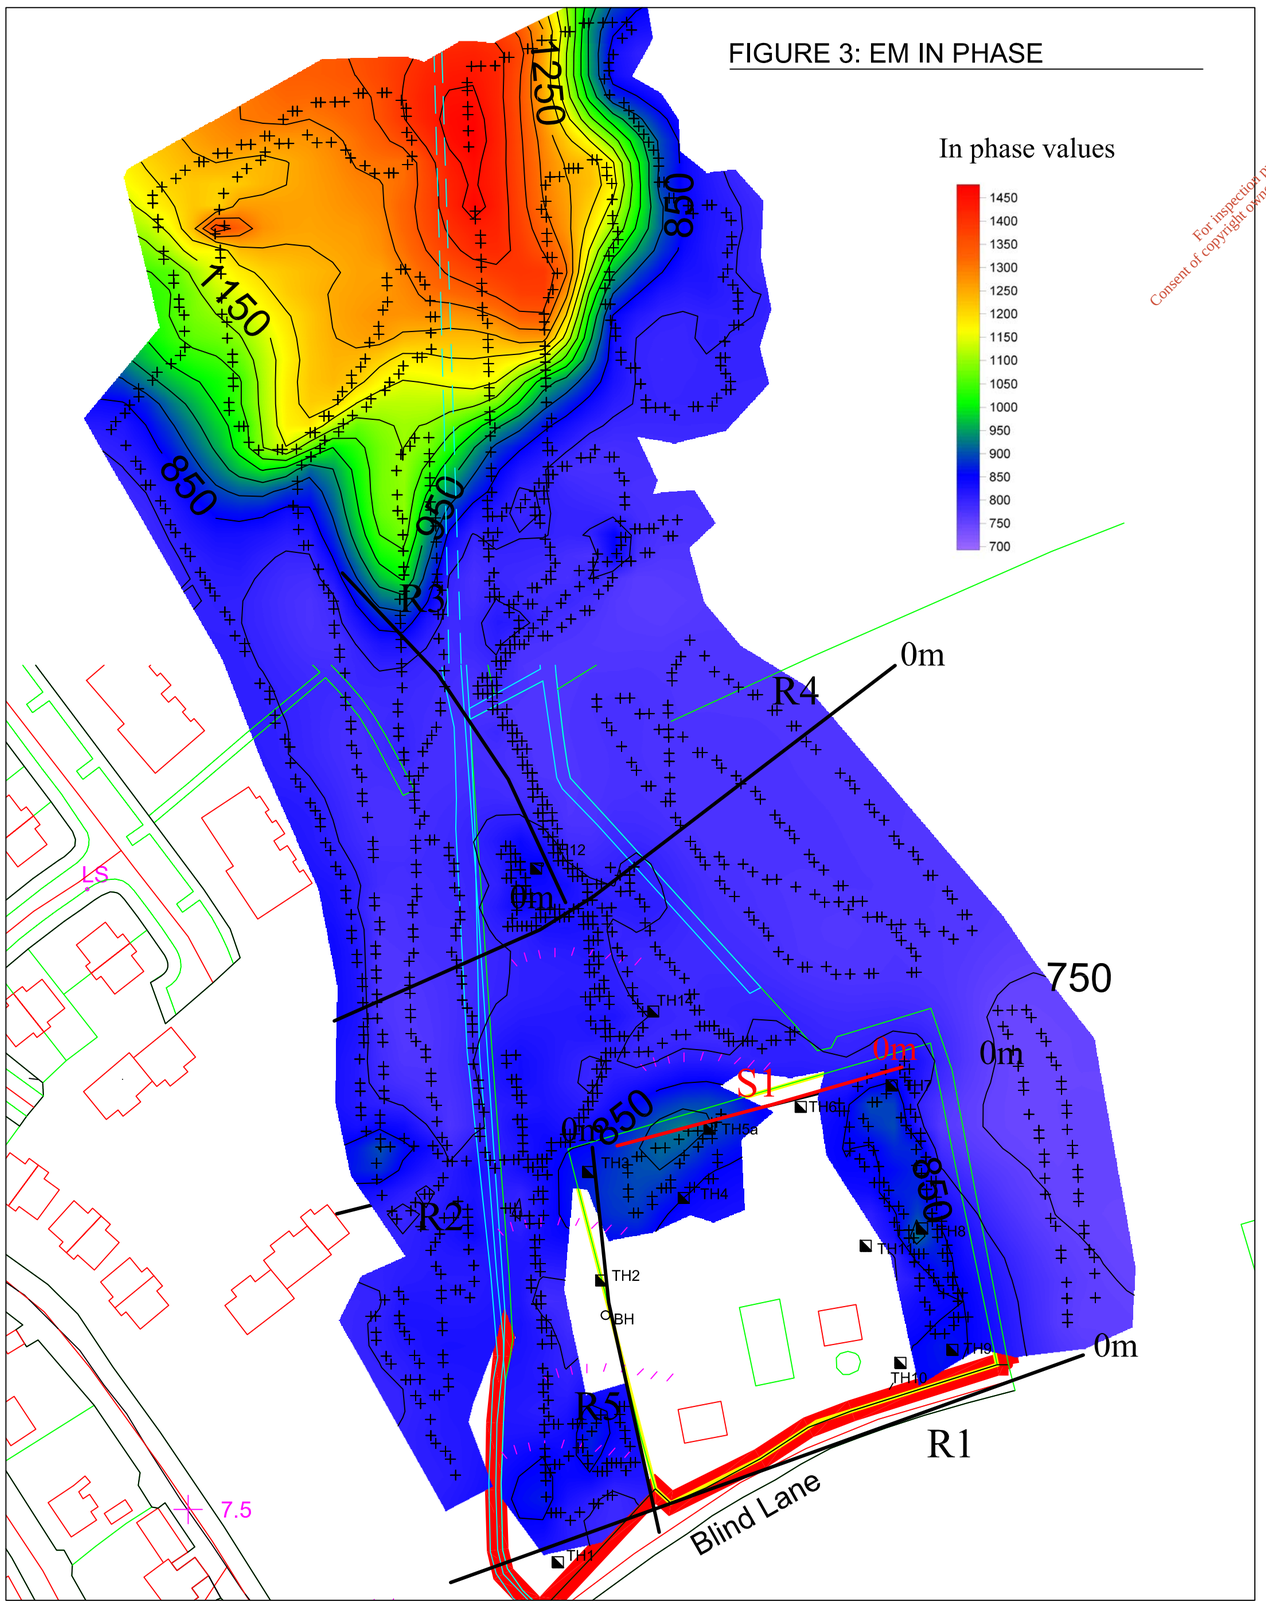
FIGURE 3: EM IN PHASE

During the survey an in phase component value was acquired simultaneously with the EM31 conductivity data. Variations in this component are indicative of the presence of metallic objects. The EM31 inphase values are contoured on Drawing 9301-03, Figure 3.

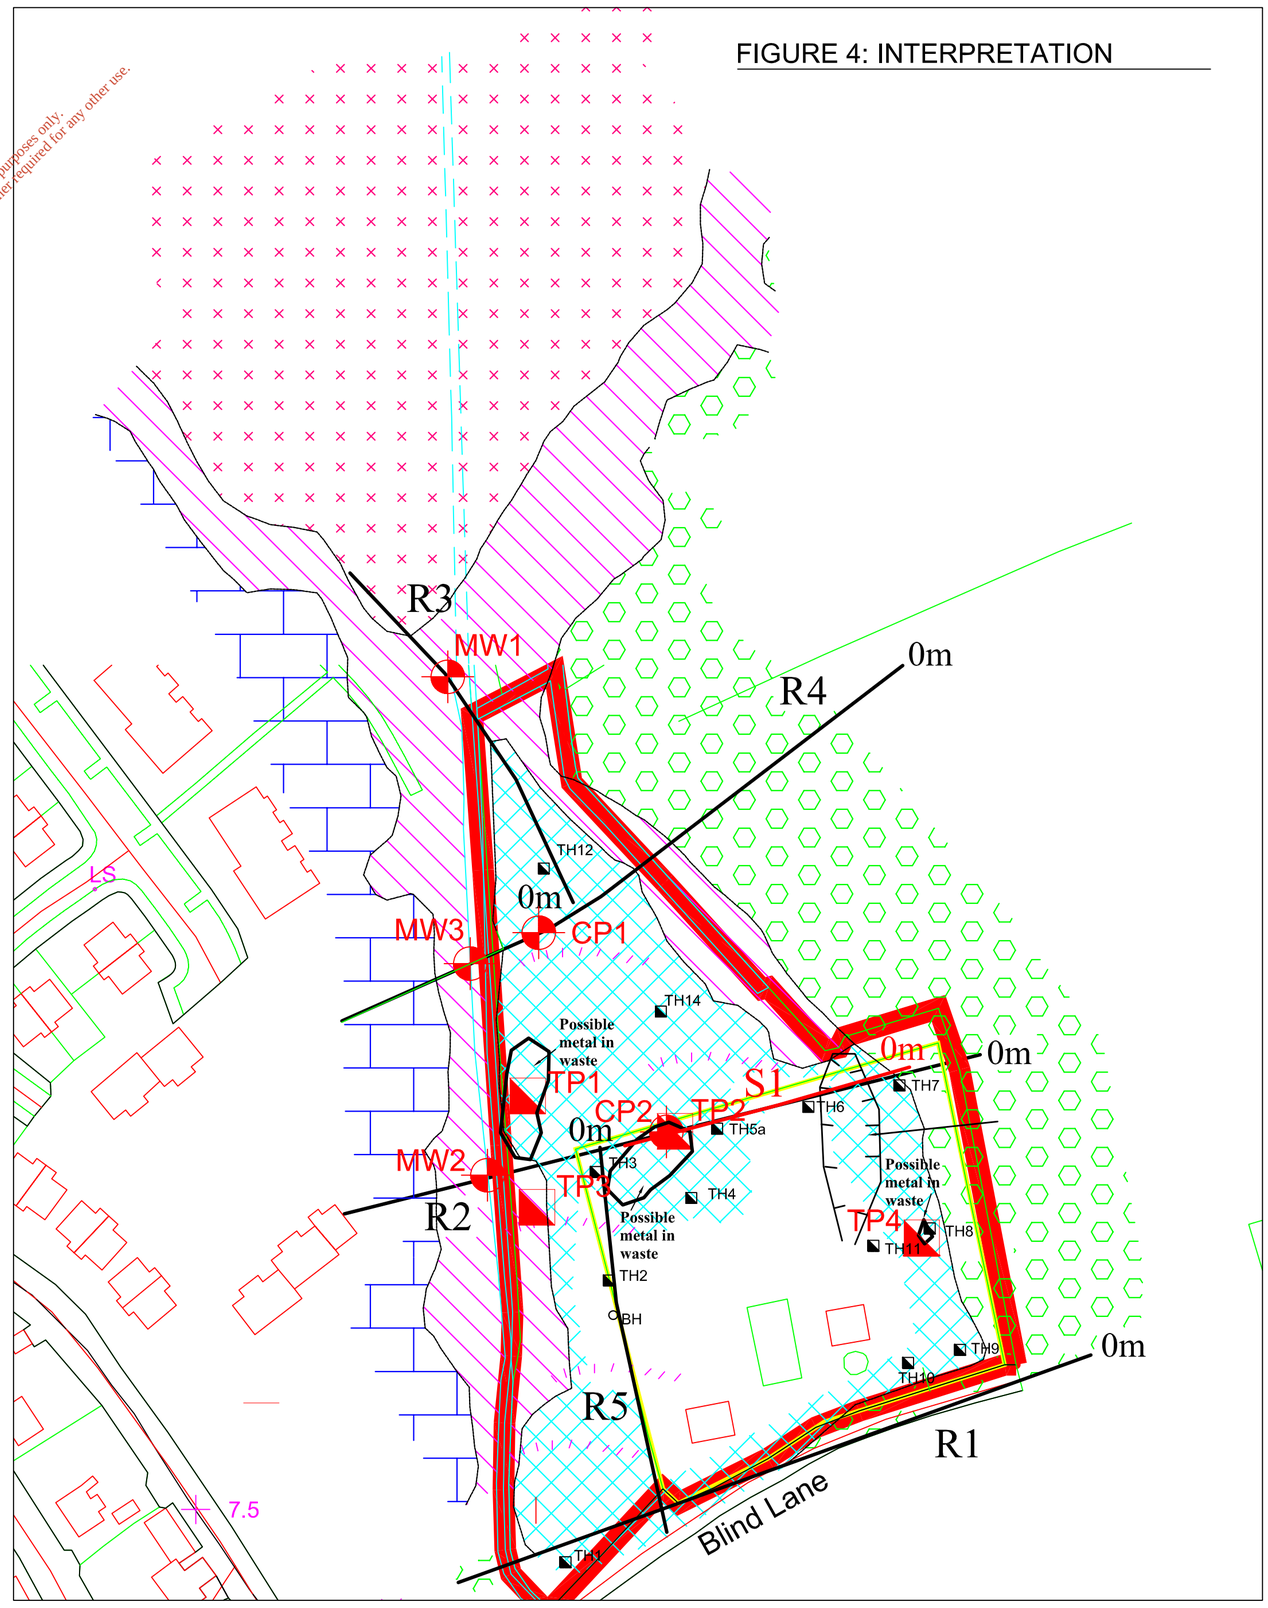
FIGURE 4: INTERPRETATION

The integrated geophysical results from each of the methods used are summarized on Drawing 9301-01, Figure 4 and on the interpreted sections included on Drawing 9301-03, Figures 3-5.

The geophysical interpretation is summarized on Drawing 9301-01, Figure 4.

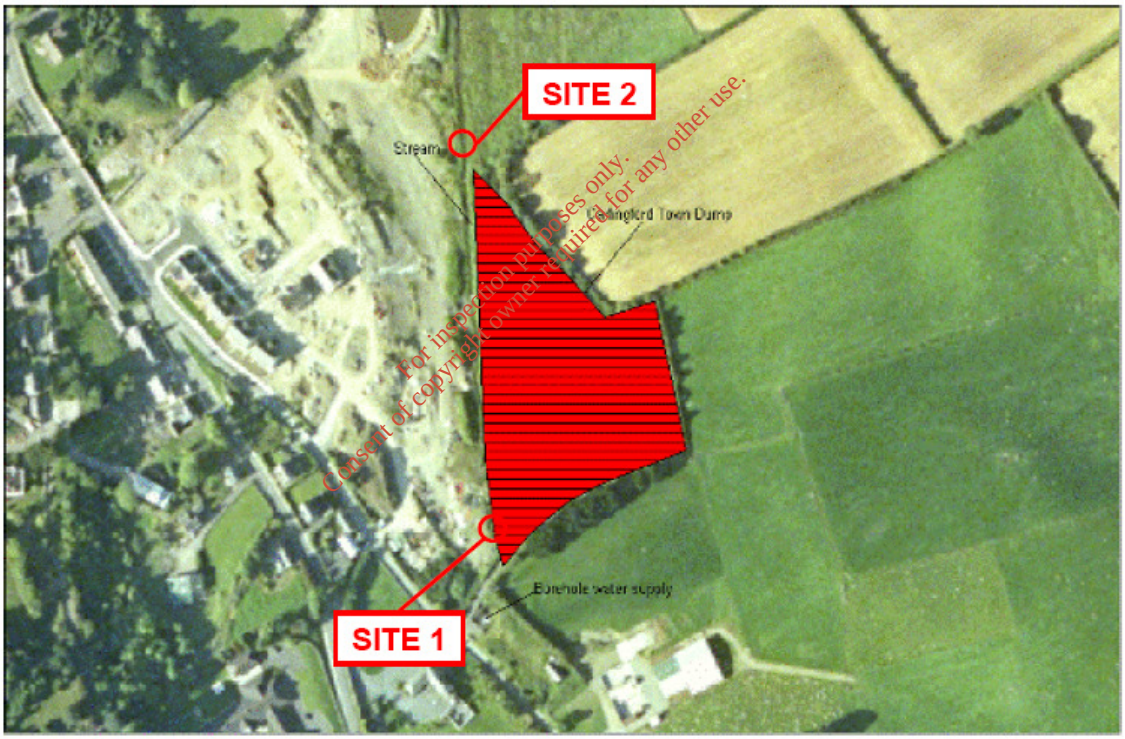
Fig. 2 Locations of sampling sites

Site 1 is located a short distance downstream of the upstream limit of the former landfill. A site immediately upstream of the landfill was not possible as the stream is culverted upstream of the former landfill. Site 2 is located immediately downstream of the former landfill Grid references were recorded at all sites using a GPS.
