FIGURE 5.1 KNOCKCRONAGHAN HISTORIC LANDFILL

CONCEPTUAL SITE MODEL

TIER 1 ENVIRONMENTAL RISK ASSESSMENT

HISTORIC LANDFILL AT KILLYCRONAGHAN LANDFILL CO. MONAGHAN

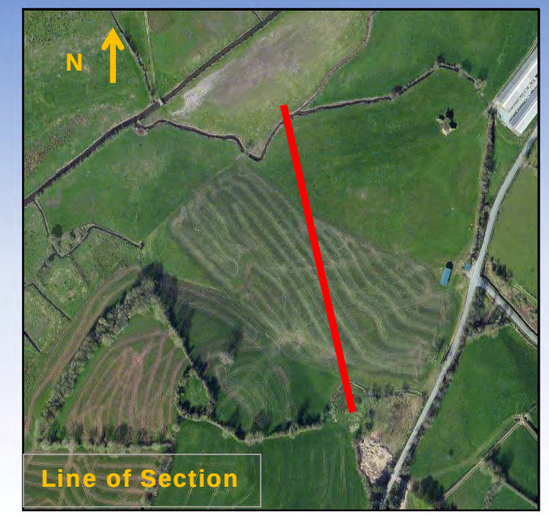
Based on this, the site can be classified as a **High Risk Classification (Class A)**. The principal risks identified on the site are the risk posed to on-site and off-site users of the identified agricultural buildings from migration of landfill gas from the waste material encountered at the site, the shallow permeable landfill cap across the site and the risk to the groundwater aquifer from the migration of leachate from the waste body.

Based on the presence of elevated ammonia and dissolved metal concentrations typical of landfill leachate, the shallow soil cap is not considered suitable at preventing rainfall infiltration into the waste body. The groundwater table also appears to be intersecting the waste body and therefore contributing to leachate migration from the landfill.

It is therefore recommended by FTC that a Tier III DQRA be undertaken for the site in conjunction with an application for a Certificate of Registration for this site.

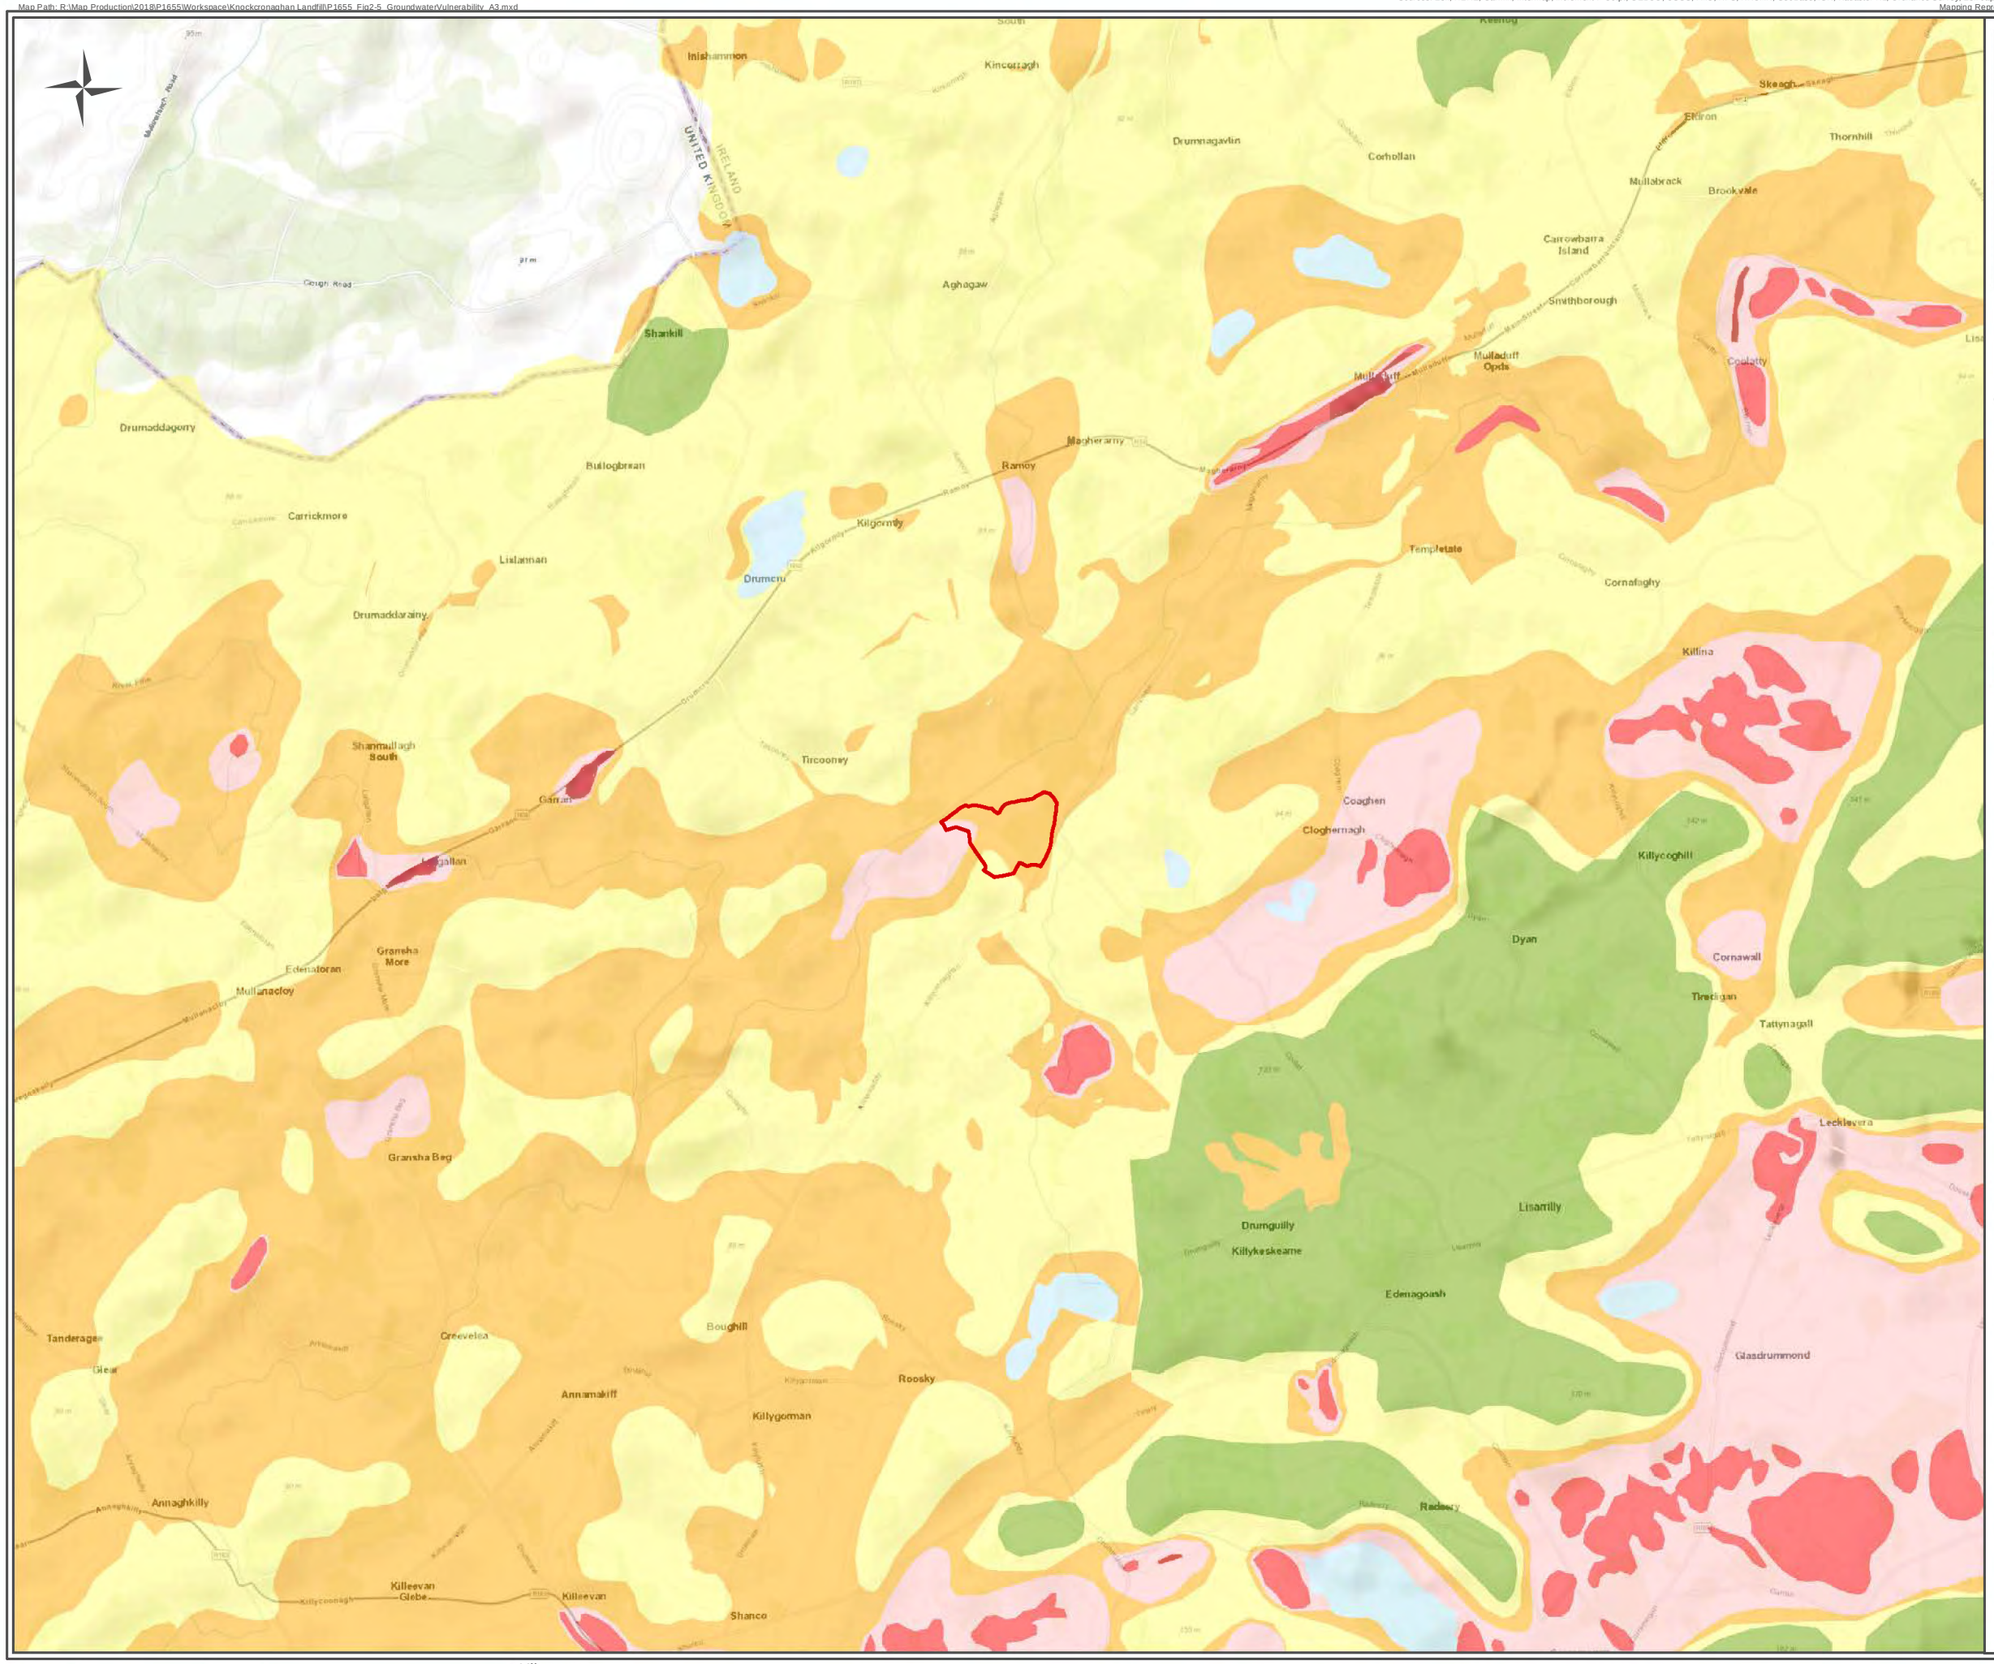
Figure No. 2.5

The Cooldaragh formation is classified as a Regionally Important Aquifer – Fissured Bedrock (Rf). The aquifer vulnerability of the site is high. The vulnerability at the drumlins themselves is lower due to the thicker subsoils comprising the drumlins.
