ASSESSMENT OF FILLED SUBSOILS FOR WASTE LICENCE APPLICATION AT NAUL, COUNTY MEATH

**ASSESSMENT OF FILLED SUBSOILS FOR WASTE LICENCE APPLICATION
AT
NAUL, COUNTY MEATH**

FINAL REPORT

Report Title: Assessment of filled subsoils for Waste Licence Application at Naul, County Meath

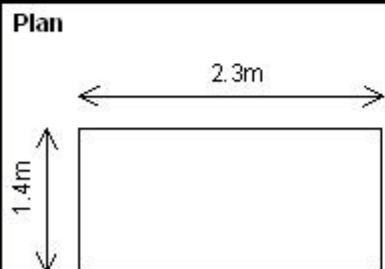
1.5								
2.0							Trial pit completed at 2.22m on dark greyish brown, massive, stn boulder clay 'fill'.	
2.22								
2.5								
3.0								
3.5

Bearing : 84° (W-E)

Stability :
 Trial pit walls very consolidated, and material very competent.

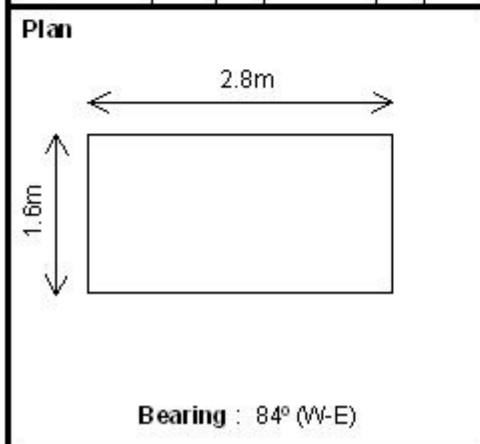
Trial pit completed at 2.5m on very dark greyish brown, massive, stiff boulder clay 'fill'.
3.0								
3.5								
4.0								
4.5								
5.0

Stability :
 Trial pit walls very consolidated, and material very competent.

General remarks :
 Dug in eastern portion of the northwestern dry, grass-covered, 'reclaimed' field. Dug on a 3° slope, falling north-northeastwards.

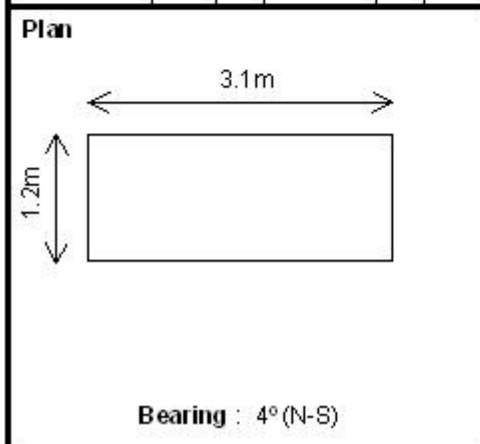
Stability :
 Trial pit walls very consolidated, and material very competent.

General remarks :
 Dug in northeastern portion of the dry, grass-covered 'reclaimed' field. Dug on a 3° slope, falling north-northeastwards, in a low area.

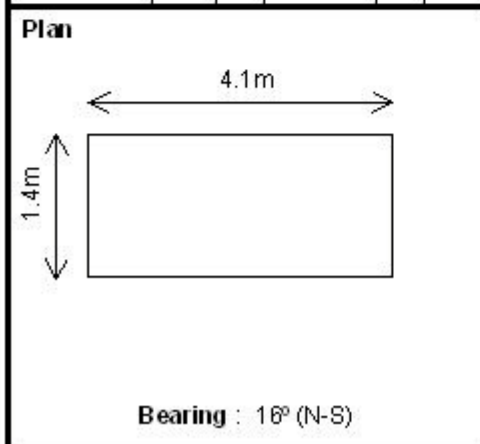
Stability :
 Trial pit walls very consolidated, and material very competent.

General remarks :
 Dug in southeastern portion of the forestry area. Dug in a flat locality, where trees are growing.
