### PAVEMENT ASSESSMENT SURVEY

ON 1.9 KM SECTION OF THE L6042,  
FROM THE JUNCTION  
WITH THE L2023 SOUTHEASTWARDS TO  
WALSHESTOWN, CO. KILDARE

October 2009

09 5071 50022

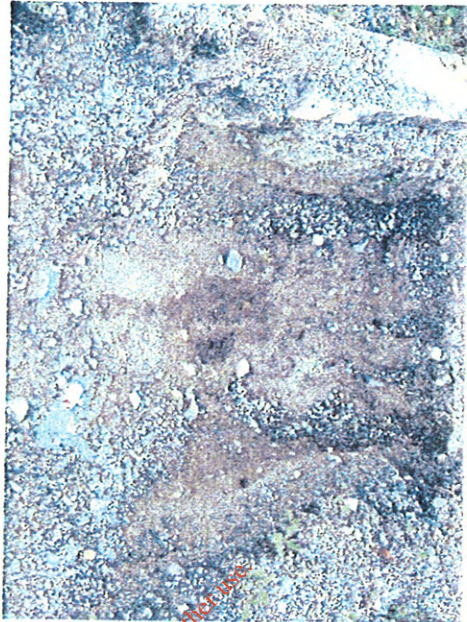
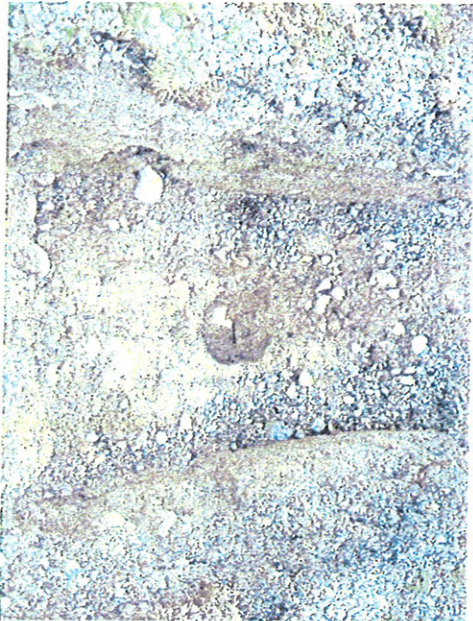
Trial Hole & Existing Building

During the assessment the existing septic tank on site was inspected and found not to meet the EPA Guidelines and therefore it is considered unsuitable for continued use and will need to be replaced with a new system.

It was noted that the soil structure in the trial hole for the first 0 – 0.8 / 1.0m of subsoil was very compact and most likely have been compacted over time by use of heavy traffic over time while the quarry was in operation.

<i>Ground Condition</i>	Very firm mainly hardcore / gravel based surface
<i>Comments on above information incorporation desk study information:</i>	
Surface waters are a target. Fast flowing stream passes front of the site.	
Limited usage of an on-site system will reduce risk.	
Existing septic tank old, single chamber and considered unsuitable - will need to be replaced

In addition as per the recommendations in Section 5.0 of the Site Characterisation Form it is advised that the subsoil be loosened to a minimum depth of 1.5m and that the percolation area is fenced off to prevent heavy traffic from causing any damage by compression to the area.

With no water in the trial hole and good soakage recorded in the percolation tests the site is suitable for an on-site sewage system subject to good practice. The existing septic tank is considered unsuitable and should be replaced. Taking into consideration the surface waters it is recommended to install an Advanced Treatment System discharging the effluent to a constructed subsurface polishing filter. The base of the trenches should be positioned between 0.8/1.0m. The system must be installed in accordance with the EPA Waste Water Manual for Domestic Houses.
