# **Annual Environmental Report 2009.**

**Licence Register No.** PO 406-02

**Licensee:** Bailieboro Foods Limited and  
Bailie Foods Ireland Limited.

**Location of Activity:** Lear, Bailieborough, Co. Cavan

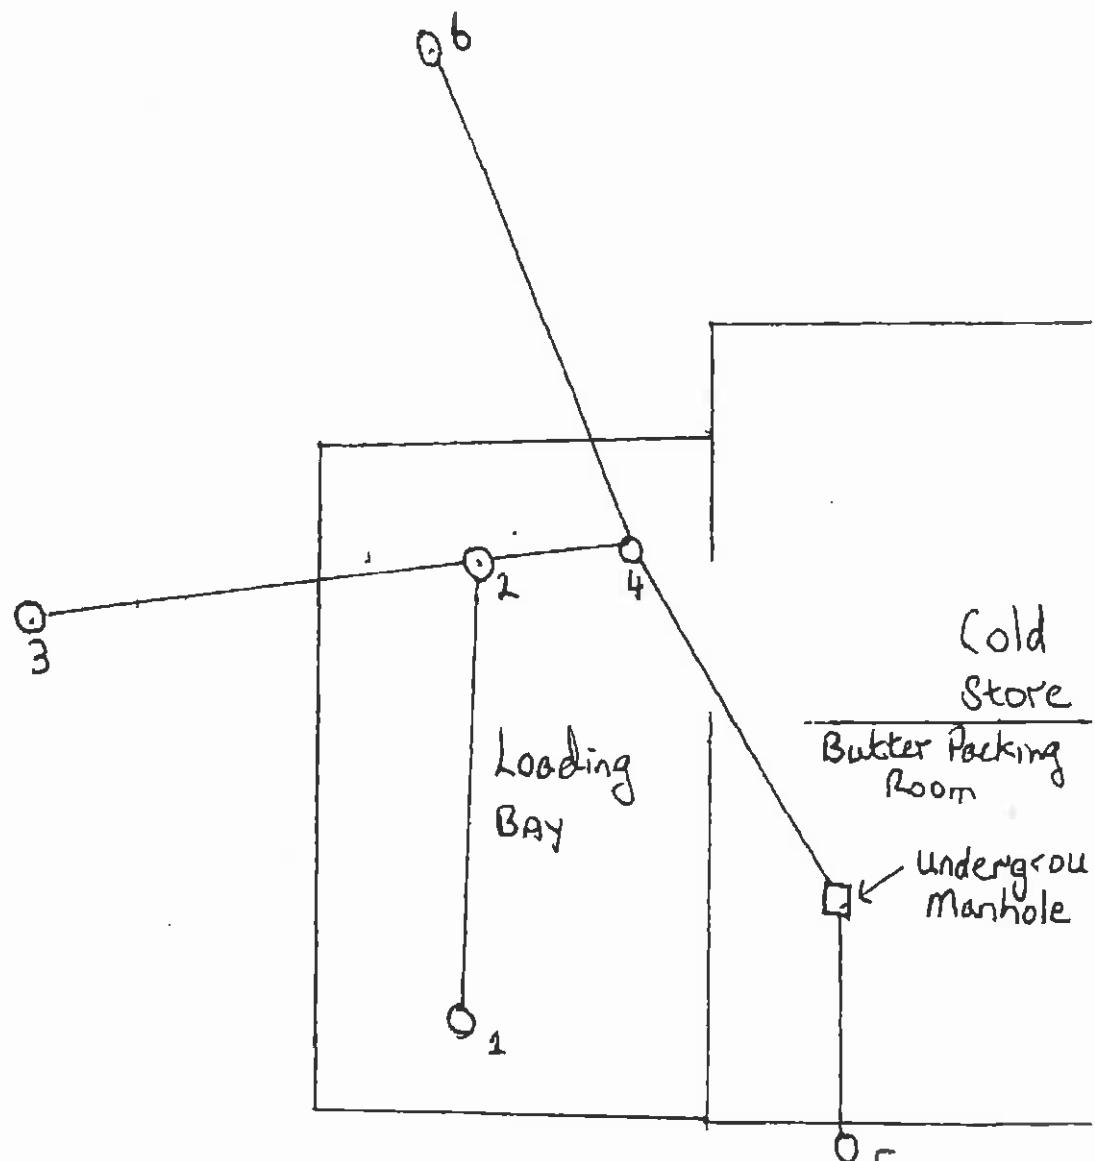
Creamery Surface Water

Road Gully is Tared over

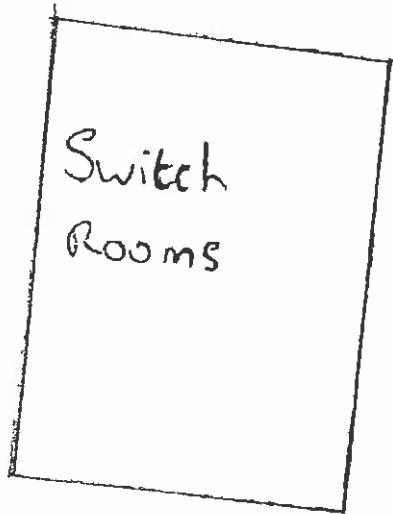
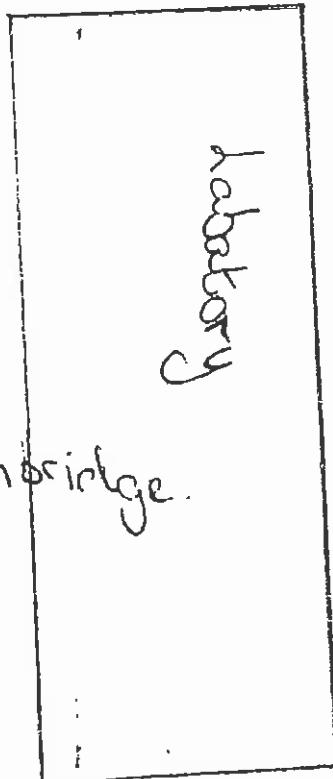
Creamery Surface water

Surface WATER Manholes we put  
Numbers To. Also show Manhole Underground  
In Butter Packing Room

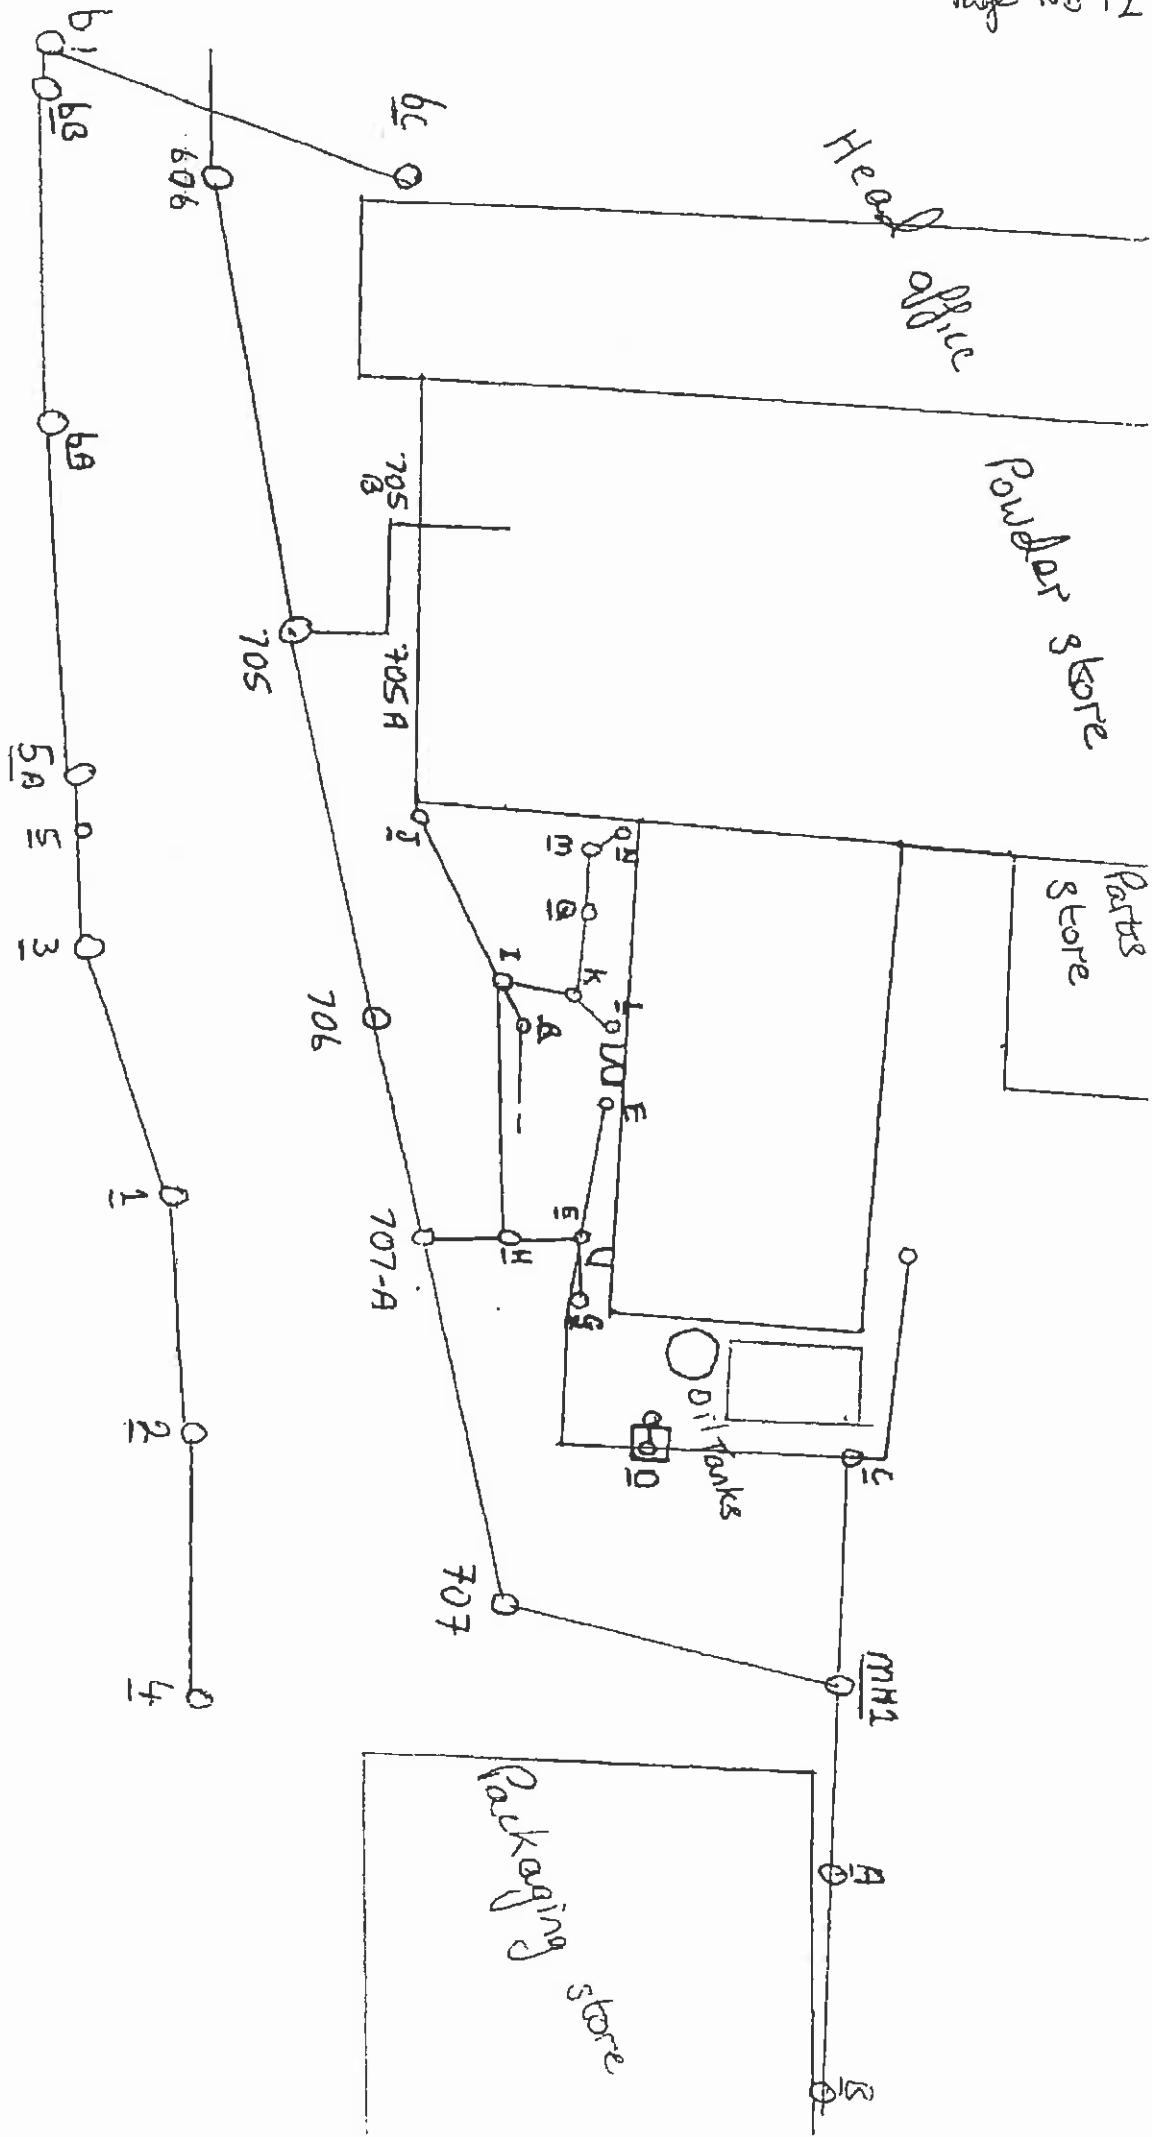
Effluent line from Manhole 22 → Effluent Tank Could Not be Surveyed  
Because of Constant Flow of Effluent

We have Numbered Manholes Not Previously Numbered - Storm MH 1 - A - B - C - D - E - F - G - H - I - J - K - L - N - M - O - Q - R  
 Also along lawn - MH 1 - 2 - 3 - 4 - 5 - SA - 6 - 6A - 6B - 6C. - Sewer line 705 - 705A - 705B - 706 - 706A
