R&A Bailey
IPPC Licence No. P0807-01

Annual Environmental Report
2011

2011 Boiler Combustion Testing Report	29
ATTACHMENT 2	30
2011 Noise Report	30
ATTACHMENT 3	31
Bund Integrity Assessment Report 2011	31

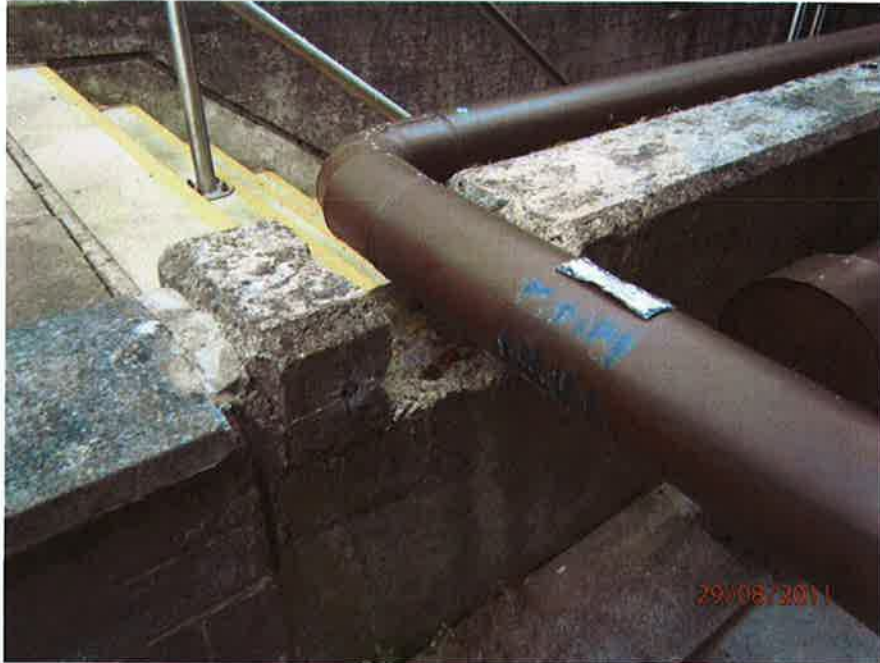
Figure 2.4: Bund 02 – Outlet pipe from CBST 4 running over stairs of ductway

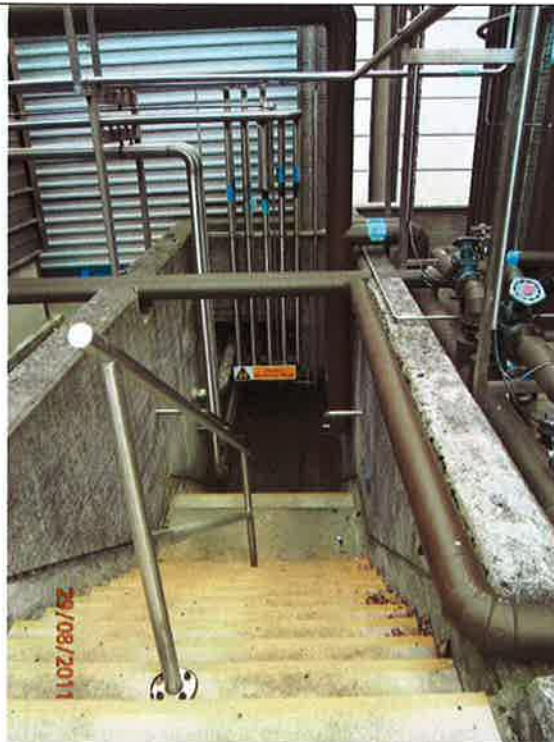
Figure 2.5: Bund 02 – View of underground piping ductway to the west of Bund 02

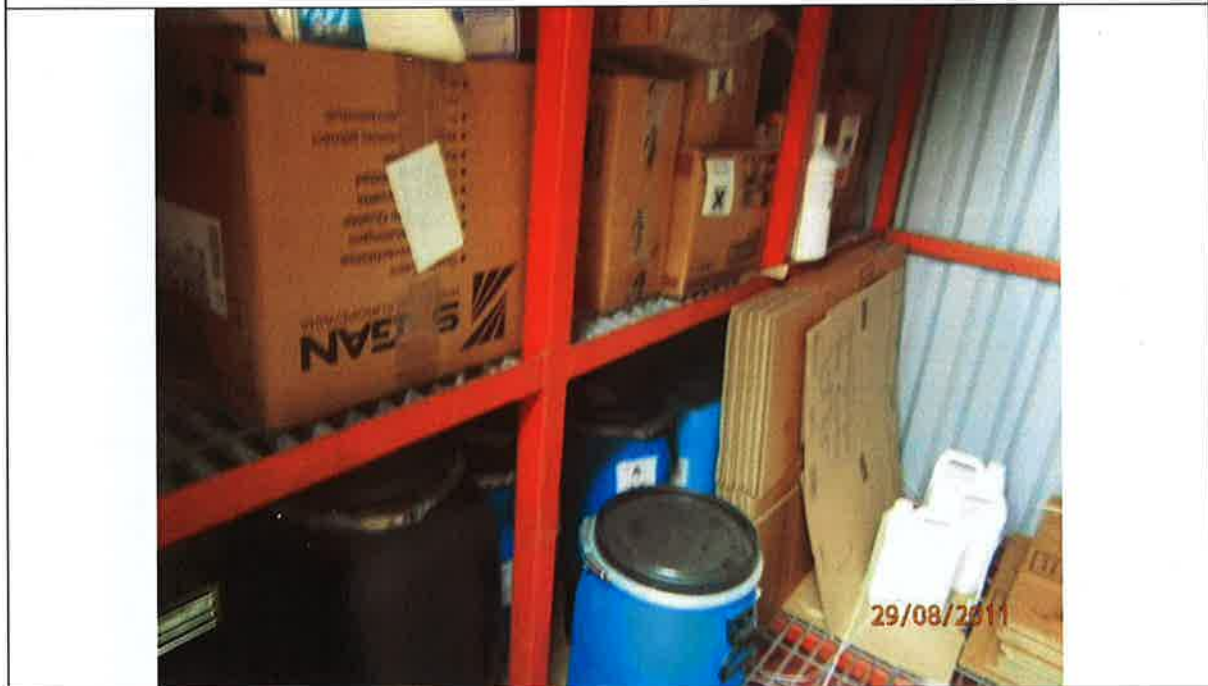
Figure 5.2: Bund 05 – Interior of bunded container

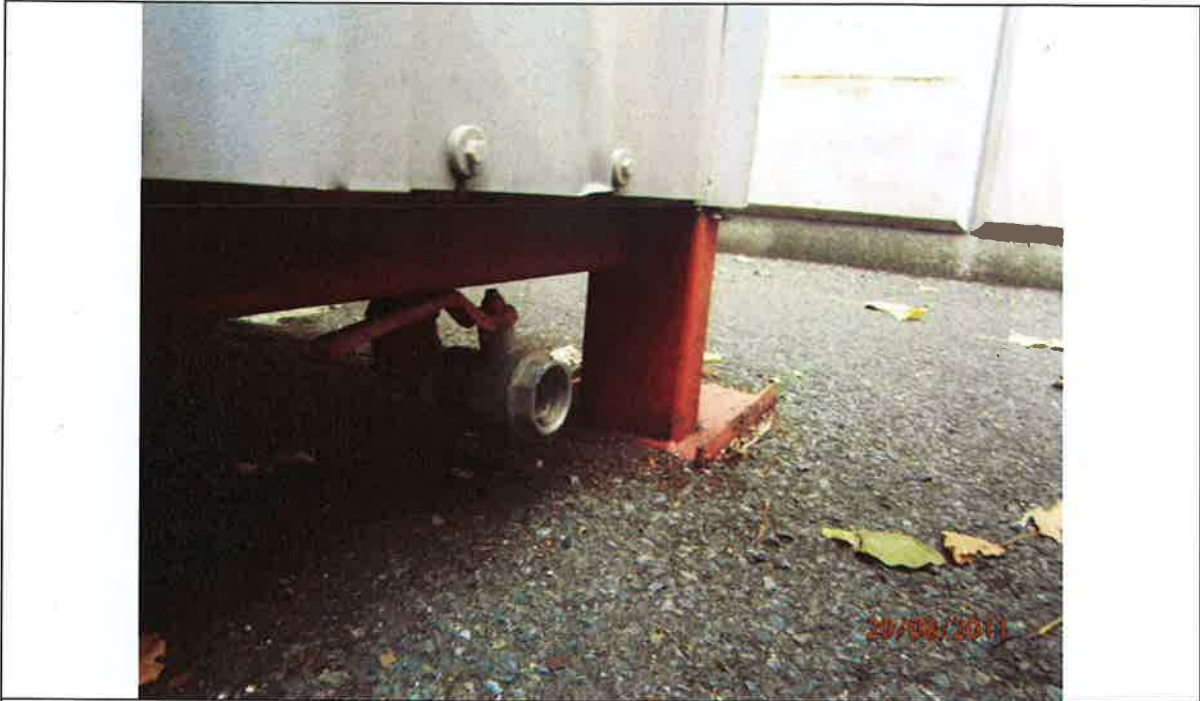
Figure 5.3: Bund 05 – Bund outlet, now with valve

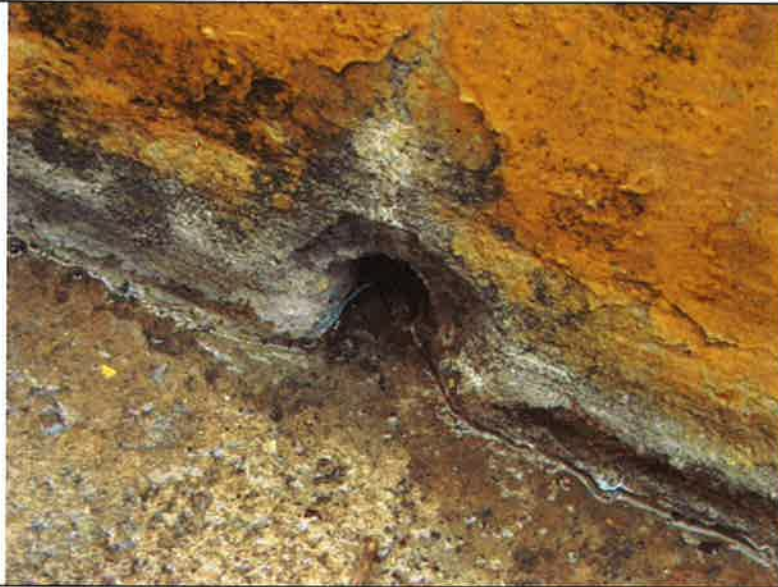
Fig. 8.2: Bund 08 - Hole on NE corner of bund

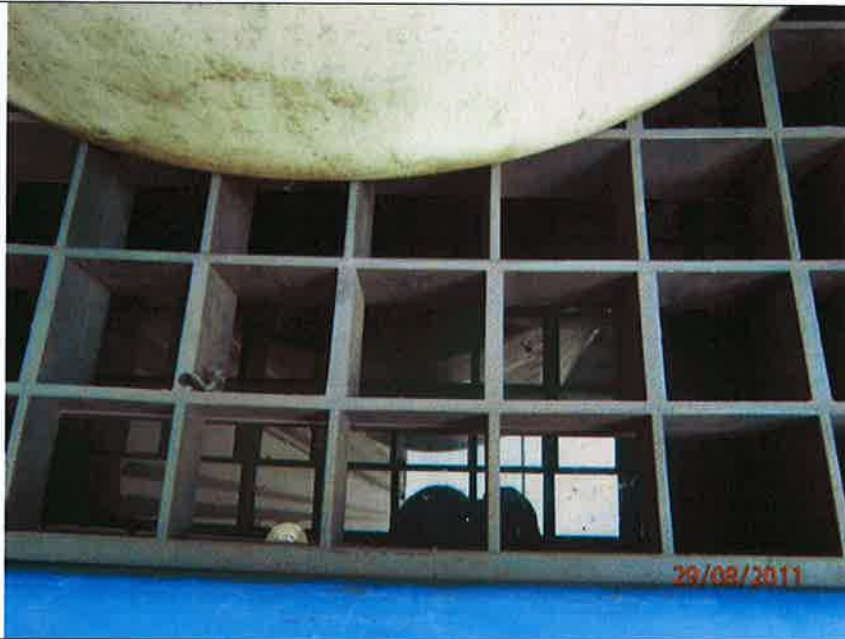
Fig. 18.3: Liquid within Bund 18 reducing bund capacity (same applies to Bund 19)

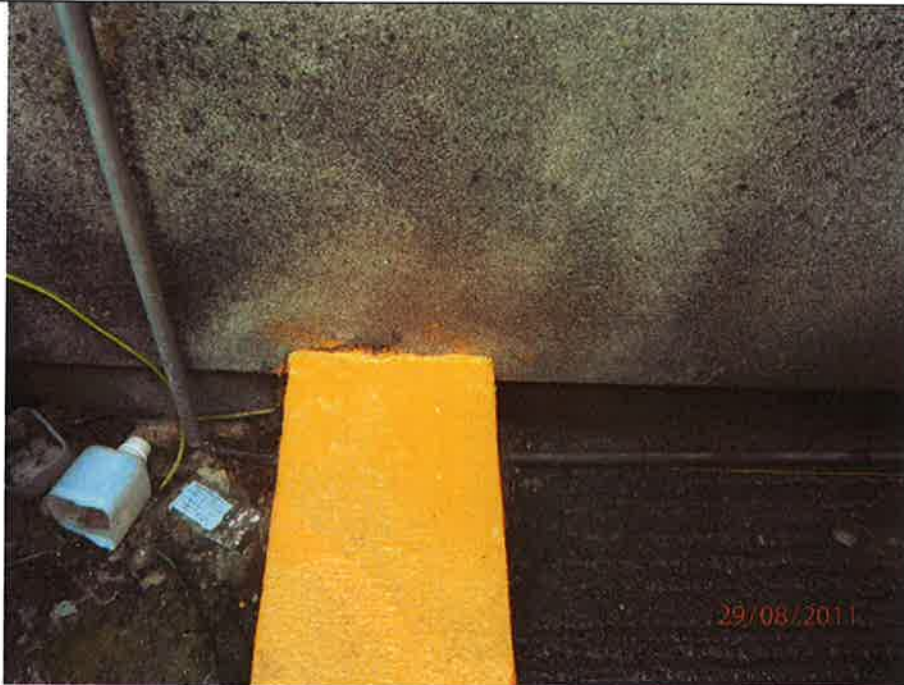
Fig. 20.2: Water draining into Bund 20 from Cooling Towers

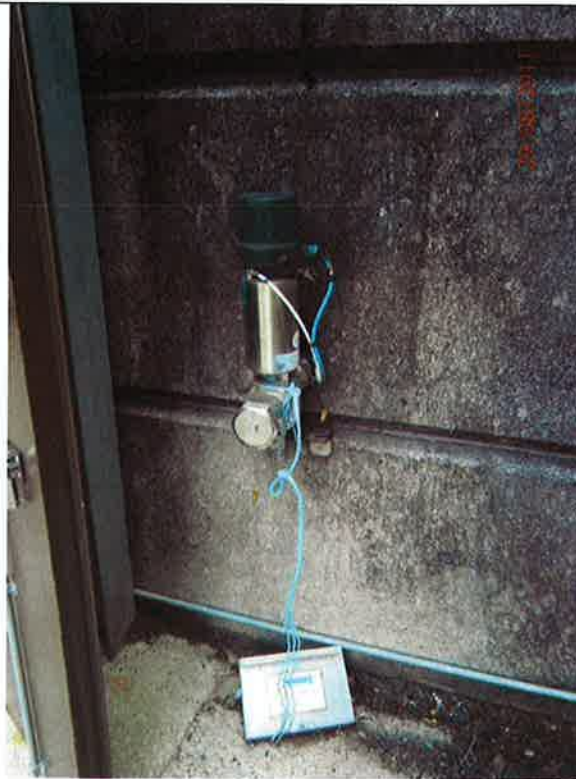
Fig. 23.1: Bund 23

Company: Diageo Baileys Global Supply		Bund Location:	
Site: DBGS, Nangor Road		To north of site behind Bottling Hall	
PM Bund Ref. No.: Bund 23 Ethanol Intake Area		Photo: Fig. 23.1 – 23.3	
Bund Dimensions: 19.2m x 3.3m x 0.7mH		Vessel(s) – Materials of Construction: Metal tanker	
Bund Materials of Construction: Unknown, assumed concrete		Vessel(s) – Total Storage Volume: 20m ³	
Bund Lining Material: N/A		Vessel(s) – 110% of Volume of Largest Vessel: 22m ³	
Bund Retention Volume: Sump 45m ³		Vessel(s) – 25% of Total Storage Volume: 5m ³	
Tank Contents: Ethanol (50%)	WGK Class	Risk Phrases	Haz Category
	1	R11	A
Compatibility of Chemicals in Bund: Ethanol only			
Results of Visual Inspection		Date of Visual Inspection: 29/08/2011	
<u>Bund & Tank Integrity:</u> Bund located underground – could not be fully inspected.			
<u>Bund Drainage System:</u> Combined bunding – local bunding is provided in the form of the 45m ³ sump. The sump drains via a manual valve to the effluent plant.

<u>General Observations:</u> Approx. 10cm (6.5m ³) of liquid retention visible in bund. Intake connection point appears to be outside bunded area (see Fig. 23.2) – therefore leak in connection pipe could lead to discharge to SW. There is a sprinkler system around intake area for protection in the event of an ethanol fire. Potential issue of sprinkler water escaping catchment should be addressed in a Fire Water Run-off Risk Assessment. Drains appear to be blocked with a build up of silt. Doubt over integrity of bund raised by site Environmental Manger.			
Housekeeping Issues:			
Deemed necessary/practicable to conduct hydrostatic test? Yes / No			
If no, give reasons: The local sump can be integrity tested.			
Results of Hydrostatic Test: N/A		Date of Hydrostatic test: N/A	
Action Required: Investigate integrity of bund and Hydrostatic test. (P) Move inlet connection point so it is positioned over bunded area, or kerb area around connection point so any spills from it are directed to the underground sump (P). The local sump should be hydrostatically tested every 3 years. A regular emptying procedure for the sump should be in place to ensure retained rainwater does not reduce the retention capacity below 22m ³ . Potential issue of sprinkler water escaping catchment should be addressed in a Fire Water Run-off Risk Assessment.

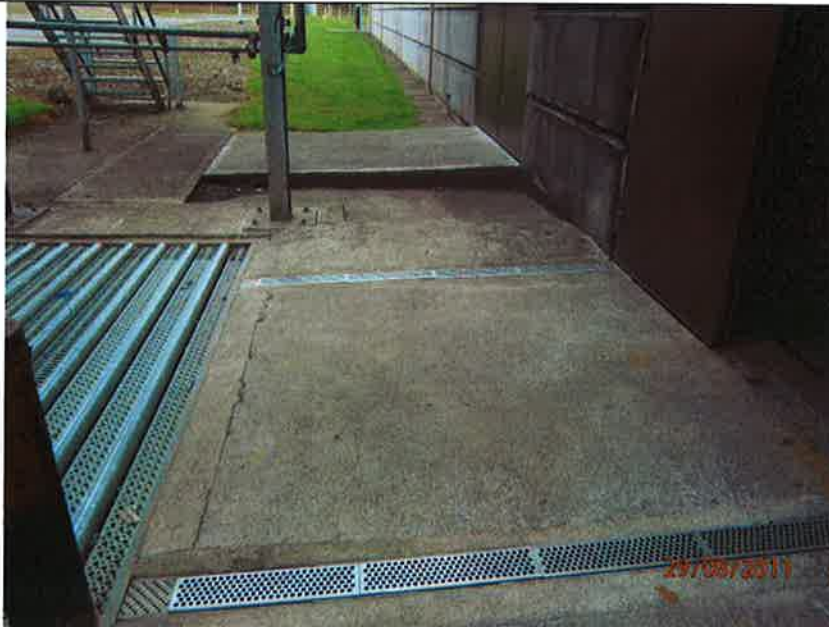
Fig. 23.2: Bund 23 – connection point for delivery, not within containment area

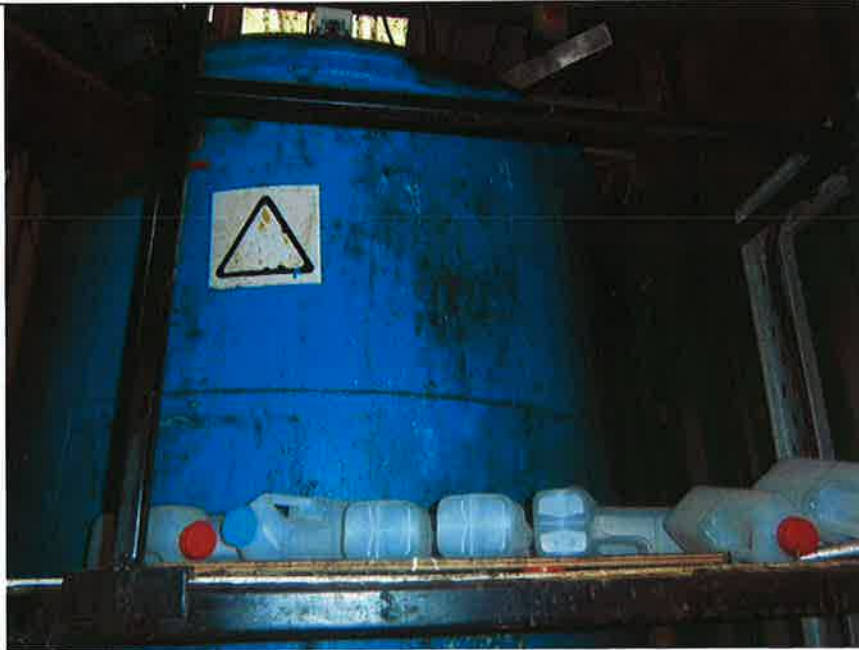
Fig. 23.3: Bund 23 – uncontained area between bund and delivery connection point

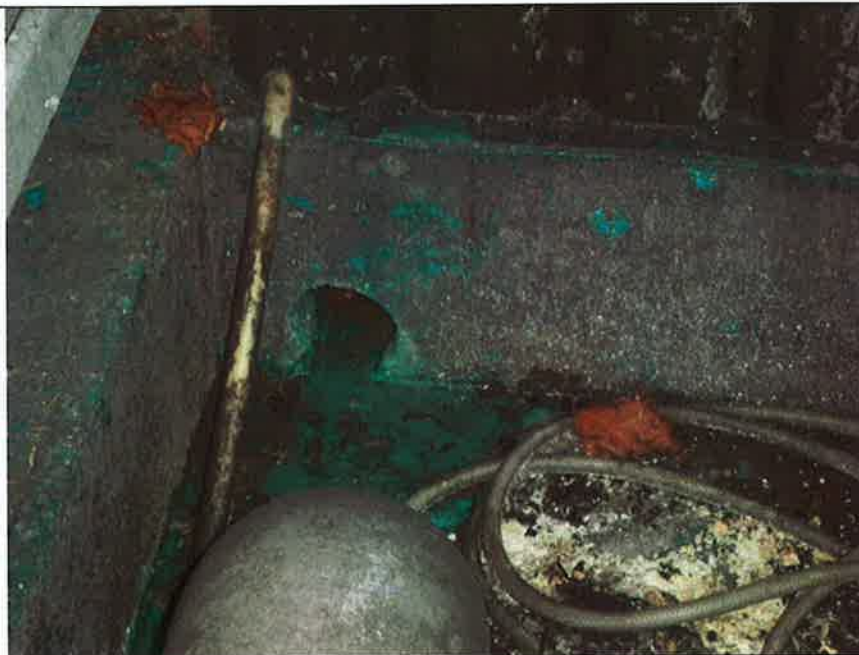
Fig. 24.2: Bund 24 – Hole in SW corner of bund

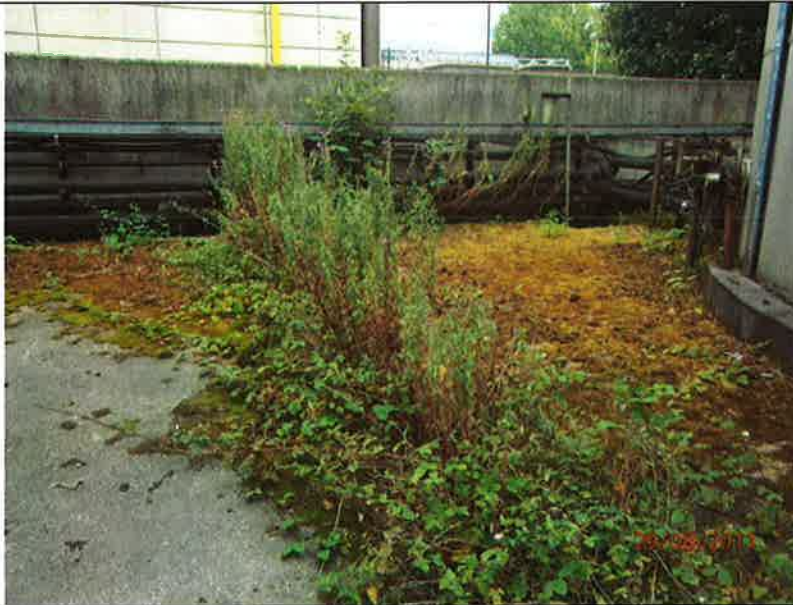
Fig 28.2: Bund 28 – Significant mossy growth and foliage coverage in bund (drainage channel filled with plant growth)

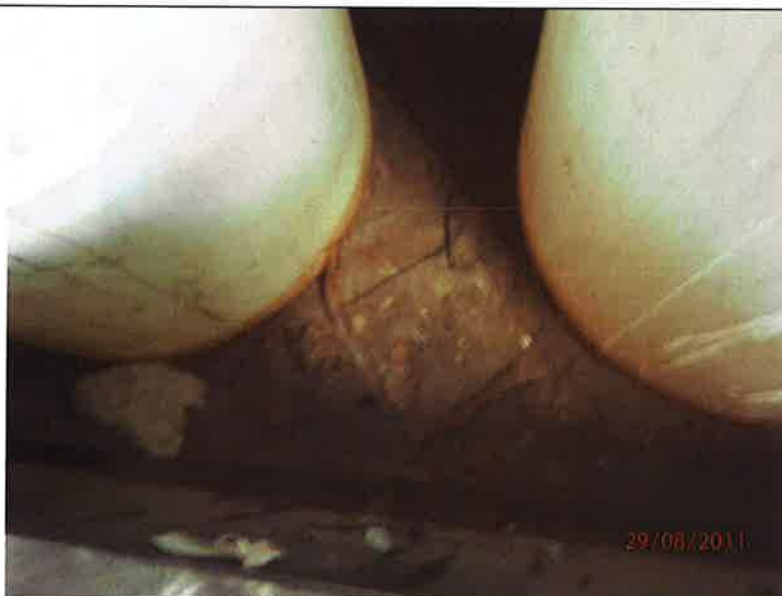
Fig 29.2: Bund 29 - Debris in base of bund

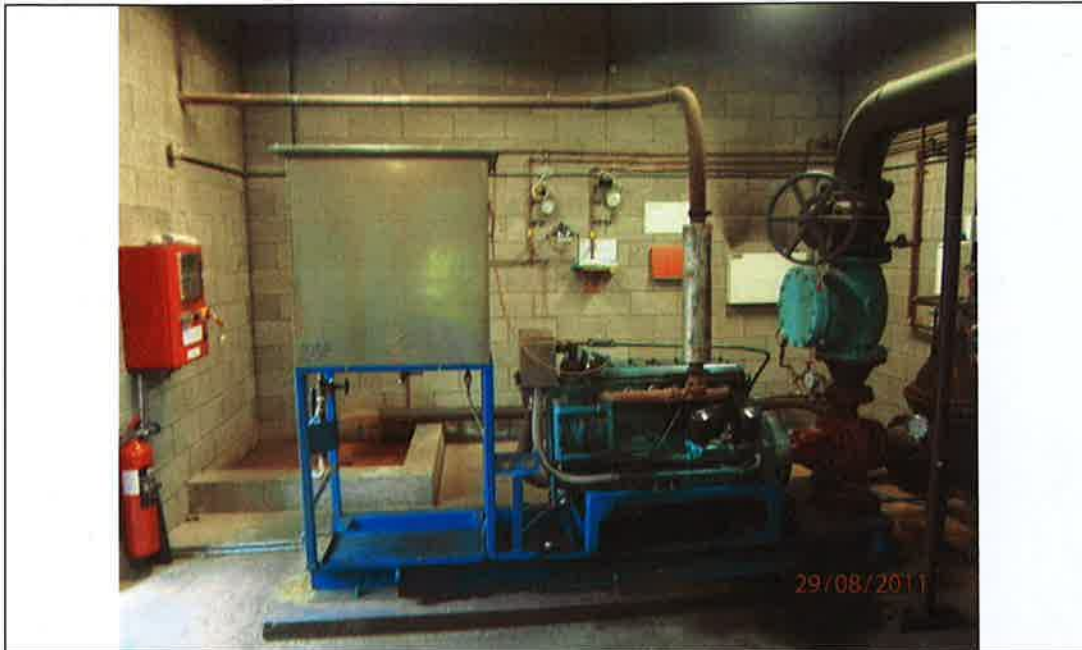
Fig 30.2: Bund 30 – Diesel tank and pump in Sprinkler Pump House

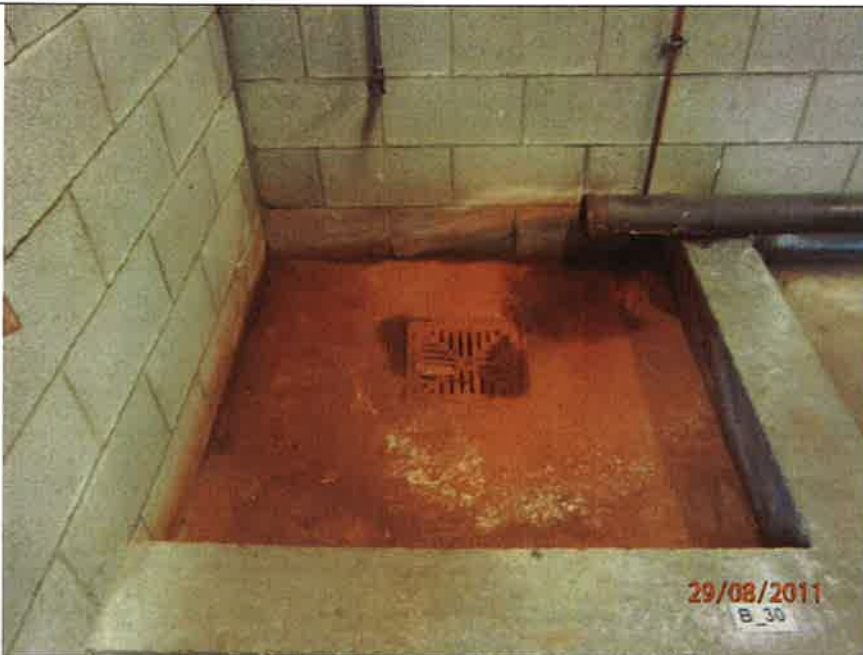
Company: Diageo Baileys Global Supply		Bund Location:	
Site: DBGS, Nangor Road		Western side of Boiler House	
PM Bund Ref. No.: Bund 30 Sprinkler Pump Room		Photo: Fig. 30.1 – 30.5	
Bund Dimensions: N/A		Vessel(s) – Materials of Construction: Stainless Steel	
Bund Materials of Construction: N/A		Vessel(s) – Total Storage Volume: 350l	
Bund Lining Material: N/A		Vessel(s) – 110% of Volume of Largest Vessel: 385l	
Bund Retention Volume: N/A		Vessel(s) – 25% of Total Storage Volume: 87.5l	
Tank Contents: Diesel Tank 350l	WGK Class	Risk Phrases	Haz Category
	2	R40	A
Compatibility of Chemicals in Bund: Diesel only			
Results of Visual Inspection		Date of Visual Inspection: 29/08/2011	
<p>Bund & Tank Integrity: Tank is in good condition – no visible cracks or leaks and ground around tank dry. Pump house also contains a diesel pump and electric pump. Residue of diesel/oil around pump.</p> <p>Bund Drainage System: No bunding around diesel tank or pump – in the event of a leak from tank or pump the diesel would flow under gap in Pump House door and into surface drainage in yard. Electrical cabling pass through wall at ground level in Northern corner of room.</p> <p>General Observations: Underground ductway for fire water pipes is covered but not sealed - in the event of a leak from tank or pump it is likely that diesel would flow into this ductway.</p> <p>Miscellaneous oil drums stored in the Pump House.</p> <p>Effluent drain for test water in NW corner of pump house.</p>

Fig 30.5: Bund 30 – Drain to effluent for water used in sprinkler pump test

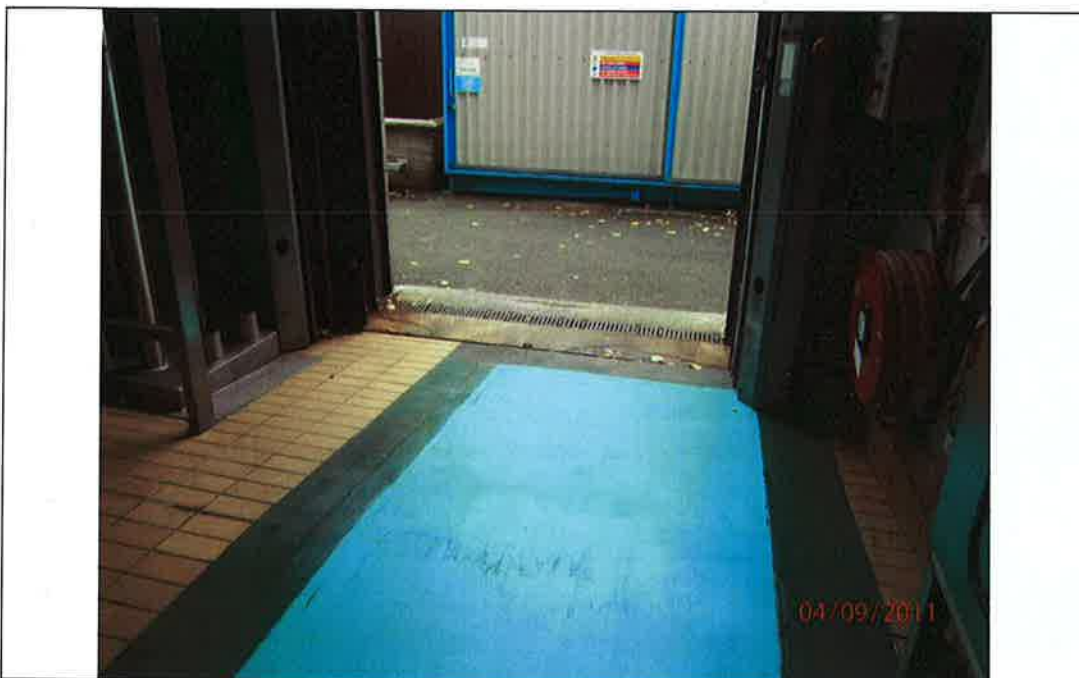
Fig. 32.1: Bund 32 - Slope from Process area to roller door out to yard on south side of site

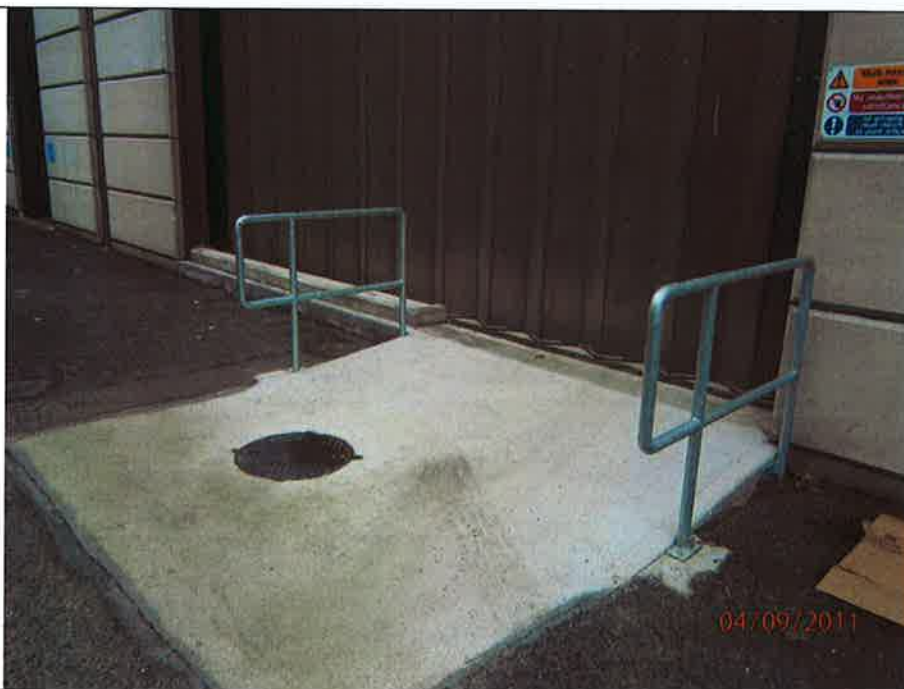
Fig. 32.2: Bund 32 – Kerbing and provision of Aco drains at concertina door

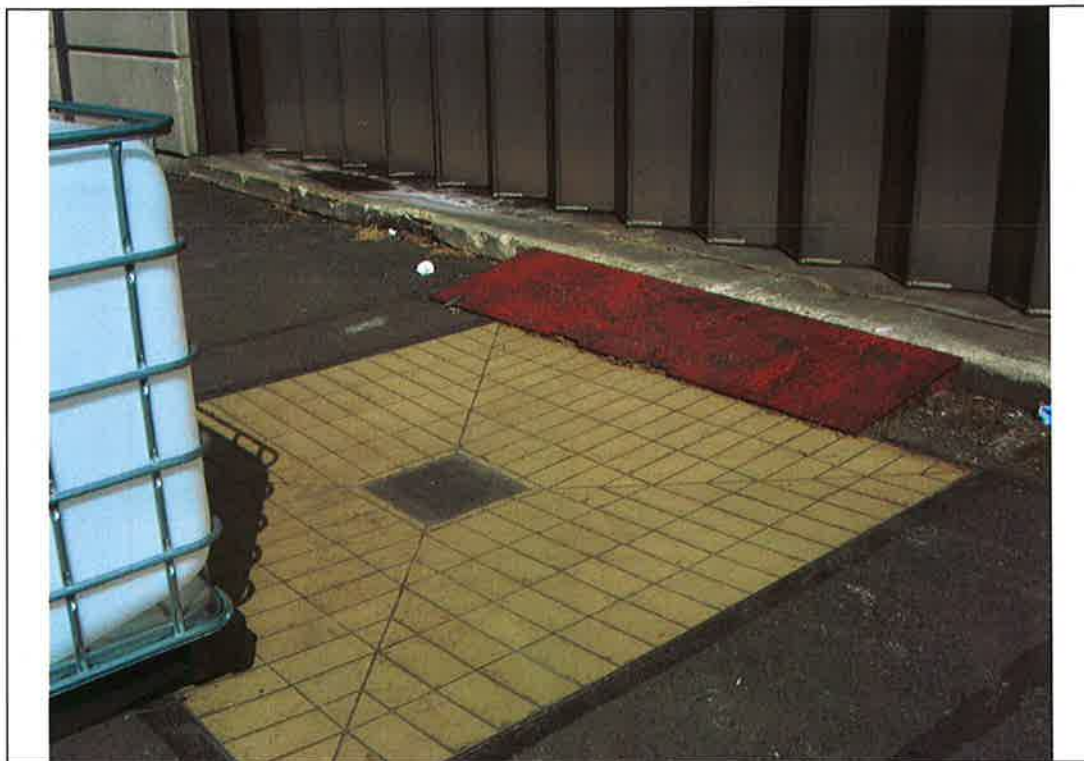
Company: Diageo Baileys Global Supply		Bund Location:			
Site: DBGS, Nangor Road		Process Area			
PM Bund Ref. No.: Bund 32 Process Tanks in Process Area		Photo: Fig. 32.1 – 32.4			
Bund Dimensions: N/A		Vessel(s) – Materials of Construction: Stainless Steel			
Bund Materials of Construction: N/A		Vessel(s) – Total Storage Volume: Approx. 800m ³			
Bund Lining Material: N/A		Vessel(s) – 110% of Volume of Largest Vessel: 77m ³			
Bund Retention Volume: N/A		Vessel(s) – 25% of Total Storage Volume: 200m ³			
Tank Contents:		WGK Class	Risk Phrases	BOD Load	Haz Category
Various Process Tanks (approx. 800m ³)		Unknown	Unknown	Unknown	Unknown
Compatibility of Chemicals in Bund: General Foodstuffs – no compatibility issue					
Results of Visual Inspection		Date of Visual Inspection: 29/08/2011			
<p>Bund & Tank Integrity: Tanks are generally in good condition. There are several effluent drains in the process area but no real containment in the event of a significant spill leak. There are three exits points from the area for spilled liquids – a roller door on the south side, a concertina door on the southside and a roller door on the west side of the building. The roller door on the west side leads to the outside area beside the sugar silos – this area is surrounded by Aco drains that lead to the effluent plant and there is a containment ramp also in this area protecting the nearest surface water drains. The concertina door on the southside has been modified since the last bund survey so that there is now an Aco drain across part of it and the rest of the doorway has been kerbed to direct any runoff into this drain. The roller door on the south side has an Aco across its full width.</p> <p>General Observations: There is a drain immediately outside the concertina door which drains to effluent.</p>

Fig. 32.3: Bund 32 – Effluent drain outside process area on south side

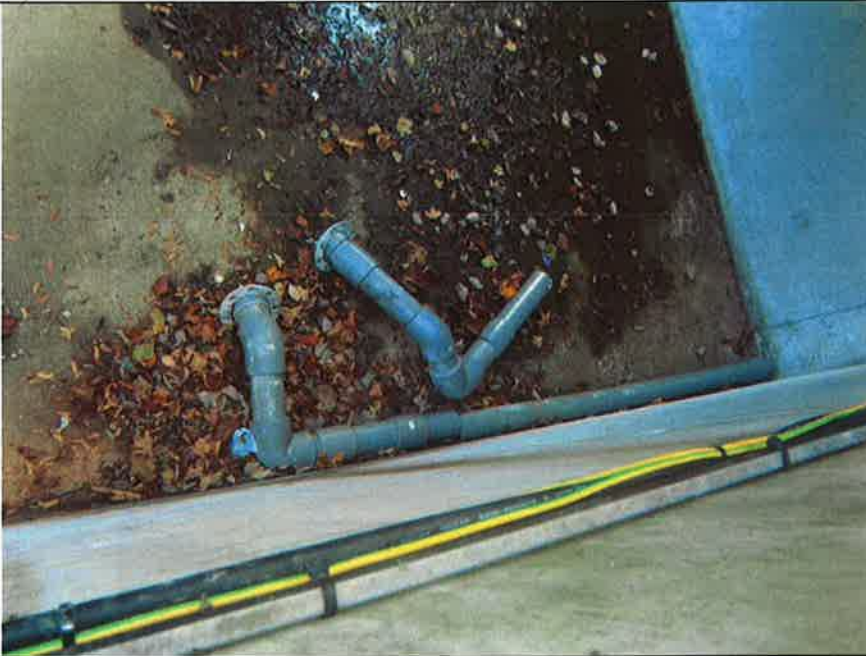
Company: Diageo Baileys Global Supply		Bund Location:	
Site: DBGS, Nangor Road		Effluent Plant	
PM Bund Ref. No.: Bund 37 Effluent Treatment Plant		Photo: Fig. 37.1 & 37.2	
Bund Dimensions: 11.6m x 11.85m x 2.45mH		Vessel(s) – Materials of Construction: Steel	
Bund Materials of Construction: Concrete		Vessel(s) – Total Storage Volume: 335m ³	
Bund Lining Material: N/A		Vessel(s) – 110% of Volume of Largest Vessel: 363m ³	
Bund Retention Volume: 337m ³		Vessel(s) – 25% of Total Storage Volume: 83.8m ³	
Tank Contents: Process effluent (approx 330m ³) Acid/Caustic Tank (approx 5m ³)	WKG Class	Risk Phrases	Haz Category
	Unknown	Unknown	Unknown
Compatibility of Chemicals in Bund: Effluent only			
Results of Visual Inspection		Date of Visual Inspection: 12/10/2011	
<p>Bund & Tank Integrity: Tank and bund in very good condition. There is no evidence of any cracking or structural damage on the walls or the floor of the bund and there does not appear to be any leaks into the bund from vessels contained within.</p> <p>Bund Drainage System: No drainage from bund to outside of bund.</p> <p>General Observations: Small build up of rain water and organic debris on the floor of the bund</p>

Fig. 37.2: Piping off-cuts in base of bund
