Roadstone Ltd  
Fortunestown,  
Tallaght,  
Dublin 24.

**A.E.R. W0269-01**

**Re: 2014 Annual Environmental Report for W0269-01, Fassaroe Waste Recovery Facility**

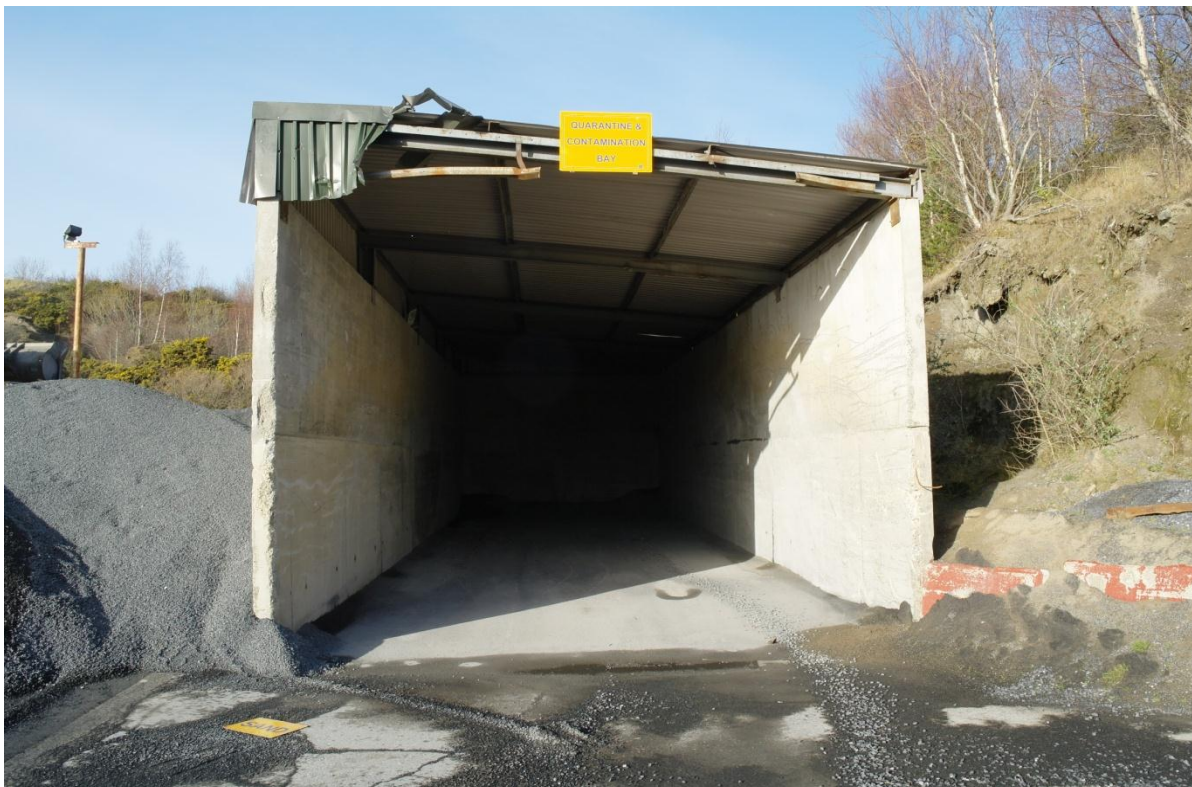
**Photo 4 – Quarantine and Contamination Bay**

The licensee has provided a waste quarantine and contamination bay that consists of a building with mass concrete floor and walls (see Photo 4 below). Non compliant wastes can

These mitigation measures reduce the risk of occurrence of this event from 'medium' to 'low'.
