Attachment E.1(iii): Site description of two potential sea disposal sites off Hook Head Report, Aquafact Ltd, November 1998

Site description of two potential sea disposal sites off Hook Head, Waterford Harbour

Attachment E.1(iv): Surveys of the Dredge Spoil Dump Site, Aquafact Ltd, 1996

**Photographic And Visual Survey Of The Seabed
In The Areas Of And Around A Dumpsite
In Waterford Harbour.**

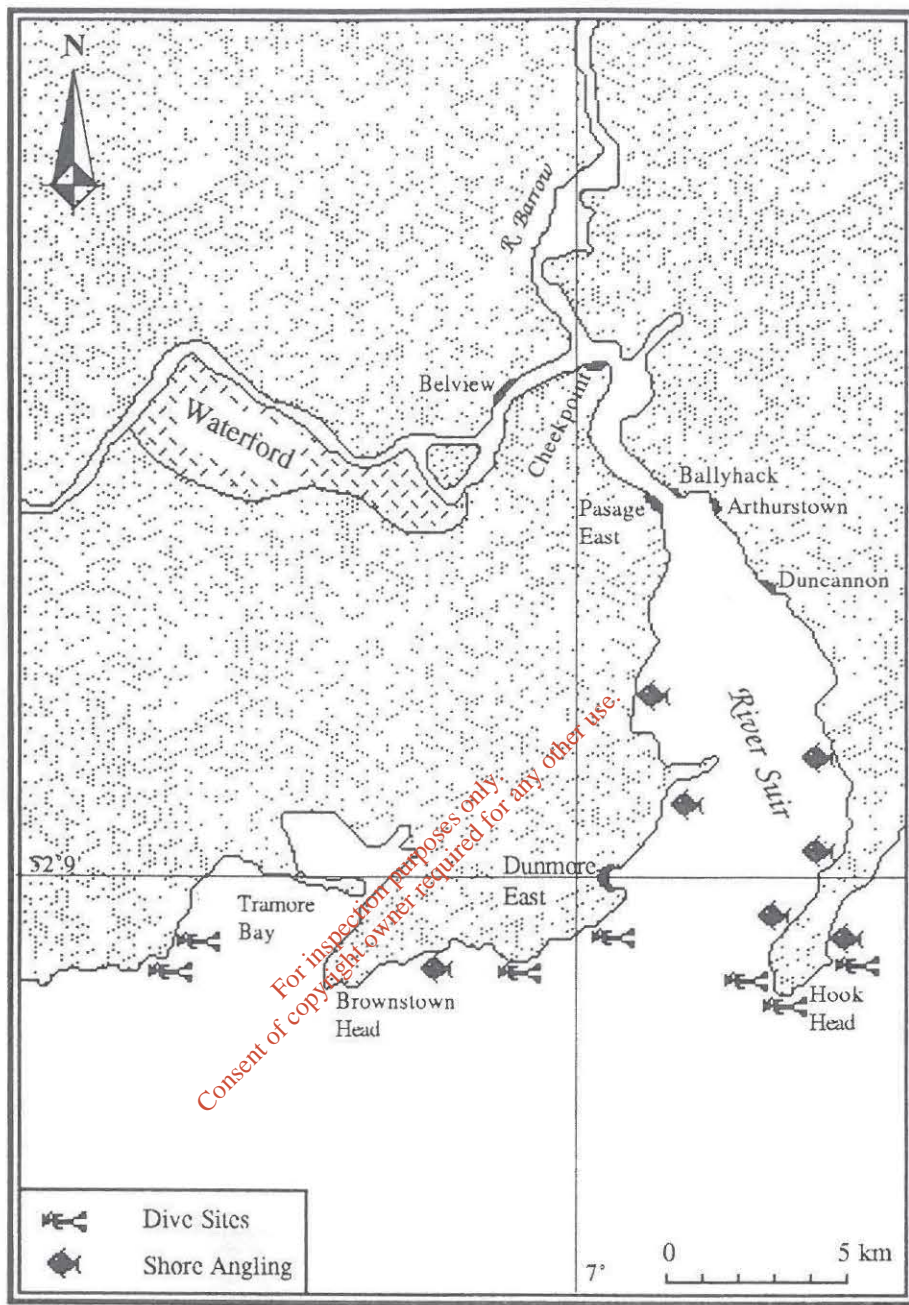
Figure 2 outlines dive and angling sites from the vicinity of Waterford Estuary. Hook Head is a high amenity area in terms of S.C.U.B.A. diving due to its ease of access and to the prominent fauna and flora found there. Doonoge Point, located just south of site 1 is listed in the Guide To Irish Dive Sites by The Underwater Council together with a number of additional sites along Hook Head. The value of these sites was highlighted by the Waterford Harbour Sub-Aqua Club in a letter published in a recent Environmental Impact Statement for a proposal to dredge marine aggregates from a site south of Waterford Harbour (Aqua-Fact, 1998). Silting of these areas will have an immediate effect on the quality of diving.

Figure 2. Location of dive sites and shore angling in the vicinity of Hook Head, Waterford Harbour.

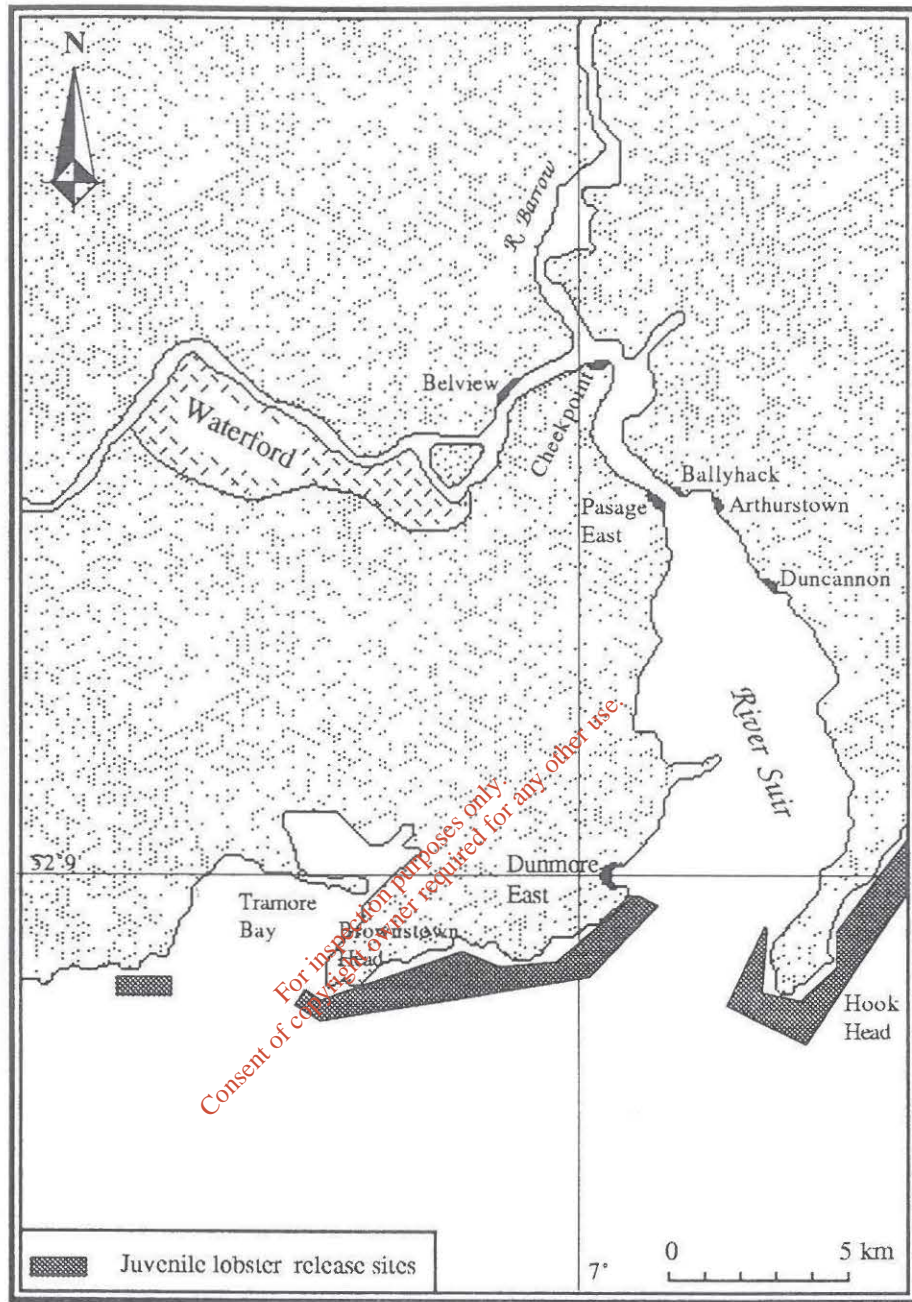
Angling will also be affected as fish are attracted by the availability of food in a rich benthic environment. Lobsters in the vicinity of the site will be affected directly by smothering or indirectly by filling of their habitats with silt. A lobster re-seeding programme is currently ongoing in the Waterford Harbour which overlaps the location of site 2 (Figure 3).

Figure 3. Location of juvenile lobster release sites, Waterford and Wexford.

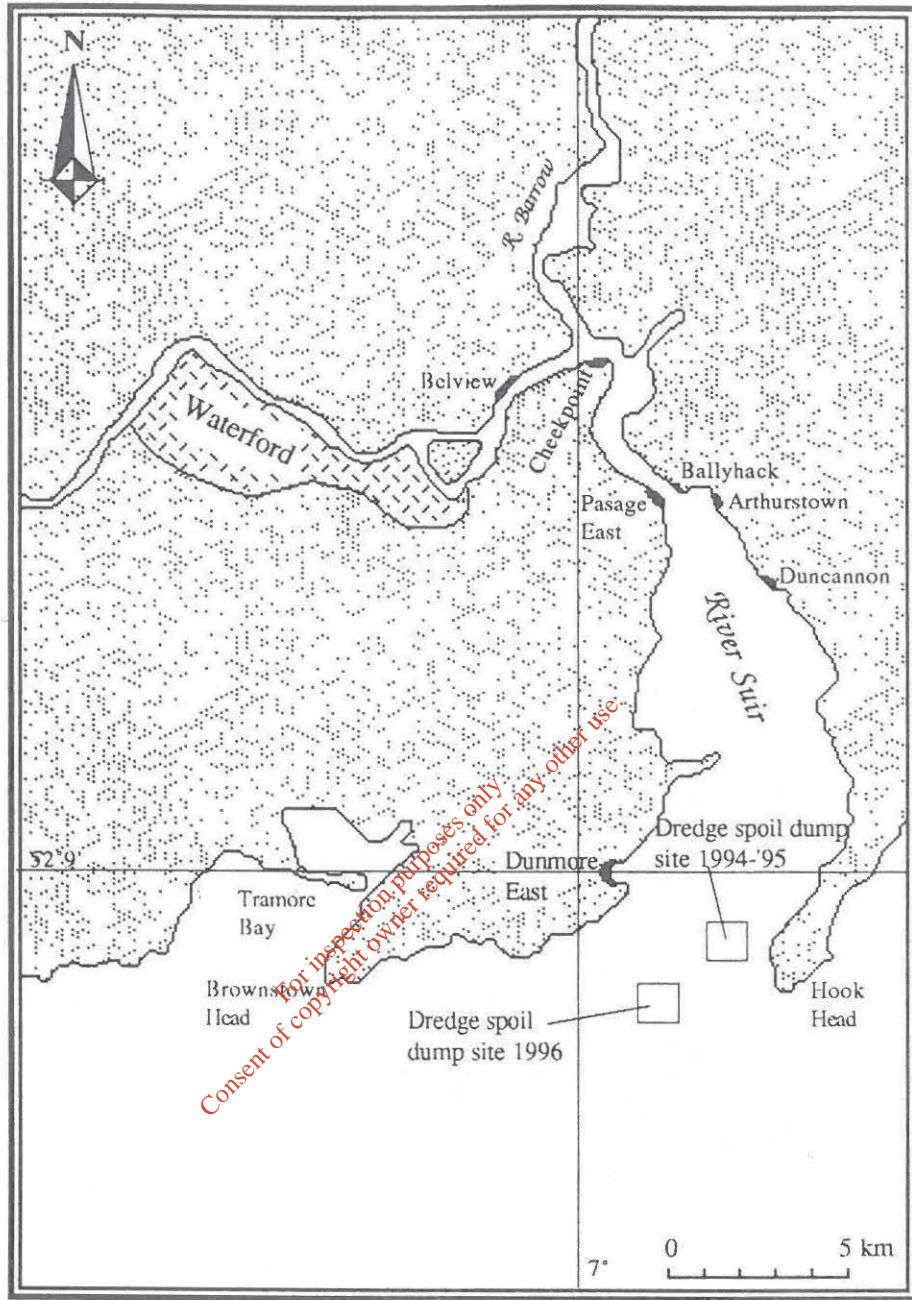
The location of previous dumpsites are presented in Figure 4. The most recent of these sites (1996) 4 was located in the mouth of the estuary, the bottom consisting of gravel of various diameters (see Aqua-Fact Report, 7th August 1996). The effects

Figure 4. Location of the Previous Waterford Harbour dredge spoil dump sites.

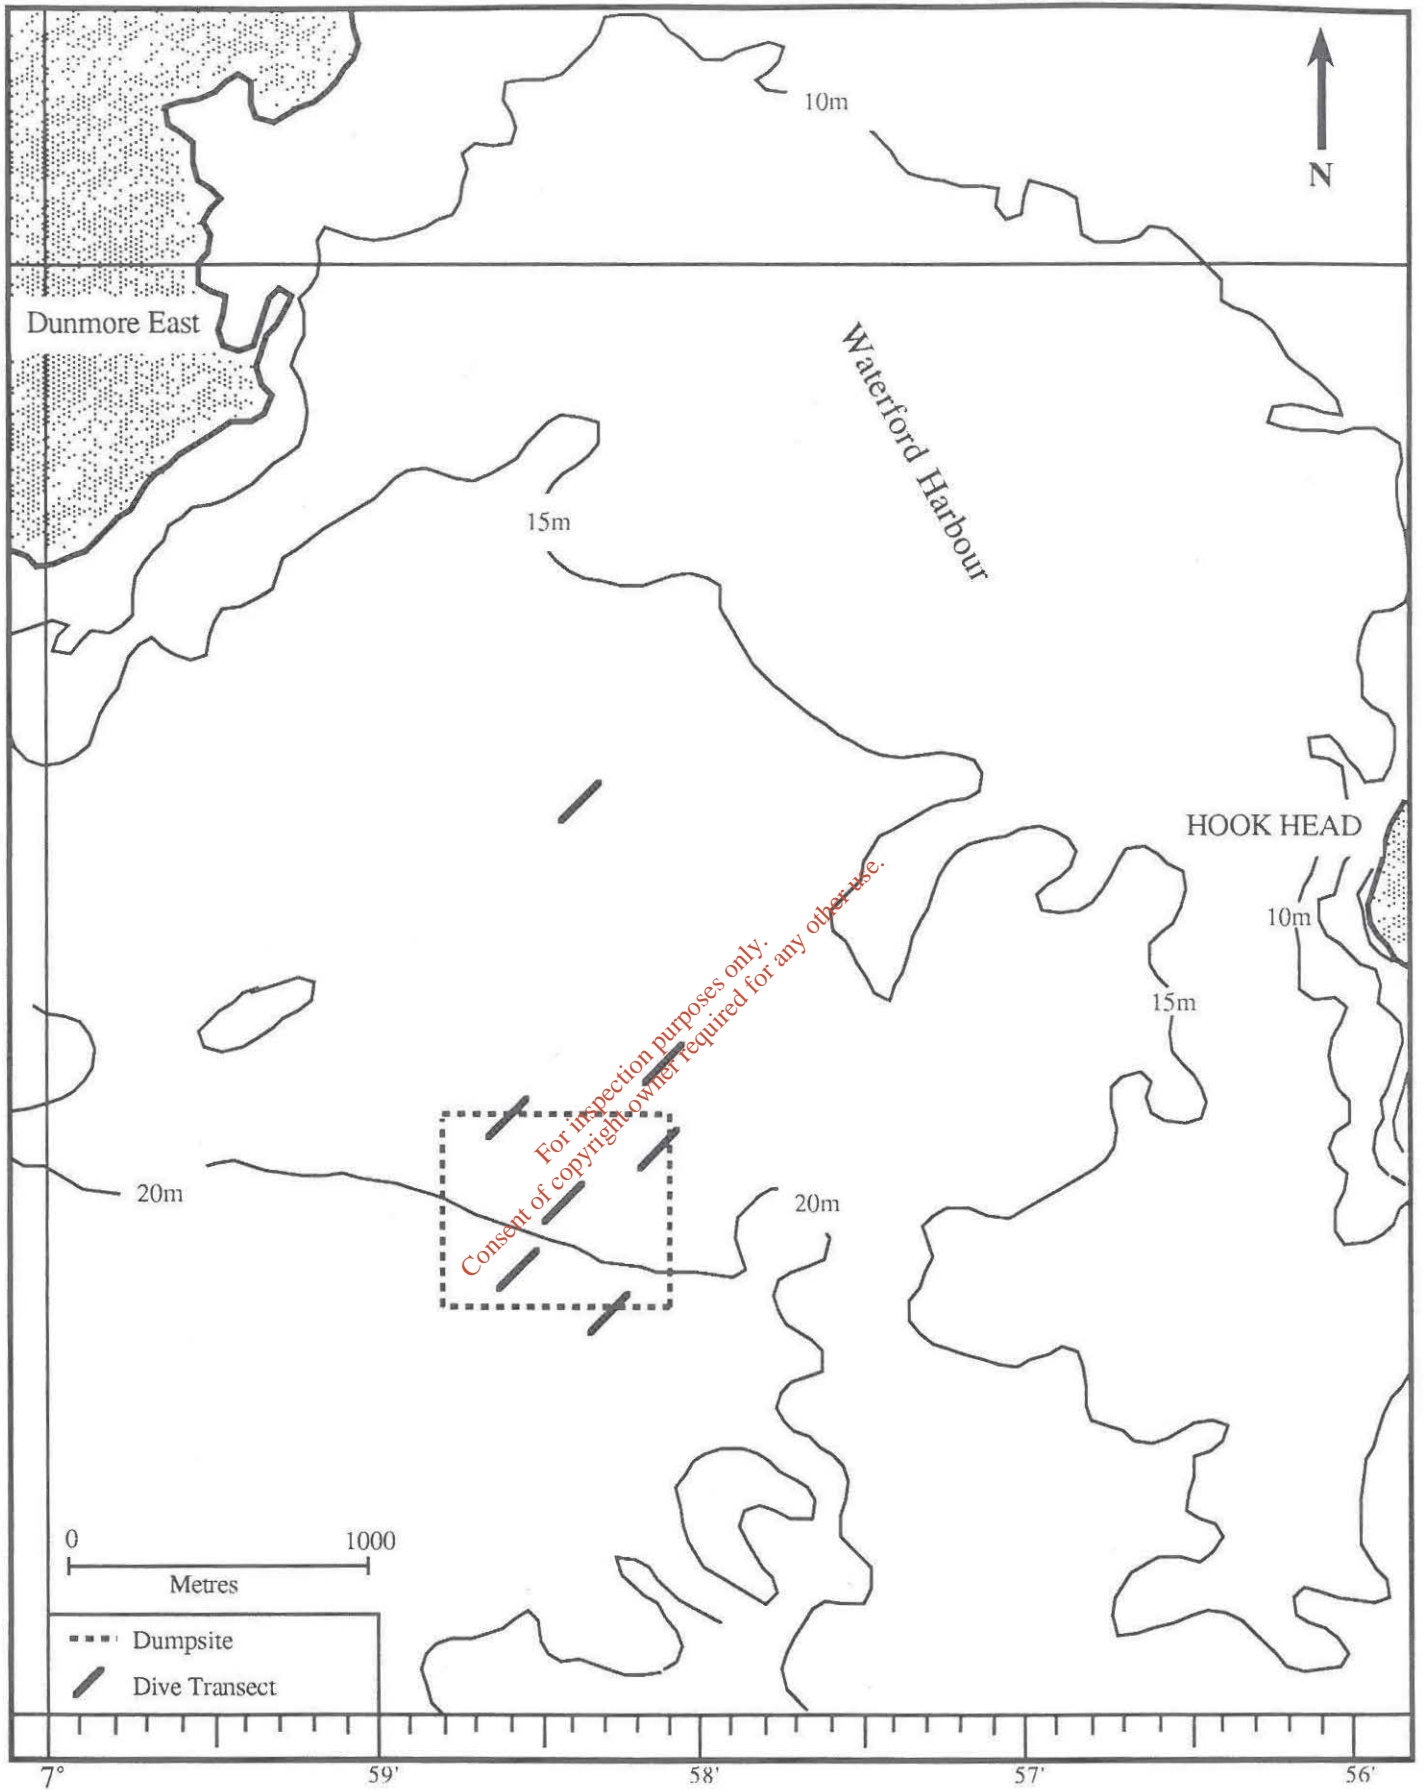
Seven dive transects were undertaken, two towards the southern end of the dumpsite, one in the centre of the dumpsite, three at the northern end of the dumpsite and a further transect north of the dumpsite heading into the harbour (see Figure 1.). Position fixes were taken with a GPS system.

Photographs 1&2 record bottom conditions along the transects taken by the diver inside the north-eastern corner of the dumpsite (see Figure 1). The bottom is covered by a fine muddy sediment with no elements of the original seafloor apparent. No fauna were seen. Photo's 3-10 record conditions along the transect to the north-east of the site. The original coarse sand bottom was observed with a light layer of fine material covering it. Occasional blocks of dredged material were located (Photo's 4, 5, 8 & 10). Hermit crabs, *Pagurus bernhardus*, were common (Photo 3).

Figure 1. Location of the dive transects in the vicinity of the dumpsite in Waterford Harbour, 15th November 1996.
