Attachment H.1 Raw Materials, Intermediates and Product Handling

Project Name: 126-22855 Greenstar, Ballyc	Project number:	Date: 27/04/2016	Contact:	
--	-----------------	---------------------	----------	--

Inspection report

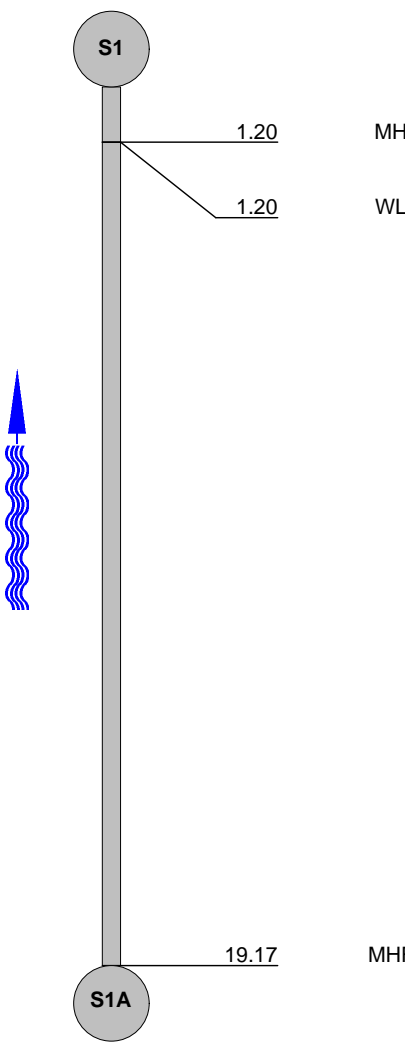
1:165	Position	Code	Observation	Photo	Grade

1.20	MH	Start node type, manhole, reference number: S1		0
	1.20	WL	Water level, 5% of the vertical dimension		0
	19.17	MHF	Finish node type, manhole reference number: S1A		0

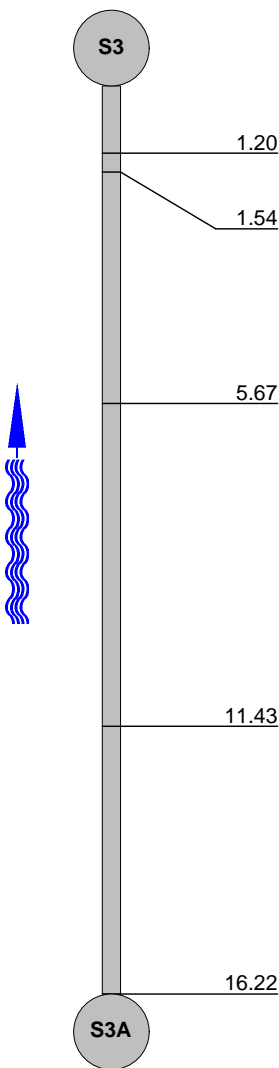
1:135	Position	Code	Observation	Photo	Grade

1.20	MH	Start node type, manhole, reference number : S3		0
	1.54	WL	Water level, 5% of the vertical dimension		0
	5.67	WL	Water level, 10% of the vertical dimension		0
	11.43	WL	Water level, 5% of the vertical dimension		0
	16.22	MHF	Finish node type, manhole reference number: S3A		0

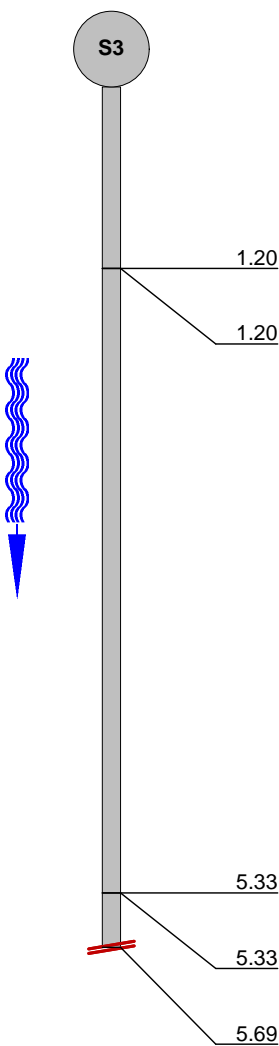
1:50	Position	Code	Observation	Photo	Grade

1.20	MH	Start node type, manhole, reference number : S3		0				
	1.20	WL	Water level, 20% of the vertical dimension		0				
	5.33	MC	Material changes, polyvinyl chloride		0				
	5.33	WL	Water level, 40% of the vertical dimension		0				
	5.69	SA	Survey abandoned Remarks: EXCESS WATER LEVEL		0				
STR no def	STR peak	STR mean	STR total	STR grade	SER no def	SER peak	SER mean	SER total	SER grade
0	0	0	0	1	0	0	0	0	1

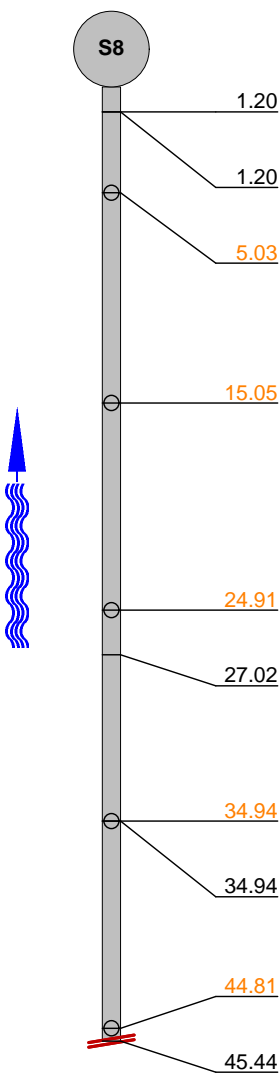
1:360	Position	Code	Observation	Photo	Grade

MH	Start node type, manhole, reference number : S8		0				
	1.20	WL	Water level, 10% of the vertical dimension		0

5.03	CXI	Connection intruding, at 12 o'clock, diameter 150mm, intrusion 15%	12_3A	3				
	15.05	CXI	Connection intruding, at 12 o'clock, diameter 150mm, intrusion 20%	12_4A	3

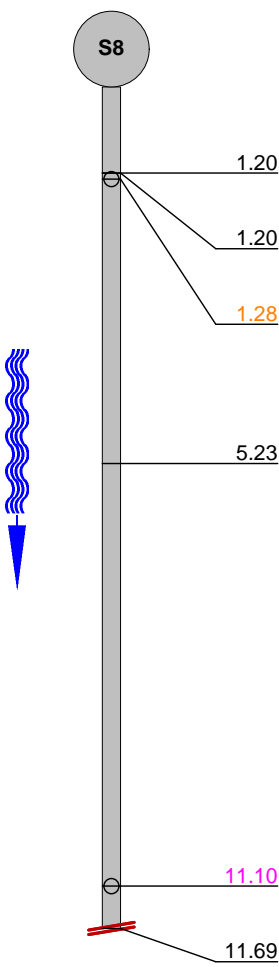
1:105	Position	Code	Observation	Photo	Grade

1.20	MH	Start node type, manhole, reference number : S8		0				
	1.20	WL	Water level, 5% of the vertical dimension		0				
	1.28	CXI	Connection intruding at 2 o'clock, diameter 150mm, intrusion 20%	13_3A	3				
	5.23	WL	Water level, 10% of the vertical dimension		0				
	11.10	CXI	Connection intruding, at 12 o'clock, diameter 150mm, intrusion 40%	13_5A	4				
	11.69	SA	Survey abandoned Remarks: UNABLE TO PASS INTRUDING CONNECTION		0				
STR no def	STR peak	STR mean	STR total	STR grade	SER no def	SER peak	SER mean	SER total	SER grade
0	0	0	0	1	2	5	0.63	7	4

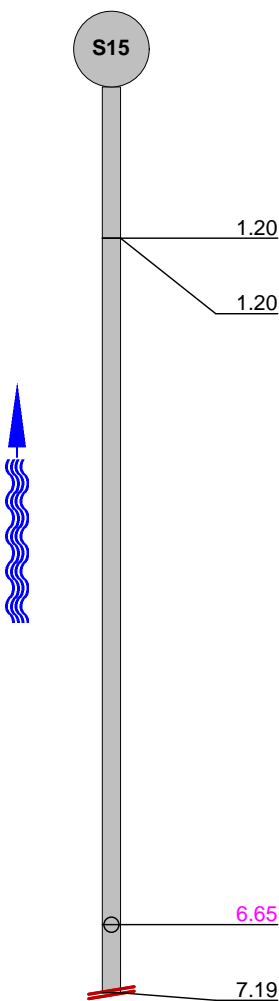
1:60	Position	Code	Observation	Photo	Grade

1.20	MH	Start node type, manhole, reference number : S15		0				
	1.20	WL	Water level, 10% of the vertical dimension		0				
	6.65	CXI	Connection intruding, at 12 o'clock, diameter 150mm, intrusion 30%	17_3A	4				
	7.19	SA	Survey abandoned Remarks: UNABLE TO PASS INTRUDING CONNECTION		0				
STR no def	STR peak	STR mean	STR total	STR grade	SER no def	SER peak	SER mean	SER total	SER grade
0	0	0	0	1	1	5	0.75	5	4

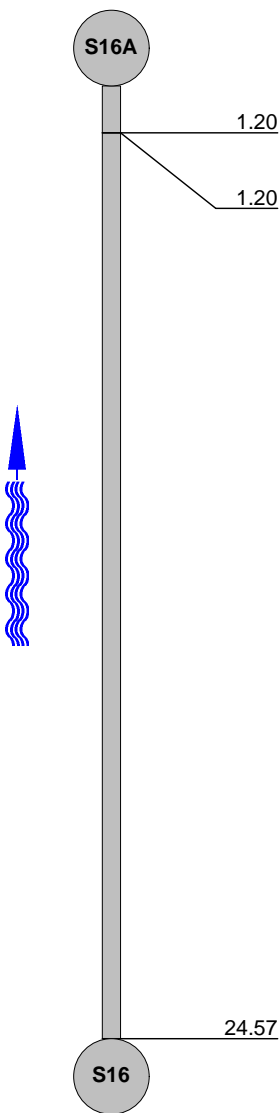
1:195	Position	Code	Observation	Photo	Grade

MH	Start node type, manhole, reference number: S16A		0

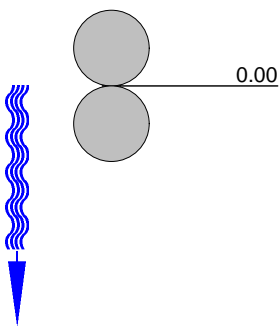
1:50	Position	Code	Observation	Photo	Grade

REM	General remark Remarks: The storm water pumps at the entrance to the business park are not working as they should. All storm drainage externally from the Greenstar Facility are surcharged causing the st		0				
STR no def	STR peak	STR mean	STR total	STR grade	SER no def	SER peak	SER mean	SER total	SER grade
