**ANNUAL ENVIRONMENTAL REPORT**  
**RILTA ENVIRONMENTAL LTD.**  
**SITE 14-A1 GREENOGUE BUSINESS PARK**  
**LICENCE NO. W0185-01**  
**JANUARY 2016 – DECEMBER 2016**

Rilta Environmental Ltd,  
Greenogue Business Park,  
Rathcoole,  
County Dublin.

Project	Annual Environmental Report 2016			
Client	Rilta Environmental Ltd W0185-01			
Report No	Date	Status	Prepared By	Reviewed By
161950209	23/03/2017	Draft	Mr Neil Sandes PGeo EurGeol	Mr Jim O'Callaghan MSc
	07/04/2107	Final

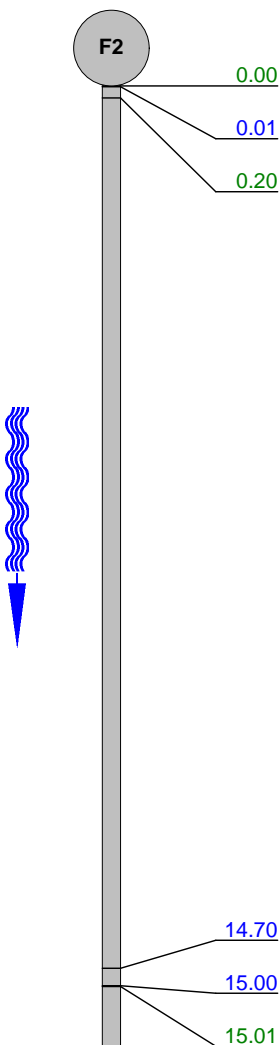
1:126	Position	Code	Observation	MPEG	Photo	Grade
	0.00	MH	Start node type, manhole, reference number : F2	00:00:05		(Constr) 0
	0.01	WL	Water level, 0% of the vertical dimension	00:00:05		(Serv) 0
	0.20	SR	Sealing ring intruding, from 6 to 12 o'clock	00:00:07	4_3A	(Constr) 1
	14.70	LL	Line deviates left	00:03:32		(Serv) 0
	15.00	WL	Water level, 0% of the vertical dimension	00:00:00		(Serv) 0
	15.01	MHF	Finish node type, manhole reference number: F3	00:00:00		(Constr) 0

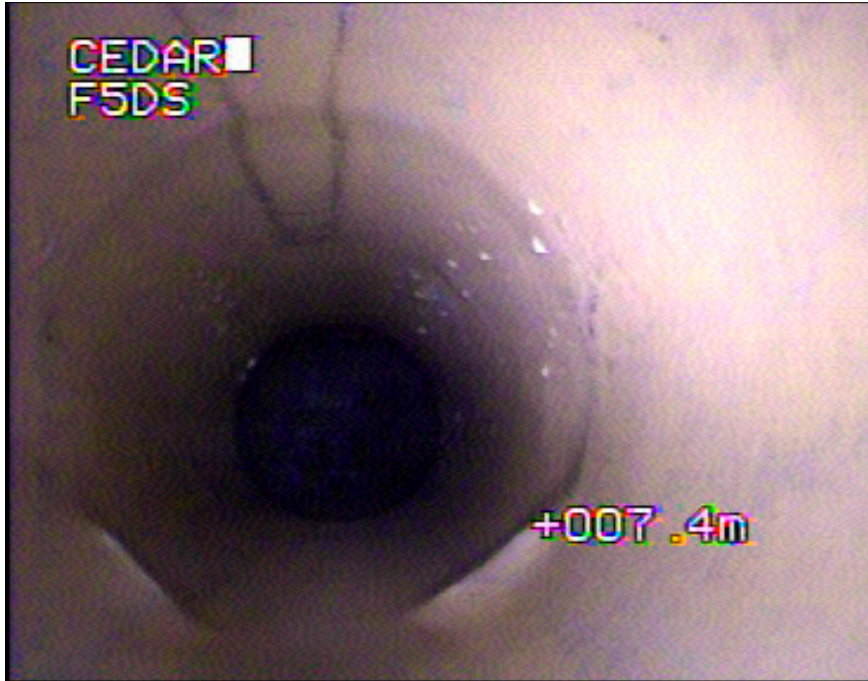
Photo: 8\_3A, MPEG #: 051216\_1, 00:01:02  
7.4m, General remark

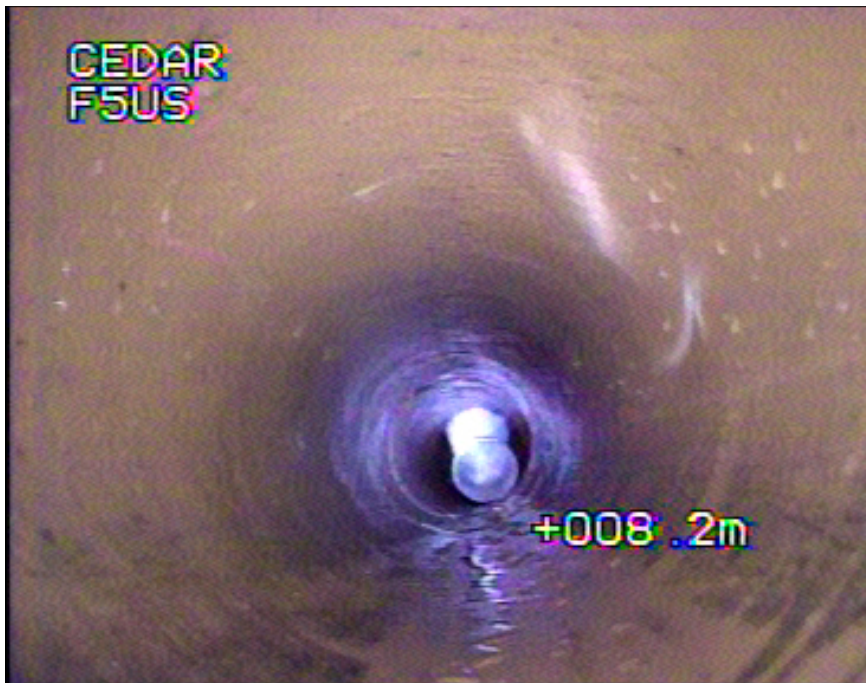
Photo: 9\_5A, MPEG #: 051216\_1, 00:01:55  
8.2m, General remark

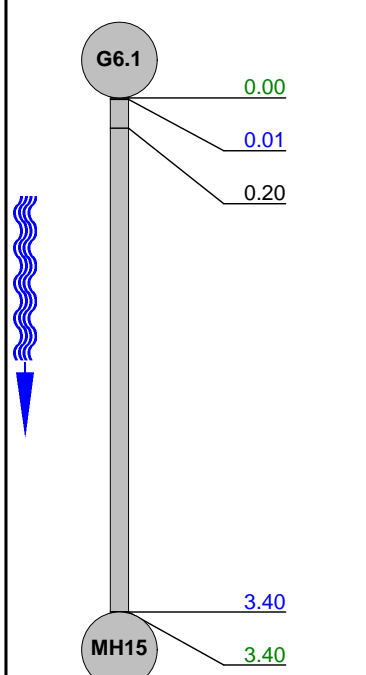
0.00	GY	Start node type, gully, reference number : G6.1	00:01:21		(Constr) 0
	0.01	WL	Water level, 0% of the vertical dimension	00:00:00		(Serv) 0
	0.20	REM	General remark Remarks: Socket are connected up side down.	00:00:05		(Misc) 0
	3.40	WL	Water level, 0% of the vertical dimension	00:00:34		(Serv) 0
	3.40	MHF	Finish node type, manhole reference number: MH15	00:00:34		(Constr) 0

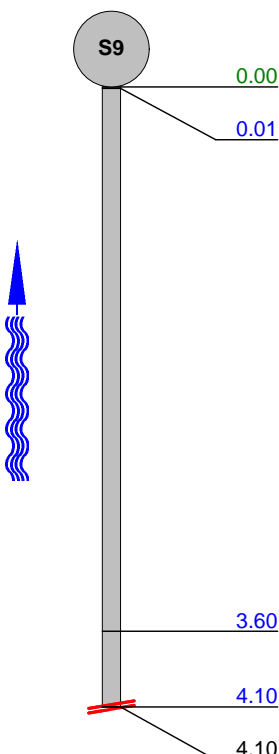
S9				
	0.00	MH	Start node type, manhole, reference number : S9	00:00:02		(Constr) 0
	0.01	WL	Water level, 0% of the vertical dimension	00:00:02		(Serv) 0
	3.60	LU	Line deviates up	00:00:30		(Serv) 0
	4.10	WL	Water level, 0% of the vertical dimension	00:00:41		(Serv) 0
	4.10	SA	Survey abandoned Remarks: Survey could not be completed due to Length of this pipe. This pipe is a water s	00:00:41		(Misc) 0

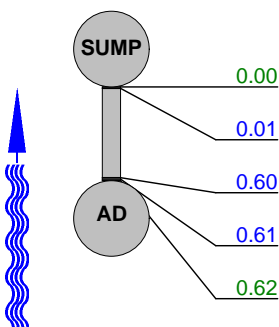
0.00	CP	Start node type, catchpit, reference number : SUMP	00:00:00		(Constr) 0
	0.01	WL	Water level, 0% of the vertical dimension	00:00:00		(Serv) 0
	0.60	RF	Roots, fine Remarks: These roots come from gap between the end of this pipe and ACCO Drain.	00:00:12	50_3A	(Serv) 2
	0.61	WL	Water level, 0% of the vertical dimension	00:01:15		(Serv) 0
	0.62	BRF	Finish node type, major connection without manhole reference number: AD Remarks: ACCO Drain.	00:01:15		(Constr) 0

<b>Structural Defects</b>					<b>Constructional Features</b>				
<b>Service Defects</b>					<b>Miscellaneous Features</b>				
STR no def	STR peak	STR mean	STR total	STR grade	SER no def	SER peak	SER mean	SER total	SER grade
0	0	0	0	1	1	1	1.61	1	3
