ANNUAL ENVIRONMENTAL REPORT
RILTA ENVIRONMENTAL LTD.
SITE 14-A1 GREENOGUE BUSINESS PARK
LICENCE NO. W0185-01
JANUARY 2016 – DECEMBER 2016

Rilta Environmental Ltd,
Greenogue Business Park,
Rathcoole,
County Dublin.

Project	Annual Environmental Report 2016			
Client	Rilta Environmental Ltd W0185-01			
Report No	Date	Status	Prepared By	Reviewed By
161950209	23/03/2017	Draft	Mr Neil Sandes PGeo EurGeol	Mr Jim O'Callaghan MSc
	07/04/2107	Final

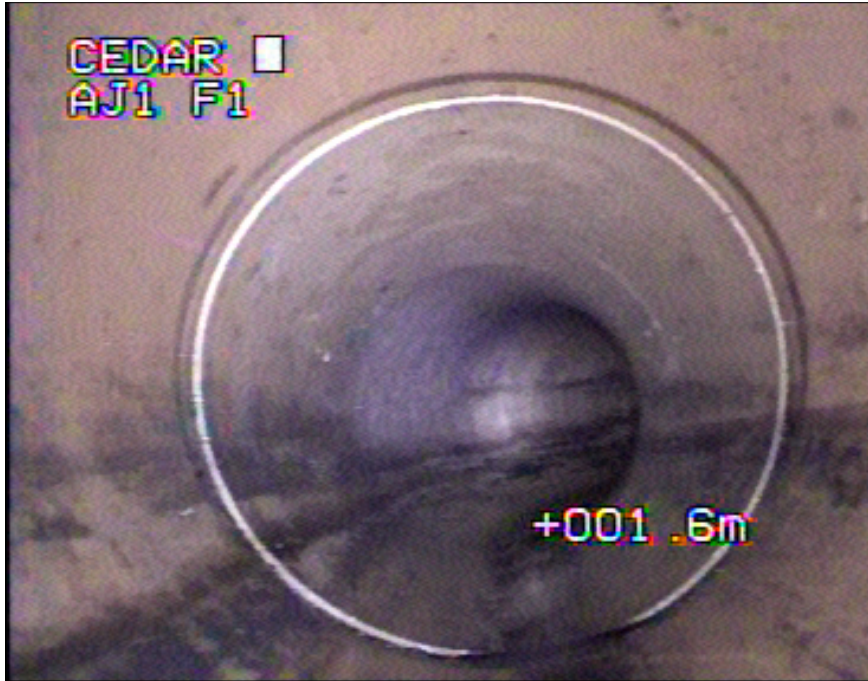
Photo: 1_6A, MPEG #: 051216_1, 00:00:00
7.71m, Finish node type, manhole reference number: F1

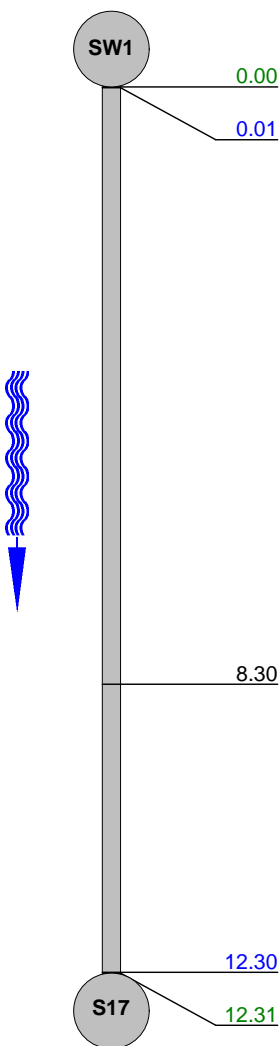
0.00	MH	Start node type, manhole, reference number : SW1 Remarks: Surface water valve.	00:00:02		(Constr) 0
	0.01	WL	Water level, 0% of the vertical dimension	00:00:02		(Serv) 0
	8.30	REM	General remark Remarks: Socket connection against the stream	00:01:15		(Misc) 0
	12.30	WL	Water level, 0% of the vertical dimension	00:01:49		(Serv) 0
	12.31	MHF	Finish node type, manhole reference number: S17	00:01:49		(Constr) 0
