ANNUAL ENVIRONMENTAL REPORT
RILTA ENVIRONMENTAL LTD.
BLOCK 402 GREENOGUE BUSINESS PARK
LICENCE NO. W0192-03
JANUARY 2016 – DECEMBER 2016

Project	Annual Environmental Report 2016			
Client	Rilta Environmental Ltd W0192-03			
Report No	Date	Status	Prepared By	Reviewed By
161950109	26/05/2017	Draft	Mr Neil Sandes PGeo EurGeol	Mr Jim O'Callaghan MSc
	26/05/2017	Final

Bund Integrity Test Report 2016 / 2017

Block 402 - CCTV Drainage Inspection Report

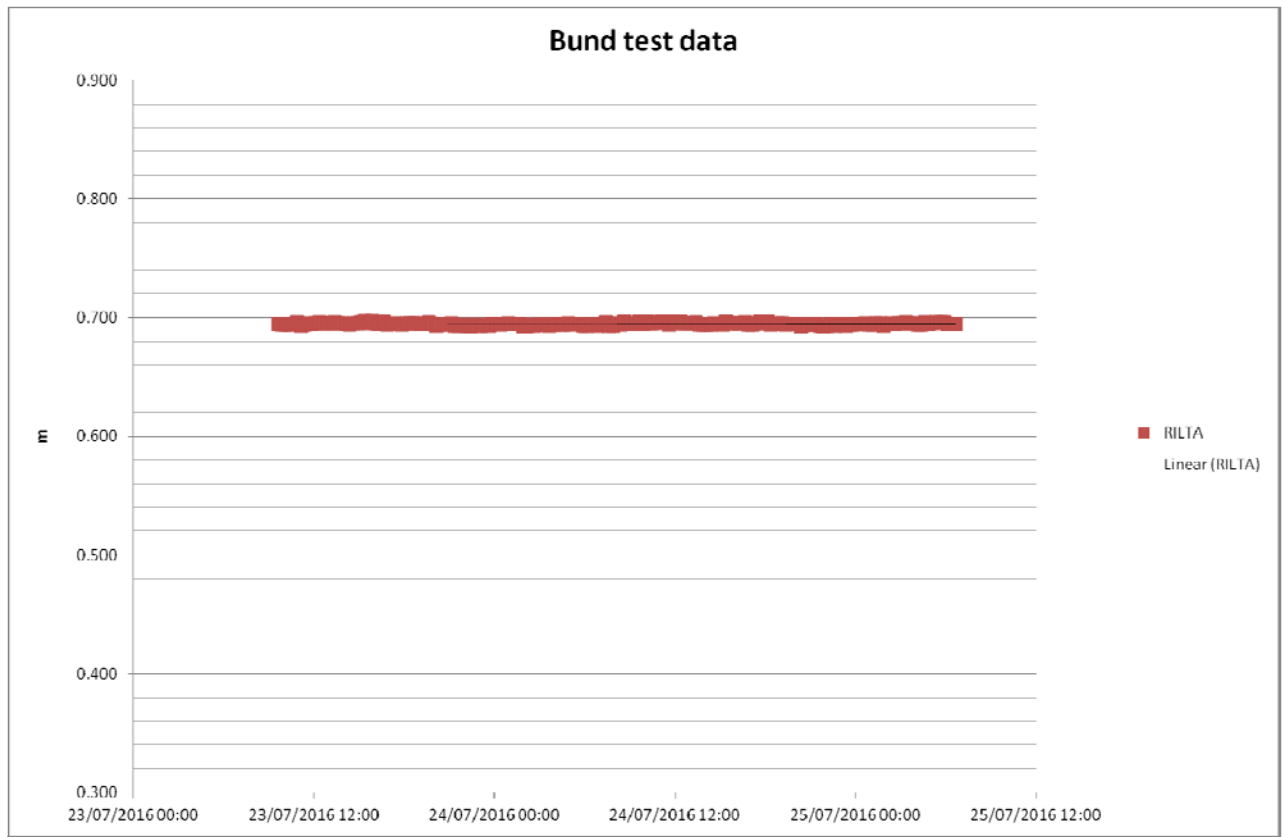
Table 4-15 Bund / Area No. 16 Test Result

Testing at this location was not impacted by facility operations.

No fluctuation in liquid levels was noted in the bunds or tanks during the first monitoring period Day 1 to Day 2 (July 23rd to July 24th 2017) and levels remained constant for the second monitoring period Day 2 to Day 3 (July 24th to July 25th 2017) Results from the controls showed no variation and were consistent with readings from all storage tanks.

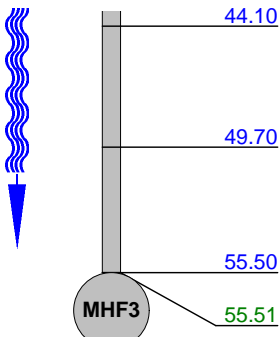
1:350	Position	Code	Observation	MPEG	Photo	Grade
	44.10	WL	Water level, 0% of the vertical dimension	00:06:16		(Serv) 0
	49.70	WL	Water level, 5% of the vertical dimension	00:07:00		(Serv) 0
	55.50	WL	Water level, 0% of the vertical dimension	00:07:51		(Serv) 0
	55.51	MHF	Finish node type, manhole reference number: MHF3	00:07:51		(Constr) 0

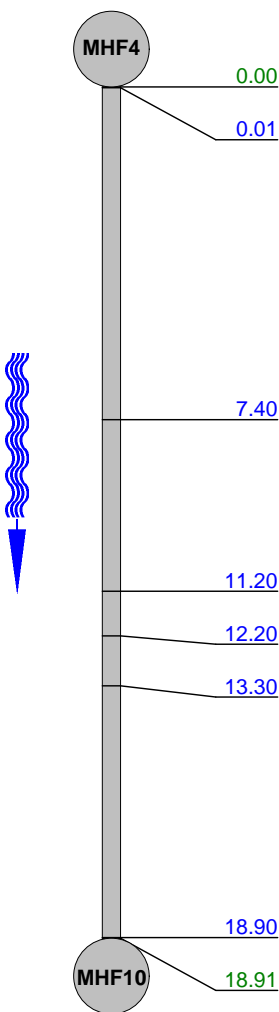
MH	Start node type, manhole, reference number : MHF4	00:00:01		(Constr) 0
	0.01	WL	Water level, 0% of the vertical dimension	00:00:01		(Serv) 0
	7.40	WL	Water level, 5% of the vertical dimension	00:00:53		(Serv) 0
	11.20	WL	Water level, 10% of the vertical dimension	00:01:19		(Serv) 0
	12.20	WL	Water level, 5% of the vertical dimension	00:01:25		(Serv) 0
	13.30	WL	Water level, 10% of the vertical dimension	00:01:33		(Serv) 0
	18.90	WL	Water level, 5% of the vertical dimension	00:02:09		(Serv) 0
	18.91	MHF	Finish node type, manhole reference number: MHF10	00:02:09		(Constr) 0

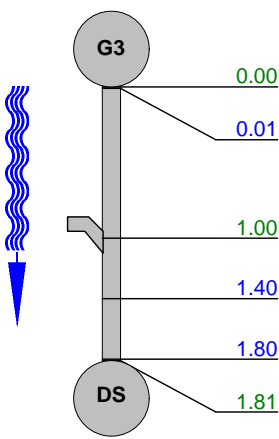
0.00	GY	Start node type, gully, reference number : G3	00:00:01		(Constr) 0
	0.01	WL	Water level, 0% of the vertical dimension	00:00:01		(Serv) 0
	1.00	CN	Connection other than junction, at 3 o'clock, diameter 150mm Remarks: Connection from G4	00:00:13		(Constr) 0
	1.40	LD	Line deviates down	00:00:20		(Serv) 0
	1.80	WL	Water level, 0% of the vertical dimension	00:00:27		(Serv) 0
	1.81	BRF	Finish node type, major connection without manhole reference number: DS Remarks: This pipe is connected to	00:00:27		(Constr) 0

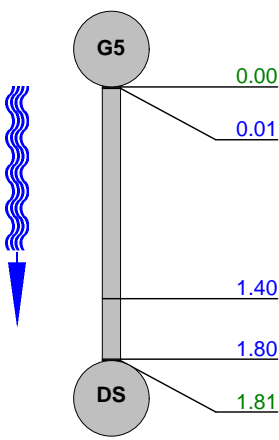
0.00	GY	Start node type, gully, reference number : G5	00:00:01		(Constr) 0
	0.01	WL	Water level, 0% of the vertical dimension	00:00:01		(Serv) 0
	1.40	LD	Line deviates down	00:00:13		(Serv) 0
	1.80	WLC	Clear water level, 0% of the vertical dimension	00:00:15		(Serv) 0
	1.81	BRF	Finish node type, major connection without manhole reference number: DS Remarks: This drain is connected t	00:00:15		(Constr) 0

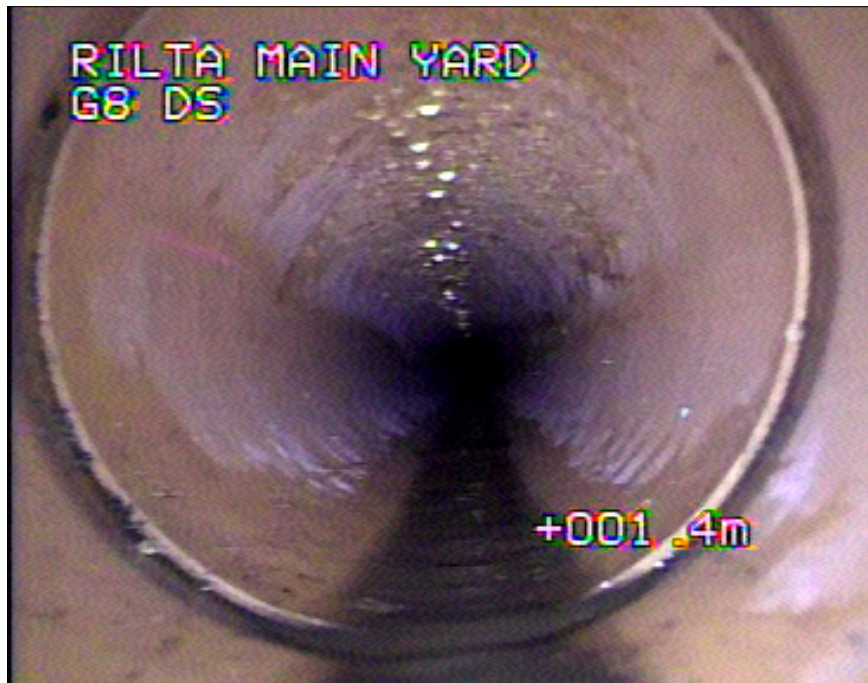
Photo: 42_3A, MPEG #: 280217_1, 00:00:15
1.4m, General remark

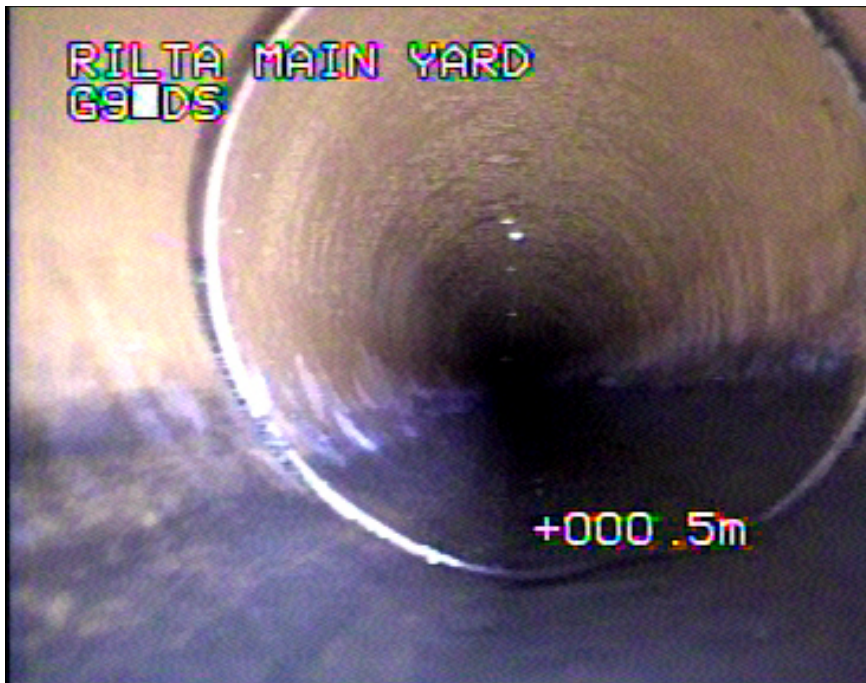
Photo: 43_3A, MPEG #: 280217_1, 00:00:08
0.6m, General remark

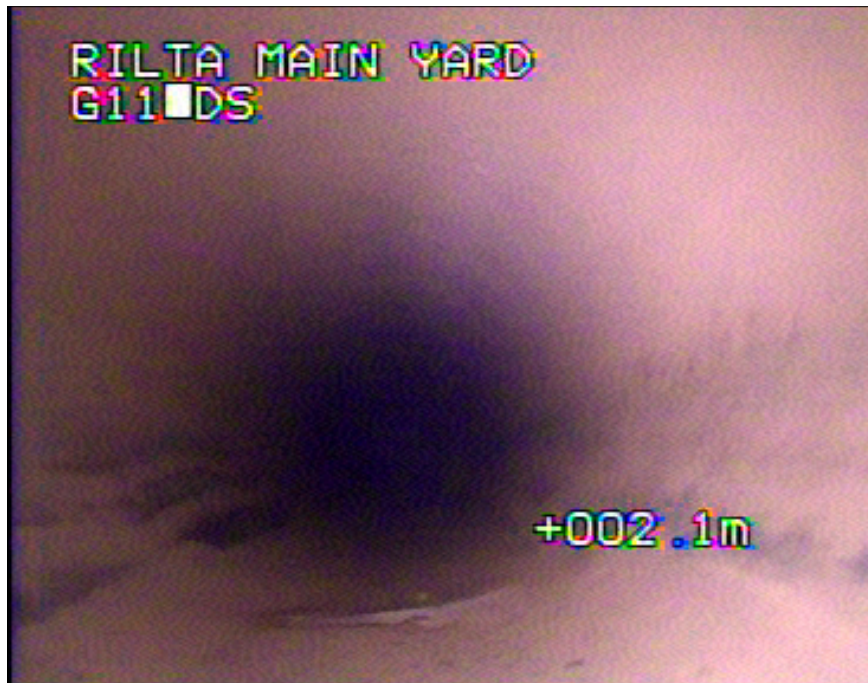
Photo: 47_3A, MPEG #: 280217_1, 00:00:59
2.2m, General remark

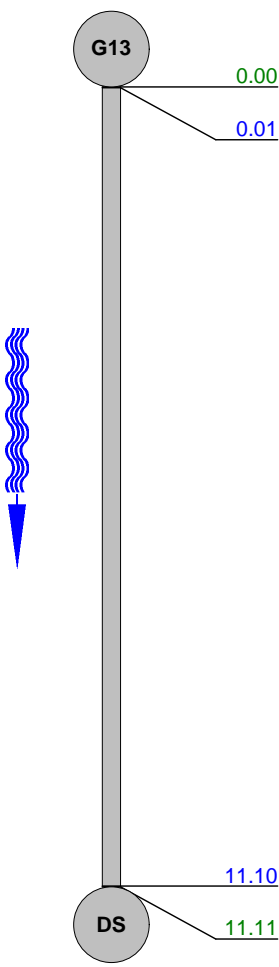
1:105	Position	Code	Observation	MPEG	Photo	Grade
	G13					
	0.00	GY	Start node type, gully, reference number : G13	00:00:01		(Constr) 0
	0.01	WL	Water level, 0% of the vertical dimension	00:00:01		(Serv) 0

11.10	WL	Water level, 0% of the vertical dimension	00:01:54		(Serv) 0
	11.11	BRF	Finish node type, major connection without manhole reference number: DS Remarks: This pipe is connected to	00:01:54		(Constr) 0
