ANNUAL ENVIRONMENTAL REPORT
RILTA ENVIRONMENTAL LTD.
SITE 14-A1 GREENOGUE BUSINESS PARK
LICENCE NO. W0185-01
JANUARY 2016 – DECEMBER 2016

Project	Annual Environmental Report 2016			
Client	Rilta Environmental Ltd W0185-01			
Report No	Date	Status	Prepared By	Reviewed By
161950209	23/03/2017	Draft	Mr Neil Sandes PGeo EurGeol	Mr Jim O'Callaghan MSc
	07/04/2107	Final

CCTV DRAINAGE INSPECTION REPORT

**Block 14A1, Grants Road,
Greenogue Business Park,
Rathcoole, Co. Dublin.**

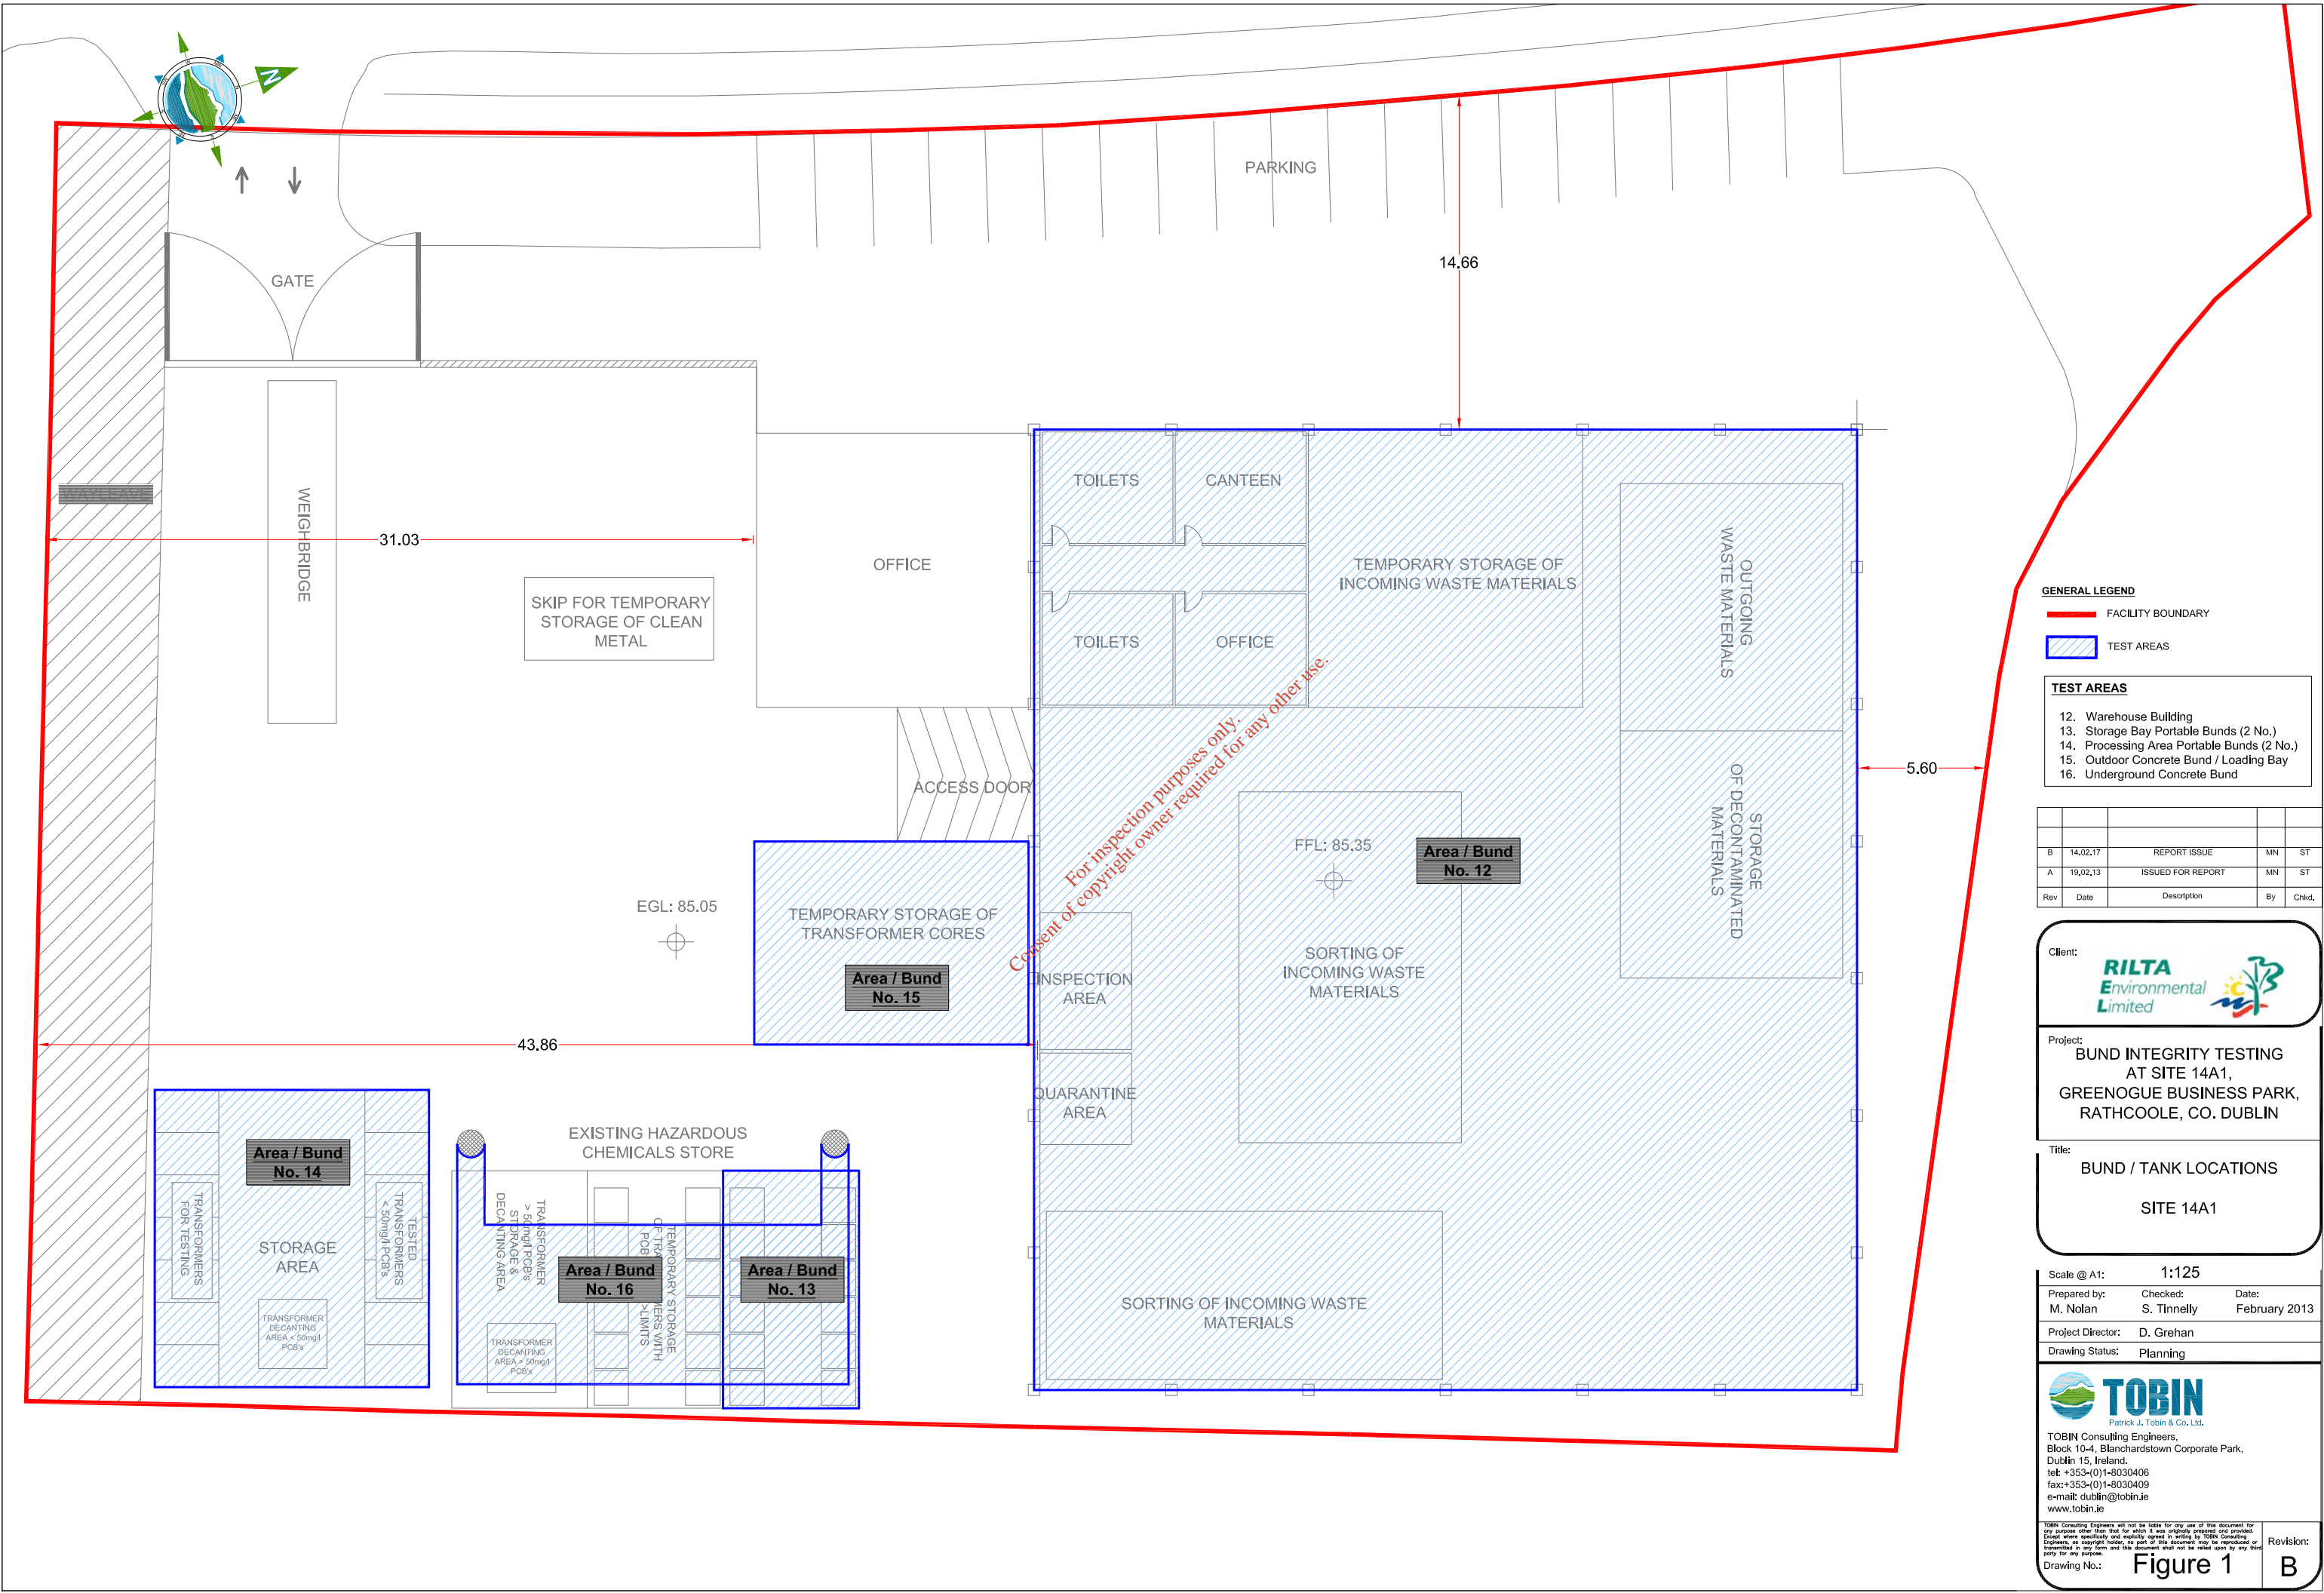
Drawing No.: **Figure 1** Revision: **B**

- TEST AREAS**
- 12. Warehouse Building
 - 13. Storage Bay Portable Bunds (2 No.)
 - 14. Processing Area Portable Bunds (2 No.)
 - 15. Outdoor Concrete Bund / Loading Bay
 - 16. Underground Concrete Bund
