**Bund Integrity Testing
at Site 14A1,
Greenogue Business Park,
Rathcoole, Co. Dublin**

Bund Integrity Testing

**Site 14A1, Greenogue Business Park
Rathcoole, Co. Dublin**

CCTV DRAINAGE INSPECTION REPORT

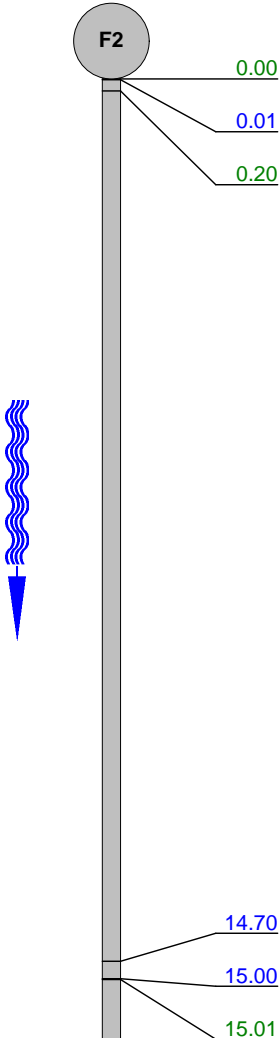
1:126	Position	Code	Observation	MPEG	Photo	Grade
	0.00	MH	Start node type, manhole, reference number : F2	00:00:05		(Constr) 0
	0.01	WL	Water level, 0% of the vertical dimension	00:00:05		(Serv) 0
	0.20	SR	Sealing ring intruding, from 6 to 12 o'clock	00:00:07	4_3A	(Constr) 1
	14.70	LL	Line deviates left	00:03:32		(Serv) 0
	15.00	WL	Water level, 0% of the vertical dimension	00:00:00		(Serv) 0
	15.01	MHF	Finish node type, manhole reference number: F3	00:00:00		(Constr) 0

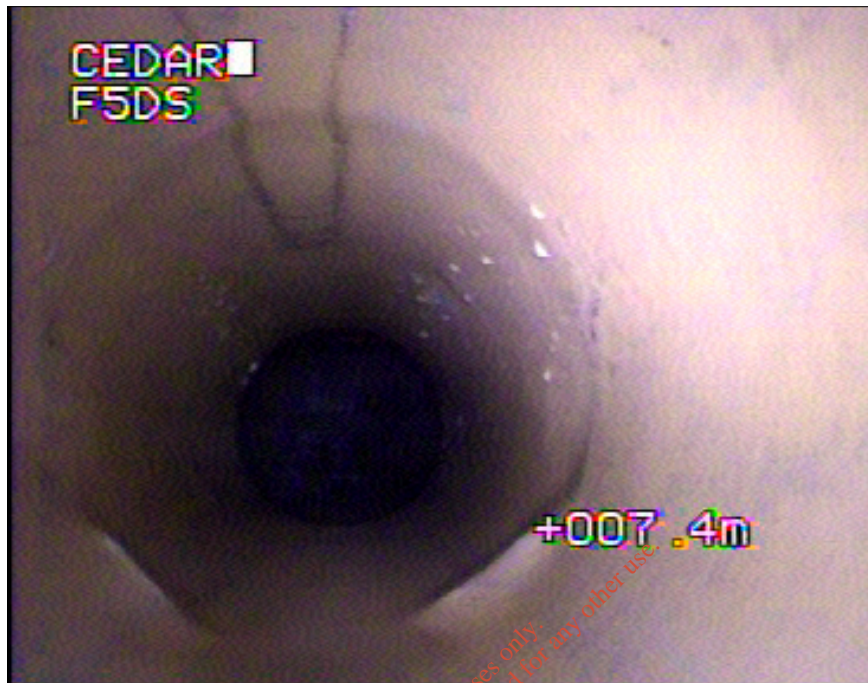
Photo: 8_3A, MPEG #: 051216_1, 00:01:02
7.4m, General remark

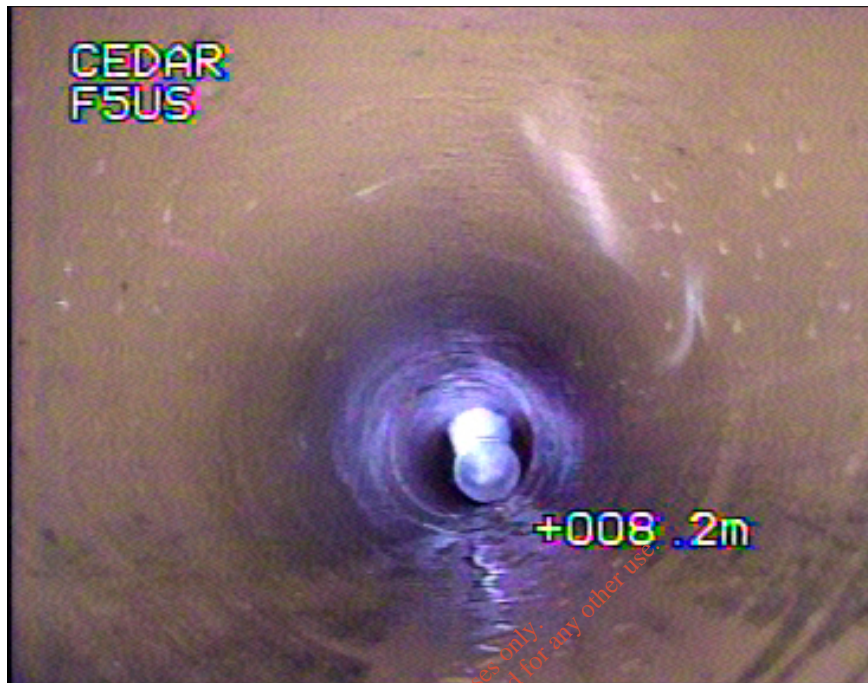
Photo: 9_5A, MPEG #: 051216_1, 00:01:55
8.2m, General remark

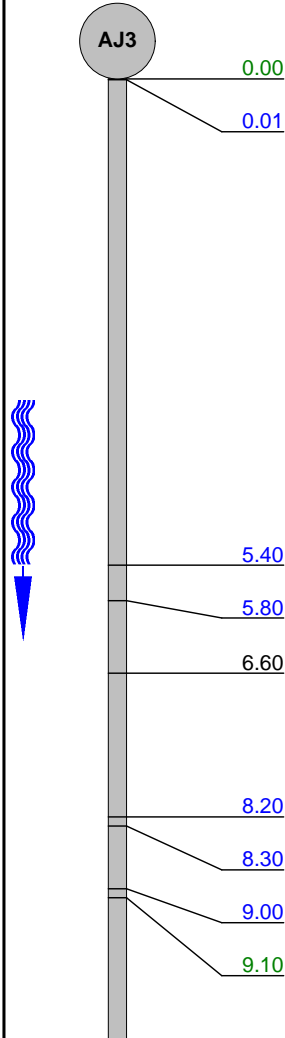
1:84	Position	Code	Observation	MPEG	Photo	Grade
	0.00	IC	Start node type, inspection chamber, reference number : AJ3	00:00:02		(Constr) 0
	0.01	WL	Water level, 5% of the vertical dimension	00:00:01		(Serv) 0
	5.40	WL	Water level, 10% of the vertical dimension	00:03:17		(Serv) 0
	5.80	WL	Water level, 30% of the vertical dimension	00:00:49		(Serv) 0
	6.60	CUW	Loss of vision, camera under water	00:00:57		(Misc) 0
	8.20	LR	Line deviates right Remarks: 45 deg.	00:01:18		(Serv) 0
	8.30	WL	Water level, 30% of the vertical dimension	00:01:20		(Serv) 0
	9.00	WL	Water level, 15% of the vertical dimension	00:01:35		(Serv) 0
	9.10	BRF	Finish node type, major connection without manhole reference number: DS Remarks: This pipe is connected to	00:01:34		(Constr) 0

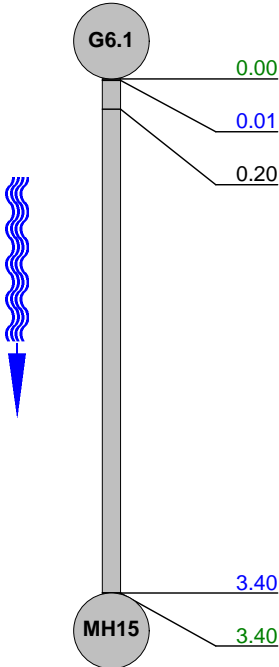
1:50	Position	Code	Observation	MPEG	Photo	Grade
	0.00	GY	Start node type, gully, reference number : G6.1	00:01:21		(Constr) 0
	0.01	WL	Water level, 0% of the vertical dimension	00:00:00		(Serv) 0
	0.20	REM	General remark Remarks: Socket are connected up side down.	00:00:05		(Misc) 0
	3.40	WL	Water level, 0% of the vertical dimension	00:00:34		(Serv) 0
	3.40	MHF	Finish node type, manhole reference number: MH15	00:00:34		(Constr) 0

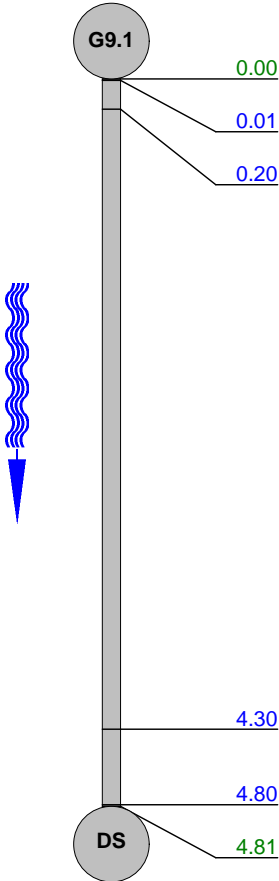
1:50	Position	Code	Observation	MPEG	Photo	Grade
	0.00	GY	Start node type, gully, reference number : G9.1	00:00:00		(Constr) 0
	0.01	WL	Water level, 0% of the vertical dimension	00:00:00		(Serv) 0
	0.20	LL	Line deviates left Remarks: 45 deg.	00:00:01		(Serv) 0
	4.30	LD	Line deviates down	00:00:42		(Serv) 0
	4.80	WL	Water level, 0% of the vertical dimension	00:01:03		(Serv) 0
	4.81	BRF	Finish node type, major connection without manhole reference number: DS Remarks: This pipe is connected to	00:01:03		(Constr) 0

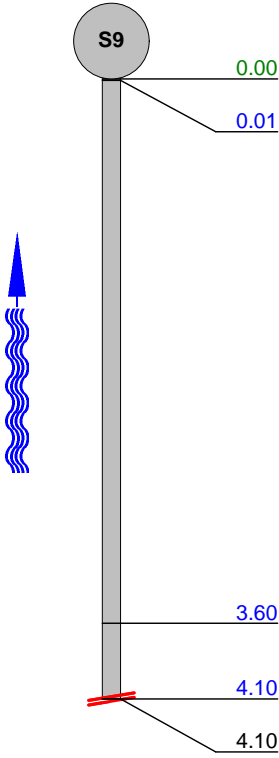
1:50	Position	Code	Observation	MPEG	Photo	Grade
	0.00	MH	Start node type, manhole, reference number : S9	00:00:02		(Constr) 0
	0.01	WL	Water level, 0% of the vertical dimension	00:00:02		(Serv) 0
	3.60	LU	Line deviates up	00:00:30		(Serv) 0
	4.10	WL	Water level, 0% of the vertical dimension	00:00:41		(Serv) 0
	4.10	SA	Survey abandoned Remarks: Survey could not be completed due to Length of this pipe. This pipe is a water s	00:00:41		(Misc) 0

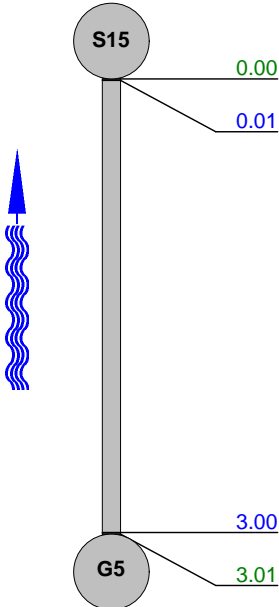
1:50	Position	Code	Observation	MPEG	Photo	Grade
	0.00	MH	Start node type, manhole, reference number : S15	00:00:00		(Constr) 0
	0.01	WL	Water level, 0% of the vertical dimension	00:00:00		(Serv) 0
	3.00	WL	Water level, 0% of the vertical dimension	00:00:26		(Serv) 0
	3.01	GYF	Finish node type, gully reference number: G5	00:00:26		(Constr) 0
