OFFICE OF ENVIRONMENTAL SUSTAINABILITY

INSPECTOR'S REPORT ON AN APPLICATION FOR A CERTIFICATE OF AUTHORISATION FOR A CLOSED LANDFILL

то:	DIRECTORS	
FROM:	Brian Meaney	- Environmental Licensing Programme
DATE:	25 September 2017	
RE:	Application for a Certificate of Authorisation from Cork County Council for a closed landfill at Kealanine	
	Certificate of Authorisation Register Number H0089-01.

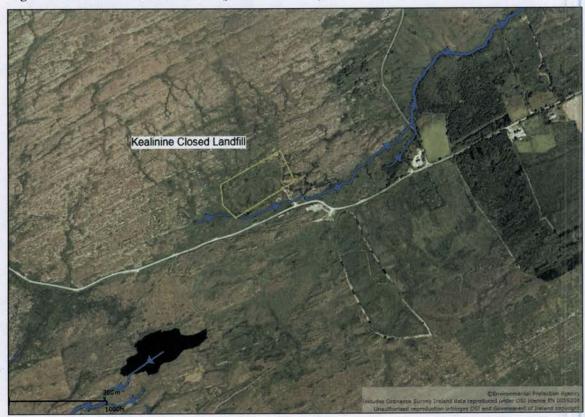
Location of facility:	Kealanine (Kealinine), situated in Co. Cork between Glengarrif (5km) and Bantry (7km), 1.5km off the N71 primary route that connects them.
	The landfill is on the southern slopes of Cobduff (380mOD) at an elevation between 109m and 119m.
	See Figure 1 and Figure 2 below.
Period of landfilling:	Ceased in November 1997.
Surrounding area:	The landfill is located in a rugged area with bedrock outcrops forming ridges separated by areas of blanket peat. Rough grazing of horses and sheep is carried out.
Core Laurey Council	A stream running along the southern boundary predates the development of the landfill.
1045	The nearest house is within 400m to the east and another is some 450m away. The next nearest house is 750m.
Area of the closed landfill:	1.82 hectares
Quantity of waste at the facility:	90,000m ³ estimated
Characterisation of waste deposited:	Municipal waste, industrial waste and hazardous waste, including wastewater sludge, end-of-life vehicles, offal and oily waste.

Figure 1 Location of closed landfill (yellow boundary) on the side of the Cobduff mountain.

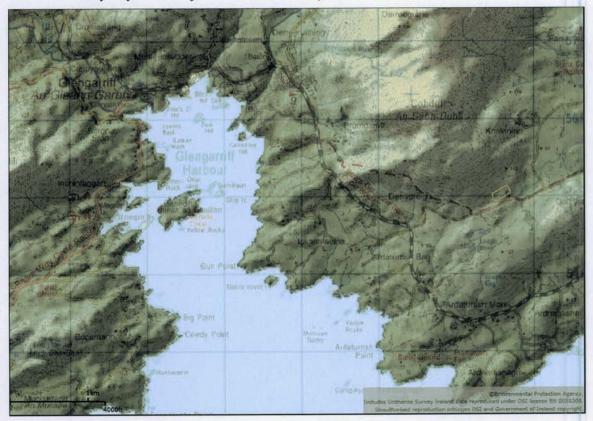
Figure 2 Location of closed landfill, towards the right middle of the image – Glengarriff is to the west and Bantry Bay is the major coastal water body shown
