HYDROGEOLOGICAL SURVEY REPORT

KILLARNEY WASTE DISPOSAL LTD

AUGHACURREEN

WASTE LICENCE NO. W0217-01

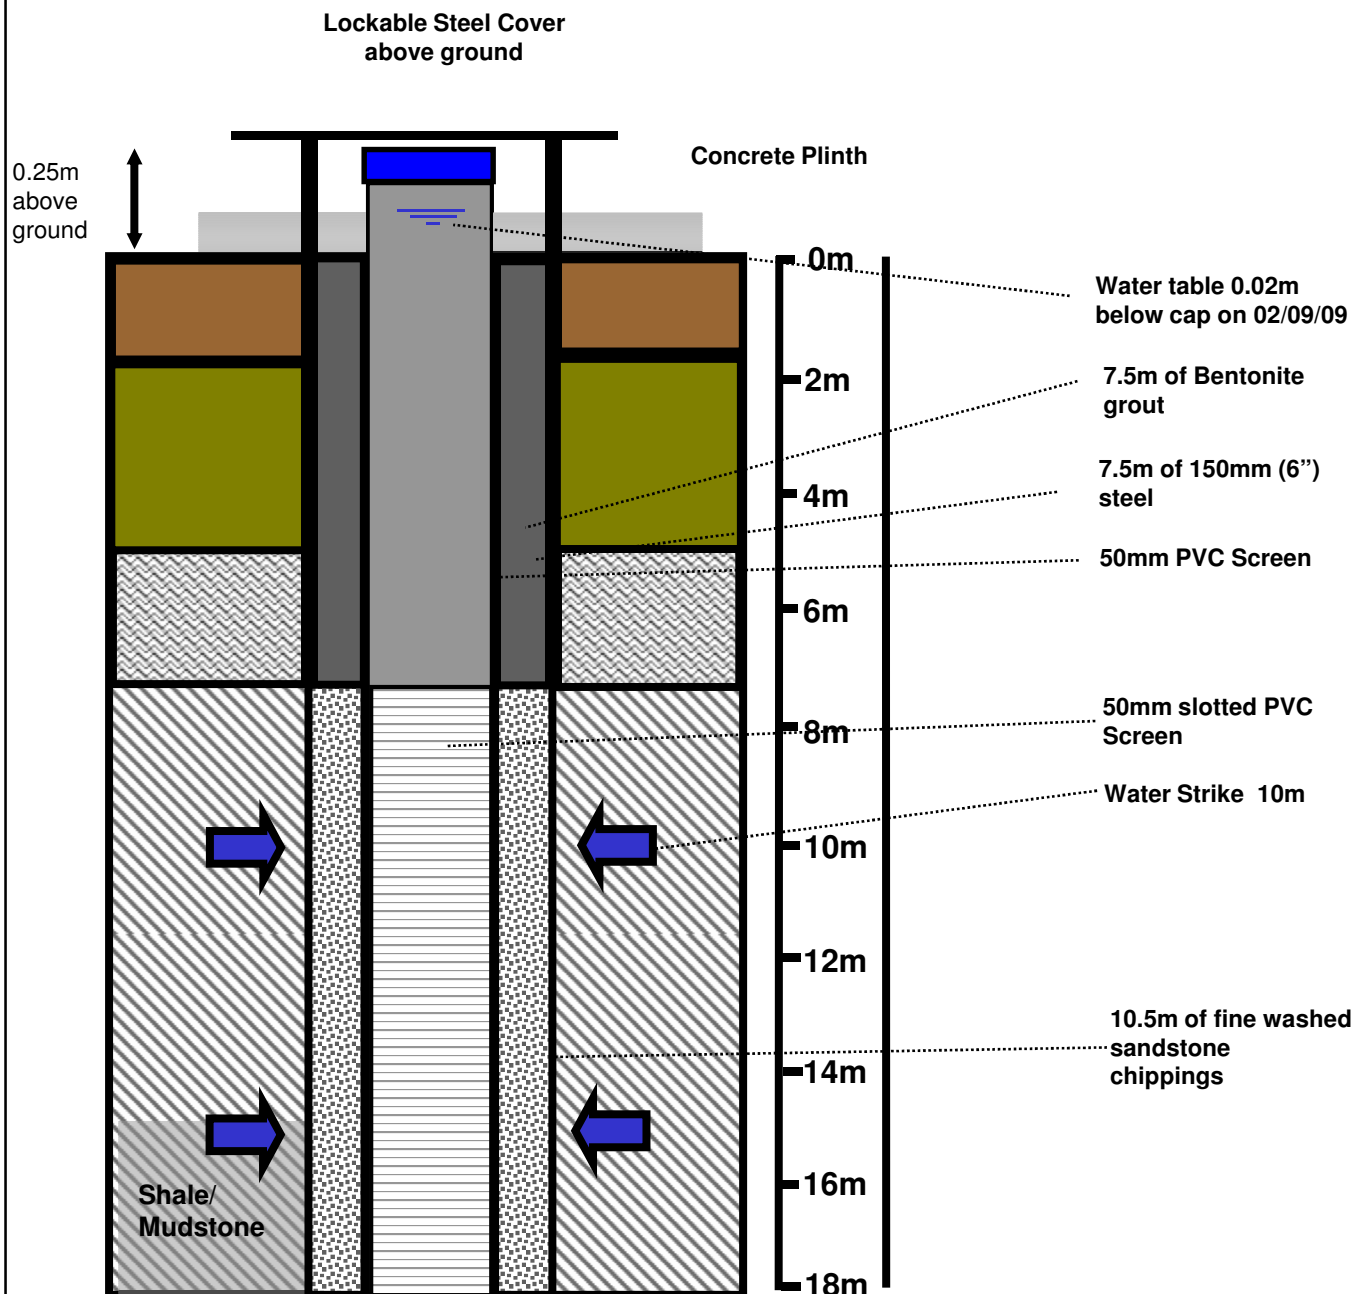
MW1

In MW-1, MW-3 and MW-4 the depth to water ranges from 0.35 to 1.9m below the top of the well casing, with discernible seasonal variation in MW-3. There are artesian conditions in MW-1, with water overflowing the top of the well pipe in the winter. The water levels indicate that bedrock aquifer is confined, with the piezometric head above the top of the weathered bedrock. The direction of groundwater flow is from the south-west to the north east.

The well is located in a wooded area to the north of the drain that flows along the north-eastern boundary. The headworks are intact (Photograph 1) but there is evidence of artesian conditions.

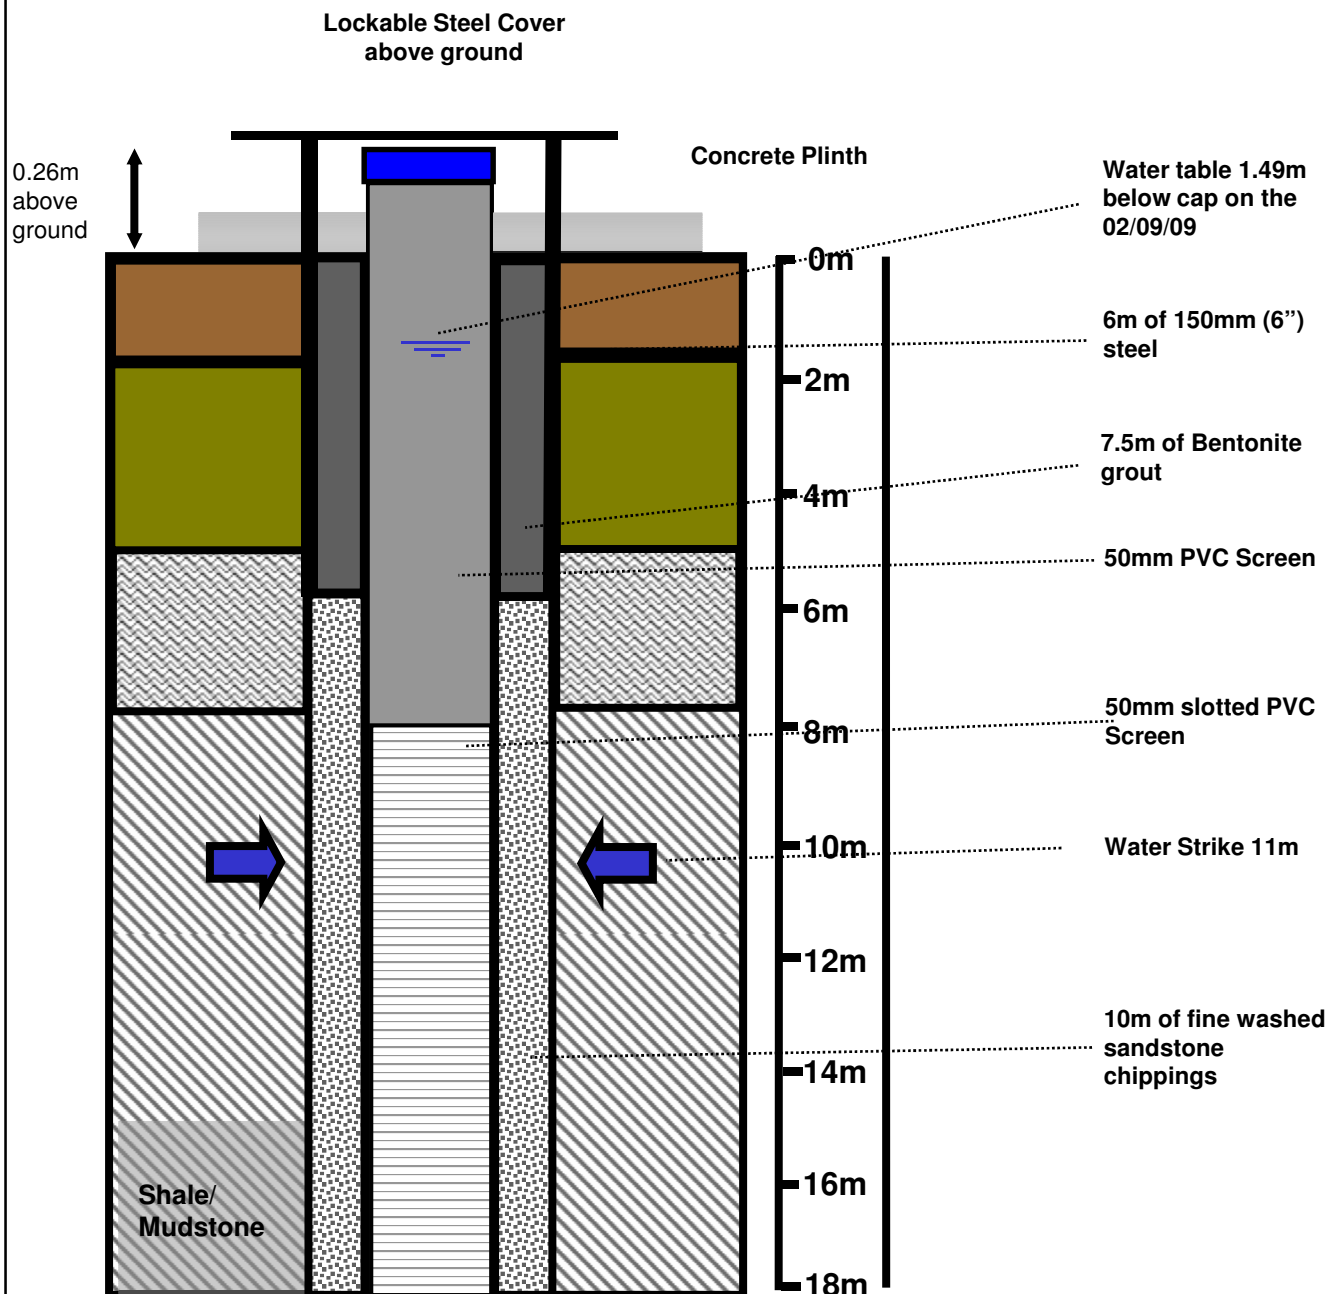
MW3

Given that the headworks on both MW-3 and MW-4 are damaged, there are no well caps and MW-4 is approximately 0.5 m below ground level, the likely source of the coliforms is faecal contamination by birds or small mammals and not off-site sources.

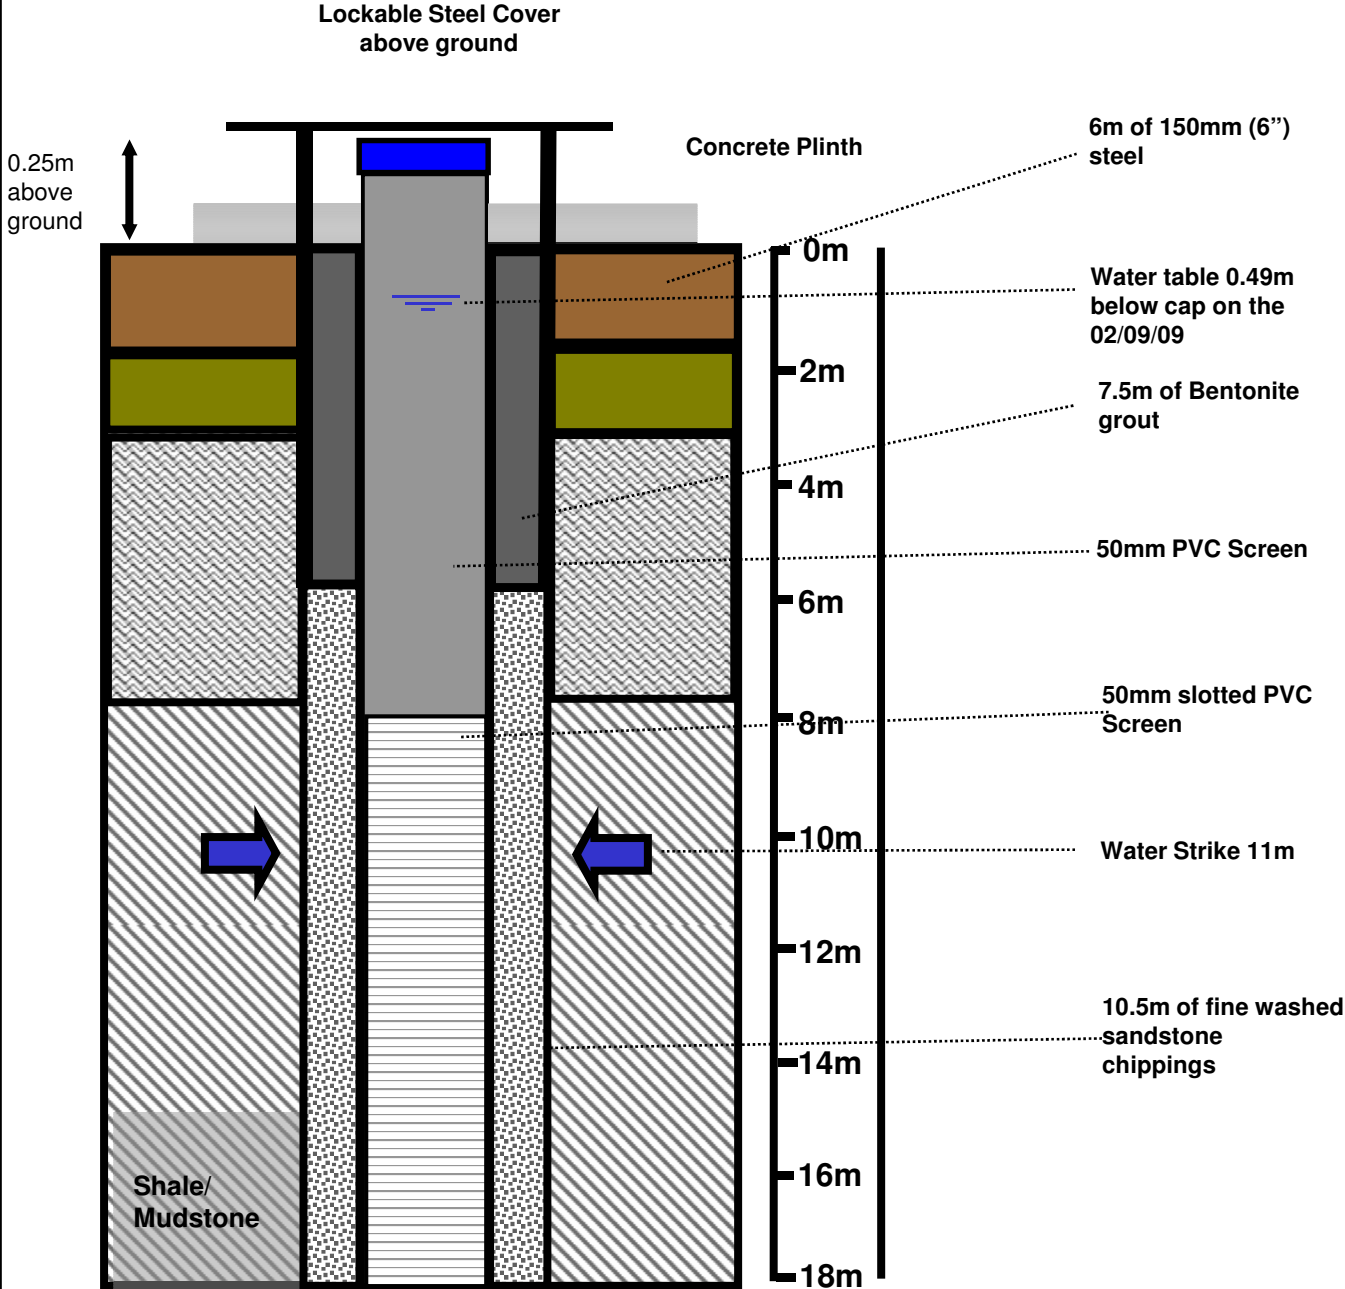
MW4

The well was protected by placing a large diameter plastic pipe on the ground and backfilling around it. However the lid on top of the casing has been removed and there is no well cap. OCM observed water had accumulated in the base of the protective pipe and the level was just below the top of the well pipe and there were leaves and litter around the well pipes. It was not possible to determine if the water in the base was overtopping groundwater or surface water.

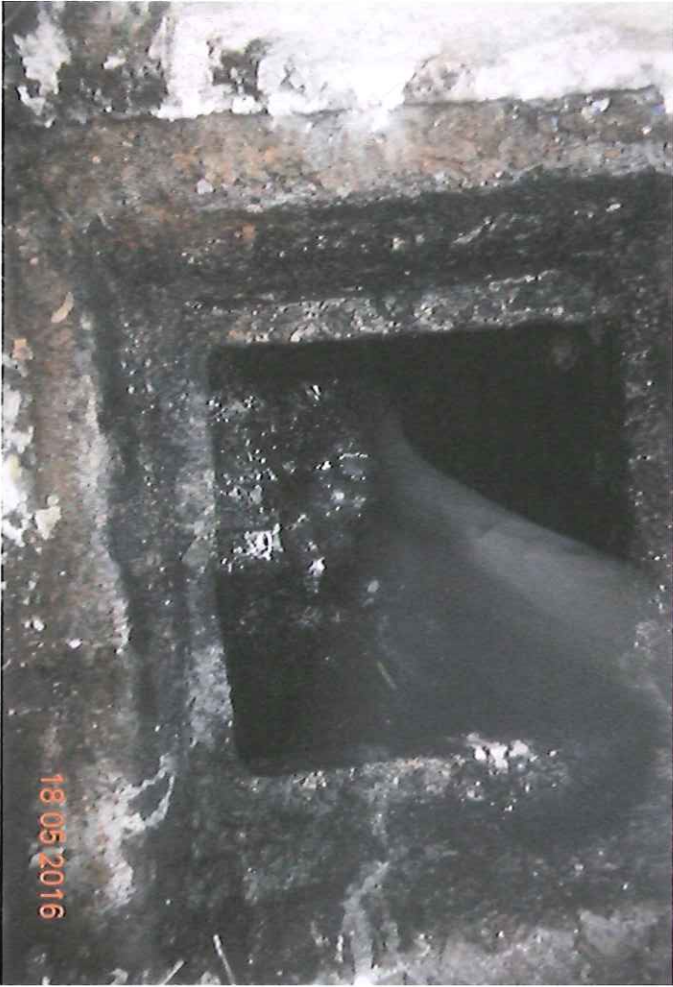
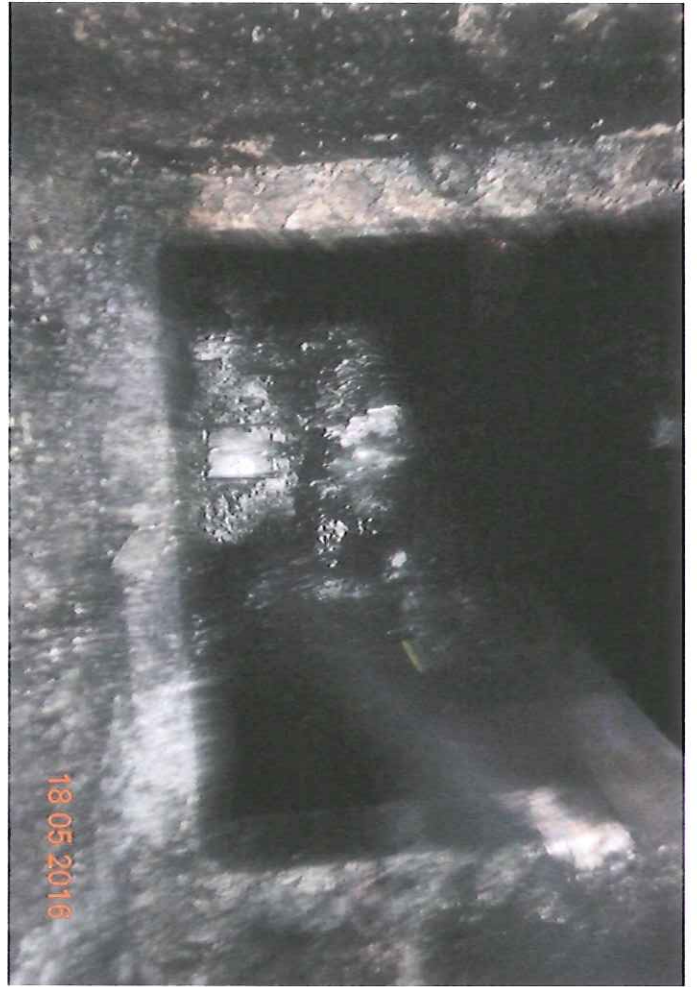
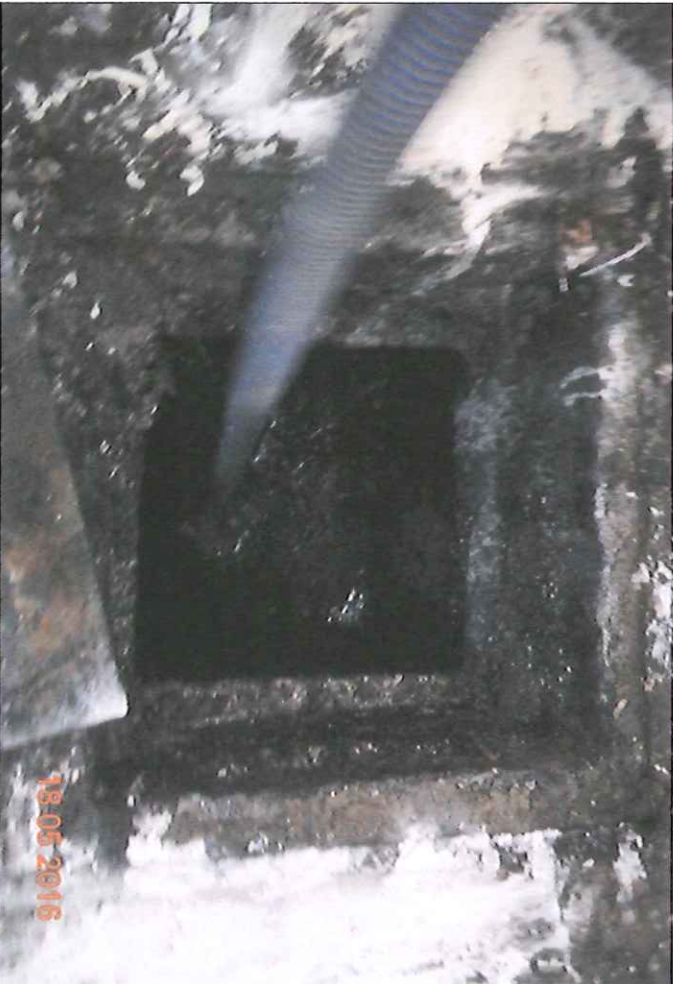
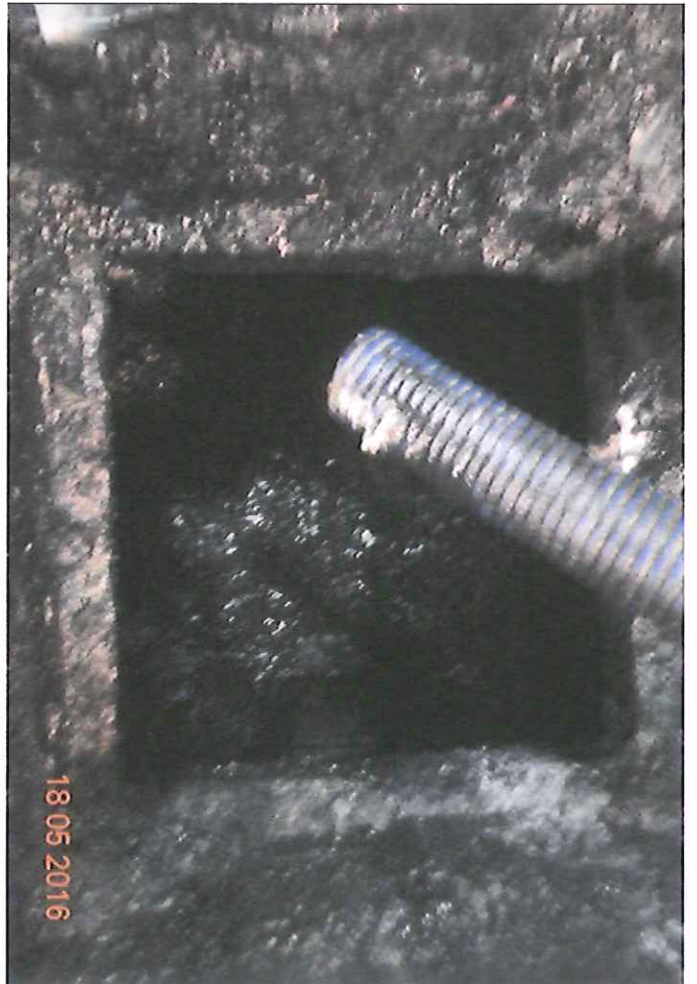
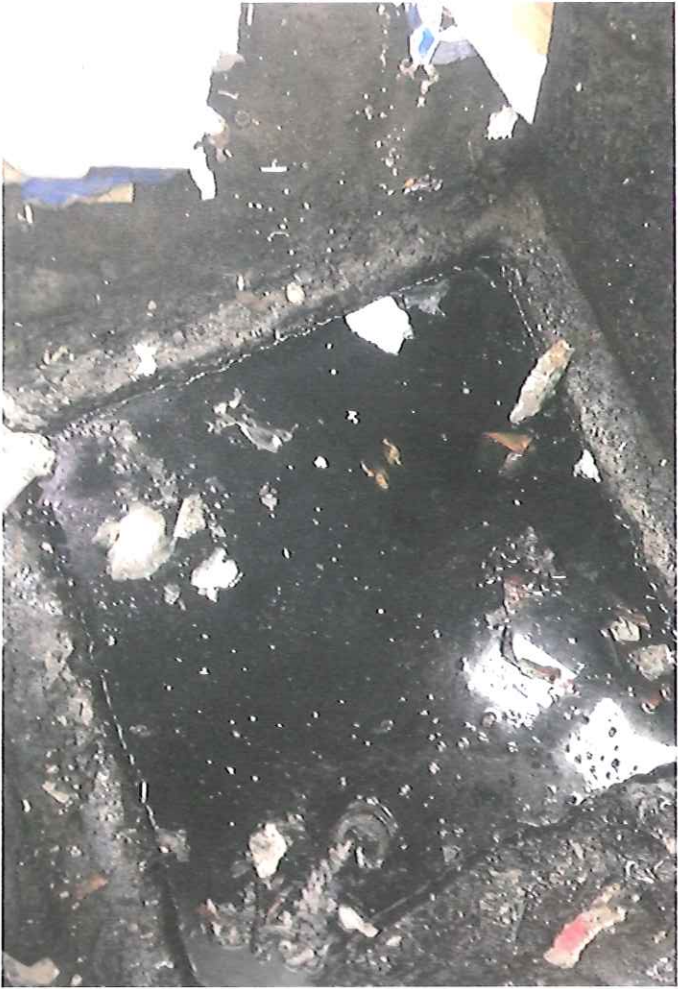
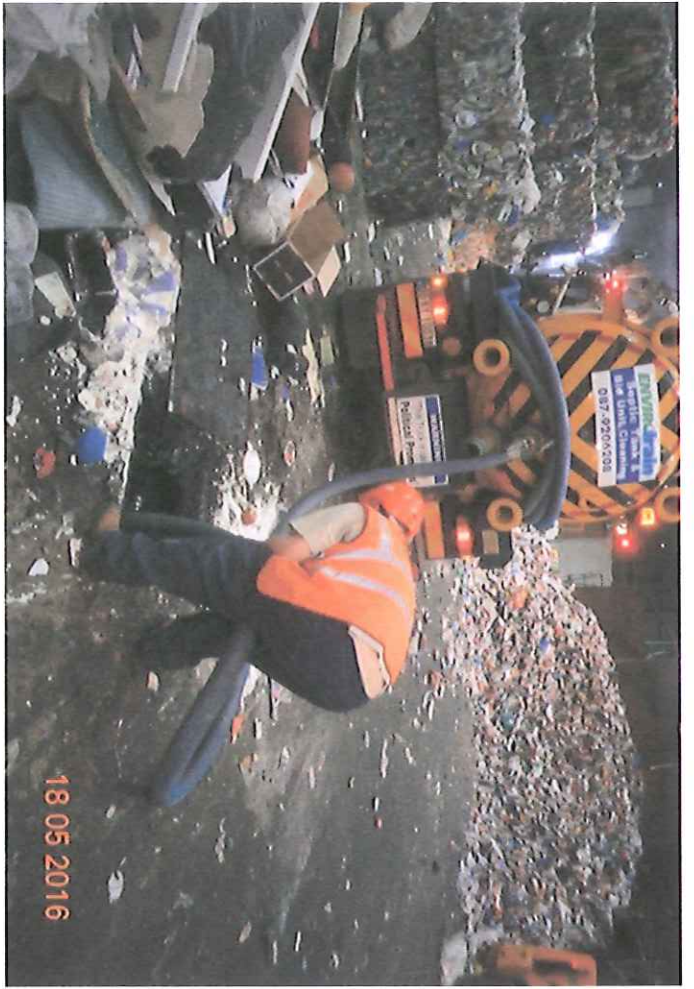
Sump 1

All underground sumps, the oil tank bund and the oil interceptor are subject to regular integrity tests, as required by the licence conditions. The foul water pipe network was surveyed in 2014 and no defects were found. The most recent tests on the sumps, bund and interceptor were completed in 2016 and all of the structures were found to be fit for purpose. Copies of the underground line survey and sump test report are in Appendix 3.

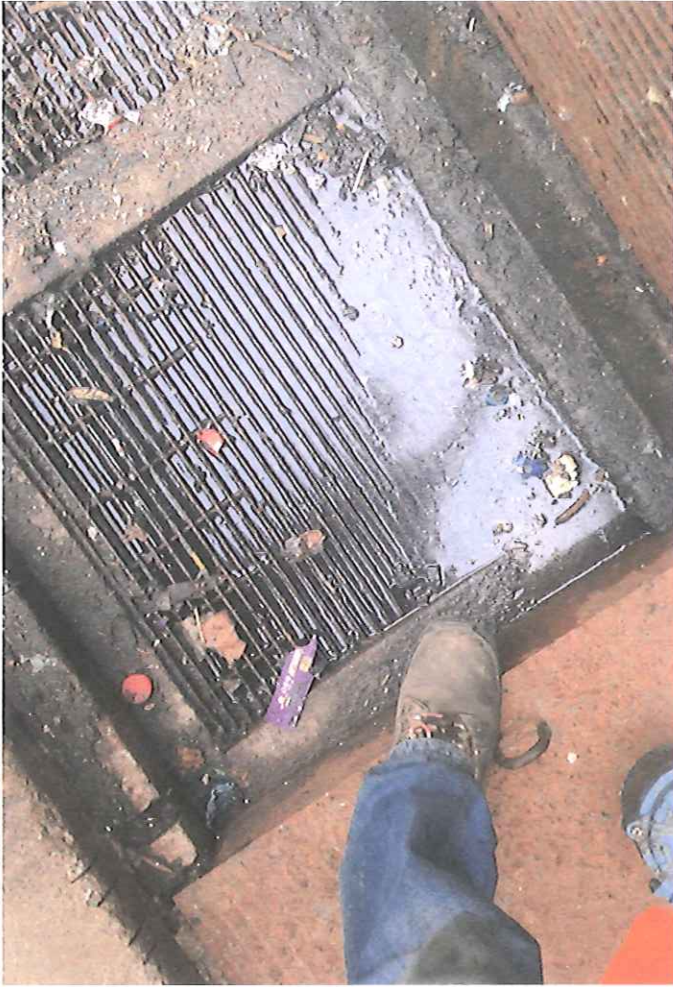
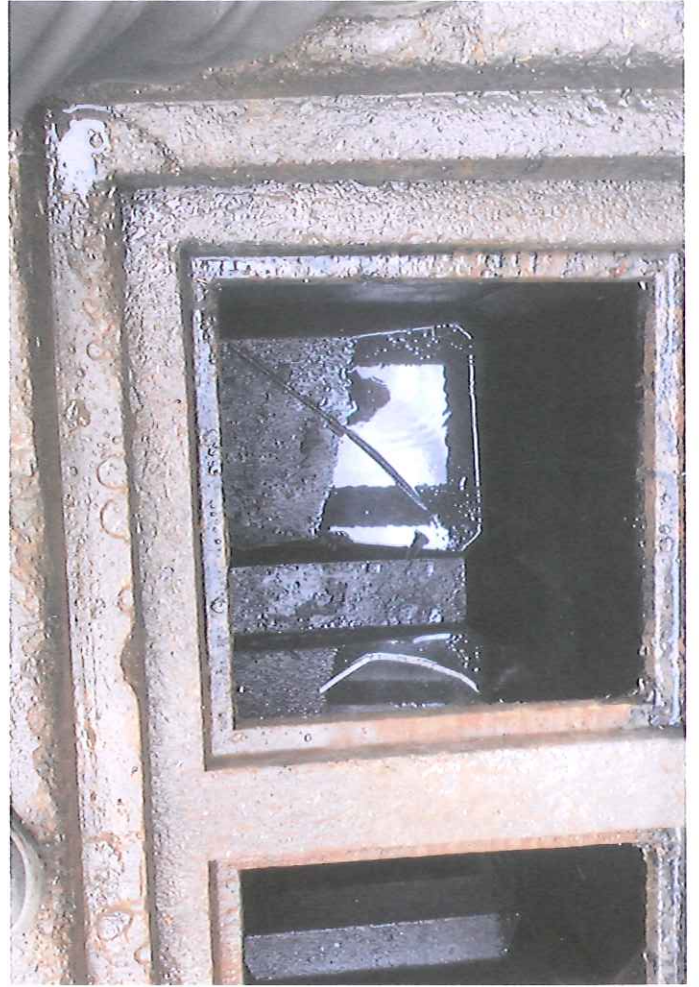
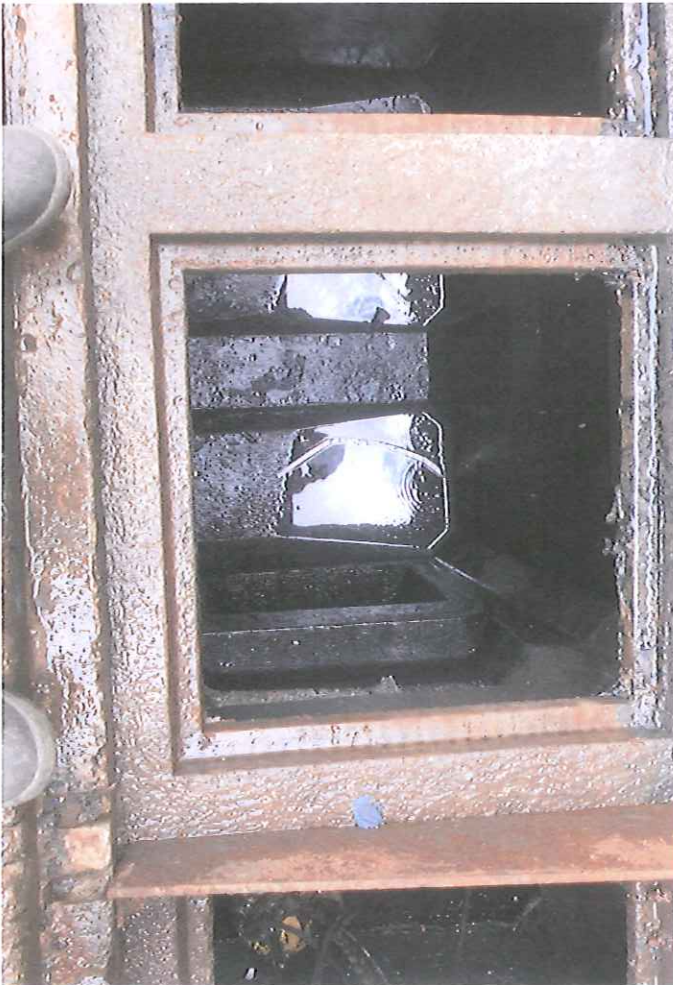
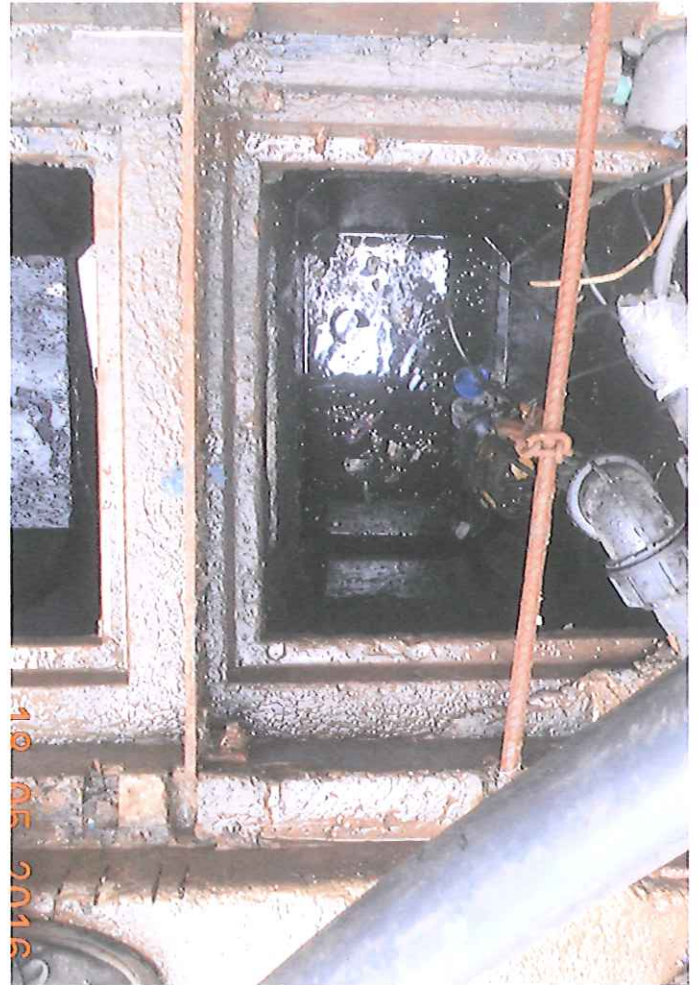
Sump 3

SUMP NUMBER	Date of Testing	Result	Comment
Sump No.1 (Leachate Sump)	17/5/2016-18/5/2016	Passed	Reinforced Concrete in good condition.
Sump No.2 (Near Office)	17/5/2016-18/5/2016	Passed	Reinforced Concrete in good condition.
Sump No.3 (Near Timber Shed)	17/5/2016-18/5/2016	Passed	Reinforced Concrete in good condition.
Sump No.4 (Oil Bund)	17/5/2016-18/5/2016	Passed	Reinforced Concrete in good condition.
Sump No.5 (Oil/Water Interceptor near Diesel Shed)	17/5/2016-18/5/2016	Passed	Reinforced Concrete in good condition.
