TIER 3

ENVIRONMENTAL RISK ASSESSMENT

FORMER MUNICIPAL LANDFILL

BALLYRAGGET,

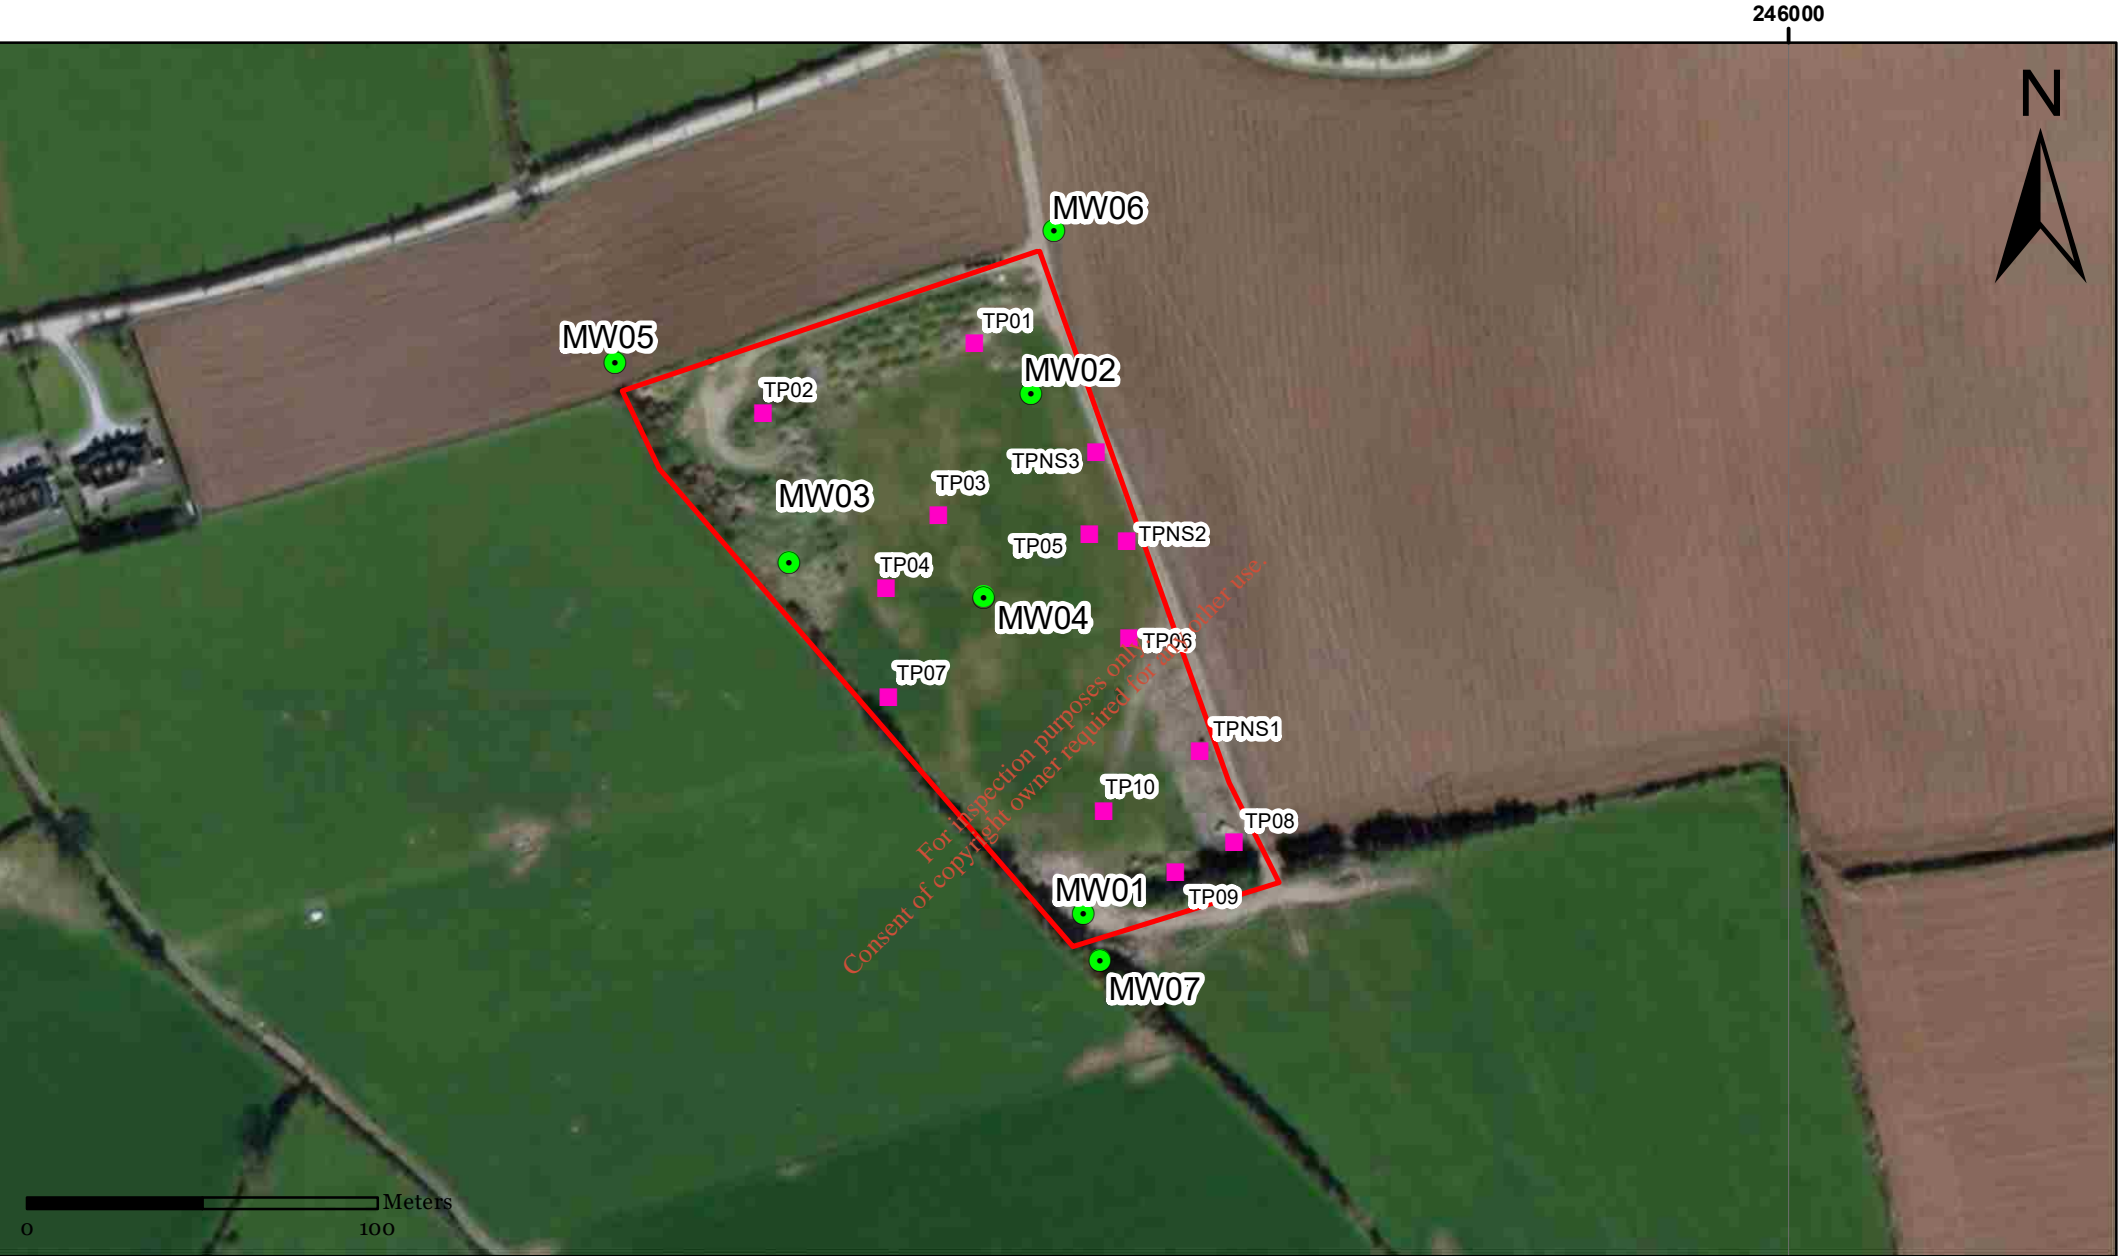
Figure 3.2 which is based on the trial pit data from the Tier 2 site investigation shows the lateral and vertical capping distribution across the site. Figure 3.3 shows the thickness of the waste. The waste is generally thickest in the east central area and thins to the north-west and south. The depth of waste varies across the site from 0.5 m (TP-7) in the west of the site to 3.3 m (TP-6) in the east of the site.

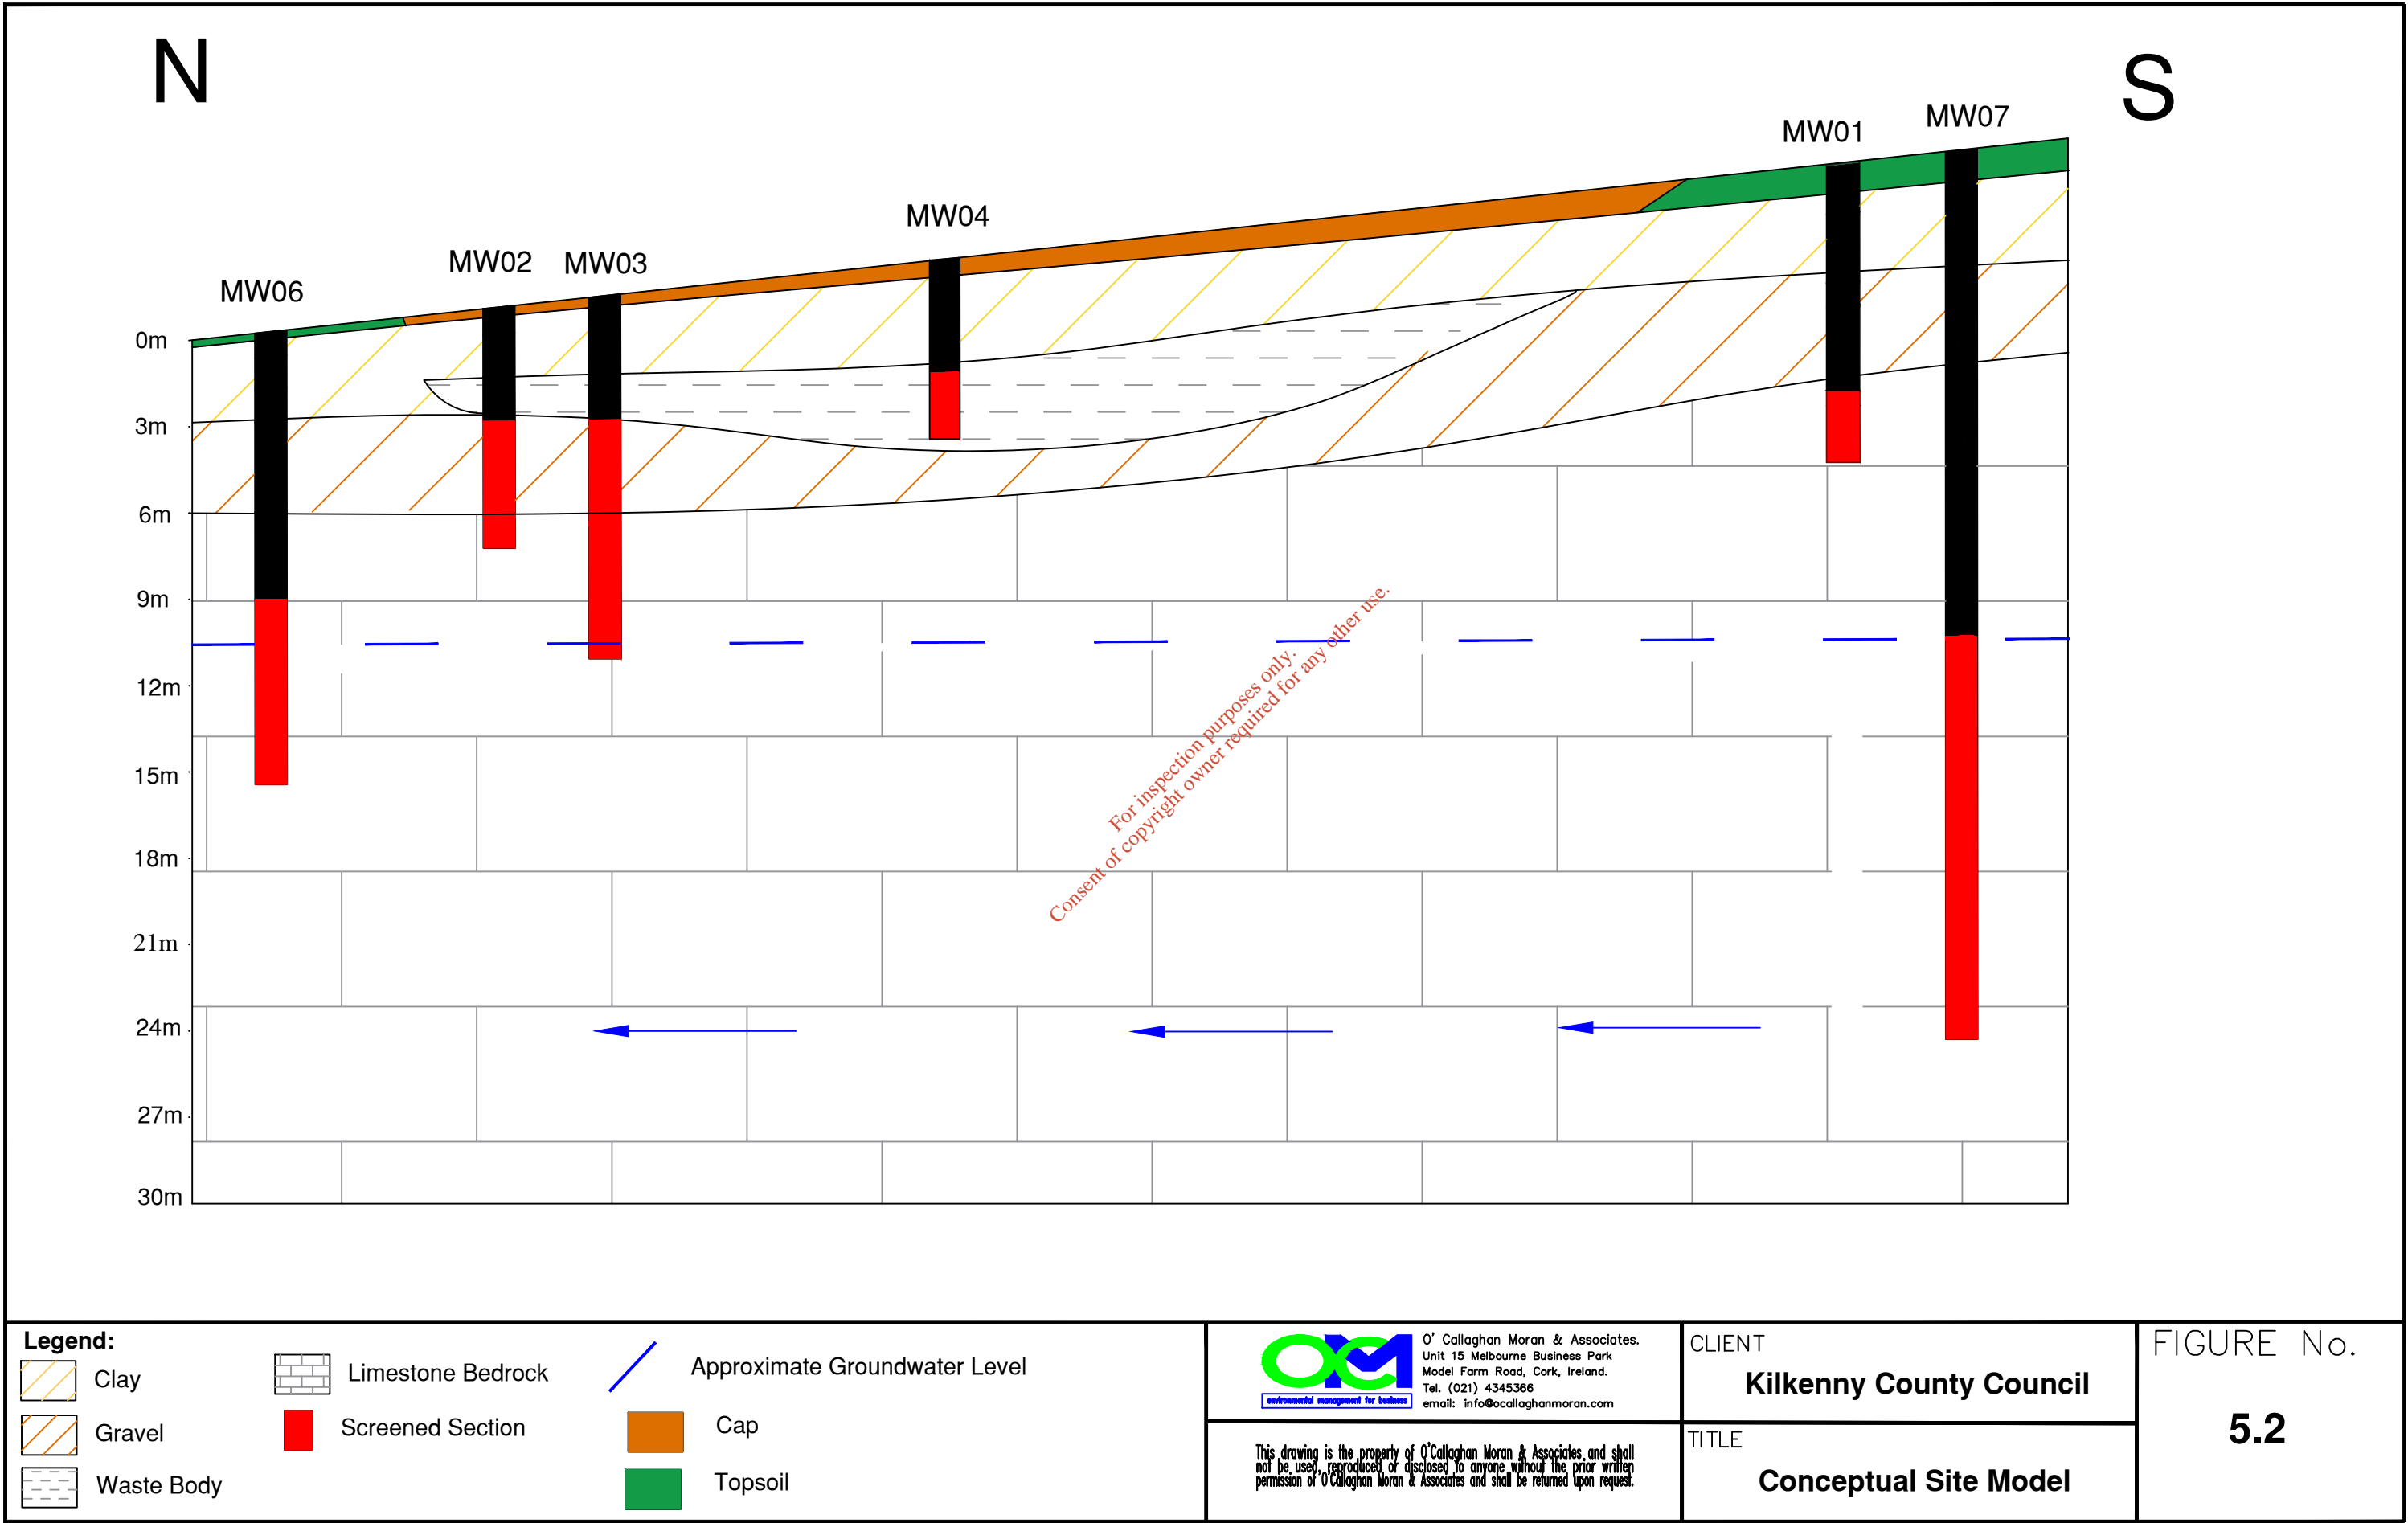
The COP requires that the Conceptual Site Model (CSM) developed during Tier 1 be refined based on the findings of further site investigations. OCM refined the CSM based on the findings of the Tier 2 and Tier 3 investigations. A schematic of the revised CSM is shown in Figure 5.2. The line of section on which the cross section is based is shown on Figure 5.3.

Rainfall recharge to the waste has been reduced by the placement of the clay capping layer. This layer is thickest where the waste is deepest. While some of the potential rainfall recharge runs off the site to the north and north-west, it is likely that there is currently significant rainfall recharge to the waste.

The landfill gas monitoring indicates the presence of elevated carbon dioxide and methane in the centre of the site, but not evidence of landfill gas migration. It is likely that landfill gas vents relatively freely to atmosphere through the cap.

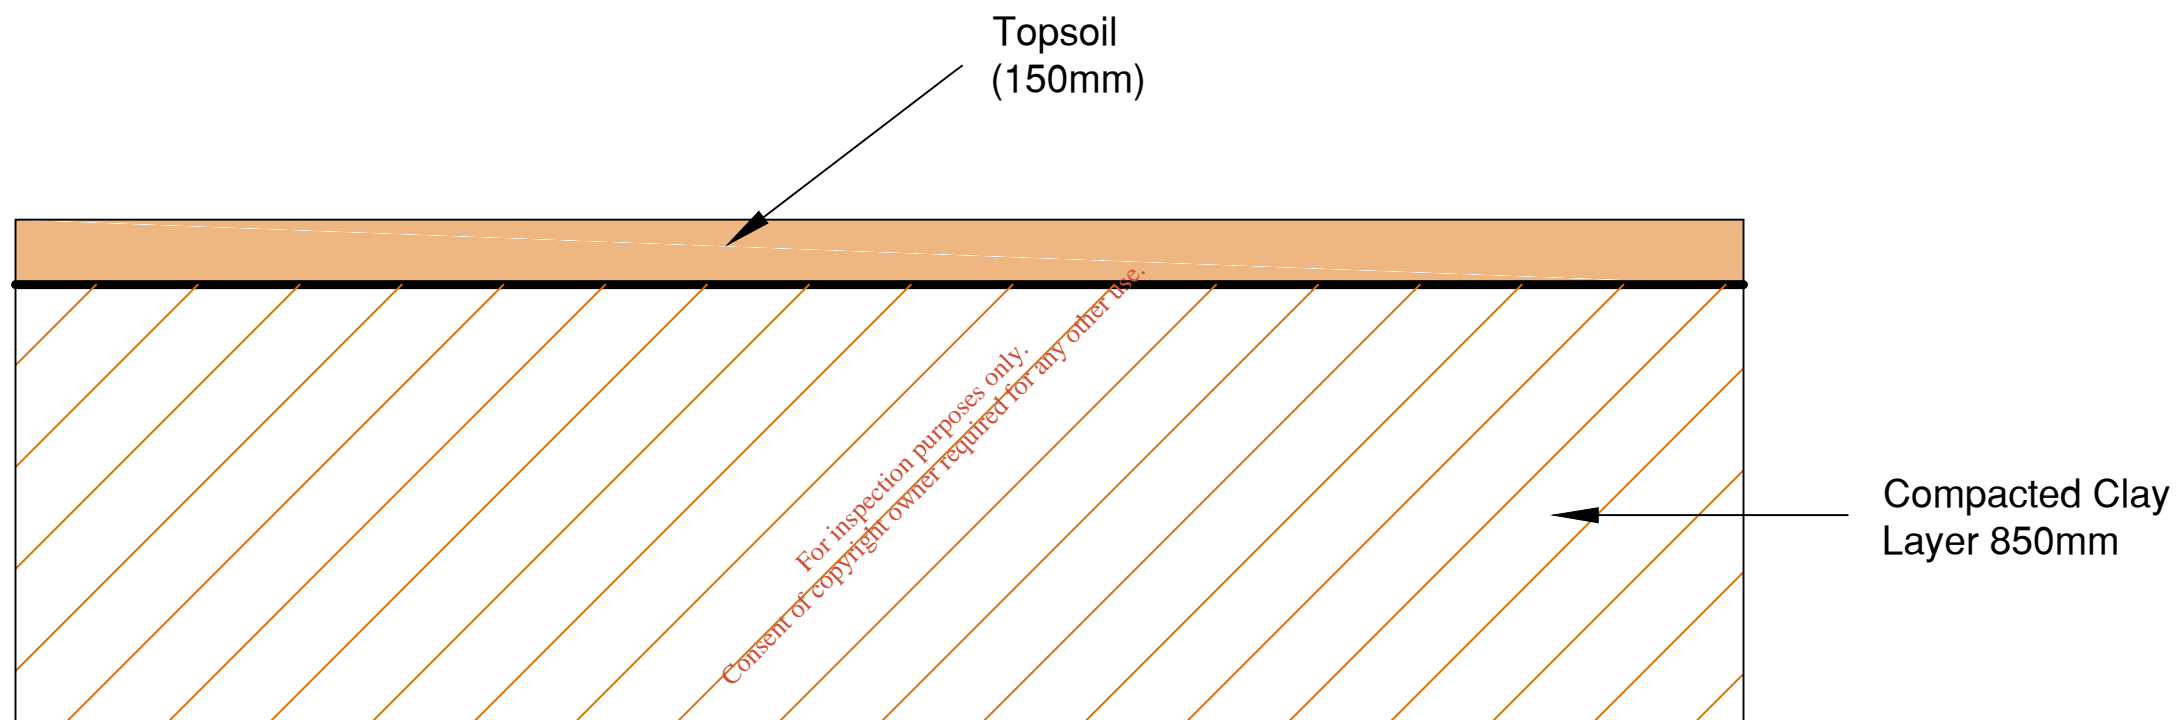
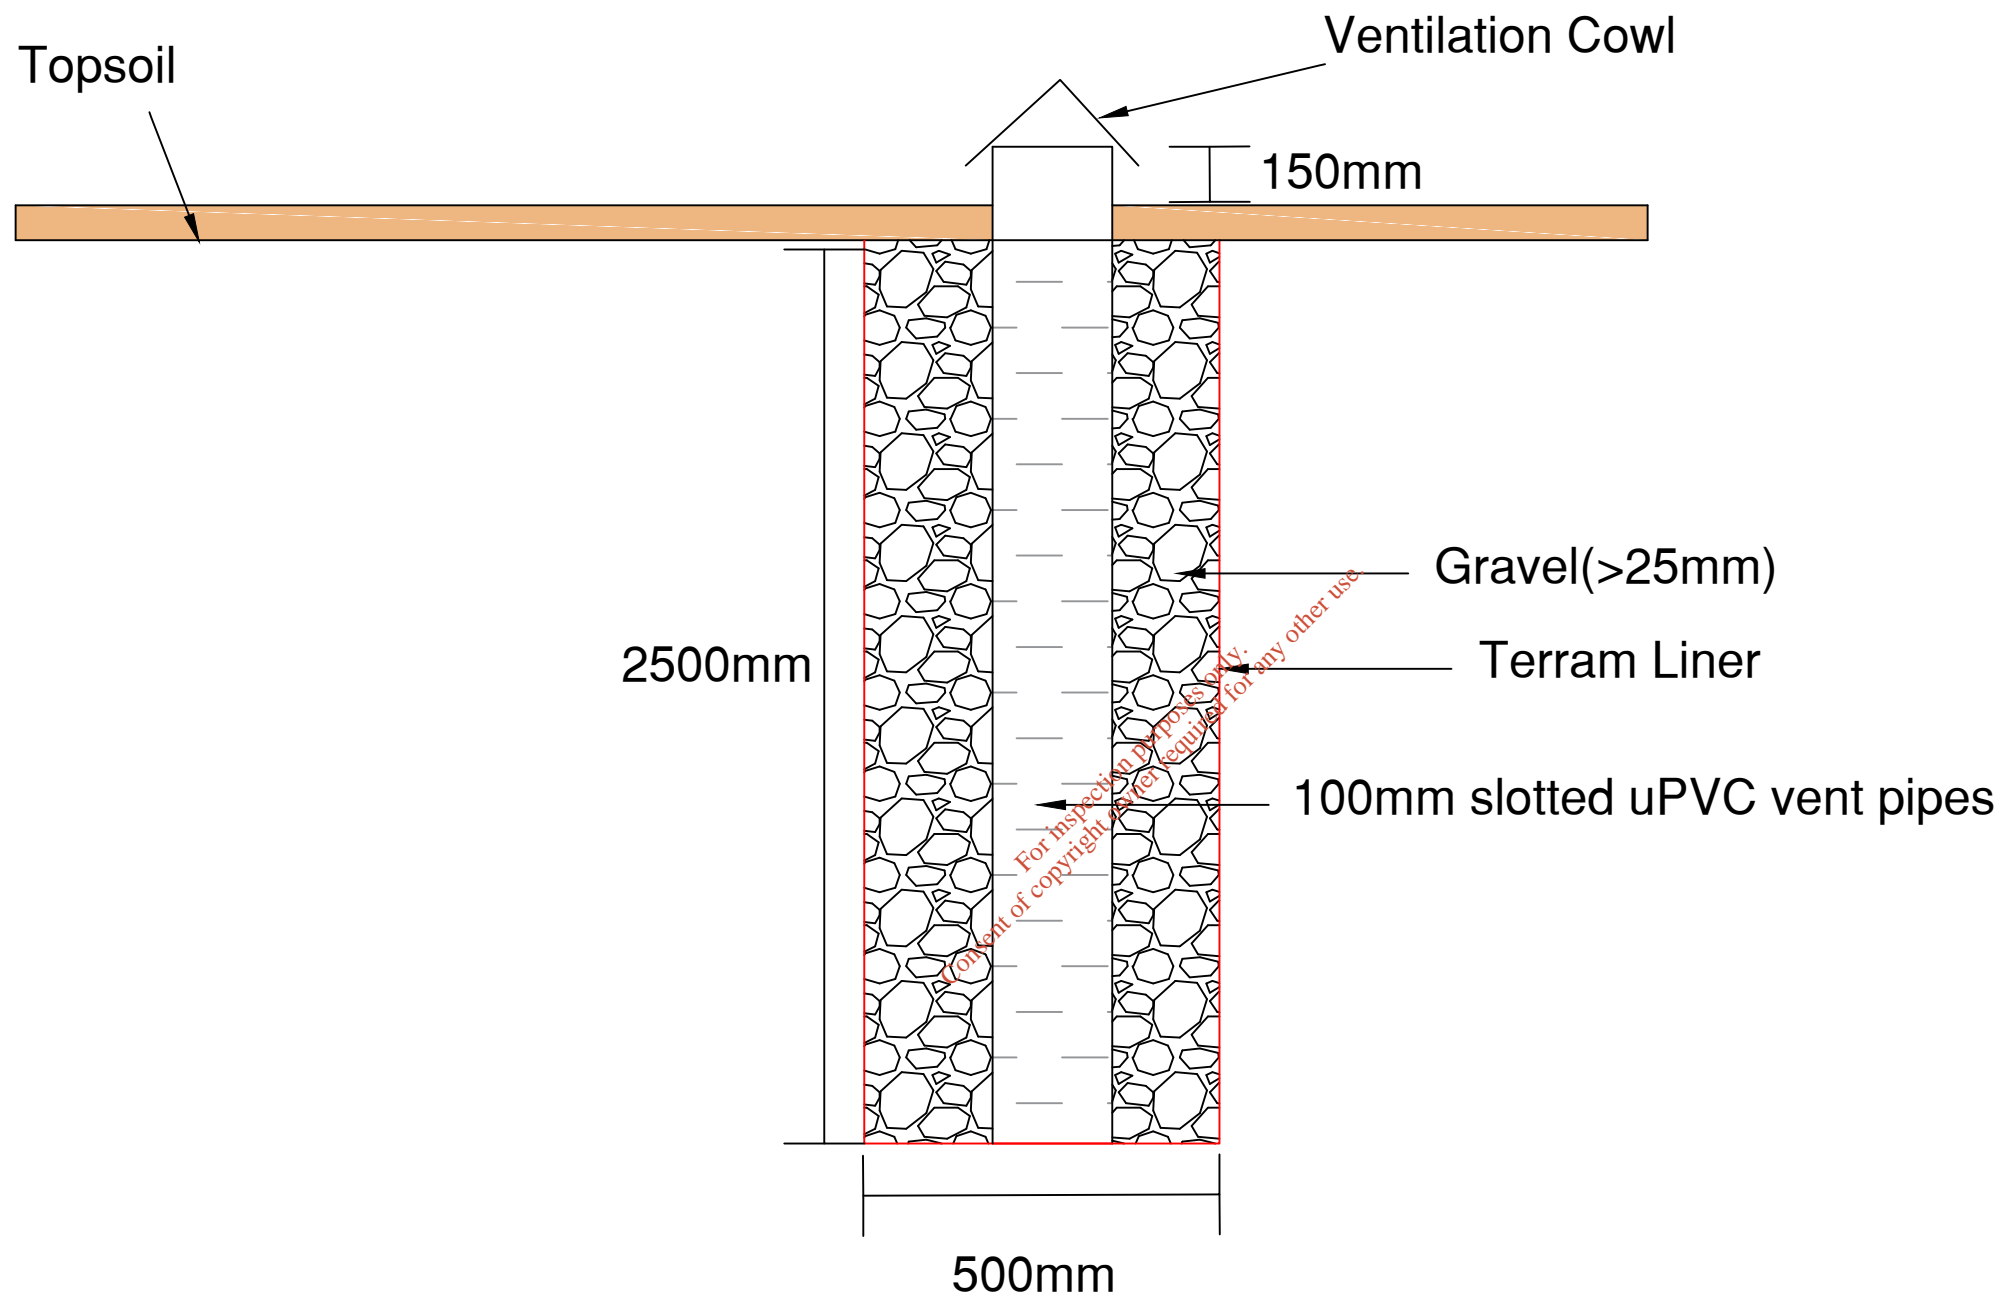
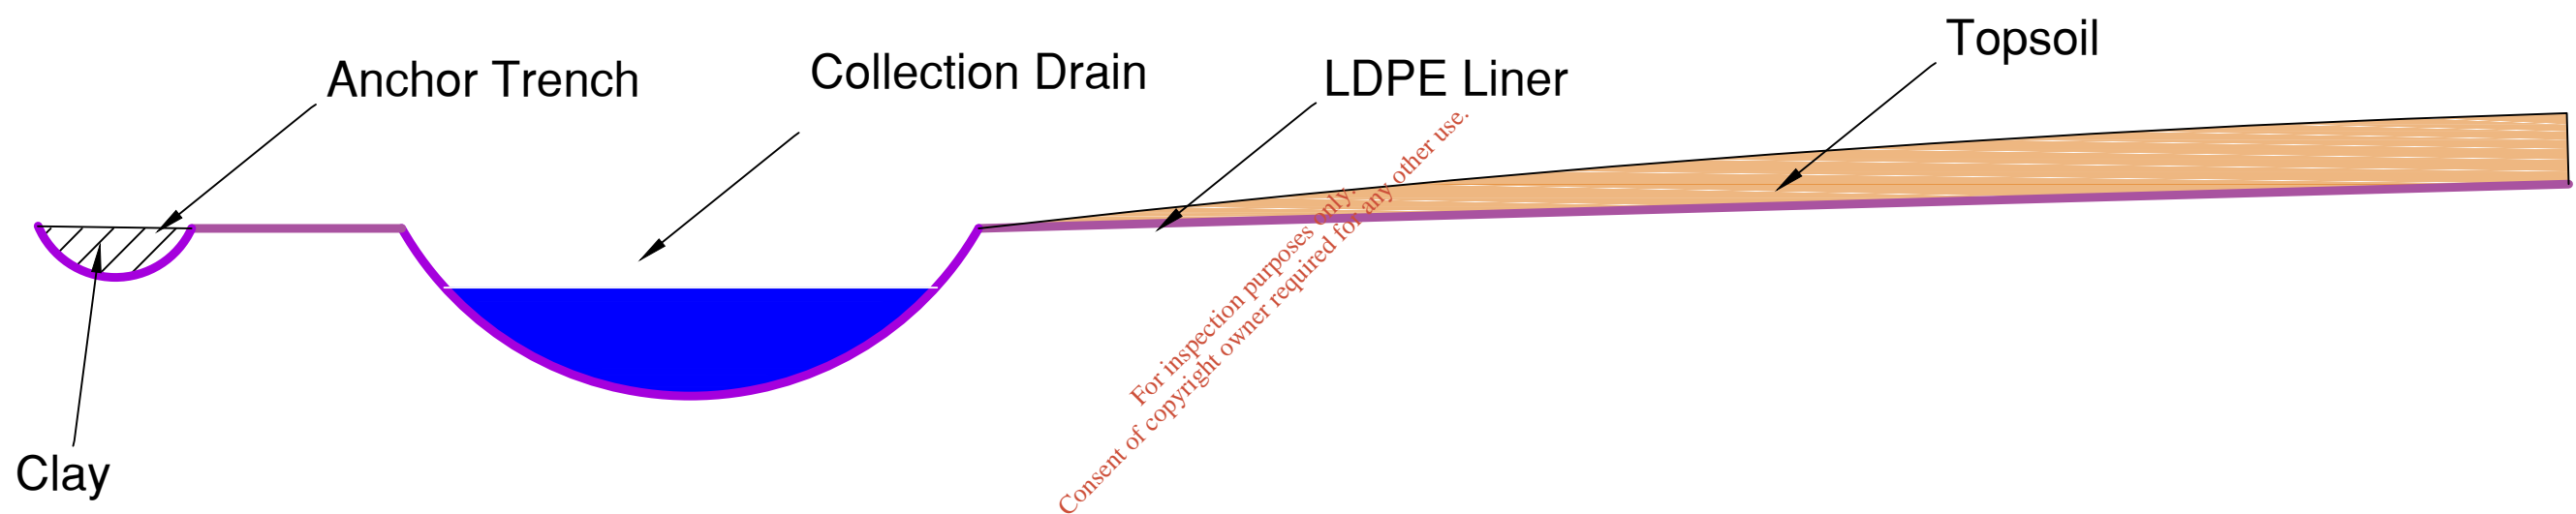
There is currently top soil and grass on the entire landfill and in some areas (central portion) this complies with the EPA recommended cap thickness. The topsoil will have to be stripped to allow additional capping soils to be placed and to allow for grading and compacting the entire capping layer.

Four gas ventilation wells should be installed, one in each quadrant of the waste, to allow passive ventilation of the gas. The well pipes should be 100mm slotted uPVC and should extend 150mm above the top soil layer. These wells should be fitted with cowls and fenced off to prevent damage by livestock.
