**TIER 3 RISK ASSESSMENT**

**FORMER LANDFILL**

**GOWRAN**

**December 2017**

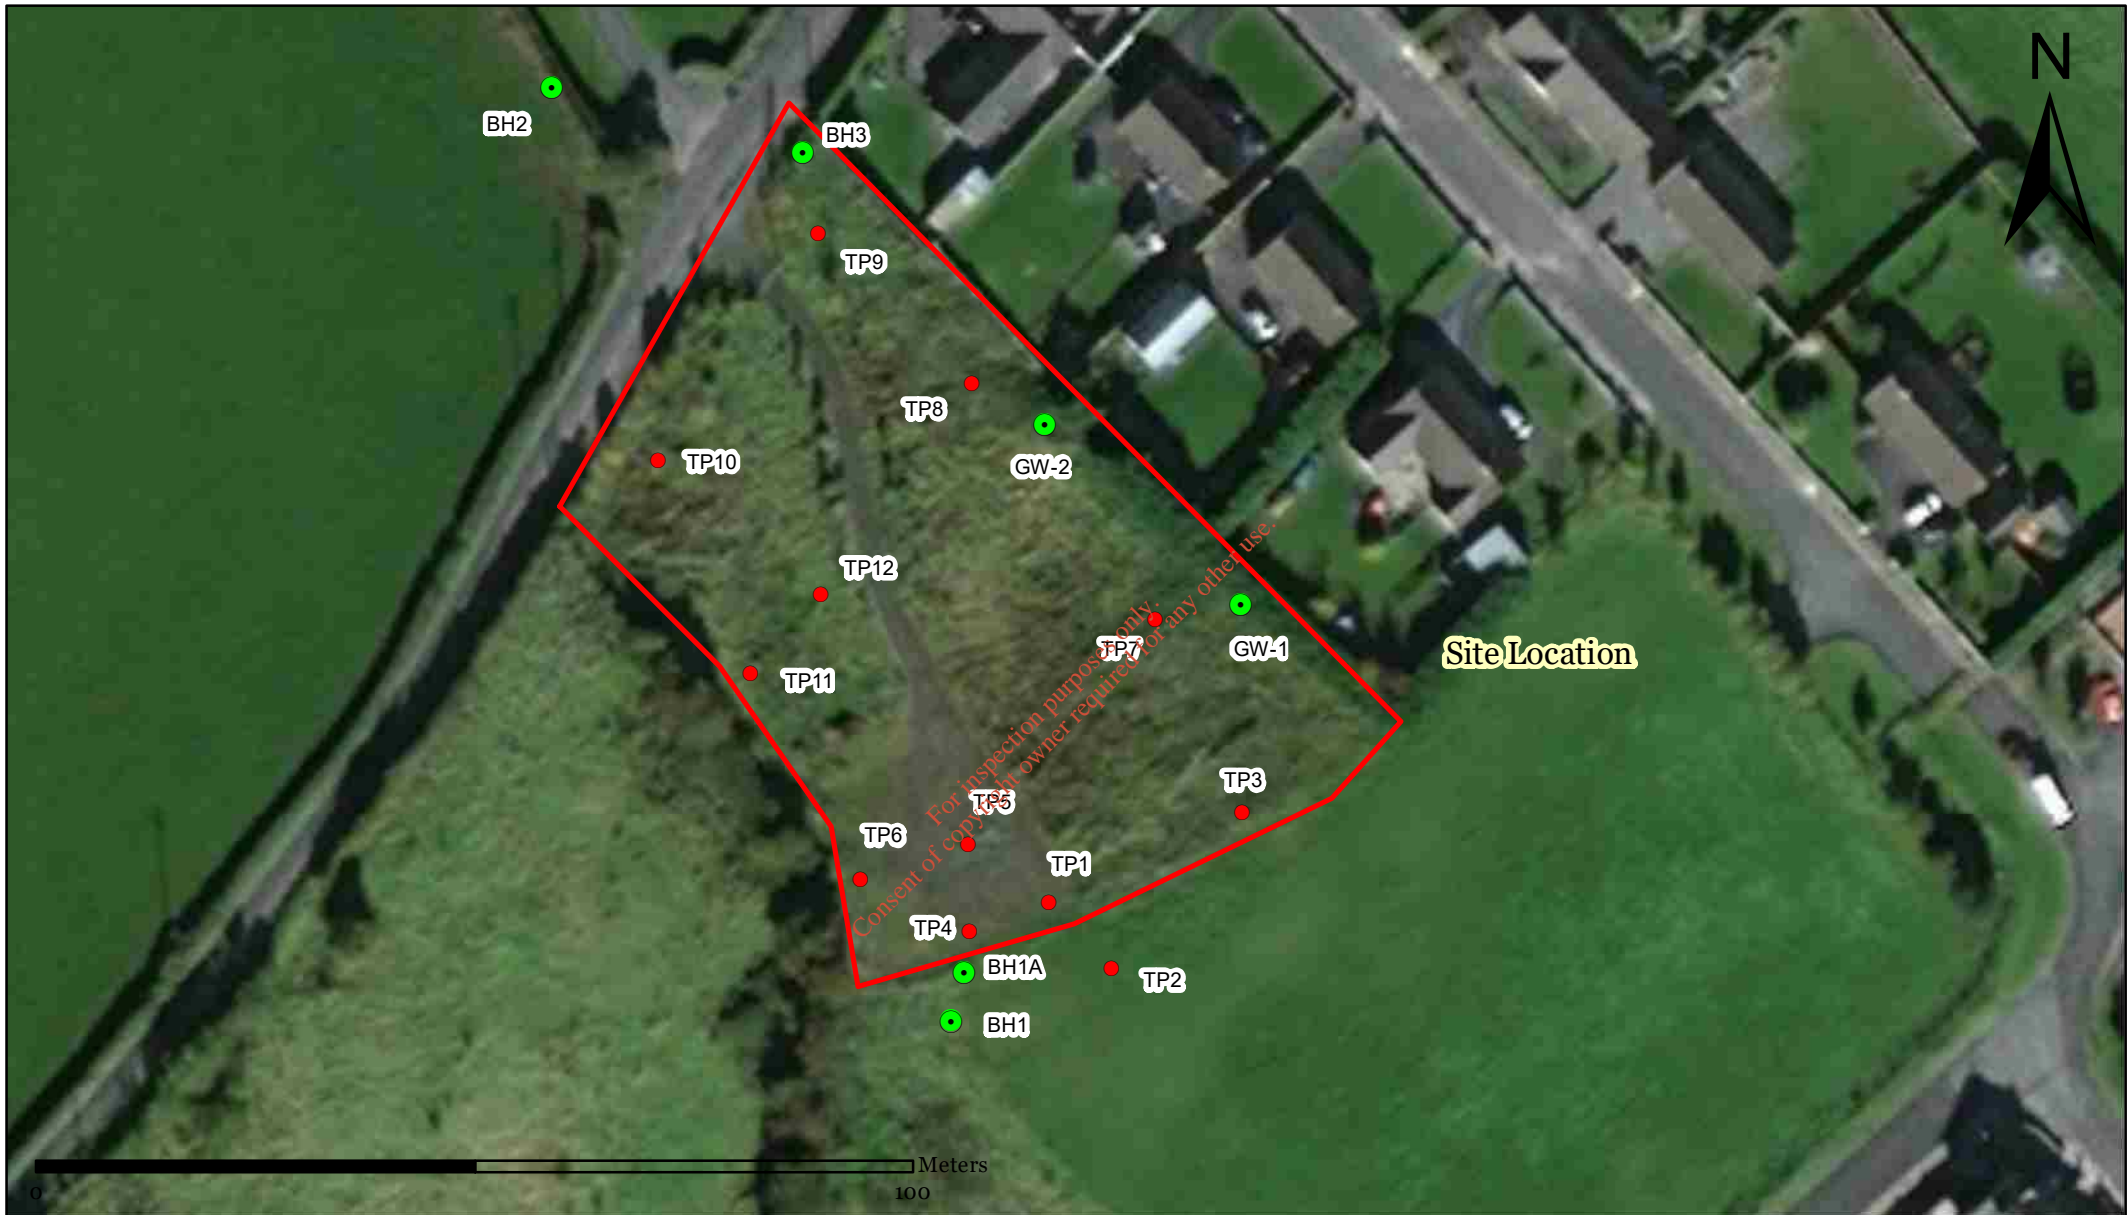
Figure 3.1

The OCM investigation involved the installation of two (2 No.) groundwater monitoring wells (BH-1A and BH-3). BH-1A was adjacent and was a replacement well for BH-1, which was dry. BH-3 was immediately down topographic gradient of the landfill in the north of the site.

Two gas monitoring wells (GW-1 and GW-2) were installed along the western boundary of the site to assess the potential for landfill gas migration to the dwellings to the north-east of the site. The locations of the FTC and OCM trial pits and monitoring wells are shown on Figure 3.1.

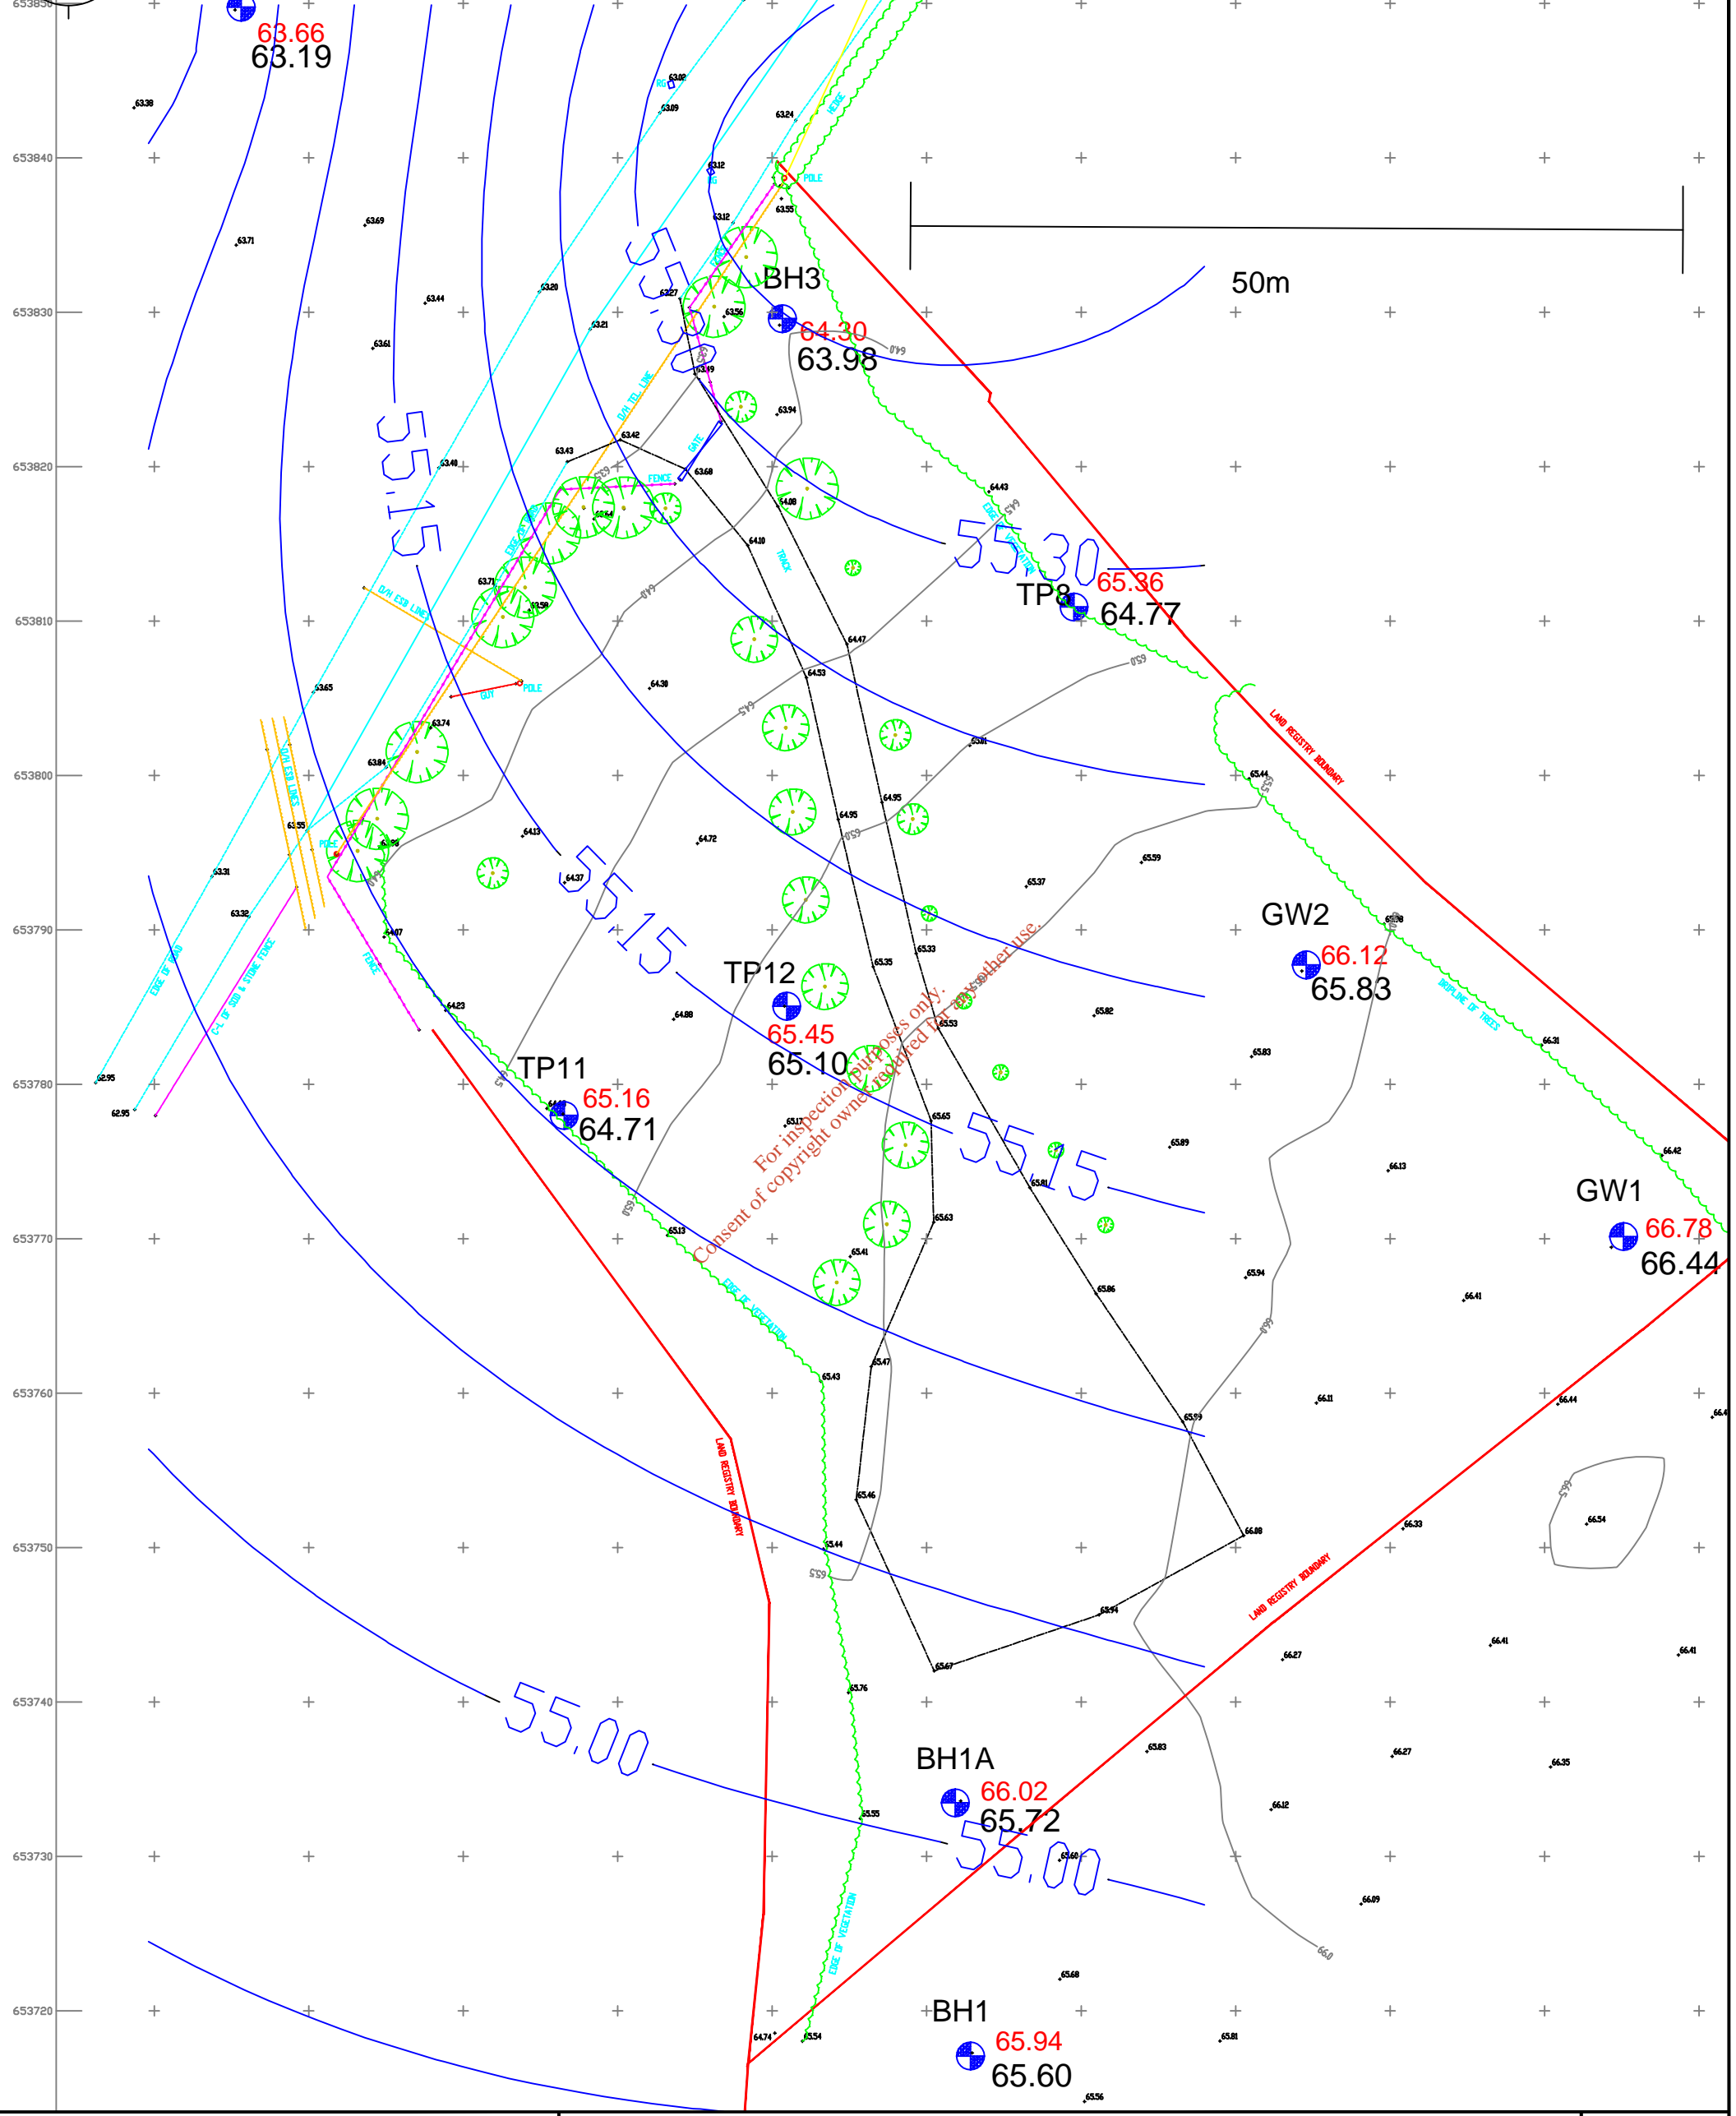
The groundwater levels recorded during the monitoring programme in November were converted to OD and used to generate a groundwater flow direction map for the site (Figure 3.4). Groundwater flows from the north-east toward the south-west. This indicates that BH-2 is located up or possibly side gradient of the landfill and BH-1A is located down hydraulic gradient of the landfill.
