ANNUAL ENVIRONMENTAL REPORT

RILTA ENVIRONMENTAL LTD.

SITE 14-A1 GREENOGUE BUSINESS PARK

JANUARY 2017 – DECEMBER 2017

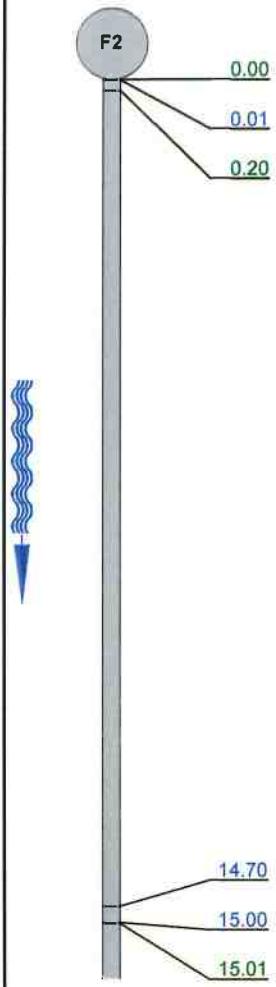
MH	Start node type, manhole, reference number : F2	00:00:05		(Constr) 0
		WL	Water level, 0% of the vertical dimension	00:00:05		(Serv) 0
		SR	Sealing ring intruding, from 6 to 12 o'clock	00:00:07	4_3A	(Constr) 1
		LL	Line deviates left	00:03:32		(Serv) 0
		WL	Water level, 0% of the vertical dimension	00:00:00		(Serv) 0
		MHF	Finish node type, manhole reference number: F3	00:00:00		(Constr) 0

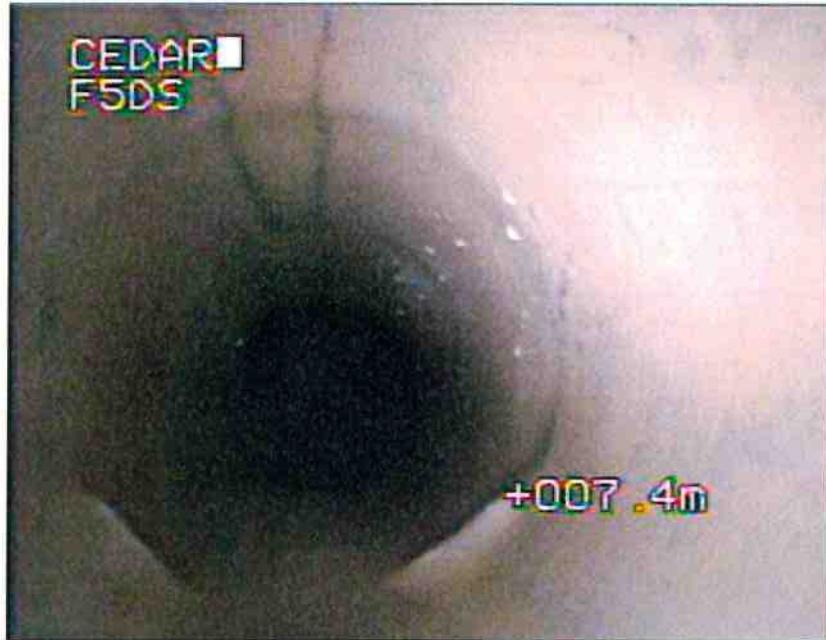
Photo: 8_3A, MPEG #: 051216_1, 00:01:02
7.4m, General remark

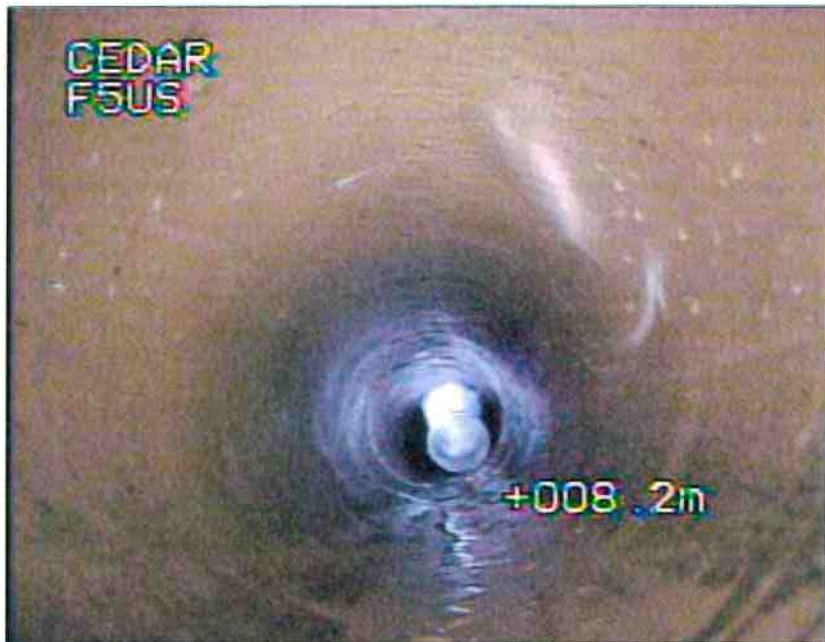
Photo: 9_5A, MPEG #: 051216_1, 00:01:55
8.2m, General remark

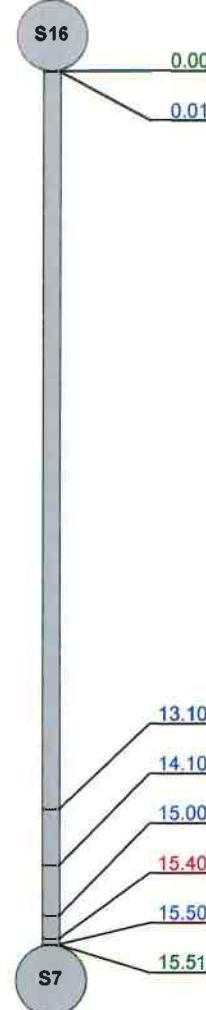
MH	Start node type, manhole, reference number : S16	00:00:00		(Constr) 0
		WL	Water level, 0% of the vertical dimension	00:00:00		(Serv) 0
		WLC	Clear water level, 5% of the vertical dimension	00:01:52		(Serv) 0
		WLC	Clear water level, 10% of the vertical dimension	00:02:00		(Serv) 0
		LL	Line deviates left Remarks: 90 deg.	00:02:07		(Serv) 0
		JDL	Joint displaced, large Remarks: Poor workmanship.	00:02:41	49_6A	(Struct) 1
		WL	Water level, 5% of the vertical dimension	00:00:00		(Serv) 0
		MHF	Finish node type, manhole reference number: S7	00:00:00		(Constr) 0

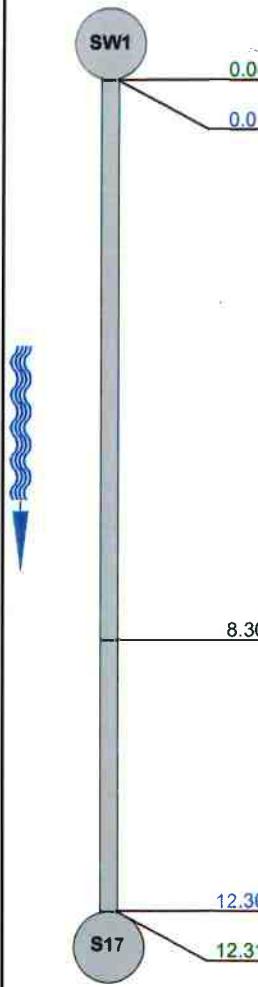
MH	Start node type, manhole, reference number : SW1 Remarks: Surface water valve.	00:00:02		(Constr) 0
		WL	Water level, 0% of the vertical dimension	00:00:02		(Serv) 0
	8.30	REM	General remark Remarks: Socket connection against the stream	00:01:15		(Misc) 0
	12.30	WL	Water level, 0% of the vertical dimension	00:01:49		(Serv) 0
	12.31	MHF	Finish node type, manhole reference number: S17	00:01:49		(Constr) 0
