**ANNUAL ENVIRONMENTAL REPORT**  
**RILTA ENVIRONMENTAL LTD.**  
**BLOCK 402 GREENOGUE BUSINESS PARK**  
**LICENCE NO. W0192-03**  
**JANUARY 2017 – DECEMBER 2017**

Rilta Environmental Ltd,  
Greenogue Business Park,  
Rathcoole,  
County Dublin.

Bund Integrity Test Report 2016 / 2017

Block 402 - CCTV Drainage Inspection Report

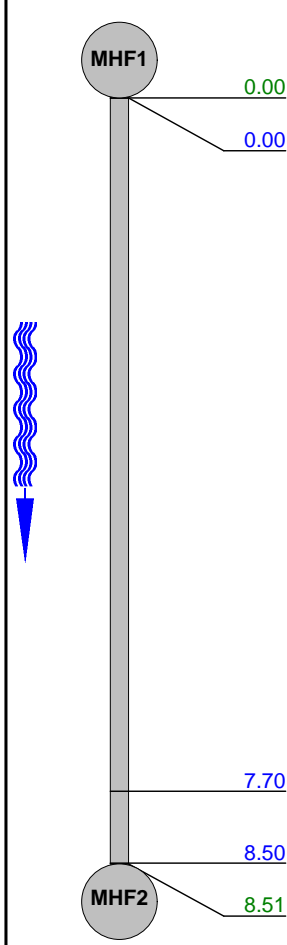
1:84	Position	Code	Observation	MPEG	Photo	Grade
	0.00	GY	Start node type, gully, reference number : MHF1	00:00:01		(Constr) 0
	0.00	WL	Water level, 0% of the vertical dimension	00:00:01		(Serv) 0
	7.70	WLC	Clear water level, 5% of the vertical dimension	00:01:19		(Serv) 0
	8.50	WL	Water level, 0% of the vertical dimension	00:01:25		(Serv) 0
	8.51	MHF	Finish node type, manhole reference number: MHF2	00:01:25		(Constr) 0

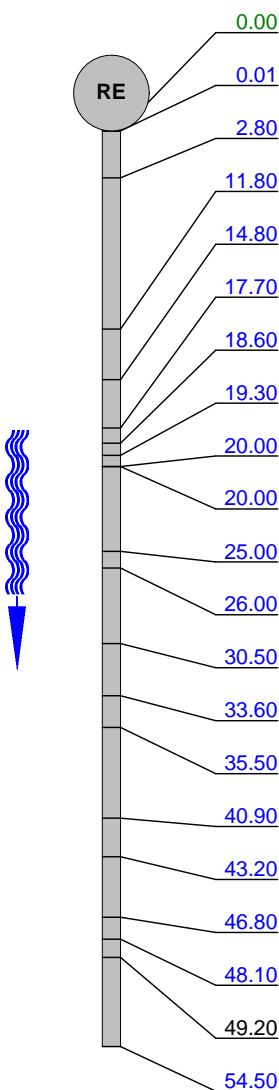
40.90	WL	Water level, 5% of the vertical dimension	00:05:44		(Serv) 0
	43.20	WL	Water level, 10% of the vertical dimension	00:06:08		(Serv) 0
	46.80	WL	Water level, 15% of the vertical dimension	00:06:03		(Serv) 0

48.10	WL	Water level, 20% of the vertical dimension	00:06:21		(Serv) 0
	49.20	CUW	Loss of vision, camera under water	00:06:36		(Misc) 0
	54.50	WL	Water level, 10% of the vertical dimension	00:07:05		(Serv) 0

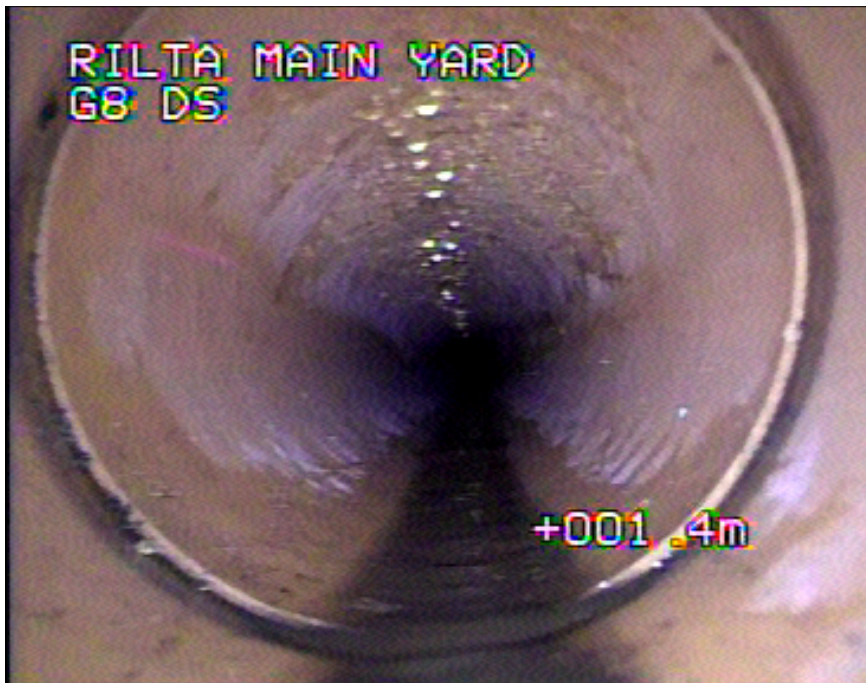
Photo: 42\_3A, MPEG #: 280217\_1, 00:00:15  
1.4m, General remark

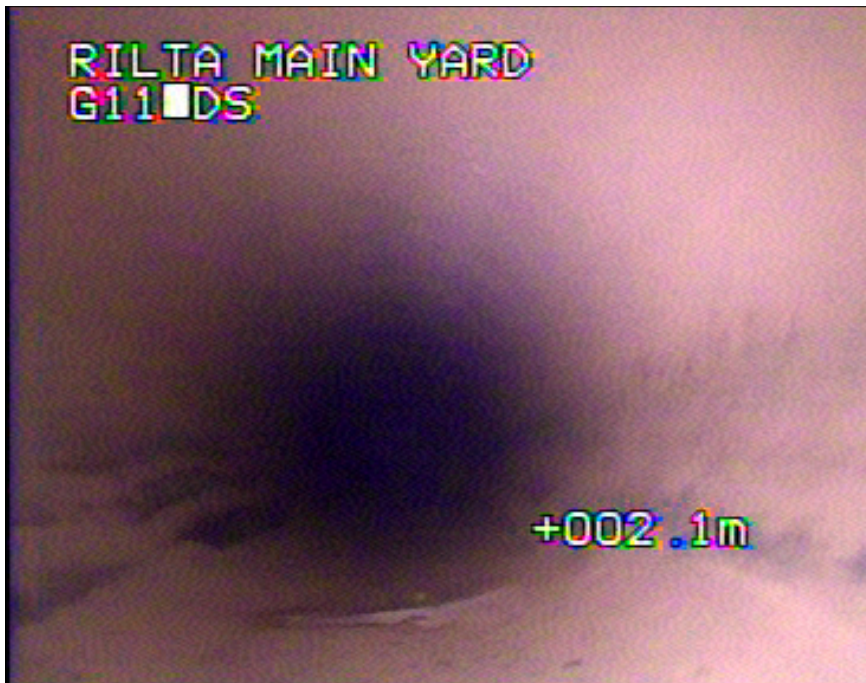
Photo: 47\_3A, MPEG #: 280217\_1, 00:00:59  
2.2m, General remark
