TIER 2 RISK ASSESSMENT

FORMER MUNICIPAL HISTORIC LANDFILL

RANTAVAN

MULLAGH

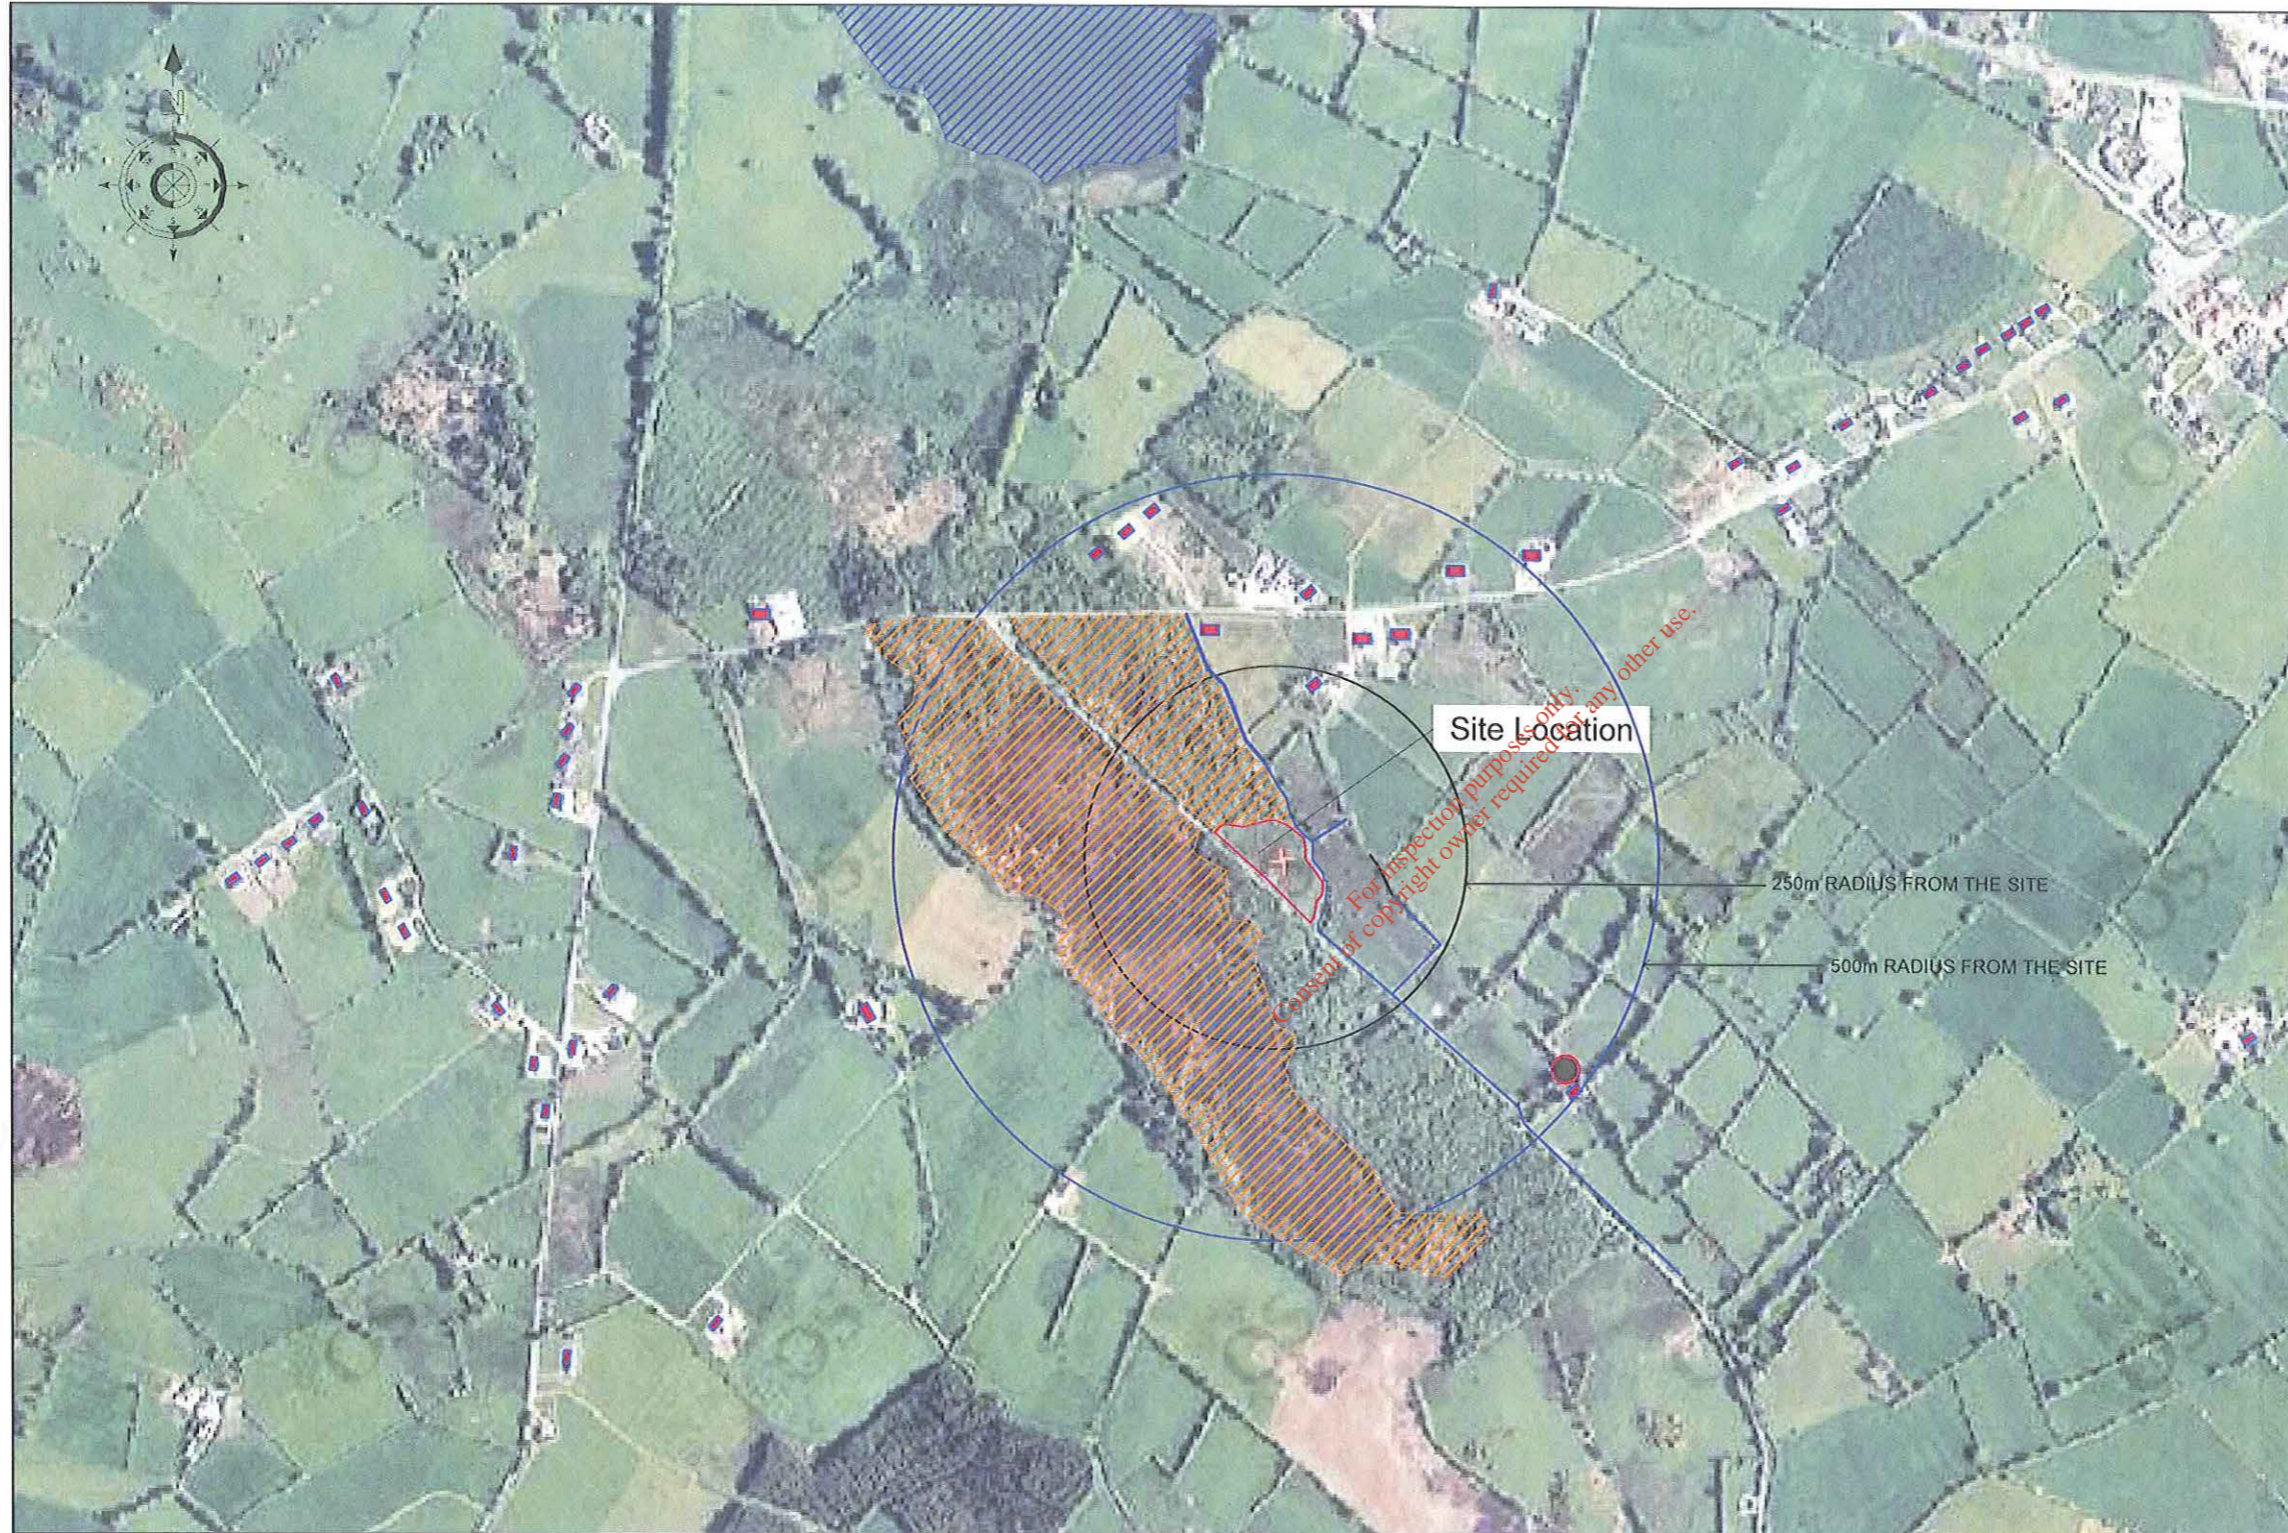
DRAWING No.	REV.
10-198-001

The main receptor is the watercourse/drain located on the north-eastern aspect of the site which is immediate to the site boundary (refer to Drawing No. 10-198-013 and 10-198-014). Dwelling houses were noted on the northern, north eastern and south eastern aspect which ranged from 220 – 370 m from the site boundary. The dwellings in the area are serviced by Mullagh Public Water Supply with the exception of one dwelling which is serviced by a private well (approximately 340 m Southeast from the site boundary). The dwelling locations are shown in Drawing No. 10-198-001. The site is generally a half circle with a total site area of around 0.7 hectares.

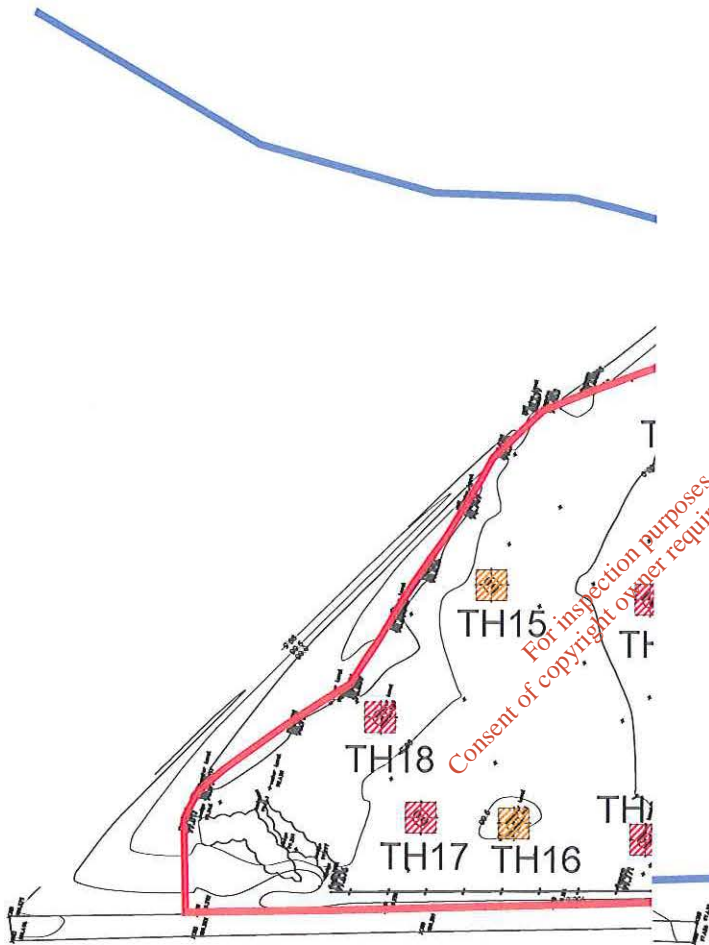
TRIAL HOLE LOCATION
SCALE 1:1000

The North-eastern extent of the landfill was defined by a hedgerow and watercourse/drain which separates the site from the adjacent agricultural land. Wastes were encountered in 18 trial holes (TH1 – TH18), but were not found in the three trial holes (TH19, TH20, TH 21) to the Southeast of the landfill. The waste extends from the local road on the Southwestern boundary to the fence on the North-western boundary. The lateral extent of the waste is shown in drawing No. 10-198-011, and covers an area of ca 8,589m². It is estimated, that approximately 18,900 tonnes of waste is deposited at the site.

The waste comprised a mix of plastic and glass bottles, occasional empty flattened steel drums, empty plastic drums, concrete pipes, steel, papers, tyres, tyre tubes, wire, end of life vehicles, vehicle parts, municipal waste, timber and trees, all of which were supported by a stony clay matrix. It is assumed that the stony clay was used as cover material when the site was operational, but no discrete layers were noted. No datable materials (newspapers, stationary) which could be used to establish the age of the waste was found. There was evidence of a significant amount of potentially hazardous waste (e.g. oils), staining or odours. Photographs 2 - 8 illustrate the types of waste encountered. Full trial holes assessment and logs can be found in the Appendix A
