APPENDIX 2

WWTP PIPELINE REPORTS

600MM Ø RISING MAIN PIPE FAILURE THROUGH LANDFILL 20-
06-06

**Site Investigation for a Proposed
Pipeline through a Lanfill Site at Skerries.**

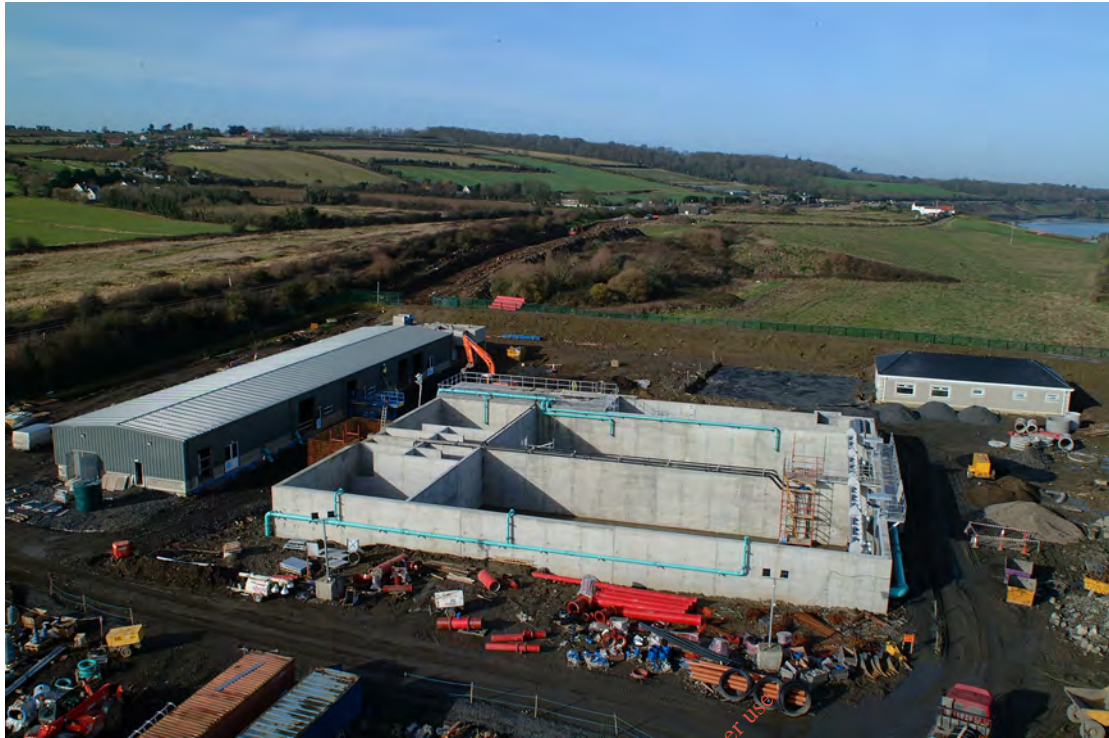
Plate A2.1 Photograph of Construction of WWTP and Rising Main taken in 2005 from western boundary facing west with Dublin-Belfast railway line to the south and historical landfill located to the west

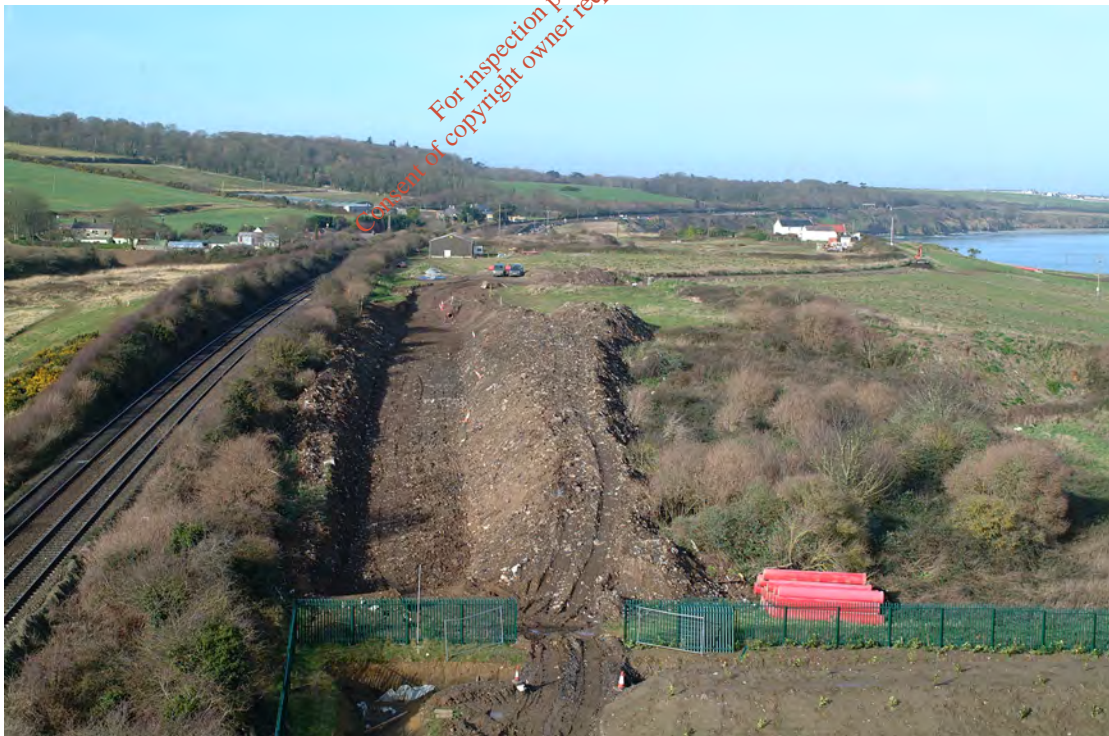
Plate A2.2 Photograph of excavation of soils for Rising Main taken in 2005 from western boundary facing west with Dublin-Belfast railway line to the south and historical landfill located to the north

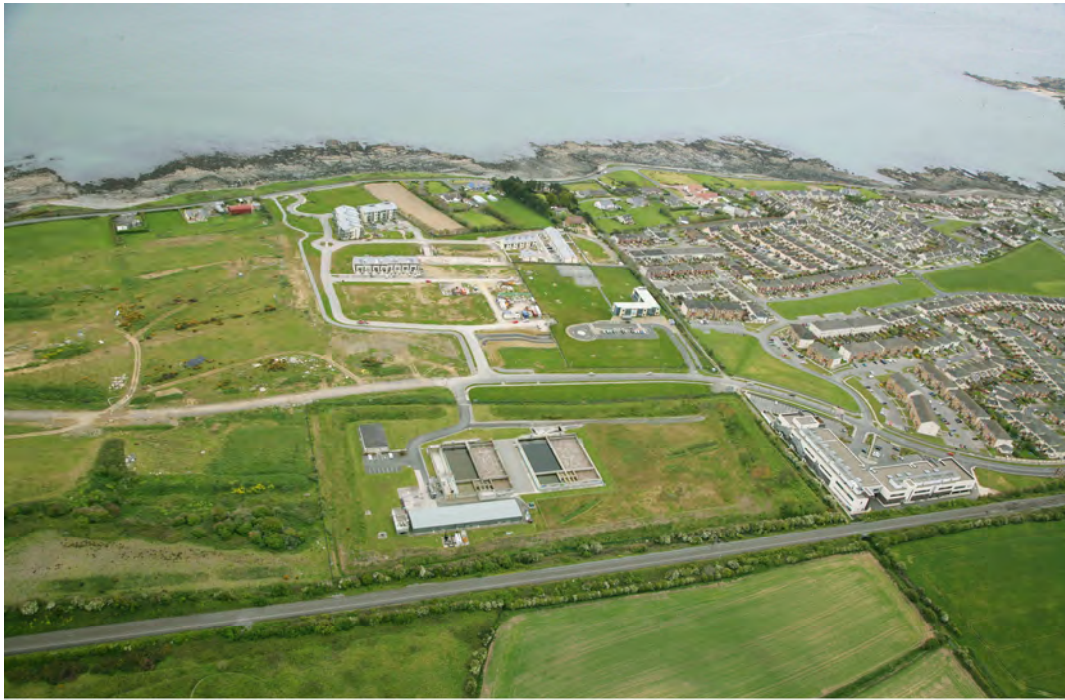
Plate A2.3 Photograph of historic landfill on 16/05/12 taken from southern boundary facing northwards with Dublin-Belfast railway line to the south and WWTP located to the east

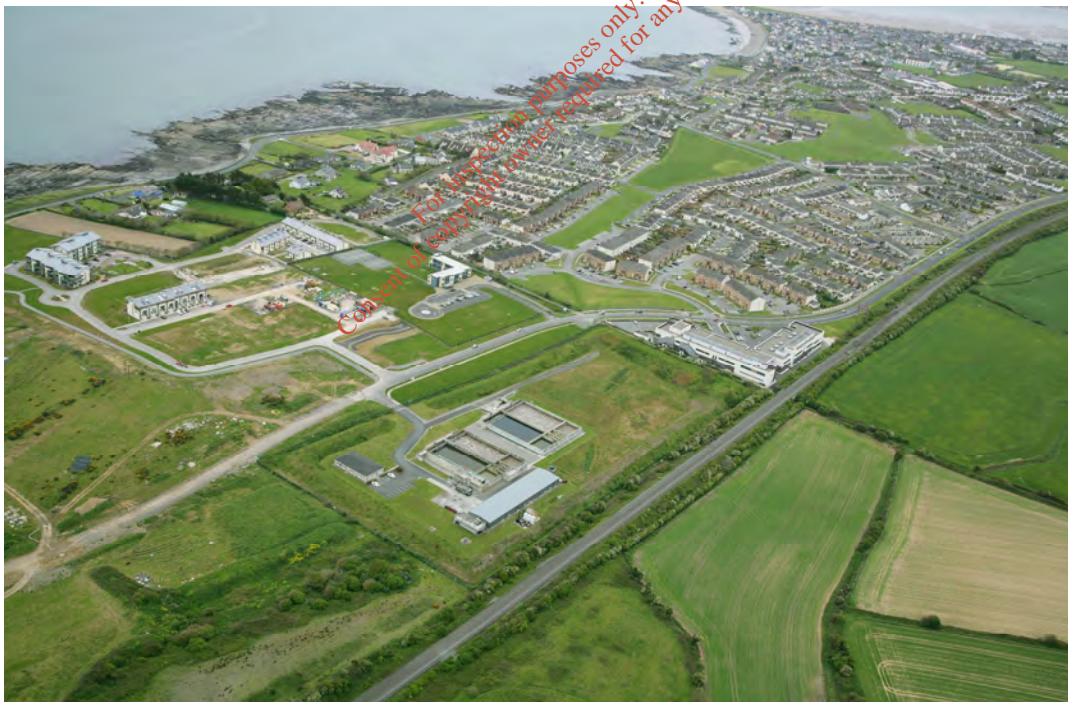
Plate A2.4 Photograph of historic landfill on 16/05/12 taken from south west boundary facing northeast with Dublin-Belfast railway line to the south and WWTP located to the east

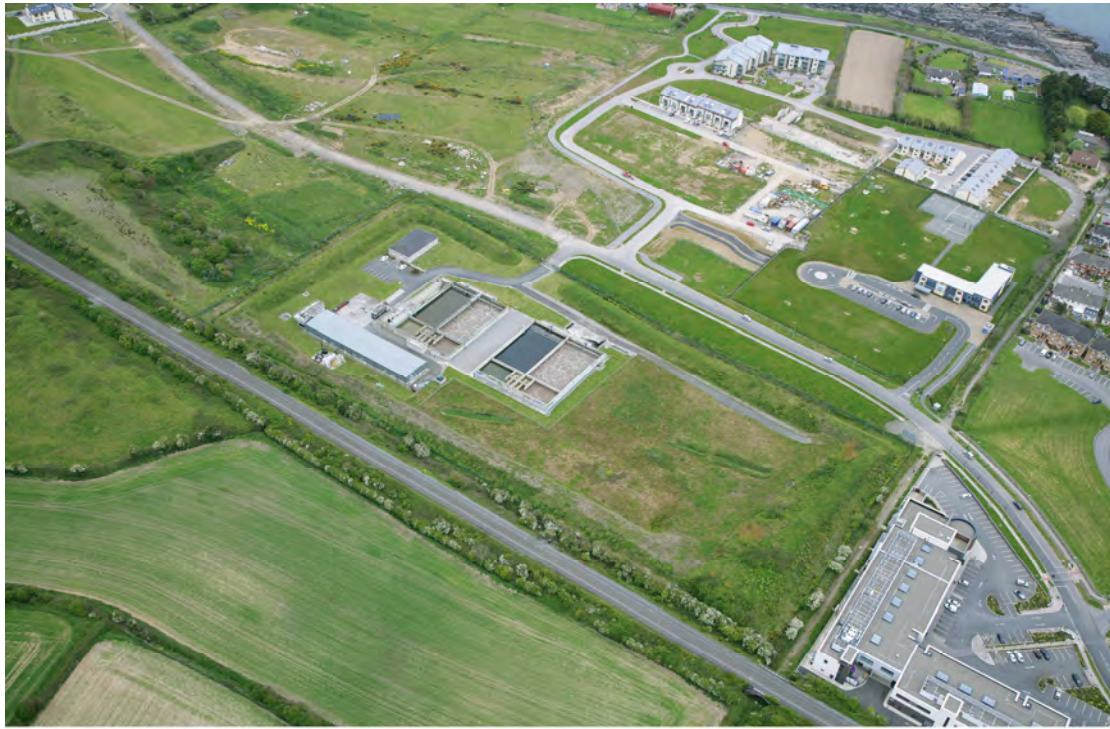
Plate A2.5 Photograph of historic landfill on 16/05/12 taken from south east boundary facing northwest with Dublin-Belfast railway line to the south and WWTP located to the east

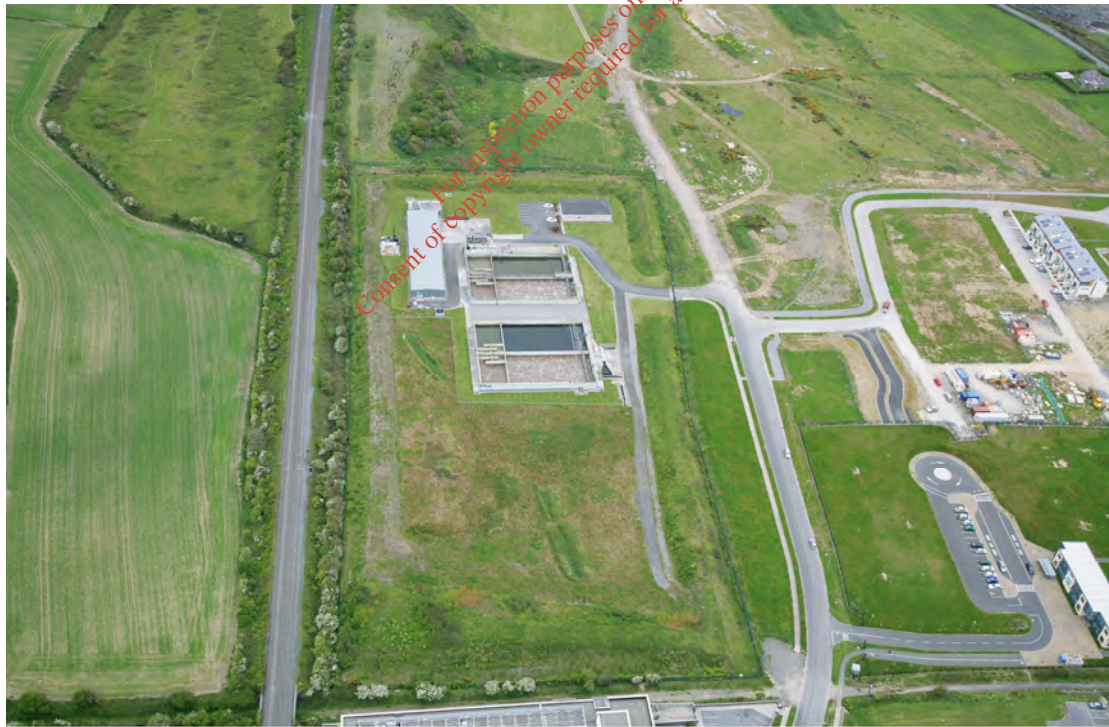
Plate A2.6 Photograph of WWTP on 16/05/12 taken from western boundary facing west with Dublin-Belfast railway line to the south and historical landfill located directly to the west
