**SHORE ROAD HISTORIC LANDFILL,
CLIFDEN, CO. GALWAY**

**APPLICATION TO EPA
FOR
CERTIFICATE OF AUTHORISATION**

***TIER 2 SITE INVESTIGATION & RISK ASSESSMENT
OF SHORE ROAD LANDFILL REPORT
(16th May 2014)***

**TIER 2 SITE INVESTIGATION & RISK ASSESSMENT
OF
FORMER SHORE ROAD LANDFILL,
CLIFDEN, CO. GALWAY**

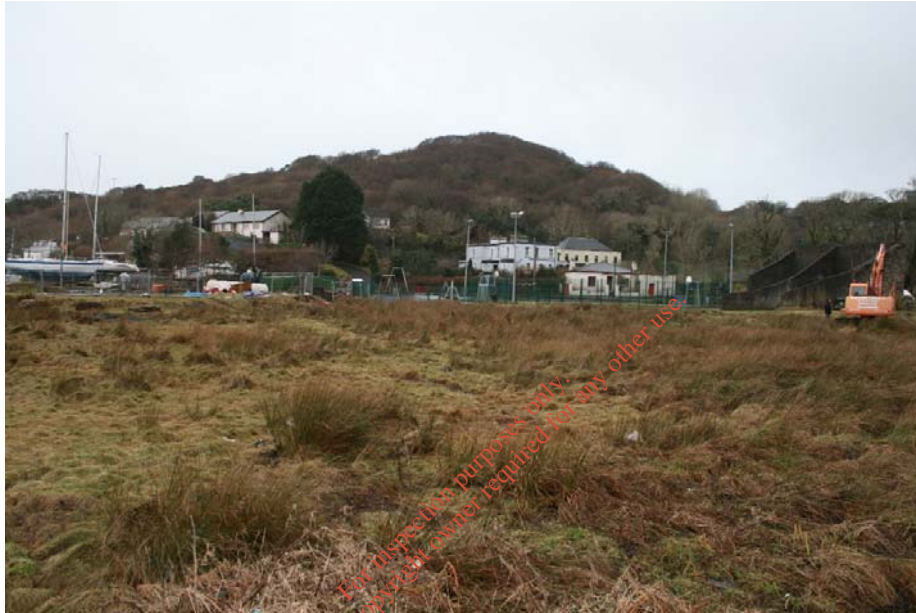
A number of public amenities are located along the sites western boundary. A public handball alley is located on the north-western corner of the site. A public basketball court and adjacent playground is located on the western boundary of the site. A sailing club boat storage yard owned by the local sailing club and slipway is located on the south-western corner of the site adjacent to the shore (see Figure 3). A helicopter landing pad is located immediately adjacent to the south-western corner of the site. This is provided with an access road. A pumping station is located besides this access road (see Plate 2 following).

Plate 2. View of handball alley, basketball court, playground, sailing club yard and helipad facing westwards

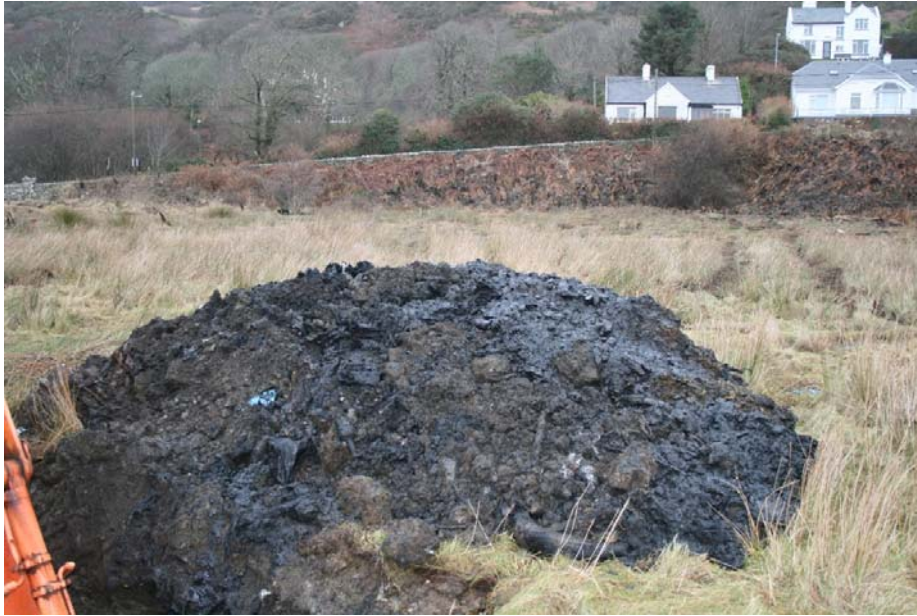
The site is located in a residential area with 4 residences located within 50m of the site's boundary (see Figure 3). Two of these residences are located approximately 10m to the north of the site's northern boundary, across the Shore Road (see Plates 3 & 4). Another residence is located to the northwest of the site (see Plates 4). This house is approximately 35m from the site boundary. Another residence is located further along the Shore Road 50m to the east of the site. Further housing exists just outside the 50m boundary, with a cluster of properties to the northeast, and a row of houses along the quay to the southwest of the site. The Clifden town hall, a public building, is located 36 meters northeast of the sites northern boundary. The site is bordered to the north by the Shore Road (i.e. also known locally as the Beach Road) which rises as it approaches the town centre. This road turns 90° to the south at the north-western corner of the site. As stated, the nearest residences to the site are located across this road to the northeast of the site (see Plate 3 following and Figure 3).

Plate 3. View of nearest residences to northeast of site facing northwards towards Shore Road

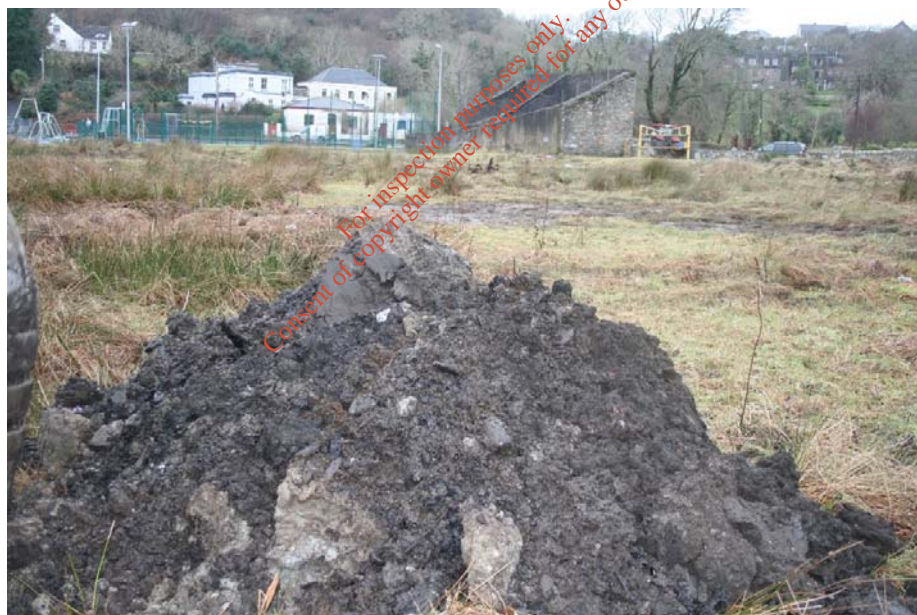
As stated, another residence is located to the northwest of the site to the west of the afore-mentioned corner (see Plate 4). This house is approximately 35m from the site boundary.

Plate 4. View of residences to northwest of site facing north-westwards towards Shore Road

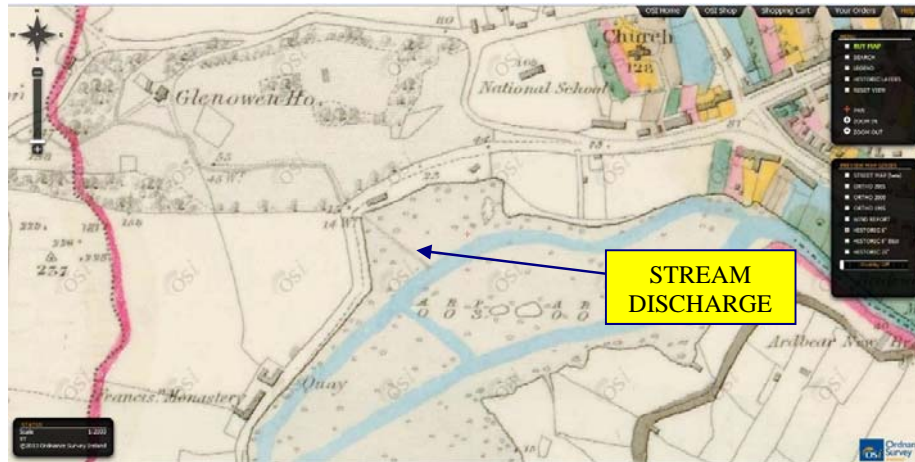
It should be noted that a review of historical 25-inch mapping indicates that the site is located on land that was formerly a part of the estuary. A review of historical 6-inch mapping indicates that the site was mostly mudflat with the high water mark (HWM) extending to an area just south of the current handball alley (see Plate 5 below). The surface water body to the northeast of the site can be seen to cross the mudflat and discharge to the estuary.

Plate 5. Historical 6-inch Ordnance Survey mapping showing location of surface water body passing through site

As stated in Section 1.4, a stream which flows towards the site from the uplands to the west of the site is culverted under the Shore Road. The route of this stream is evident on 6-inch historical mapping in Plate 5. This culvert was not encountered during the site investigation nor was it found during an inspection of the mudflats to the south of the site during low tide. It is assumed that this culvert runs in a north to south direction along the western boundary of the site.

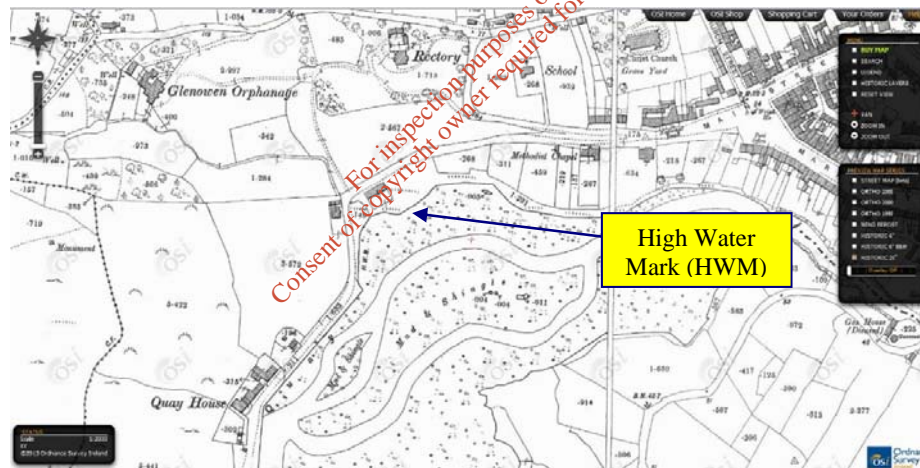
A review of historical 25-inch mapping indicates that the site was by 1900, infilled to almost 50% of its current volume with the high water mark now being marked some 20m to the south of that shown on the 6-inch mapping. The location of the current handball alley to the northwest of the site is clear on the 25-inch mapping (see Plate 6 below). However, it should be noted that the discharge point of the stream to the northwest of the site is now not clear.

Plate 6. Historical 25-inch Ordnance Survey mapping showing location of new high water mark (HWM)

A review of historical 25-inch mapping indicates that the site was by 1900, infilled to almost 50% of its current volume with the high water mark now being marked some 20m to the south of that shown on the 6-inch mapping. The location of the current handball alley to the northwest of the site is clear on the 25-inch mapping (see Plate 6 previous). However, it should be noted that the discharge point of the stream to the northwest of the site is now not clear on Plate 6.

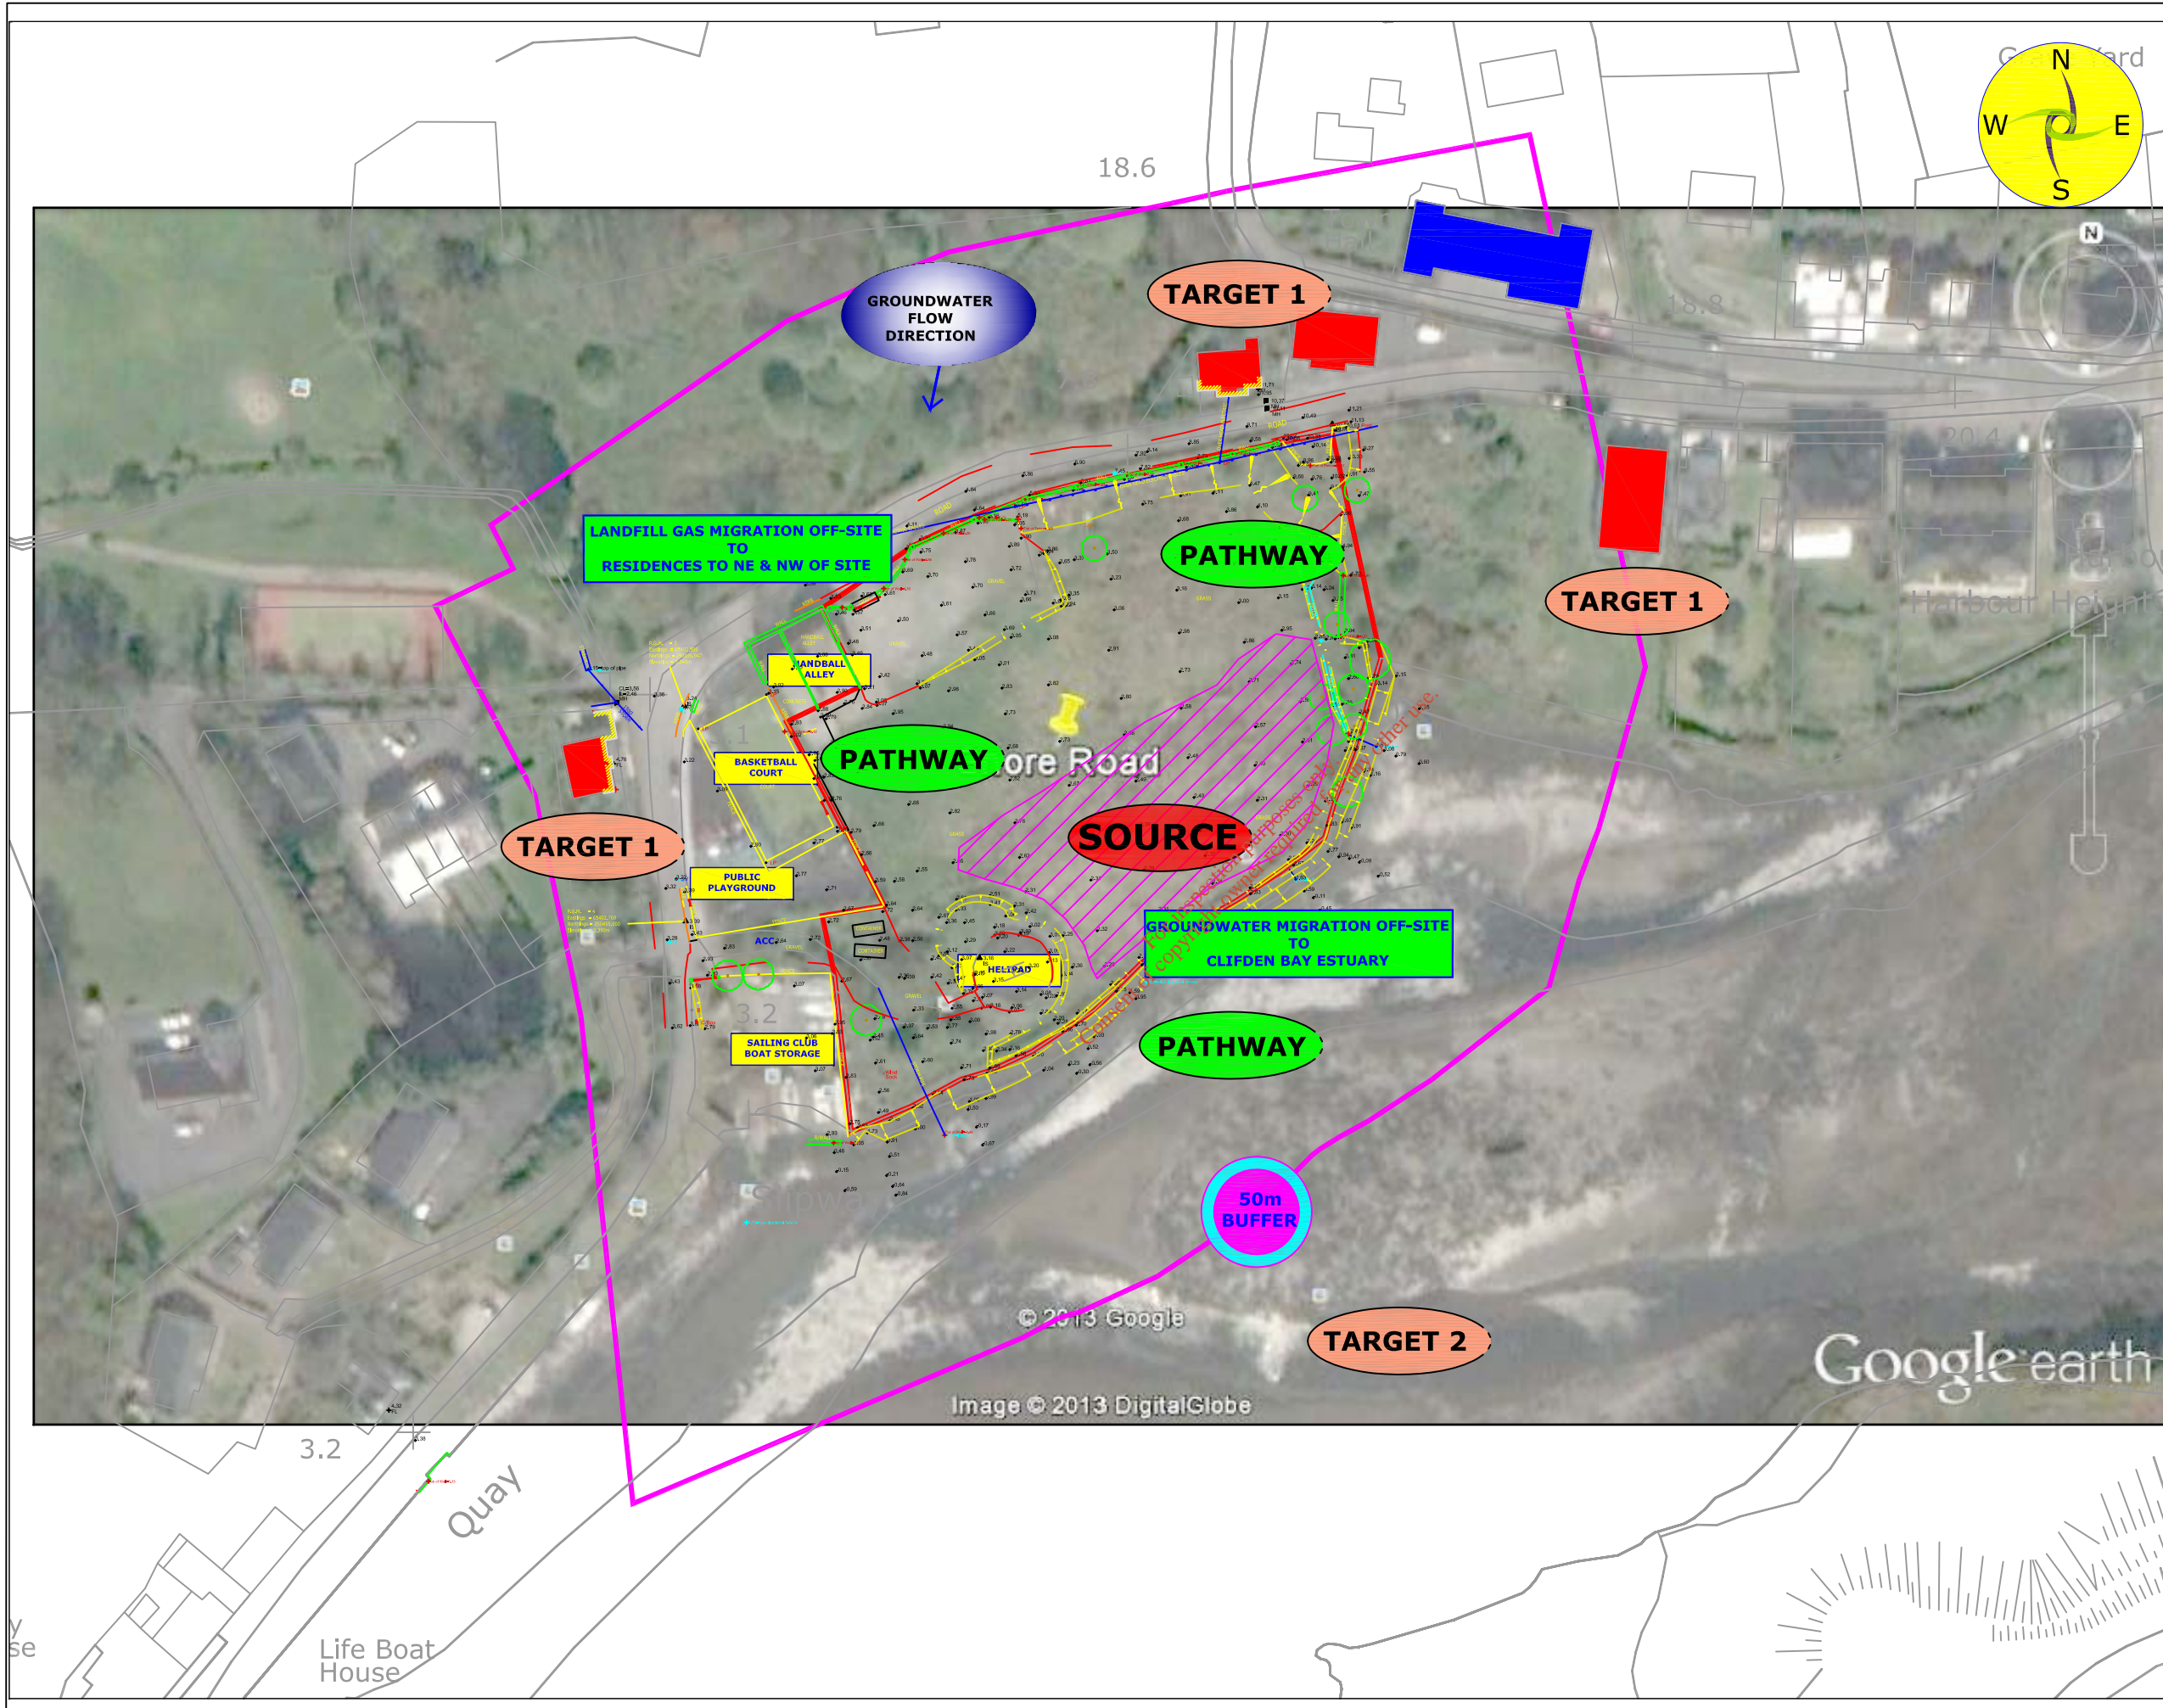
Drawing No.: Figure 6

A Plan Site Conceptual Model illustrating the potentially complete pollutant linkages is included in Figure 6. Future risks to construction workers will be task specific and can be managed with appropriate health and safety protocols thus are not considered further in this report.
