# Cartron Big Landfill

## Datagap Analysis & Tier 1 Assessment

### Longford County Council

22 November 2017

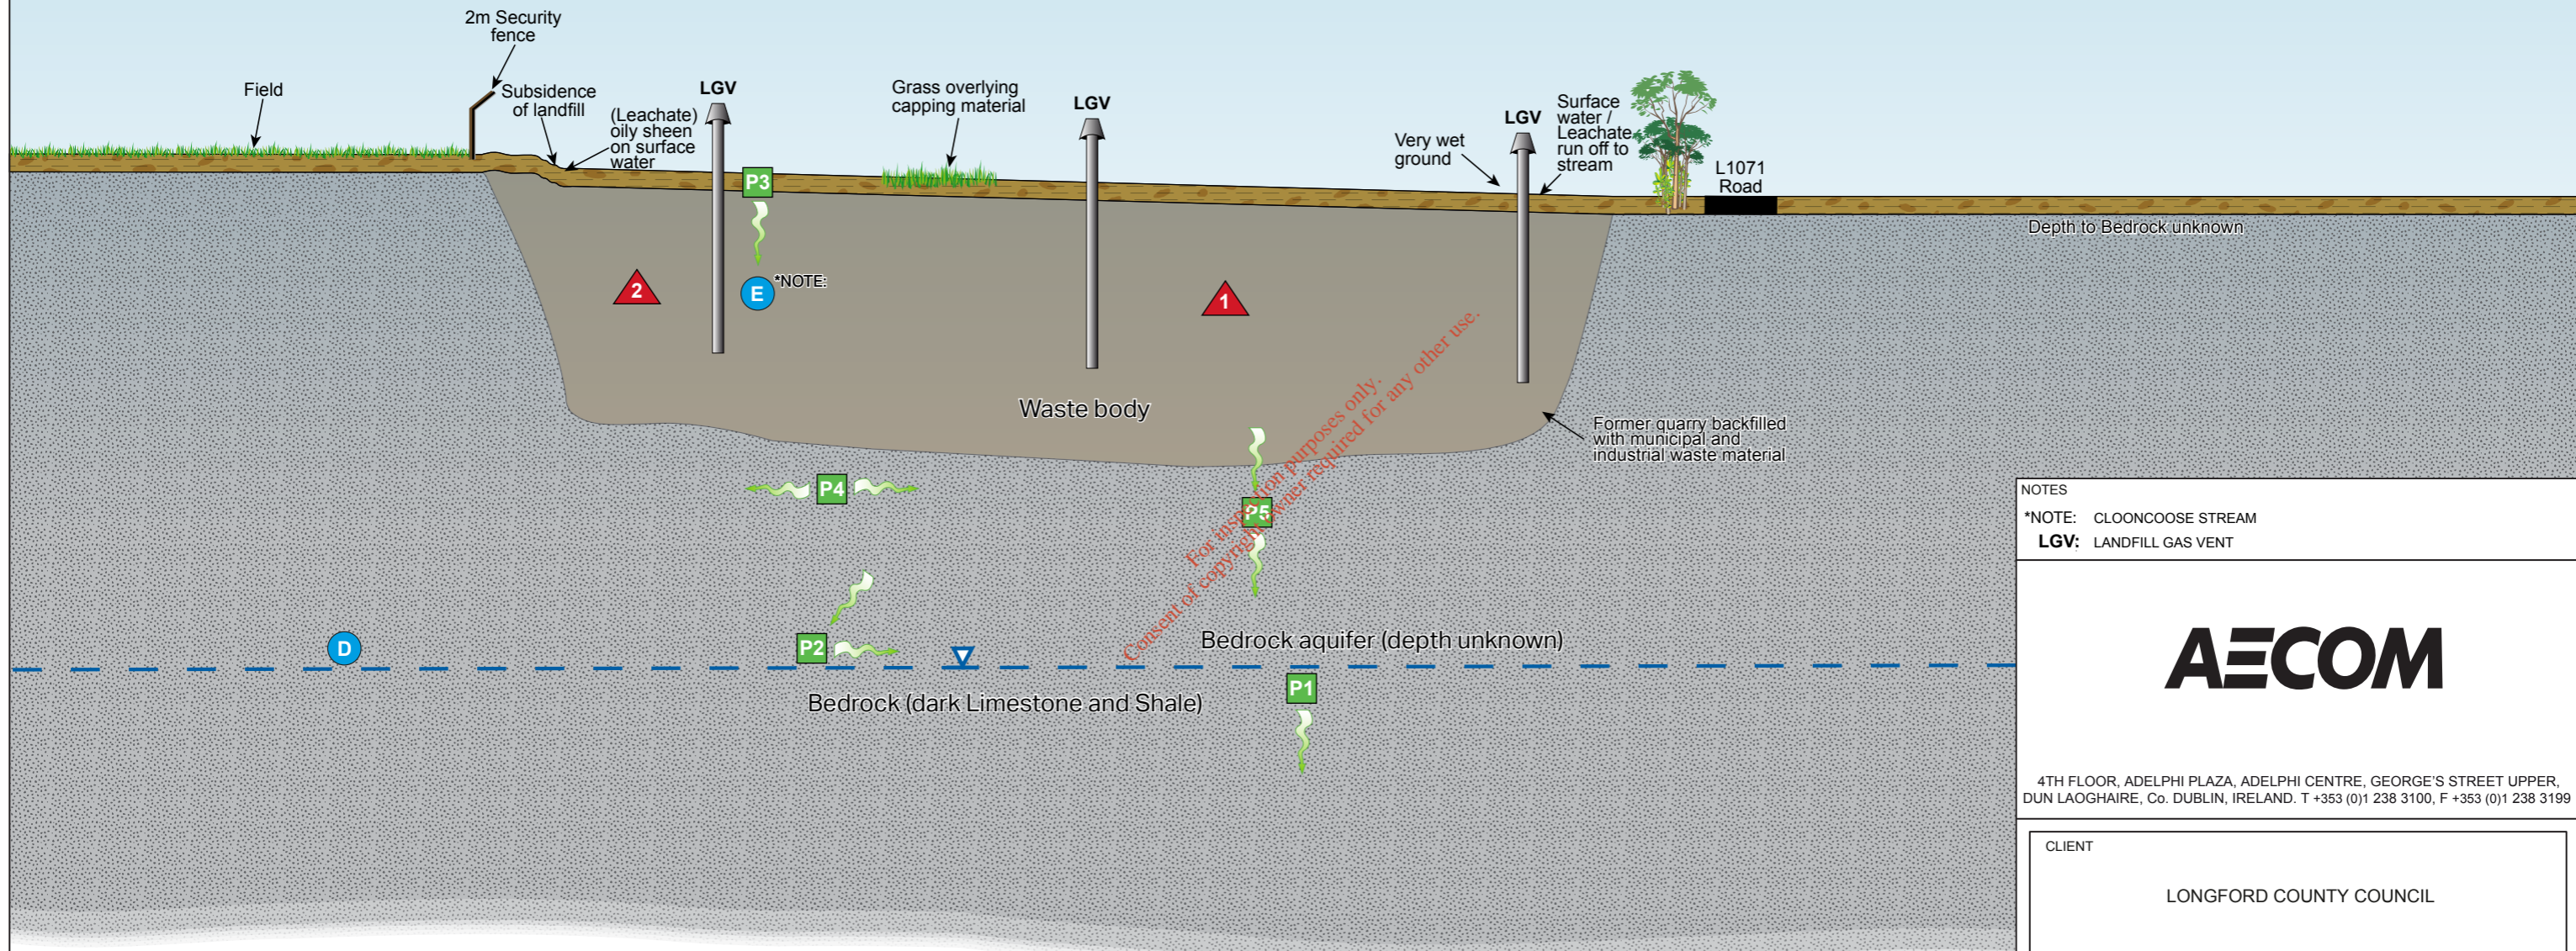
SOURCES	PATHWAYS	RECEPTORS	GEOLOGY KEY
<b>1</b> LEACHATE	<b>P1</b> GROUNDWATER VERTICAL (VULNERABILITY)	<b>A</b> RESIDENTIAL DWELLING WITHIN 100M SOUTH	WASTE BODY
<b>2</b> LANDFILL GAS	<b>P2</b> GROUNDWATER HORIZONTAL (GROUNDWATER FLOW REGIME)	<b>B</b> PROPOSED NHA WITHIN 100M NORTH	SUBSOIL
	<b>P3</b> SURFACE WATER DRAINAGE/RUNOFF	<b>C</b> POSSIBLE PUBLIC WATER SUPPLY, 1.5KM EAST	BEDROCK
	<b>P4</b> LATERAL MIGRATION (SUBSOIL)	<b>D</b> AQUIFER	NOTIONAL GROUNDWATER LEVEL
	<b>P5</b> VERTICAL MIGRATION (SUBSOIL)	<b>E</b> SURFACE WATER BODY
