Golder Associates (UK) Limited

**INVESTIGATION INTO THE CAUSES OF THE
SURFACE SUBSIDENCE
AT GALMOY MINE, CW ORE-BODY,
MARCH 2002**

March, 2002

021-9302 (02511369)

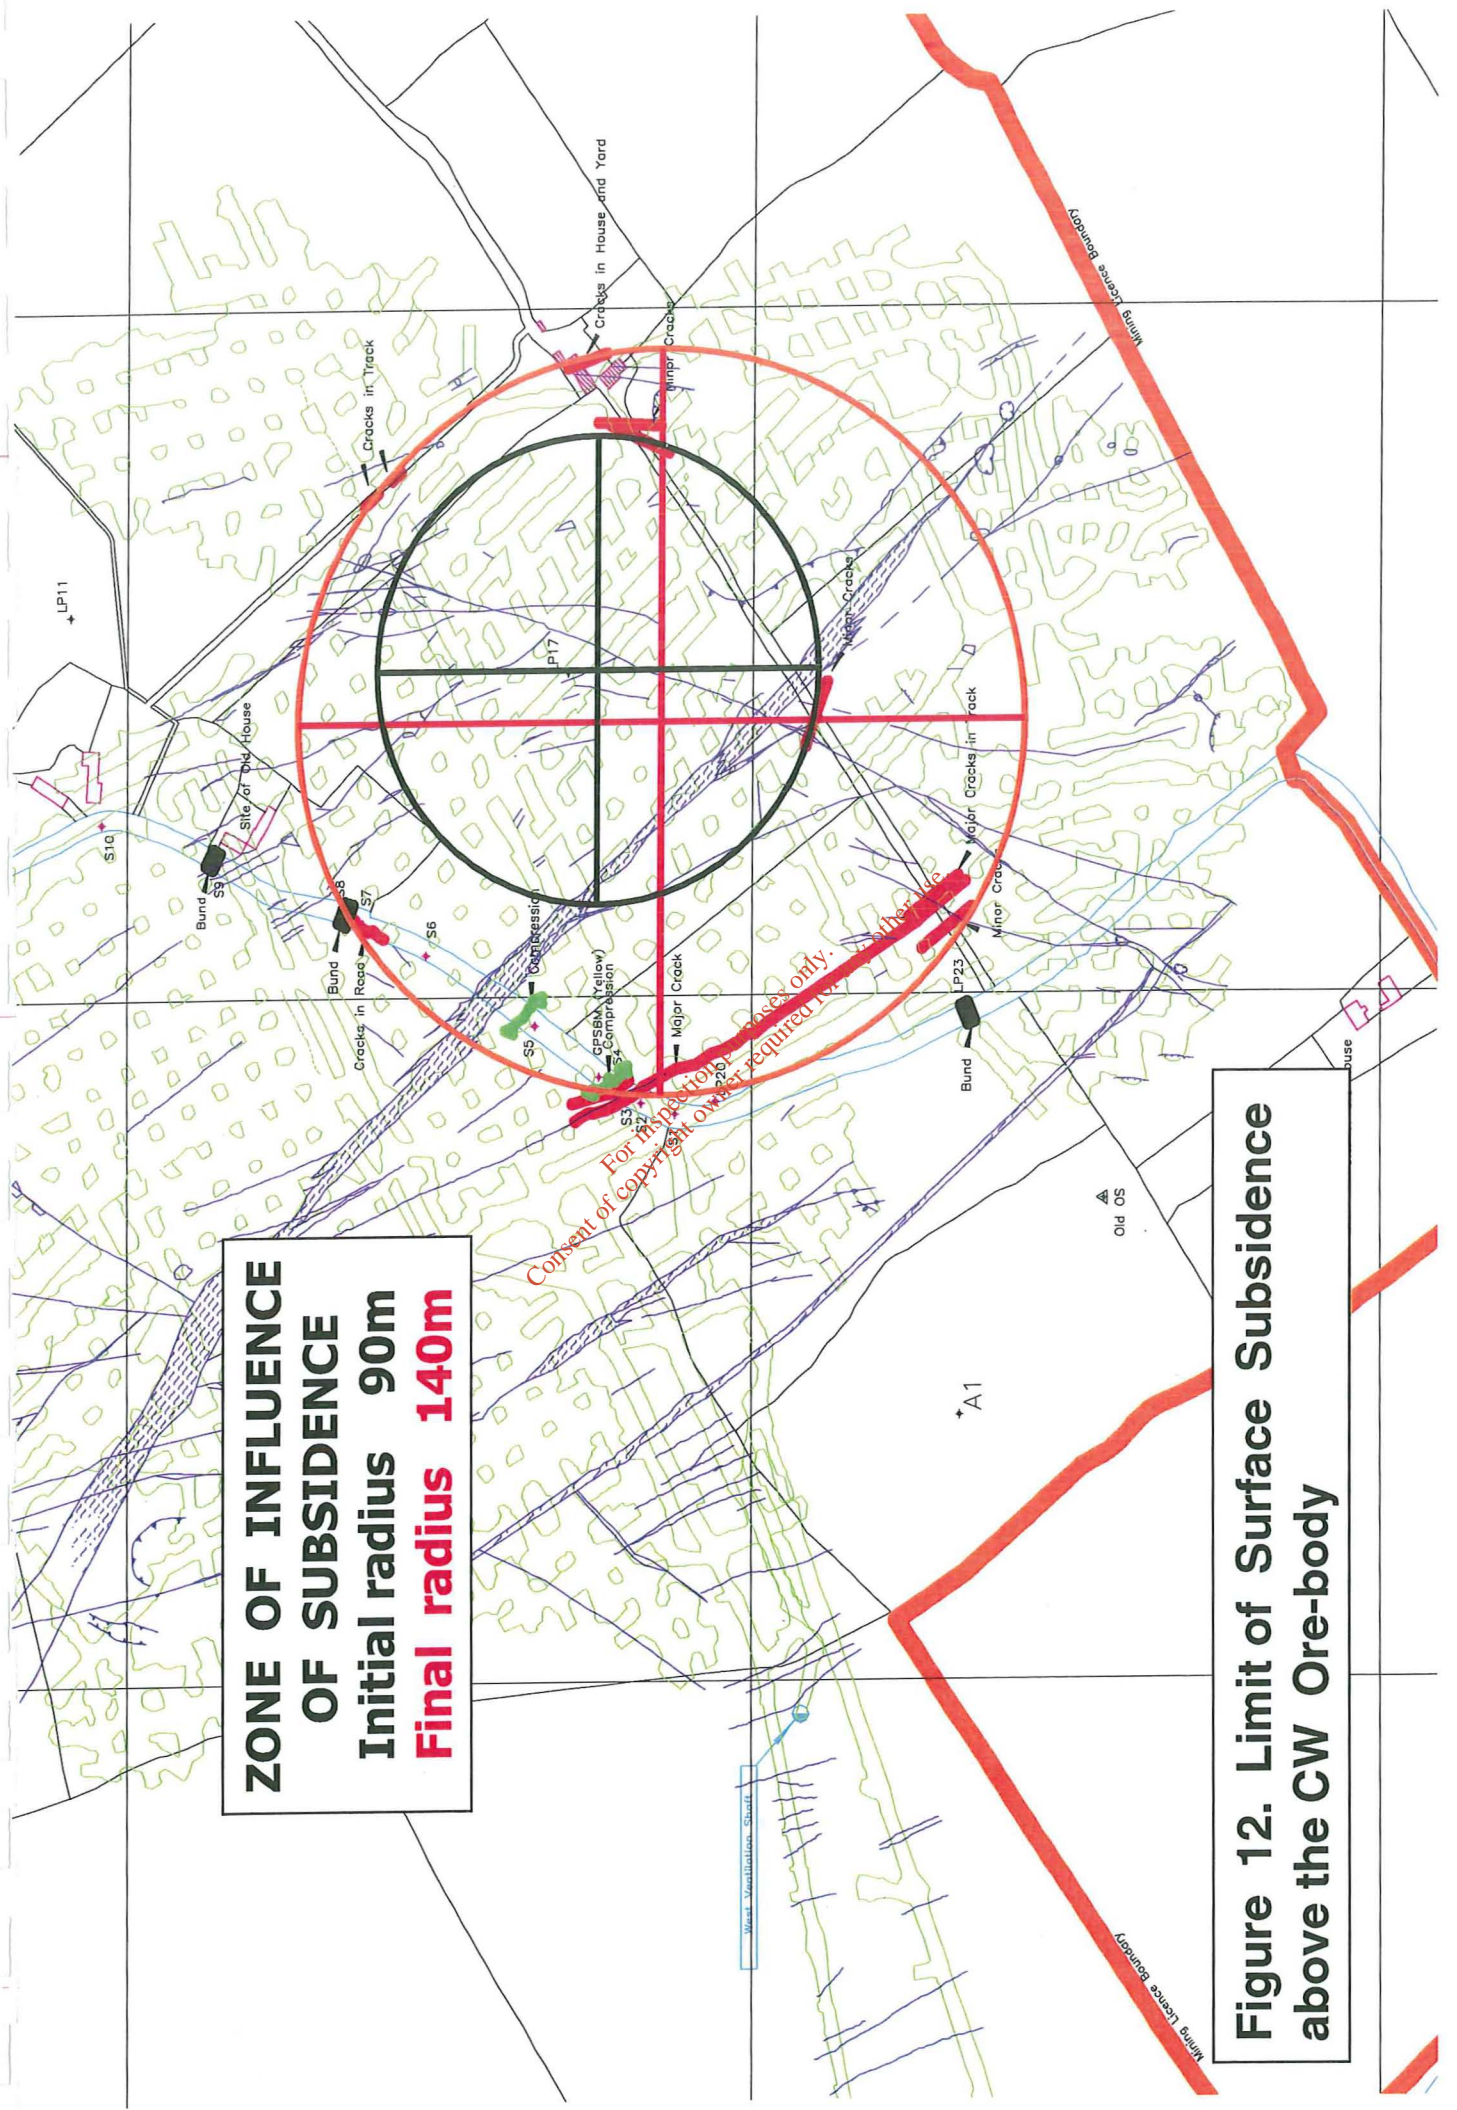
Figure 12. Limit of Surface Subsidence above the CW Ore-body

These events occurred over the weekend of February 1st to 4th, 2002, since the compression ridges were not observed prior to Monday, February 4th 2002. Unlike the small compression at the top of the hill, the larger compression ridge at the bottom of the hill continued to increase as the rock overlying the I-Stope and J/K-Stopes continued to subside and to converge. The very small cracks on the farm access tracks and in the farm yard indicate the proximity of the limit of zone of subsidence. Apart from these cracks, there is no discernable evidence of movement beyond this limit (Figure 12).

Figure 12 shows the actual limits of the subsidence above the CW Ore-body, as defined by the extent of the tension cracks. The location of these limits of subsidence indicates that the actual angle of influence for the CW Ore-body is very close to 90 degrees and the provision of a caution zone defined by an angle of influence of 60 degrees is conservative.
