GALMOY MINE

Investigation of the Possible Causes of the Sinkhole in the vicinity of the Galmoy Mine Workings and Recommended Remediation

Report Number 14507150031.R01.A0

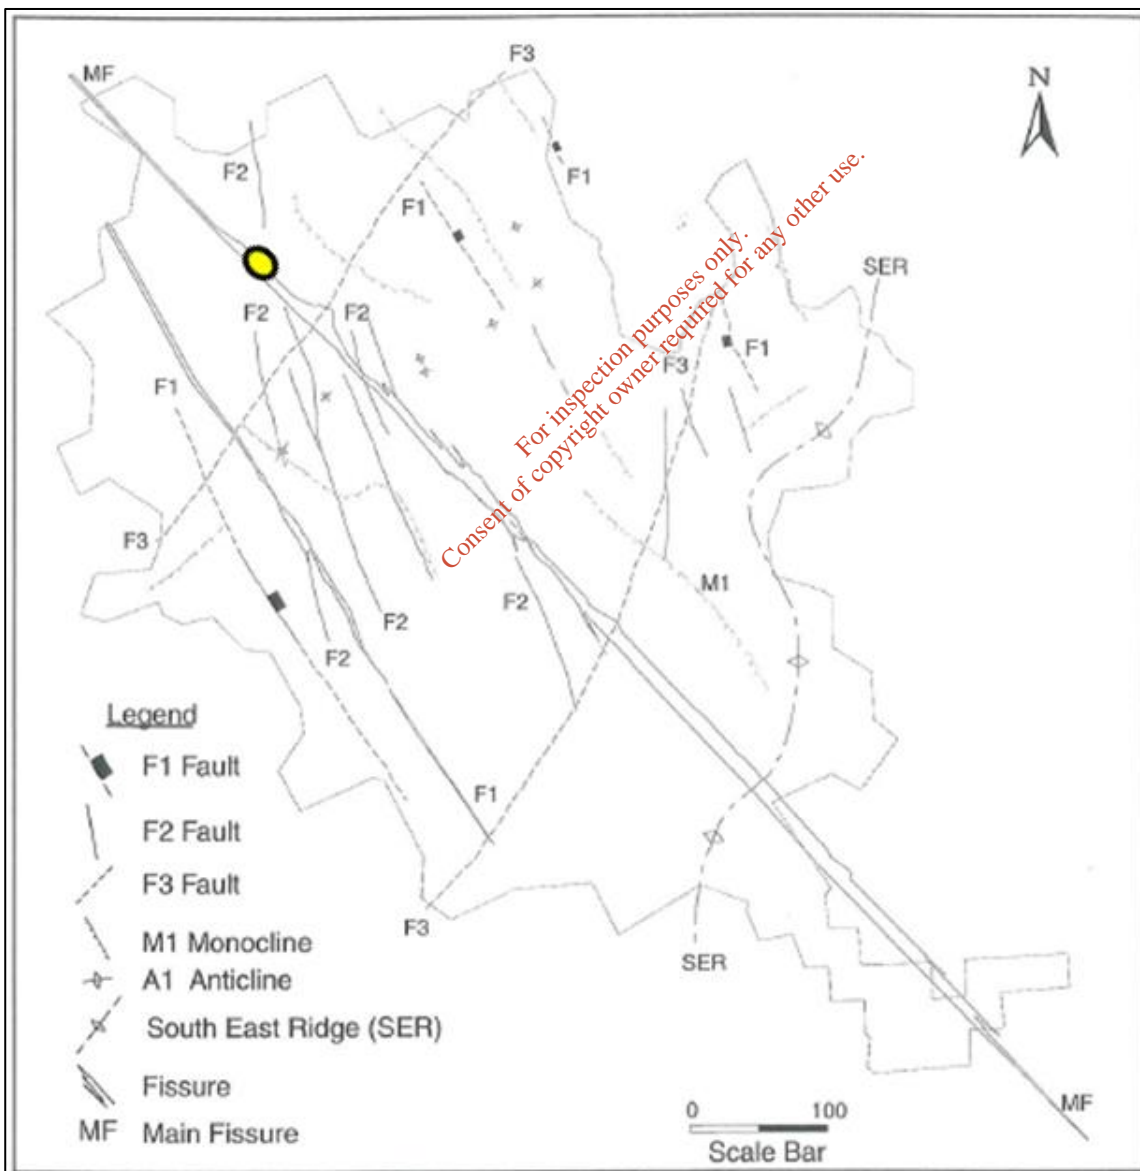
Figure 3: Main structural features of the CW Orebody (location of sinkhole in yellow), (Lowther et al, 2000)

The area in the vicinity of the mine is cut by numerous fissures/fractures/faults. Three main sets are recognized in the CW Orebody: NNW trending (Main Fissure and F1), N-S trending (F2) and NE trending (F3) structures (Figure 3).

The structures that appear to control the location of the mineralization in the CW Orebody is the steeply dipping (about 83° to the NE) NNW trending fault zone, known as the Main Fissure, with displacement down to the east of between 2 to 3 m and an undulating NE-SW trending anticlinal structure (the southeast ridge, SER) which plunges to the SW (Figure 3). The Main Fissure is interpreted as marking the position of a pathway for mineralizing fluids from below. This feature pinches and swells dramatically over very short distances both along the dip and strike, with weathered areas up to 8 m wide being recorded laterally (from underground mapping). The Main Fissure has subsequently been the focus of intense karst weathering and is filled with a mixture of strongly fractured rock, sand and highly altered, clayey material.

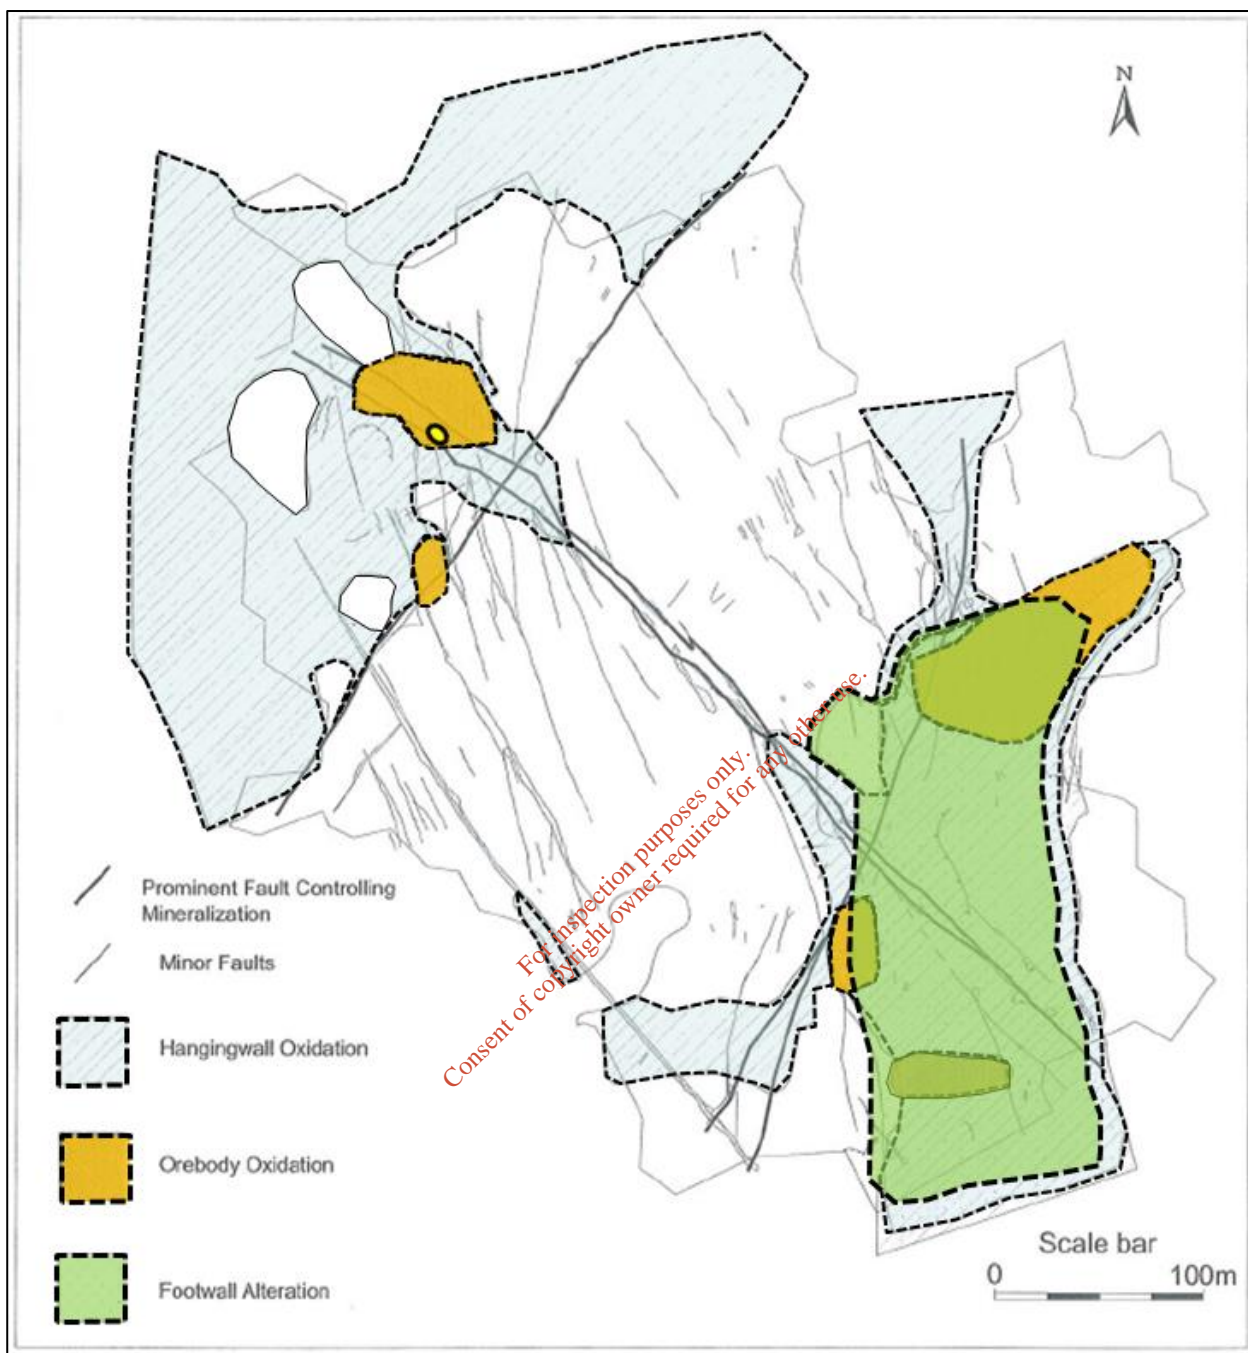
Figure 5: Areas of alteration associated with the CW Orebody (location of sinkhole in yellow), (Lowther et al, 2000)

Within the CW Orebody three types of alteration (Table 1) were recognised from underground mapping and borehole information. This alteration manifested itself in the form of oxidation/weathering in the orebody hangingwall and also in places in the orebody itself due to a lower water-table in Tertiary times (Figure 5). Additional alteration was also recognised in the footwall of the CW Orebody, where leaching of the ABL (by hydrothermal fluids) is suggested to have taken place.

From underground mapping a well-developed, NE-SW trending, sub-vertical structure (F3) was identified as possibly acting as a control on the lateral extent of both hangingwall and orebody alteration / oxidation during Tertiary times (Figure 3).

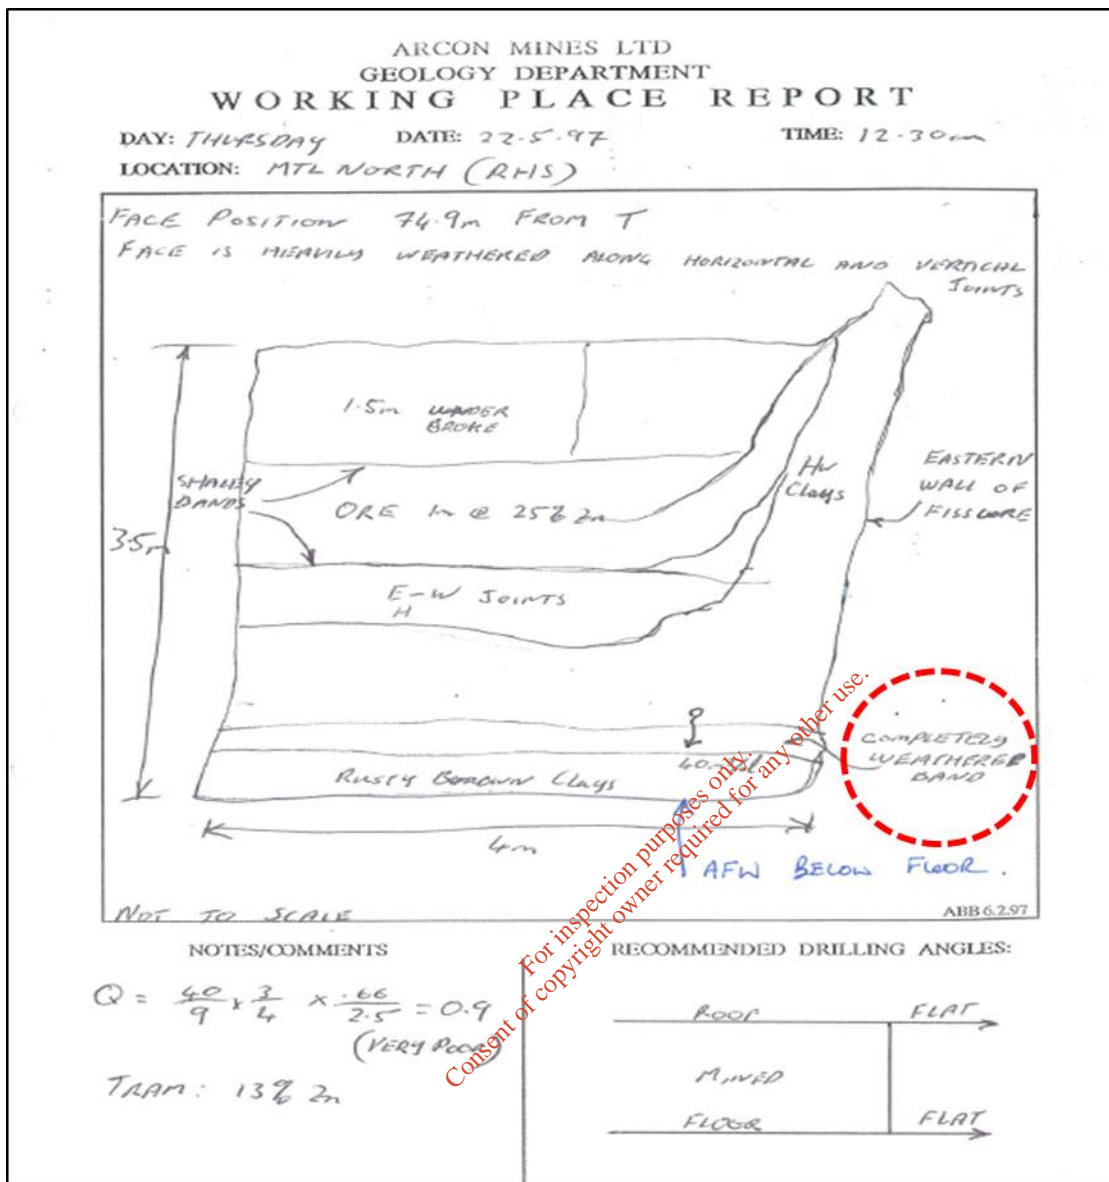
Figure 6: Face mapping sheet for MTL North (a development drive in close proximity to the Main Fissure)

Also, from underground mapping the nature and extent of oxidation and associated ground conditions can be seen where areas of mineralization has been completely altered / weathered and where poor/unstable ground conditions have been encountered when a sub-vertical fissure intersects the excavation (note water-make and low Q value of 0.9 for the face in Figure 6 – a development drive in close proximity to the Main Fissure).

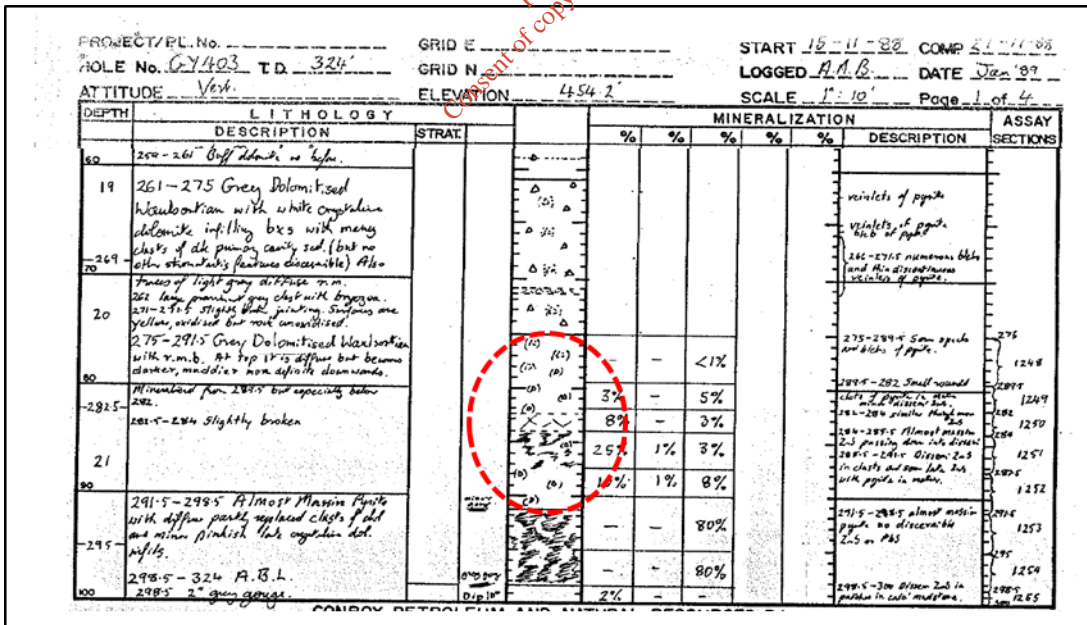
Figure 11: Borehole log for GY403 (drilled adjacent to the Main Fissure) showing a zone of 100% recovery at orebody level (red dashed line) (note scale on log is in feet)

However, borehole GY403 drilled adjacent to the Main Fissure (see Figure 9 for location) encountered 100% recovery at orebody level (Figure 11), indicating the variable nature of karstification in the vicinity of the Main Fissure at the orebody horizon (i.e. karstification 'pinches and swells').

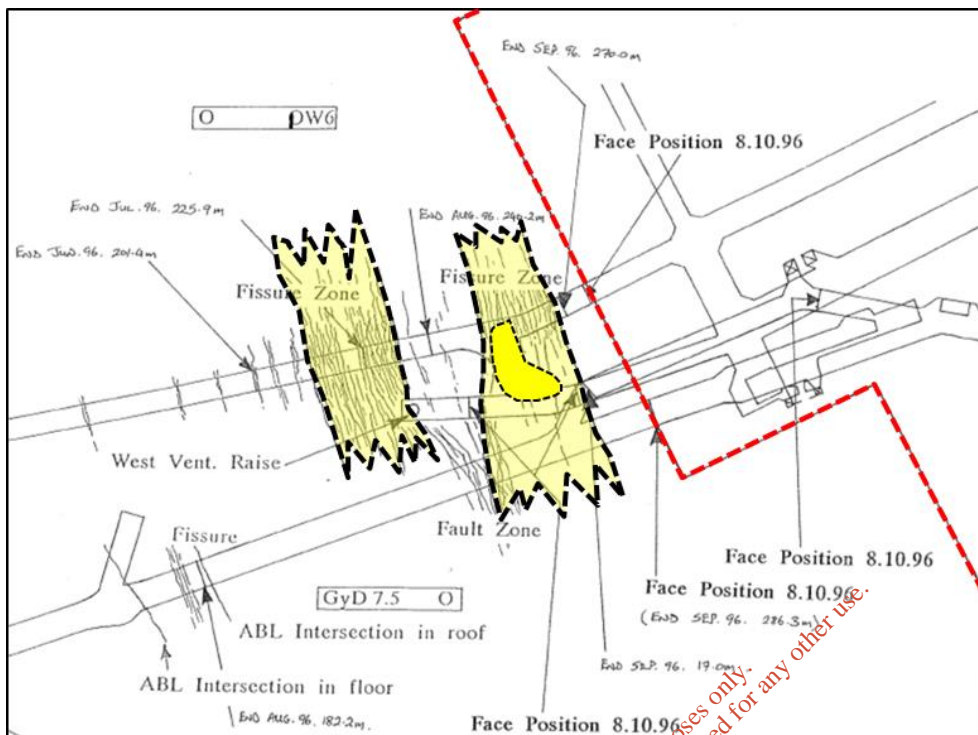
Figure 12: Plan showing location of NW-SE trending fissure zone along western edge of CW Orebody (red dashed line). Palaeokarst feature in yellow

Again illustrating the variable nature of the rock mass, a NW-SE trending fissure zone was intersected to the west of the orebody (Figure 12 and Figure 13). This structure was intersected in the No1. Access Decline

during mine development and is associated with a palaeokarst feature at the orebody elevation similar to that intersected to the west of the Main Fissure in Figure 9).

The palaeokarst feature when mined into was found to be choked with clays and dolomite sands.

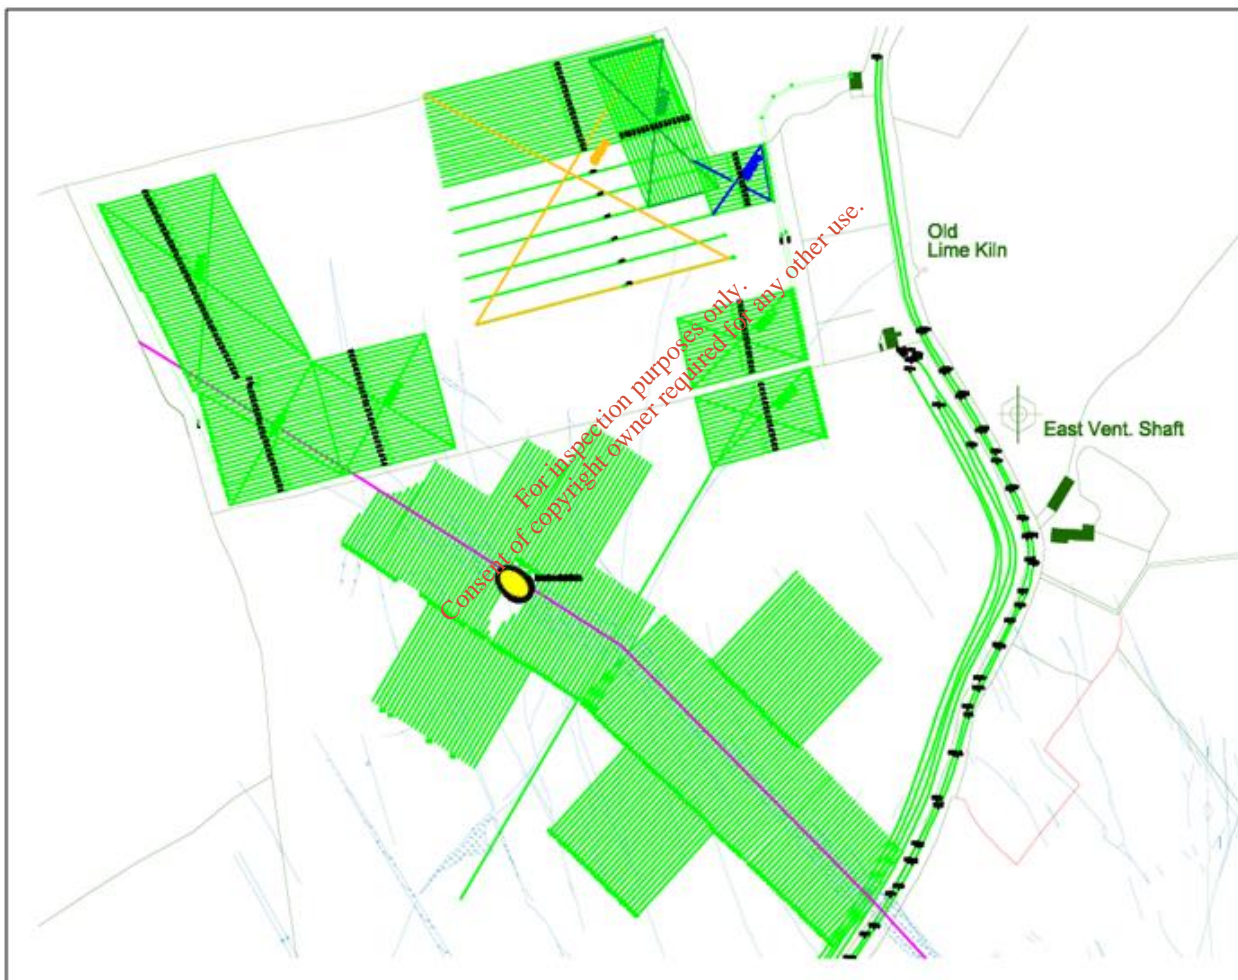
Figure 16: Showing layout of GPR profiles (green), landholding (red), centre-line of Main Fissure (magenta) and sinkhole (yellow)

A total of 540 GPR profiles using a 100 Mhz frequency transmitter was used to collect data in the grass field surrounding the sinkhole and the field to the north. Data was collected perpendicular to the strike of the Main Fissure along parallel profiles 2 m apart (Figure 16). Two profiles were also collected along the public road (815m in length) adjacent to the grass field. A further four profiles at 2 m intervals were also collected parallel to the road. Depending on ground conditions, depth of penetration was typically 6 to 8 m below ground level (bgl). The higher than average depth penetration for the GPR is related to the sandy nature of the glacial till underlying the field (indicating a relatively free-draining medium).

All GPR profiles were processed to enhance their reflected signal and then visually screened for reflections that might indicate the presence of anomalies.

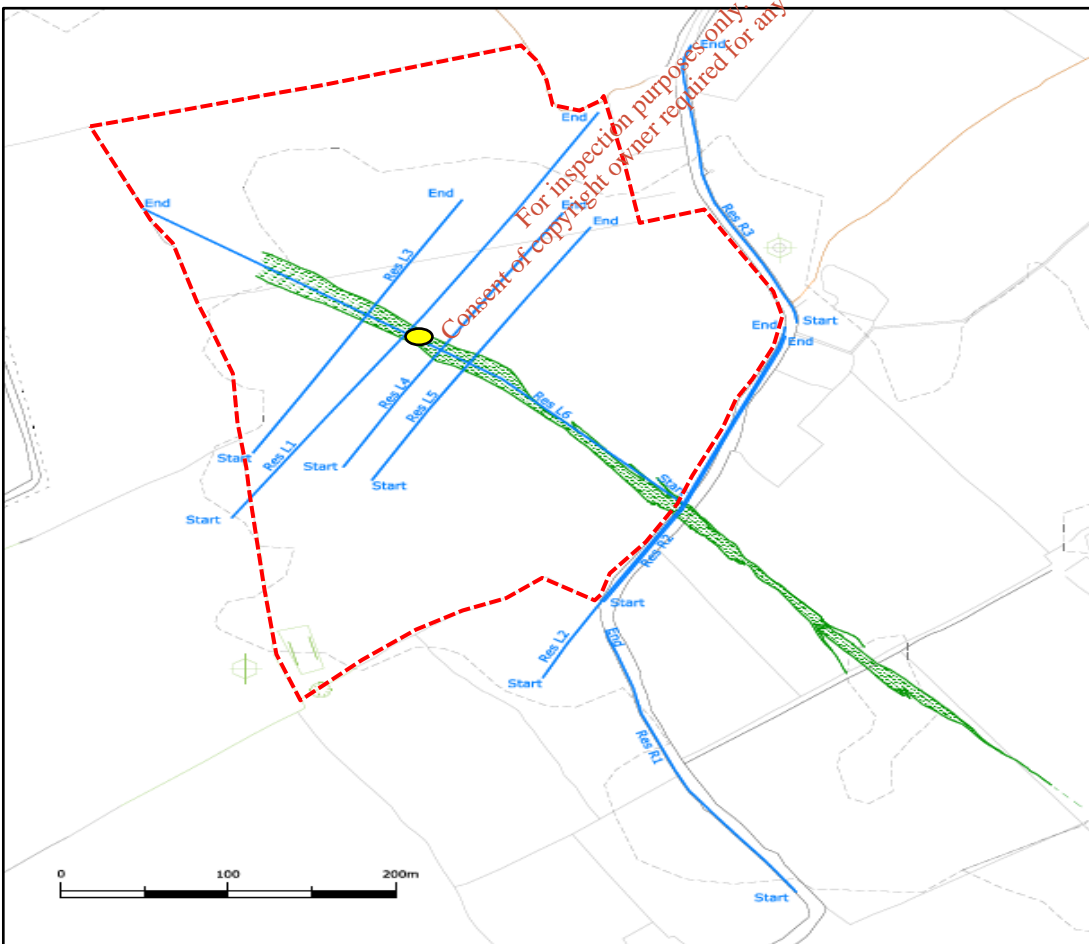
Figure 20: Showing layout of ERI lines (blue, landholding (red), Main Fissure (green) and sinkhole (yellow)

A total of nine ERI lines were surveyed, with four lines (Res L1, Res L3, Res L4 and Res L5) being surveyed across the Main Fissure in the vicinity of the sinkhole, one along the length of the Main Fissure (Res L6), and four along the public road (Res L2, Res R1, Res R2 and Res R3) (Figure 20).

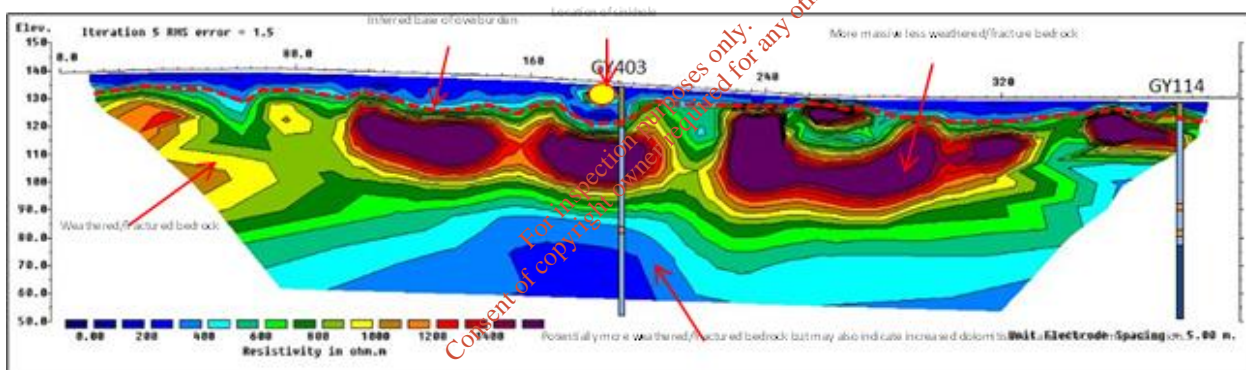
Figure 22: ERI line: Res L1 looking north-west

The pseudosections for the lines surveyed (Figure 22 to Figure 27) correlate well with the information from the mineral exploration boreholes, with resistivity values of typically <200 ohm metres indicating the presence of overburden material and, values of between 200 and 600 ohm metres indicating a heavily weathered/fractured dolomitised limestone bedrock typically between 20 to 30 m bgl. Below ca. 20 to 30 m bgl resistivity values indicate the presence of less weathered/fractured bedrock to locally within 10 to 20 m of the orebody horizon where bedrock can become more weathered and fractured.

The ERI pseudosections for lines Res L1 and Res L3 to Res L6 show similar resistivity patterns. This similarity corroborates with information provided by the existing mineral exploration boreholes by confirming the highly variable nature of the ground conditions (i.e. an undulating bedrock surface, areas of highly weathered and fractured bedrock and areas of more massive and less well fractured bedrock) underlying the field in the vicinity of the Main Fissure. In contrast, the pseudosection for line Res L2 exhibits more massive, less weathered/fractured rock underlying the public road. The resistivity values and patterns from the start of line Res L6 to chainage 160 m (Figure 27) exhibits similar resistivity values and patterns to the entire length of line Res L2 (Figure 23). This indicates that in general, the rockmass underlying the field in the vicinity of the Main Fissure is naturally more weathered/fractured than that underlying the road. Further evidence for this observation can be found at the orebody horizon where distinct weathering and alteration is associated with the hangingwall of the CW Orebody north of a well-developed NE-SW trending sub-vertical structure (see F3 in Figure 3).

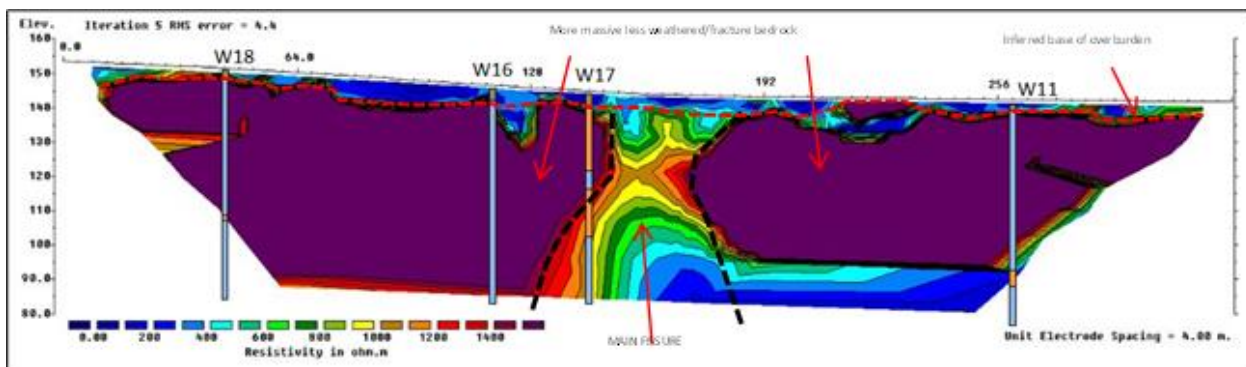
Figure 23: ERI line: Res L2 looking north-west

Below ca. 25 m depth and under the road (Lines R1 – R3) resistivity values tend to be >1000 ohm metres indicating the presence of a more massive less weathered/fractured dolomitised limestone. Line Res L2 (Figure 23) along the road exhibits resistivity values > 1000 ohm metres for the most part except around chainage 160 m, where lower resistivity values correlate well with the position of the Main Fissure as it's mapped underground.

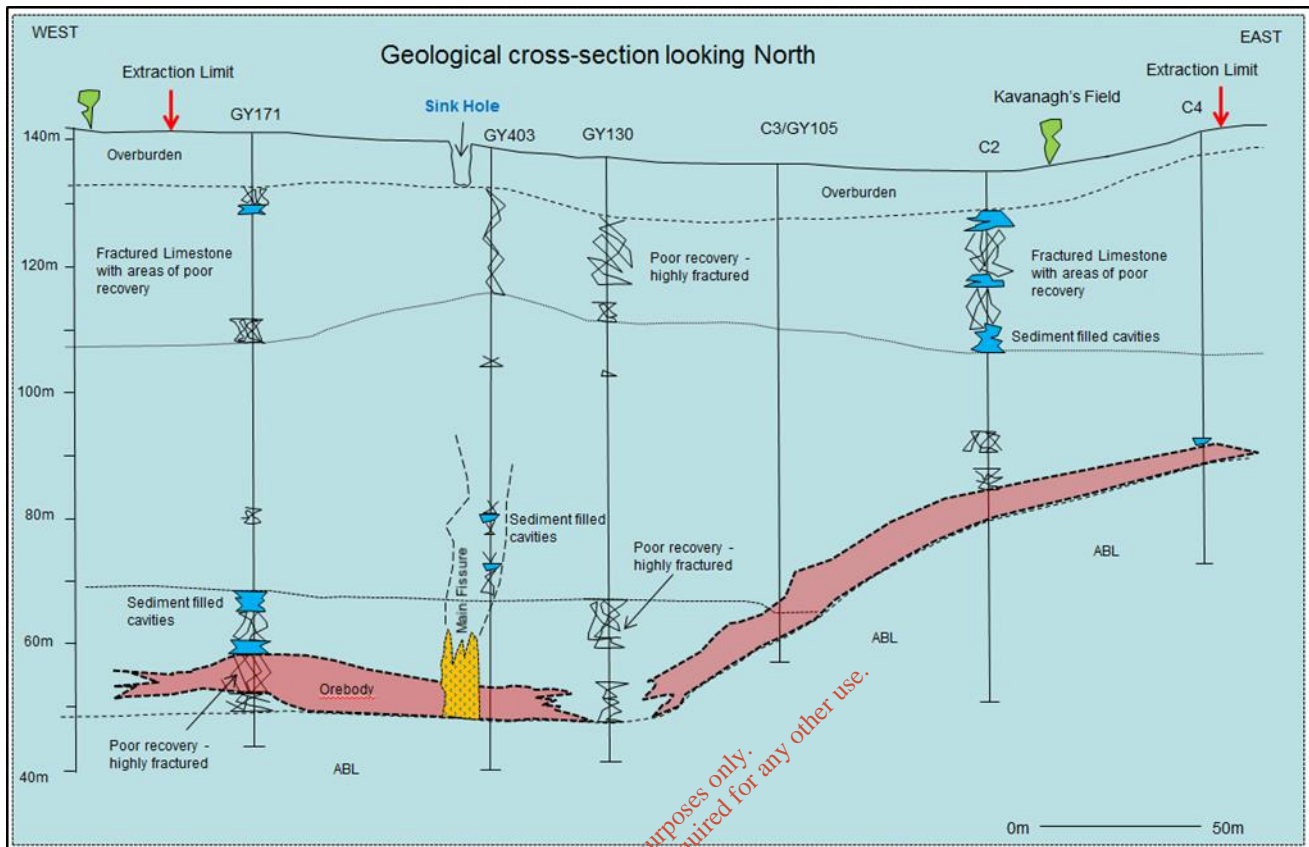
Figure 29: Schematic cross-section CW Orebody showing typical ground conditions in the vicinity of the sinkhole

The initial top 20 to 30 m of the Waulsortian tends to have more intensely weathered fractures and joints, with core recovery from boreholes typically less than 100%. Below this weathered zone the rock tends to become more competent, with less weathered and tighter fractures and joints. Within 10 to 20 m of the orebody hangingwall areas of highly weathered ground can occur. These areas of deep seated weathering which developed during Tertiary times are associated with sub-vertical features and sub-horizontal argillaceous bands and can also occur within the orebody itself (Figure 29).

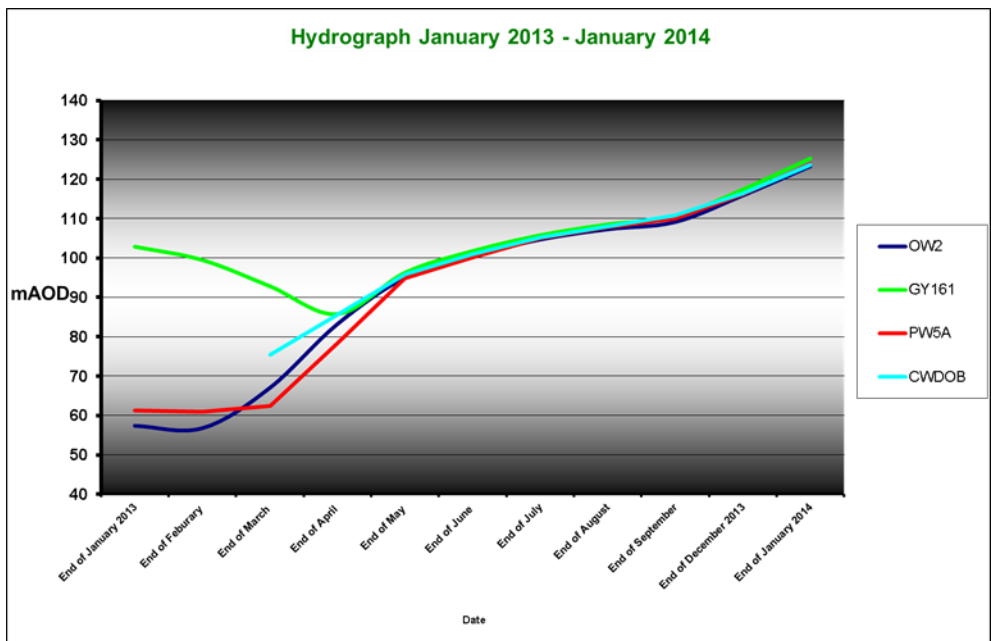
Figure 34: Hydrograph showing groundwater recovery (Lundin Mining)

It is noted however that although the withdrawal of water by means of abstraction or dewatering of a quarry or mine and subsequent water-table drawdown is considered to be the most usual cause of dropout sinkhole formation (Waltham et al 2010), no dropout sinkholes developed at Galmoy during the period of active mine dewatering and declining groundwater levels.

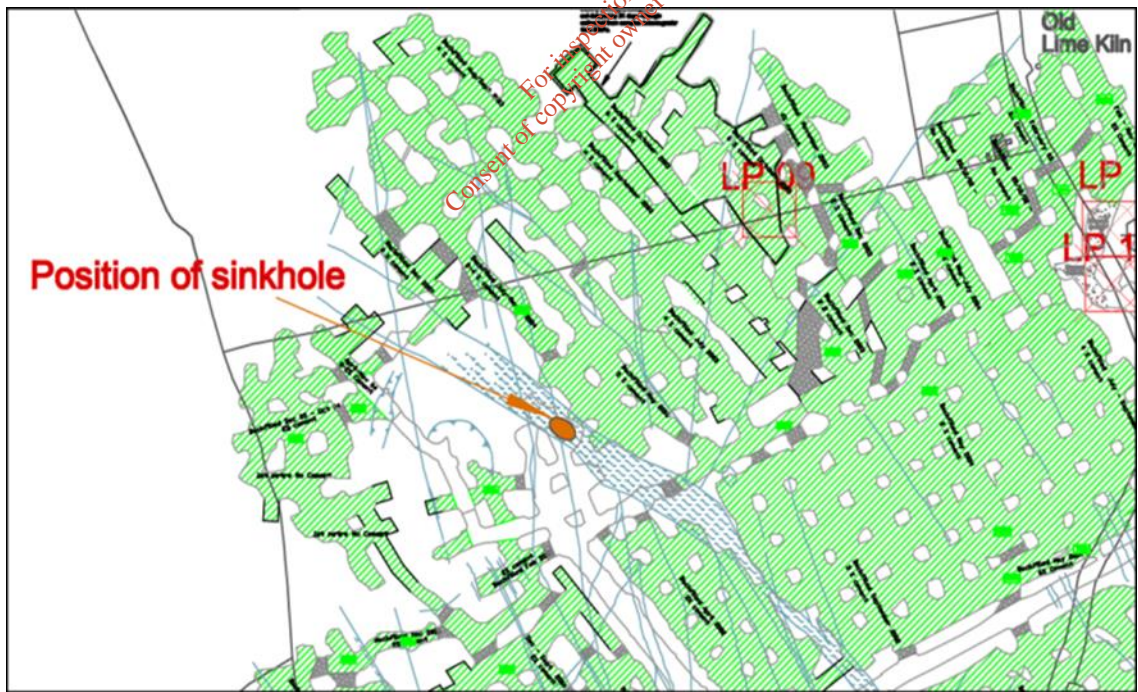
Figure 35: Plan showing relative location of the Main Fissure, sinkhole and mine working

The sinkhole is situated above the Main Fissure and approximately 80 m above the mine workings (Figure 35 and Figure 36).

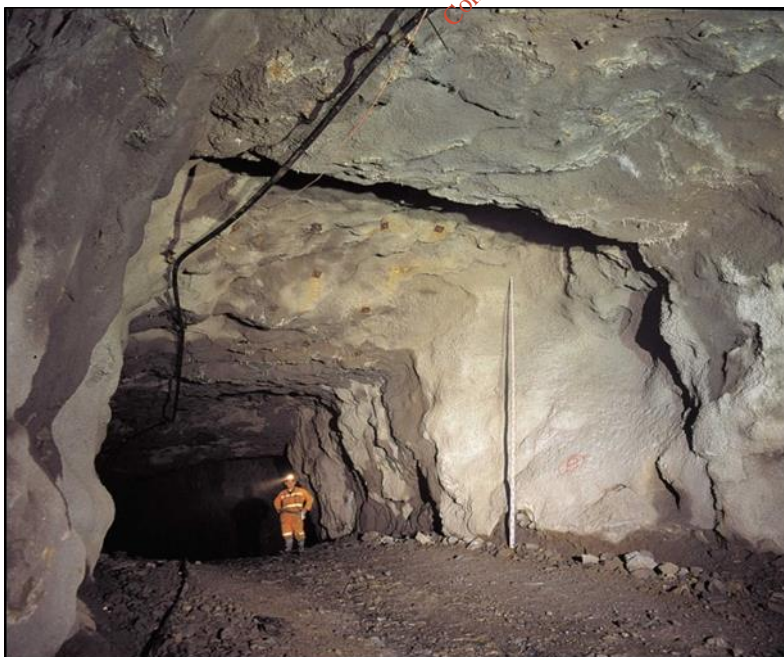
Figure 37: Shotcreted Fissure underground at Galmoy

When the Main Fissure was intersected by the mine workings it was found that it generally 'made' water containing sand and silt / clay for extended periods (weeks to months), following intersection. Generally the rock within the Main Fissure required additional support either with shotcrete (Figure 37) and / or the installation of steel arches.

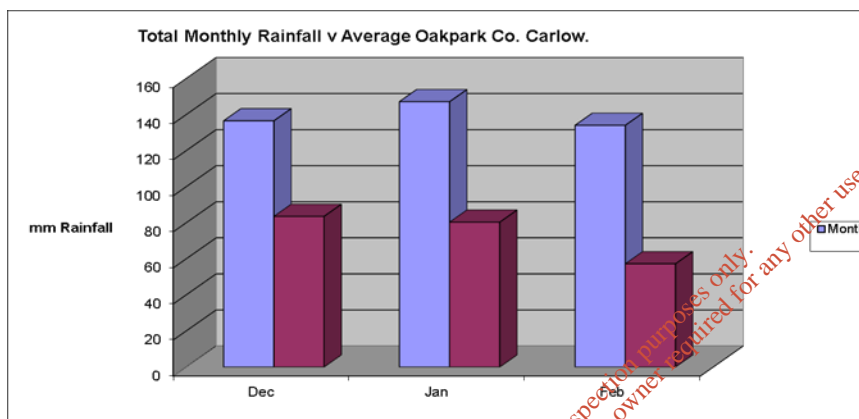
Figure 38: Monthly rainfall data vs average (Lundin Mining)

The void that formed upwards from the superficial deposit-bedrock interface probably grew to close to its final size whilst the mine was being actively dewatered, with the arch close to the threshold of instability. The exceptionally heavy rainfall between December 2013 and February 2014 (Figure 38) would have saturated the soil overlying the void increasing its weight and the additional loading from spreading of soiled water, together with the weight of the tractor, probably caused material to spall from the roof of the void such that it failed that evening.

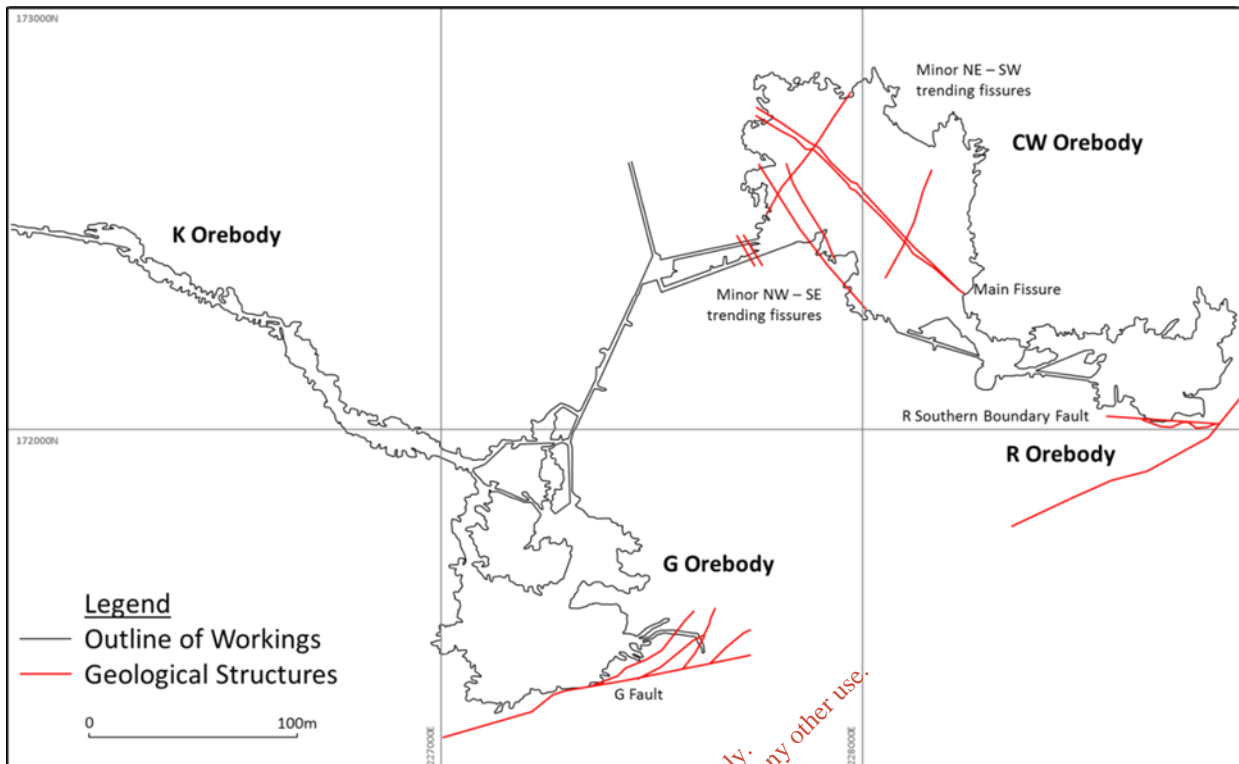
Figure 41: Significant Geological Structures Galmoy Orebodies

CW Orebody Main Fissure: The sinkhole that developed in February 2014 coincided with the mapped underground trace of the Main Fissure. The Main Fissure is a prominent geological structure which was identified during mining of the CW Orebody. The fissure has a strike slip component associated with sub parallel joints. On mining, the intersection of workings with the fissure was associated with locally high ground water inflows. Along the fissure there is locally a high degree of weathering, giving rise to enhanced hydraulic conductivity in that area. For the most part the fissure is downslope of a local drainage / catchment area. A prominent bedrock depression along the strike of the feature has been identified using geophysics. The structure of the fissure pinches and swells both along strike and dip. From underground mapping, the feature is well developed in the CW Orebody.

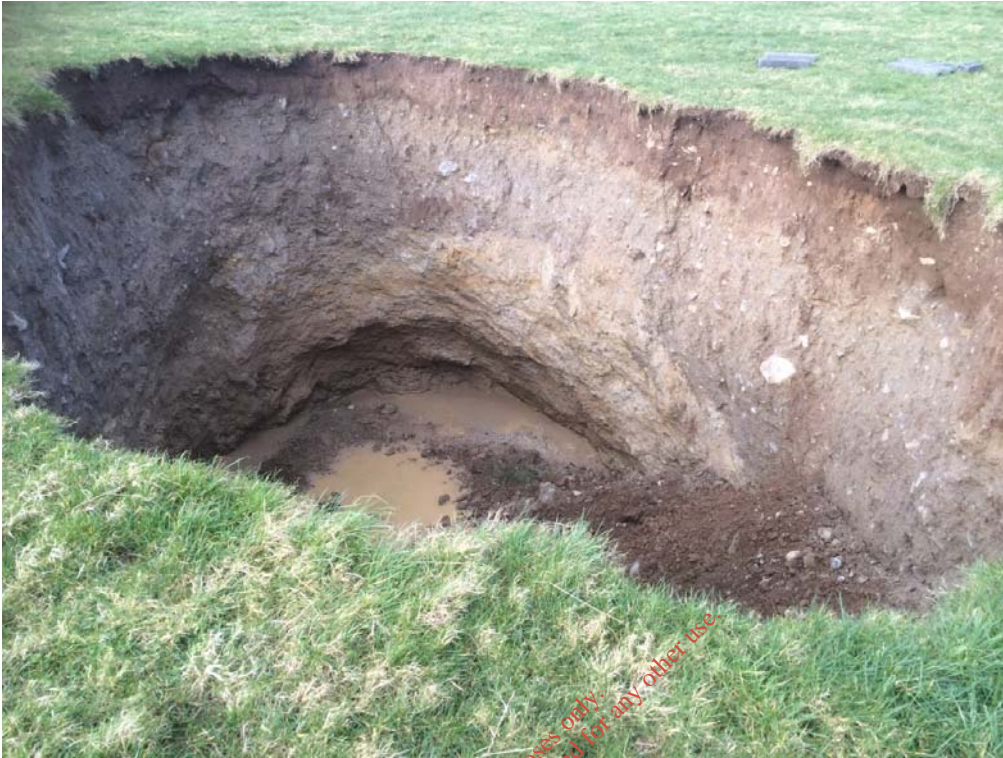
The sinkhole (diameter c. 8m) is located in a grass field to the east of Galmoy Mine Plant with approximate coordinates of ING 227836 172698 (Fig. 2.1). From an AutoCAD map of the mine infrastructure, provided by the client, the sinkhole is seen to be located above an area of backfilled mine and above the Main Fissure with a width of up to 8m. It is understood that the Main Fissure zone was mapped during the development of the mine.

Fig. 2.1 Existing sinkhole

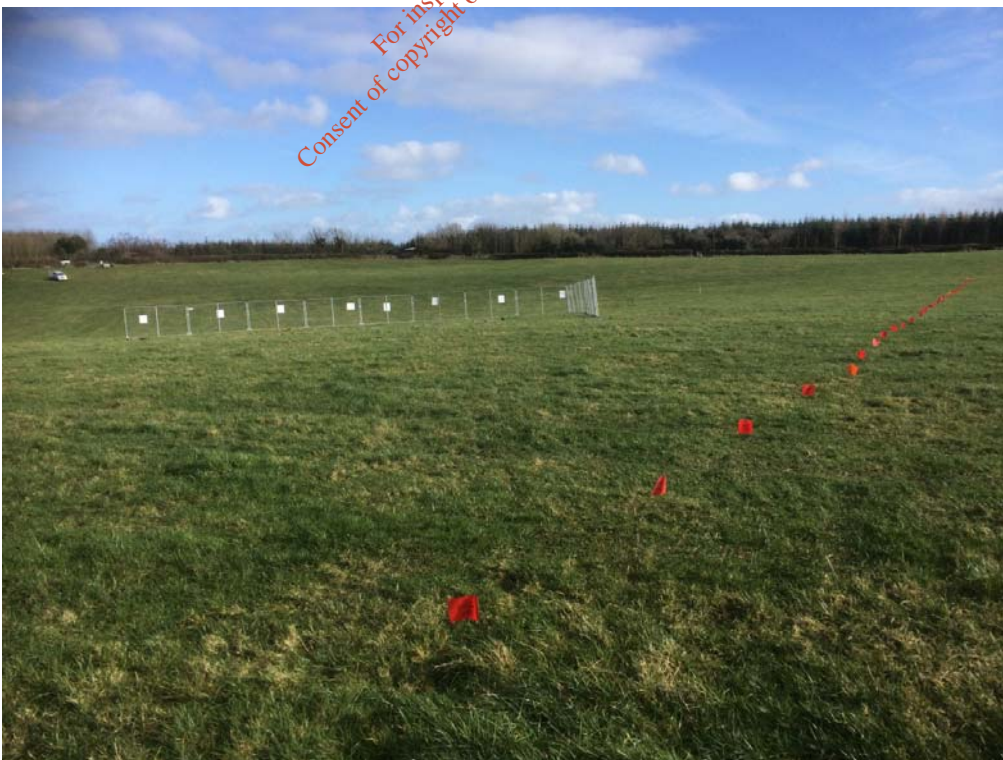
The topography of the site ranges from approximately 130mOD to 150mOD (Fig. 2.2) with an undulating surface that appears to be related to variations in bedrock topography, especially in the north-eastern part of the survey area.

Fig. 2.2 Field in which sinkhole occurred

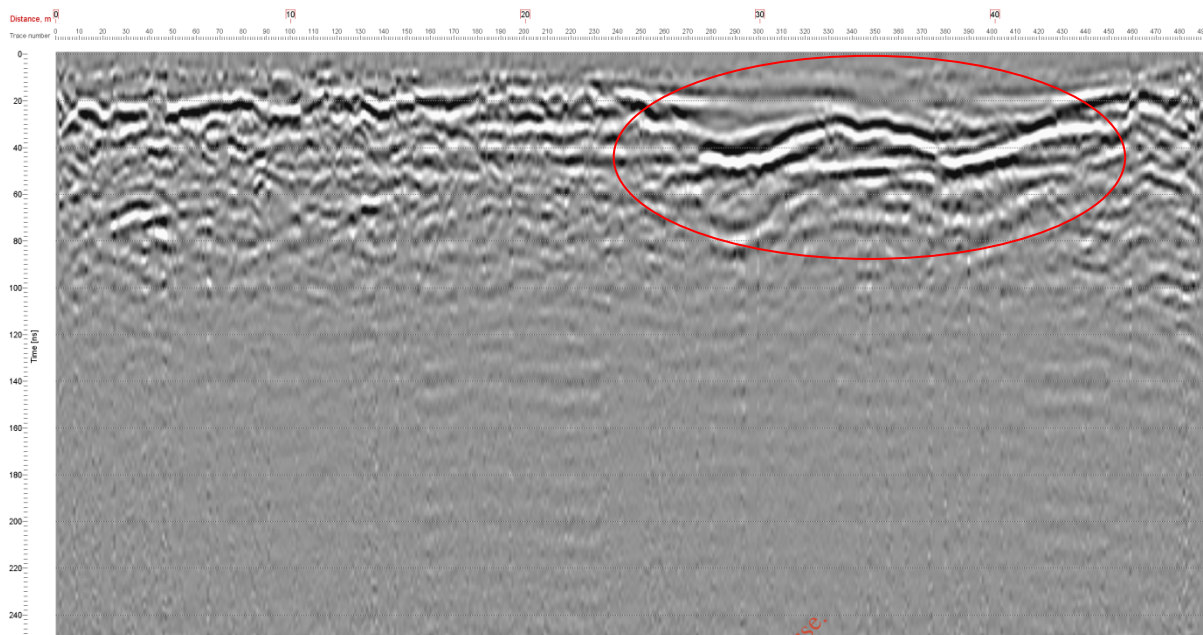
A surface depression to the south-east of the existing sinkhole was evident at the time of survey. (This depression is outlined on the original OSI 6" sheet from c. 1850). This depression was surveyed and showed up as a large area of anomalous reflections on the GPR data, indicative of previous subsidence and infilling (Fig. 3.1). A similar reflection pattern occurs at location A8 but only occurs on one profile. This feature could be further investigated by probing.

Fig. 3.1 Shallow reflections from 25-45m at surface depression south-east of sinkhole.

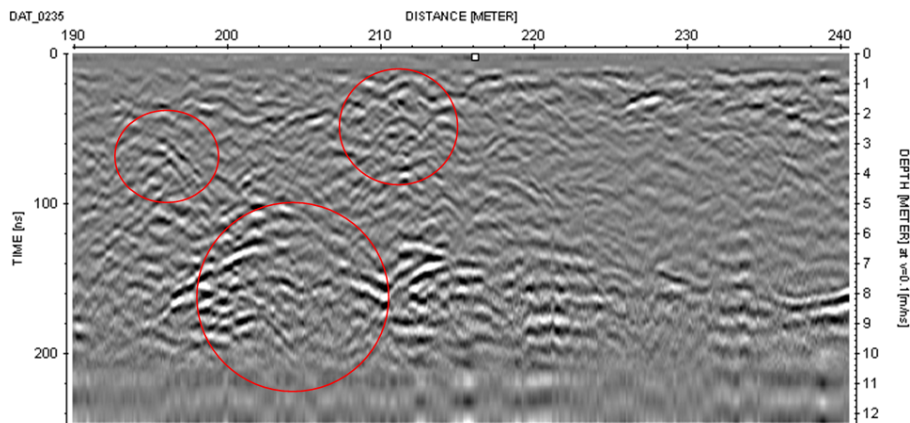
Anomaly No. A22

Anomaly A22 occurs along the county road between 195-220m from the northern end of the road GPR profiles (Fig. 3.2), and there are also a number of other possible anomalies in the immediate vicinity (Fig. 3.2). This correlates with an area where some underground settlement was known to have previously occurred within the mine area. There are also similar reflections (Anomaly A2) along the road profile at 720-730m and at 800m (Anomaly A1). Consideration could be given to investigating by probing in the vicinity of these anomalies.

Fig. 3.2 Deep and shallow reflections from area between 195-220m along county road profile.

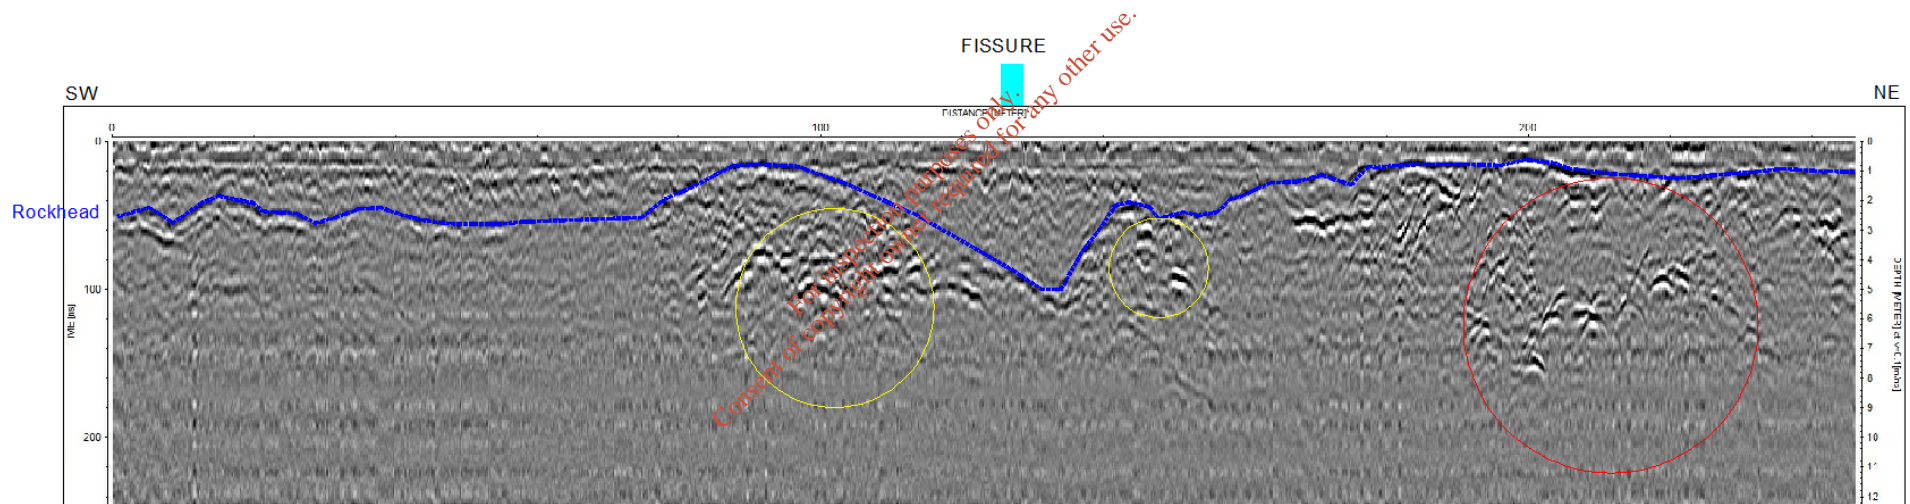
A 250m long SW-NE trending profile was recorded through the southern field (Fig. 3.4) and clearly shows the thickening of overburden in the vicinity of the fissure. Deep point reflectors indicative of possible cavities or changes in material within the bedrock can be seen at the north-eastern end of the profile (red circle).

Fig. 3.4 Profile running SW-NE through the centre of the southern field. Depth penetration of up to 8m has been achieved. The main fissure zone intersects the profile at 128m. The increase in depth to bedrock in the vicinity of the fissure is clearly visible. Point reflections on either side of the fissure indicate possible sand filled cavities (yellow). To the NE deeper reflectors (red) within the rock can be seen around chainage 200m.

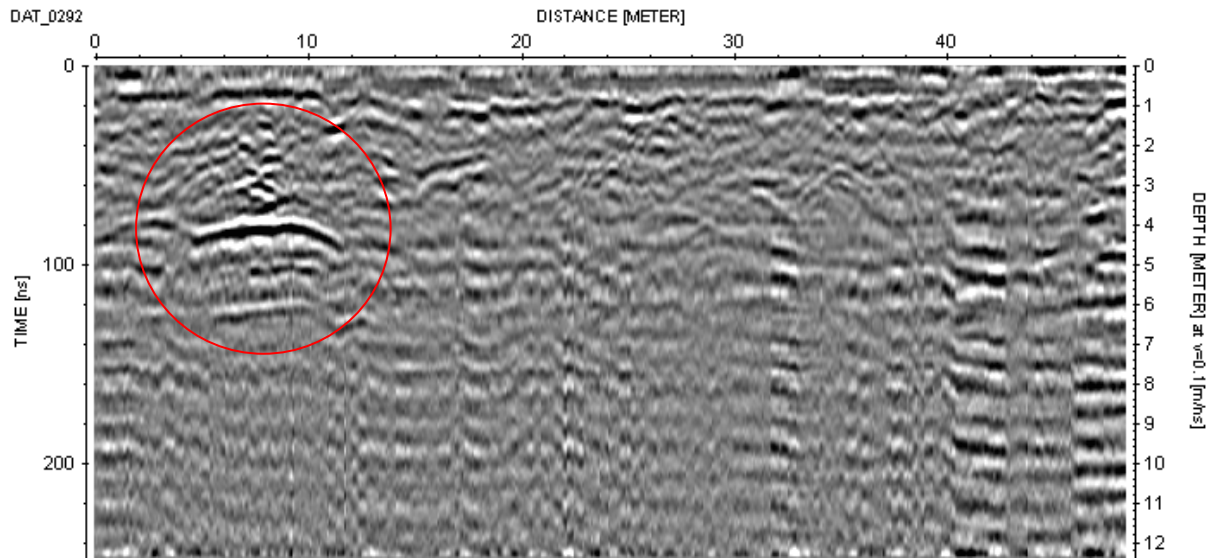
Anomaly No. A3

There is a cluster of reflections in the southern part of the southern field and immediately south of the fissure zone, A3, A4 and A32. These may be due to rock pinnacles but could be investigated given their proximity to the fissure zone and the road.

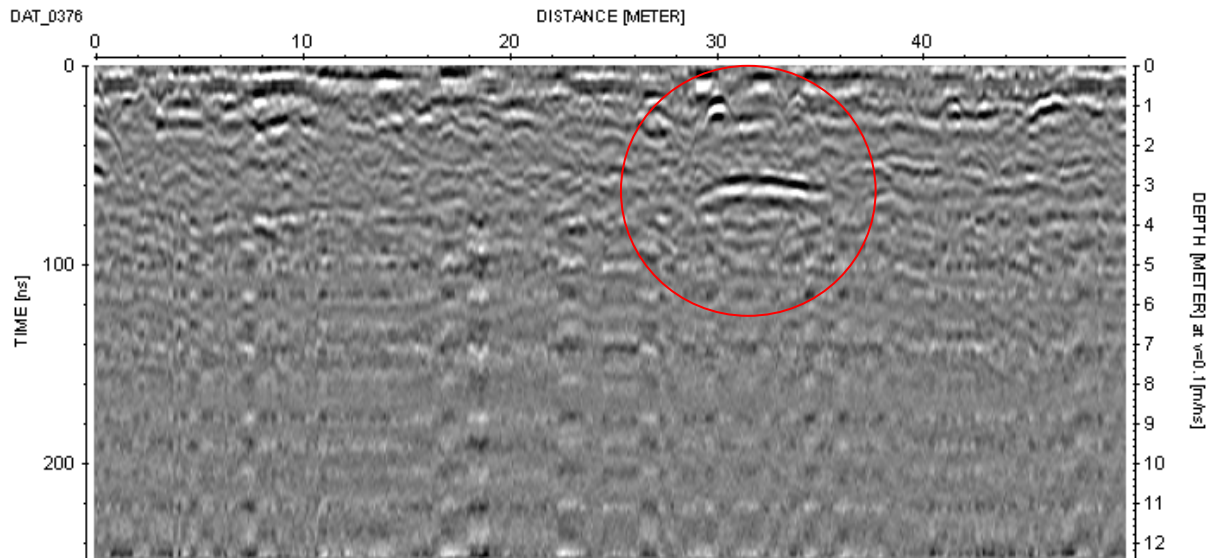
Anomaly No. A16

There are three clusters of reflections to the south of the existing sinkhole and these are labelled as Anomalies A16, A17 and A26 on Drawing AGL14045-01. These features could be further investigated by probing.

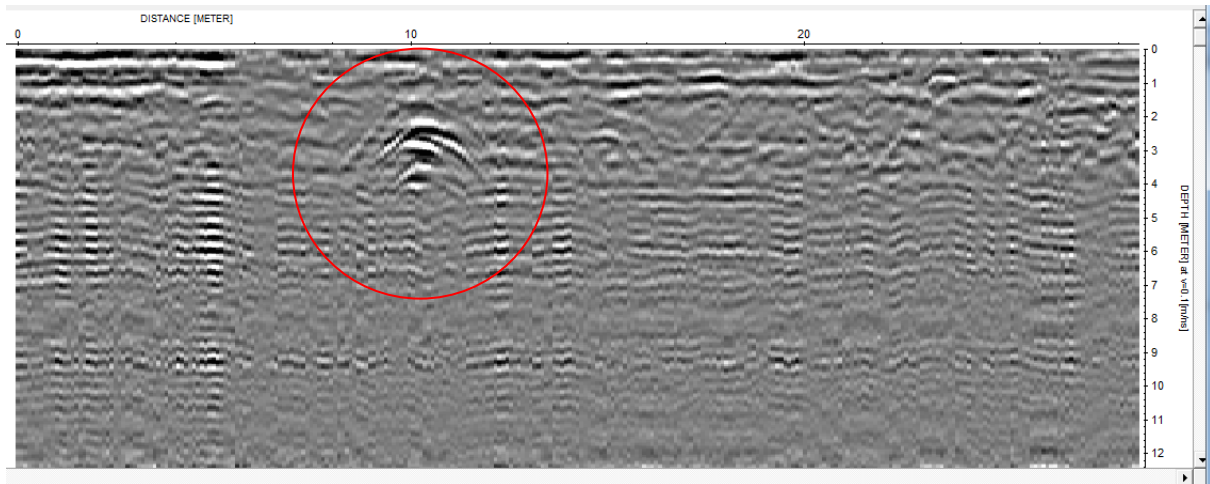
Anomaly A28 Record 578 showing point reflector at 10.2m at depth of 1.4m.
