GALMOY MINE

Investigation of the Possible Causes of the Sinkhole in the vicinity of the Galmoy Mine Workings and Recommended Remediation

Report Number 14507150031.R01.A0

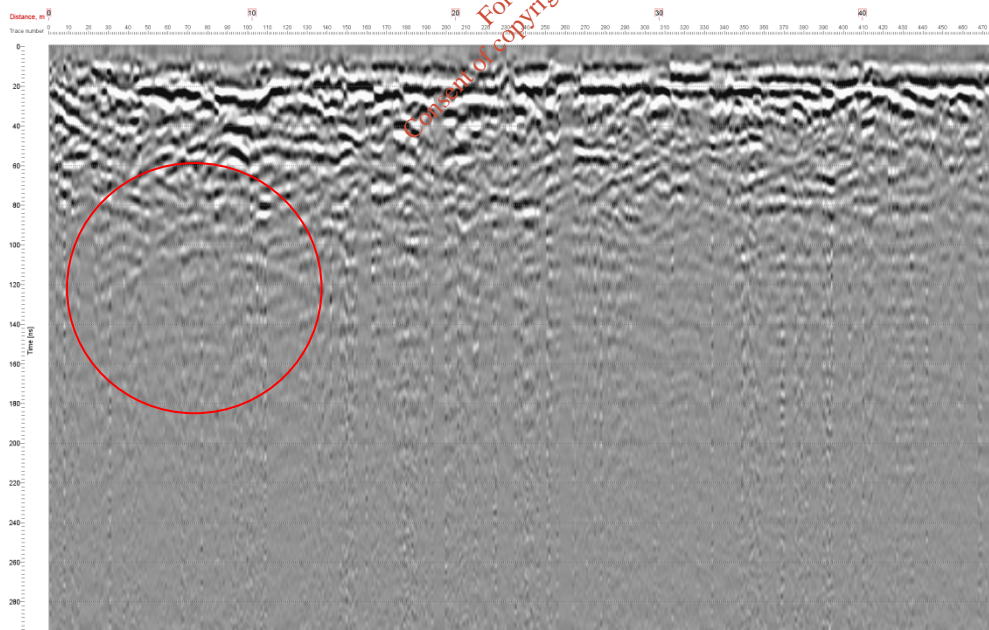
Anomaly A31. Very weak but large anomaly centred at 8m along the profile.

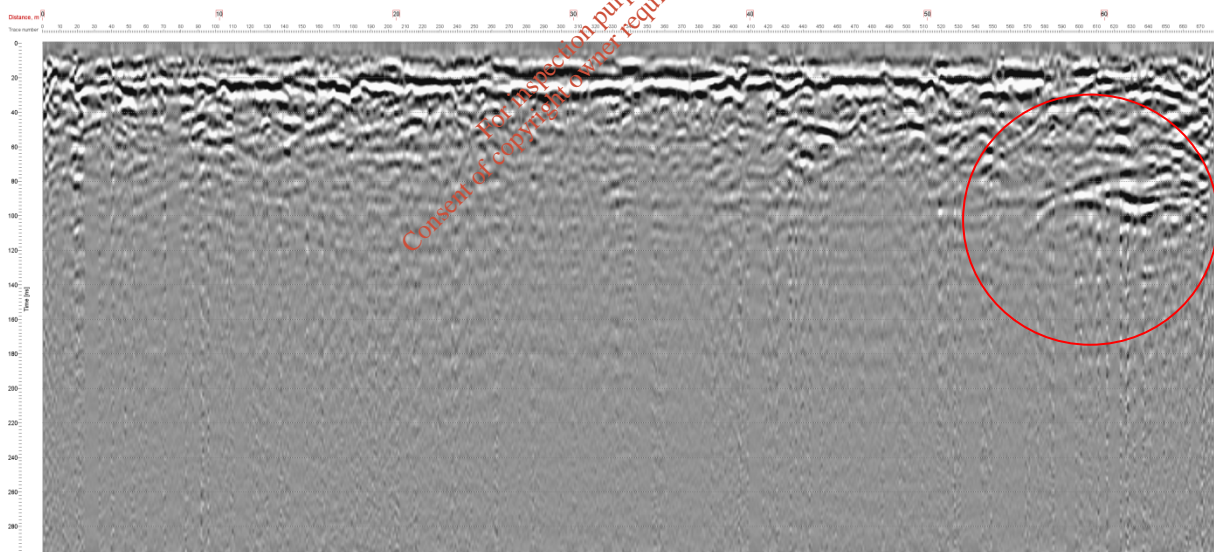
Anomaly A33. Anomaly centred at 58.7m along the profile.

It is recommended that a selected number of the probable anomalies from A1 to A33 (see Table 3.1) be investigated with use of dynamic probing on a 2m grid.
